FORT HUACHUCA, CAVALRY STABLE
(Building No. 30025)
(Building No. 87)
(Building No. 123)
(Building No. 3036)
Clarkson Road
Sierra Vista vicinity
Cochise County
Arizona

HISTORIC AMERICAN BUILDINGS SURVEY

HABS NO. AZ-210-C

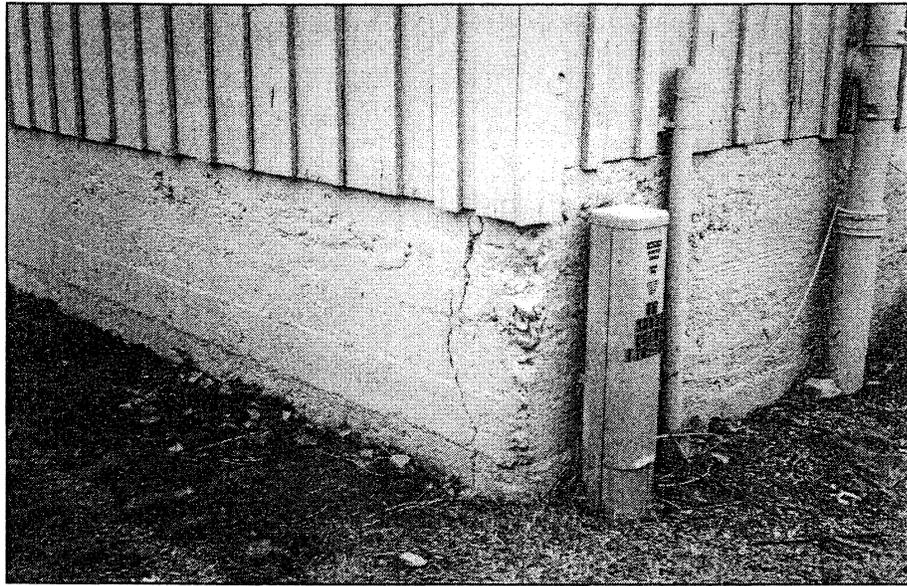
2. Foundations: Foundations are hand-poured, board-formed concrete and comprise an 8-inch-thick stem wall. It is unlikely there is any steel reinforcing in this foundation. Due to the site slope, the stem wall is not visible at the east end of the building, but it is exposed along most of the south façade and the entire north and west facades. In the northwest corner, the stem wall is 2 ft, 8 inches from the earth to the bottom of the wall sheathing. Its hand-poured quality is seen in occasional voids and seams from uneven board placement. The stem wall is painted tan to match the current color of the walls. The stem wall is currently in fair condition with some cracks, abrasion, and corner deterioration. There is no sign of major structural cracking. Where the wall has deteriorated or in voids, it can be seen that a large stone aggregate was used in the original concrete mix (Figure C.3).

FIGURE C.3. CONCRETE STEM WALL, NORTHWEST CORNER, SHOWING MINOR CRACK. STEM WALL HAS BEEN RECENTLY PAINTED (PHOTOGRAPH BY JANET PARKHURST, JANUARY 2005).

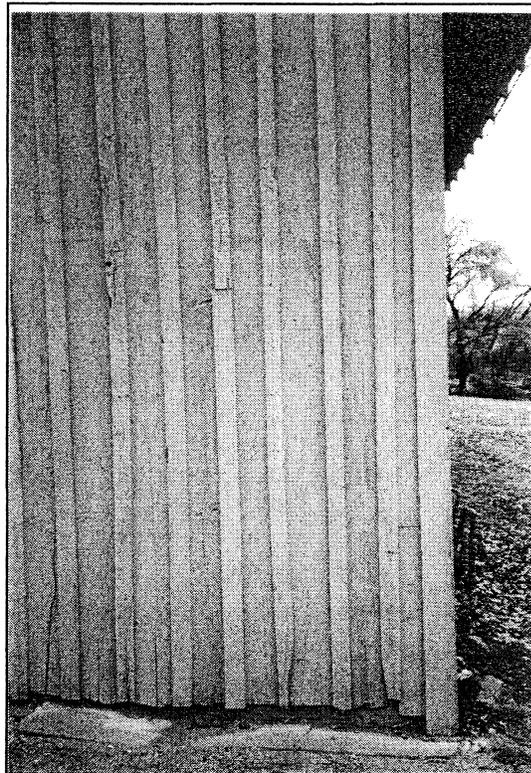
The condition of the exterior walls is fair owing to preservation from the recent maintenance. The boards and battens are obviously early vintage, and members are damaged at the bottom, with some broken or split parts elsewhere (Figure C.4).

FIGURE C.4. EAST BOARD-AND-BATTEN SHEATHED WALL AT NORTH CORNER, SHOWING RECENT PAINT JOB, PLUS DAMAGED MEMBERS AT THE BOTTOM (PHOTOGRAPH BY JANET PARKHURST, JANUARY 2005).

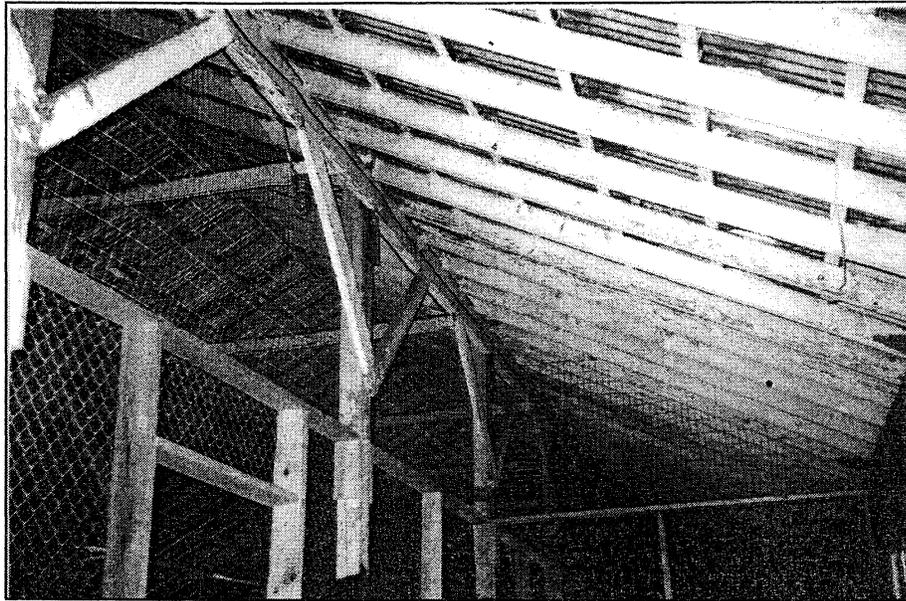
Many of the longitudinal ties at the 9-inch to 7-inch level have been removed, as have lateral ties to the wall. This work occurred when flimsy frame walls were constructed to convert bays to storage cages (Figure C.5). In the former south saddle room, the perimeter bearing wall is seriously tilted out and dislodged from the sill. This problem occurs along approximately three bays, starting at the east end, and leaves a gap up to 7 inches wide (Figure C.6). A remedial post and beam has been added inside as bracing to mitigate this condition.

FIGURE C.5. FRAMING DETAIL SHOWING TYPICAL MISSING TIE MEMBERS, FROM INSIDE A STORAGE CAGE NORTH OF THE AISLE. THIS STRUCTURAL DAMAGE IS RECENT (PHOTOGRAPH BY JANET PARKHURST, JANUARY 2005).

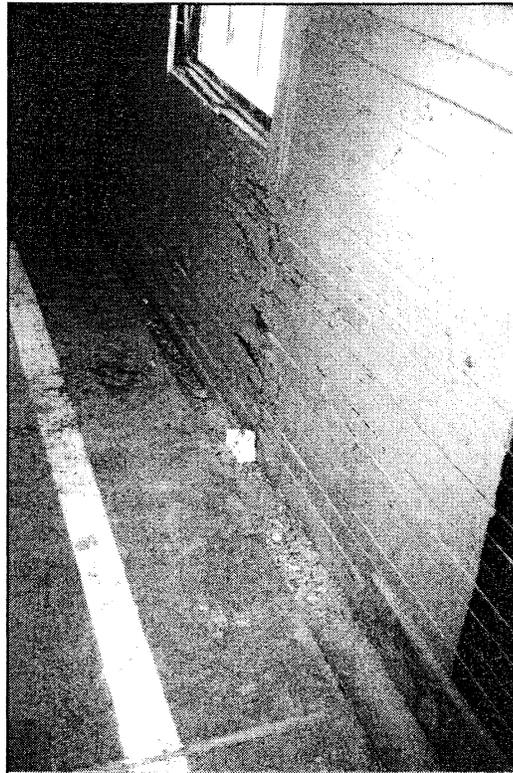
Structural members in Building 30025 are in fair-to-poor condition due to wood deterioration, removal without replacement of some structural members that contribute to an integrated system, and movement of one perimeter wall from its sill. These serious problems require a structural investigation. Although two posts have been replaced along with their diagonal bracing, several posts have splits and interior rot or insect damage near the base, sporadically along six bays. In a unique case, one extra post has been installed.

FIGURE C.6. SOUTH PERIMETER BEARING WALL, SERIOUSLY TILTED OUT FROM SILL, AT EAST END OF BUILDING (PHOTOGRAPH BY JANET PARKHURST, JANUARY 2005).

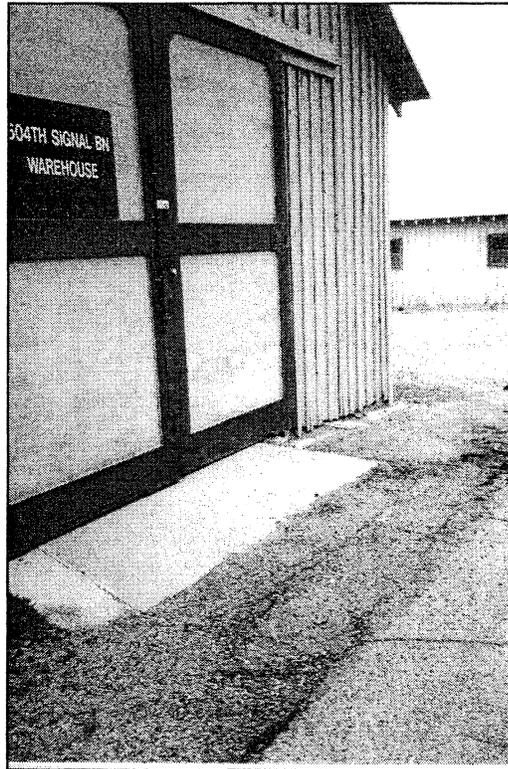
5. Entrance aprons, ramps: Photographs on Q.M.C. forms No. 173a and 117 do not show any kind of grade-level apron at the principal, east entry up to 1941 (Figure C.2; Figure C-S.1). The current, slightly sloped, angled concrete apron between the east door and the road pavement was probably installed between 1951 and 1955 (Figure C.7). Asphalt covers the east edge of this feature.

FIGURE C.7. ANGLED CONCRETE APRON AT EAST ENTRY, PROBABLY INSTALLED WHEN THE BUILDING WAS CONVERTED TO A WAREHOUSE (PHOTOGRAPH BY JANET PARKHURST, JANUARY 2005).

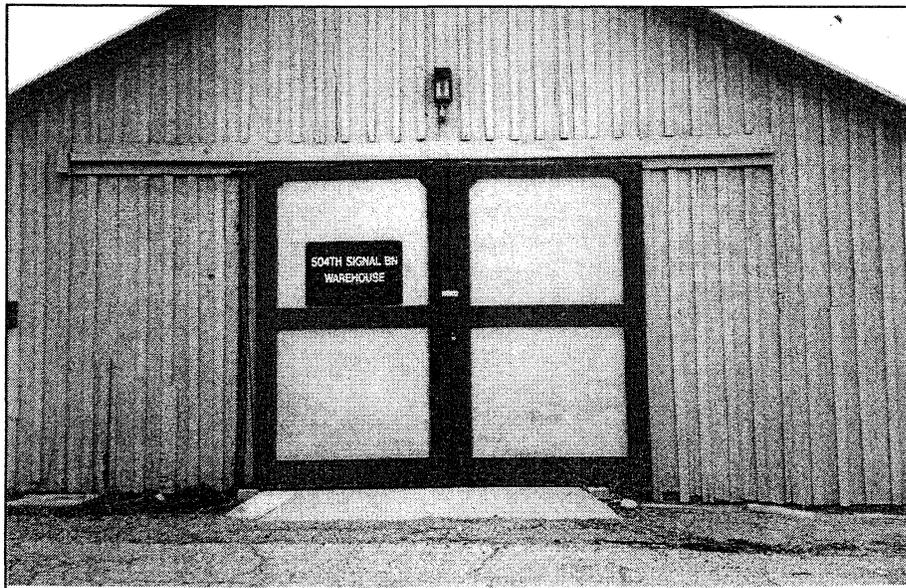
The east or principal entry has a pair of single leaf sliding doors. They are a non-original assembly of the same vintage as the doors on Building 30023, being more recent than 1941. The sliding doors are suspended on metal brackets that slide in a steel track above. Inside, 2-inch-thick boards have been added at the lintel level to which the steel track is bolted. The track has a sheet metal cover that is dislodged and deformed in places. The east door opening is 9 ft, 6 ½ inches wide by 9 ft, 6 inches high. The doors are an assembly of plywood in grooved board stiles and rails. The corners are secured by diagonal, sheet metal plates. The metal elements, which appear on both faces of the door, are through-bolted (Figure C.8).

FIGURE C.8. EAST FAÇADE SHOWING SLIDING DOOR ON A STEEL TRACK. EACH DOOR LEAF IS A PLYWOOD ASSEMBLY IN BOARD STILES AND RAILS (PHOTOGRAPH BY JANET PARKHURST, JANUARY 2005).

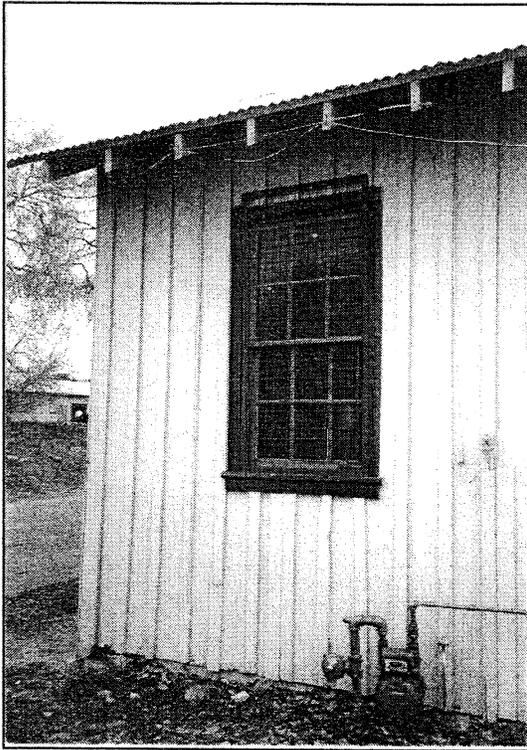
Identical, six-over-six, double-hung windows that originally served the storage rooms are found on the east end. There are three double-hung windows on the south façade and two on the north façade installed in 2-ft, 8-inch by 5-ft, 2-inch rough openings. Identical, six-pane windows to serve former stalls are installed in 2-ft, 10-inch-square openings. Originally up-swinging hoppers, most were later boxed inside with 1-inch-thick boards in the head and jambs to fix them. Both window types have ¾" x 3 ¾" casing and a 1 ¼" x 8" sill. Inside, a second layer of ¾" casing was added after the open frame walls were sheathed. A few stall windows were then reset and hinged to the added casing so they could swing inward (Figure C.9; HABS No. AZ-210-C-3).

Currently windows have either steel-frame or wood-frame, square-wire mesh grills attached to the casings. The windows, exterior casing, and wood grill frames have been recently painted and are thus in fair condition.

FIGURE C.9. ORIGINAL DOUBLE-HUNG WINDOW ON NORTH WALL WITH AN ADDED STEEL FRAME, WIRE-MESH SECURITY GRILL (PHOTOGRAPH BY JANET PARKHURST, JANUARY 2005).

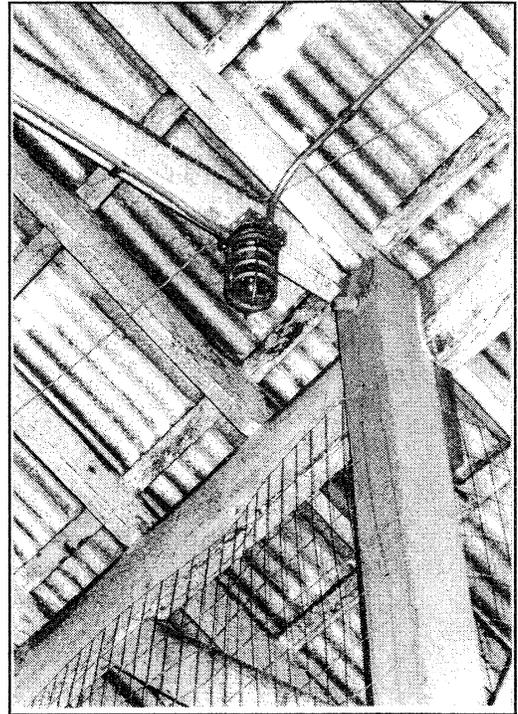
FIGURE C.14. "CAGE" LIGHT FIXTURE ON CROSS-AISLE FRAMING TIE, PROBABLY A RECENT INSTALLATION (PHOTOGRAPH BY JANET PARKHURST, JANUARY 2005).
