FORT HUACHUCA, CAVALRY STABLE
(Building No. 30026)
(Building No. 88)
(Building No. 124)
(Building No. 3037)
Clarkson Road
Sierra Vista vicinity
Cochise County
Arizona

HISTORIC AMERICAN BUILDINGS SURVEY
National Park Service
U.S. Department of the Interior
1849 C Street NW
Washington, DC 20240-0001

FORT HUACHUCA, CAVALRY STABLE
(FORT HUACHUCA, BUILDING 30026)
(FORT HUACHUCA, BUILDING 88)
(FORT HUACHUCA, BUILDING 124)
(FORT HUACHUCA, BUILDING 3037)

HABS NO. AZ-210-D

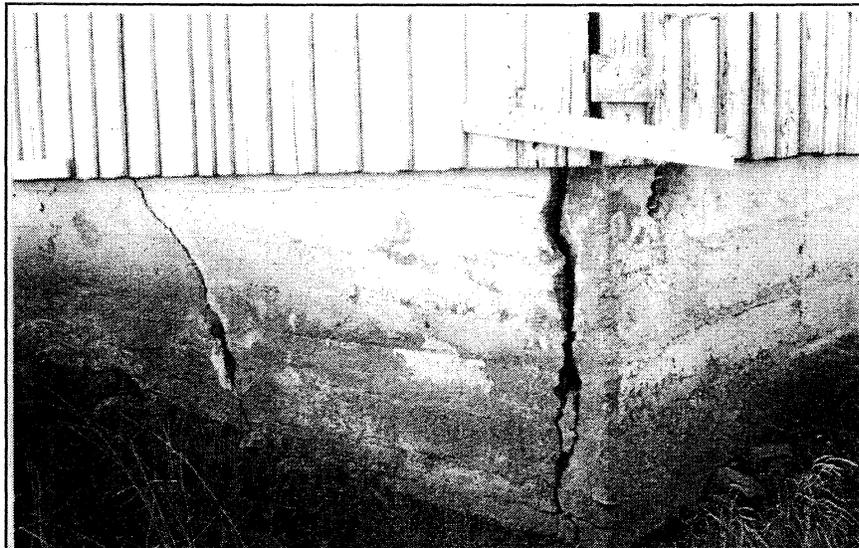
2. Foundations: Foundations are hand-poured, board-formed concrete and comprise an 8-inch-thick stem wall. It is unlikely there is any steel reinforcing in this foundation. Due to the site slope, the stem wall is not visible near the east end of the building, but it is exposed along most of the north façade and elsewhere. Its hand-poured quality is seen in occasional voids and seams from uneven board placement. The stem wall is painted tan to match the current color of the walls. The stem wall is mostly in fair condition with some narrow cracks and abrasion, but there are two large structural cracks on the north wall near the west end. They are in the zone of the large deciduous trees adjacent to the building and extend through a stone retaining wall feature. Roots may have caused the cracks. Where the wall has deteriorated or in voids, it can be seen that a large stone aggregate was used in the original concrete mix (Figure D.4).

FIGURE D.4. CONCRETE STEM WALL AT NORTHWEST CORNER, SHOWING SERIOUS FOUNDATION CRACKS (PHOTOGRAPH BY JANET PARKHURST, JANUARY 2005).

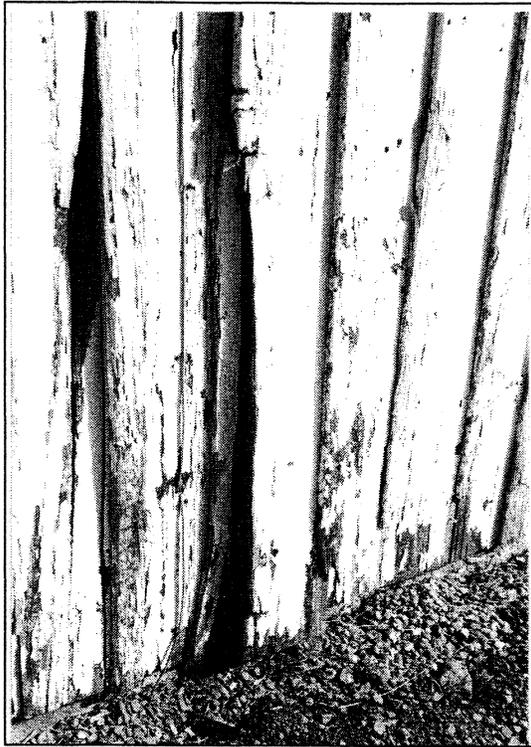
The condition of the exterior walls at this time ranges from fair to poor, with the poor condition largely on the south and west walls. Although painted, some boards and battens are split and broken or dislodged from the frame. Deterioration is especially evident along the lower edges. The last coating of paint is also weathered and deteriorating, especially on the south façade (Figure D.5).

FIGURE D.5. EXTERIOR SOUTH WALL, SHOWING DETERIORATED BOARD-AND-BATTEN SIDING AT BASE (PHOTOGRAPH BY JANET PARKHURST, JANUARY 2005).

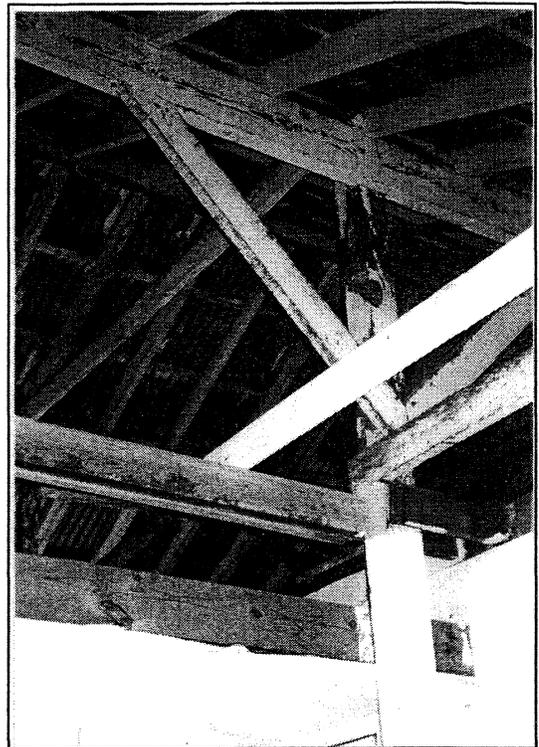
The posts are 6" x 6" redwood timbers that extend from the concrete foundation pad to the bottom edge of a rafter. Except for the longitudinal 3" x 10" support header and the 3" x 6" tie beam at the top of the posts, framing members are 2" x 6"s. It can be observed that posts are tied, in typical fashion, longitudinally along the aisle at the top and at 9 ft, 7 inches above the floor. There are flanking, diagonal, braces. This bracing gives a truss-like appearance. Each post is also connected to the top of the nearest wall by a tie beam attached to a rafter and the wall plate. Such tying occurs on the east side of every sixth rafter. Where visible in the storage area of Building 30026, most structural members are intact. However, a few tie beams have been cut (Figure D.6).

FIGURE D.6. ROOF STRUCTURE, VISIBLE ONLY IN OPEN AREA AT WEST END OF BUILDING (PHOTOGRAPH BY JANET PARKHURST, JANUARY 2005).

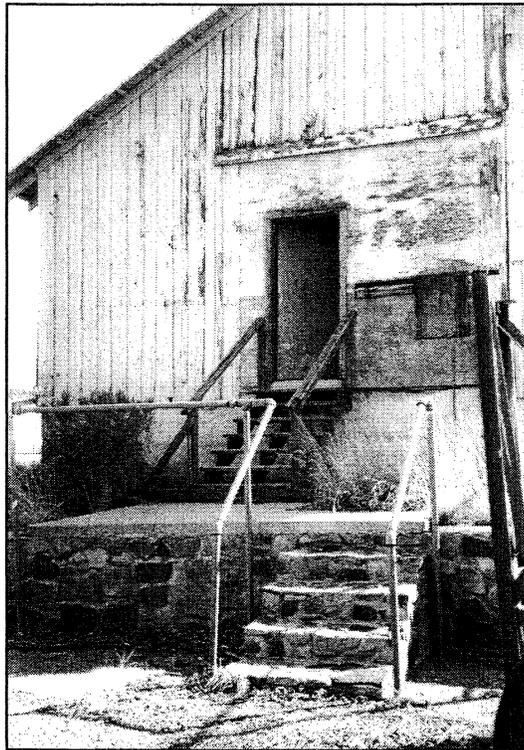
On the west end, a 13-ft-wide strip of earth building "pad" for Building 30026 is contained in a stone retaining wall approximately 2 ft, 6 ½ inches high from the asphalt pavement at grade. This retaining wall continues around the north façade of the building at the west end. It may have been one of many Depression-era, W.P.A. projects constructed at Fort Huachuca (Parkhurst and Thiel 2005). It is an additional 4 ft, 6 inches from the building pad to the west door sill. To accommodate the rise in this location, a feature has been built includ-

ing a base of stone stairs, a concrete landing, and a flight of wood stairs to the main door (Figure D.7).

FIGURE D.7. STONE RETAINING WALL AND STAIRS, CONCRETE LANDING, AND WOODEN STAIRS PROVIDING VERTICAL ACCESS TO THE WEST DOOR (PHOTOGRAPH BY JANET PARKHURST, JANUARY 2005).

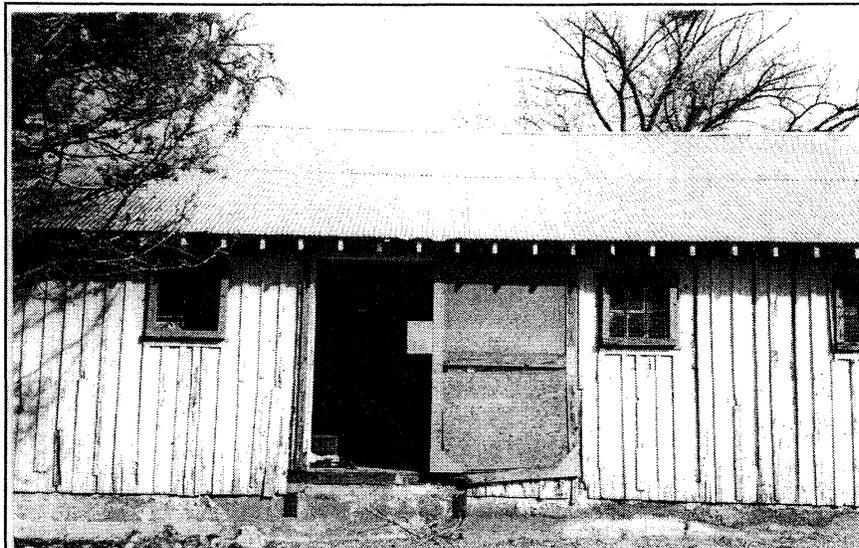
The single-leaf sliding door on the south façade slides to the east of a 5-ft, 8 ½-inch-wide by 8-ft, 9-inch-high opening. The leaf is suspended by metal brackets from a metal track. Similar in construction to doors seen on the other cavalry stables, it is more recent than 1941. It is an assembly of plywood in grooved board stiles and rails. The corners are secured by diagonal, sheet metal plates. The metal elements, which appear on both faces of the door, are through-bolted (Figure D.8). The second door opening toward the east end of the south façade is for a 3-ft, 0-inch by 6-ft, 8-inch door that is currently missing.

FIGURE D.8. SOUTH DOOR, A SLIDING ASSEMBLY OF PLYWOOD WITH BOARD STILES AND RAILS (PHOTOGRAPH BY JANET PARKHURST, JANUARY 2005).

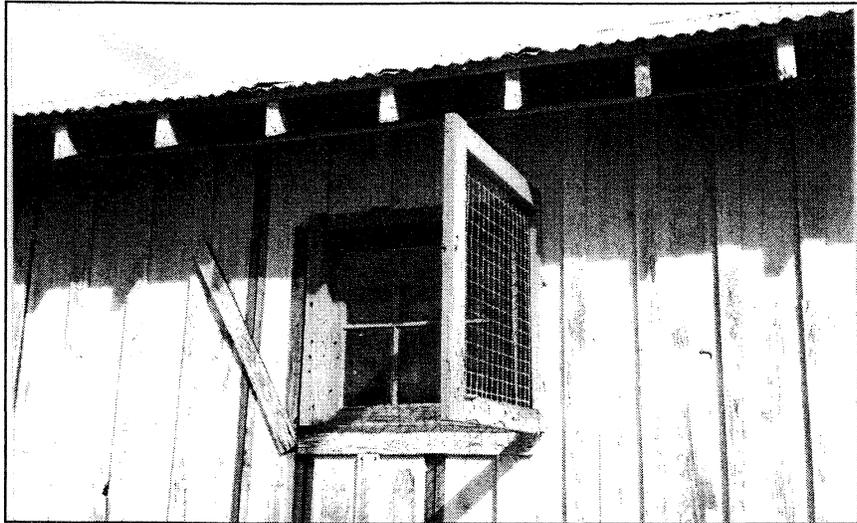
b. Windows: Windows are a very interesting feature on this building and, from outside, they reflect either the original interior use when the building was a stable or later office use. They are located on the south and north walls only. Most, but not all, of the original stall windows remain, even though some of them later served office spaces. They are the typical, square, six-pane windows with glazing in a rough opening approximately 2 ft, 10 inches square. The window sash itself was manufactured (Figure D.9).

The windows, exterior casing, and wood grill frames are very weathered but repairable. Steel diamond-mesh grills are in good condition. Window type and opening alterations are most noticeable on the north façade.

FIGURE D.9. STALL WINDOW ON SOUTH WALL WITH SECURITY GRILL DISLODGED (PHOTOGRAPH BY JANET PARKHURST, JANUARY 2005).
