FORT HUACHUCA, CAVALRY STABLE
(Building No. 30027)
(Building No. 89)
(Building No. 125)
(Building No. 3038)
Clarkson Road
Sierra Vista vicinity
Cochise County
Arizona

FORT HUACHUCA, CAVALRY STABLE
(FORT HUACHUCA, BUILDING 30027)
(FORT HUACHUCA, BUILDING 89)
(FORT HUACHUCA, BUILDING 125)
(FORT HUACHUCA, BUILDING 3038)

HABS NO. AZ-210-E

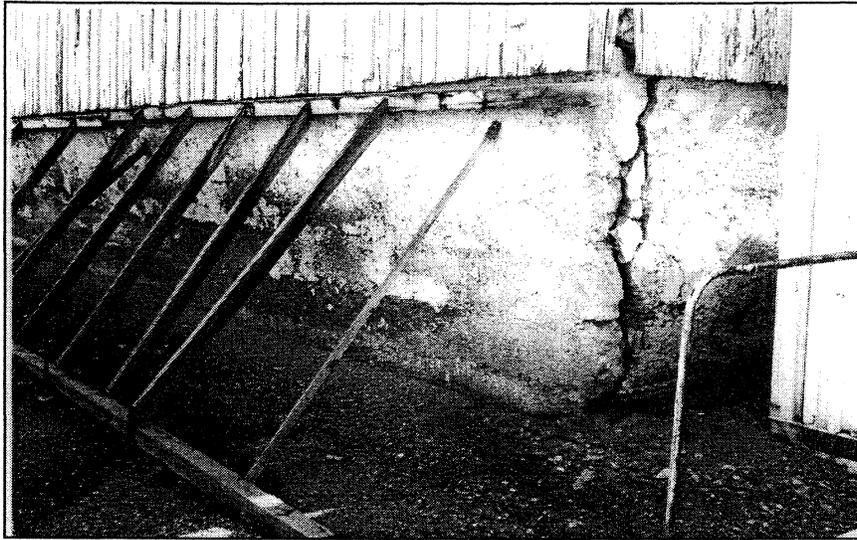
There is a major structural crack on the northwest corner where the foundation is being shored by boards attached to a sill that is braced by steel rods in the pavement. The stem wall is otherwise in fair to poor condition with some cracks, abrasion, and corner deterioration. Where the wall has deteriorated or in voids, it can be seen that a large stone aggregate was used in the original concrete mix (Figure E.3).

FIGURE E.3. CONCRETE STEM WALL, NORTHWEST CORNER, SHOWING SERIOUS STRUCTURAL CRACK AND SHORING (PHOTOGRAPH BY JANET PARKHURST, JANUARY 2005).

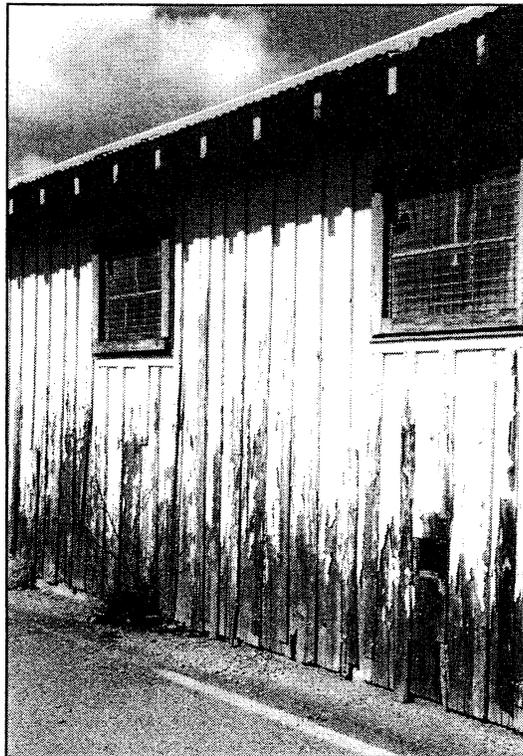
The condition of the exterior walls at this time ranges from fair to poor, with the poor condition largely on the south and west walls. There is considerable paint peeling, some broken and dislodged boards and battens, and dislodging of nails. Typically, the lower edge of the exterior cladding is more damaged (Figure E.4).

FIGURE E.4. BADLY WEATHERED BOARD-AND-BATTEN WALL, SOUTH FAÇADE, SHOWING LOWER EDGE DETERIORATION (PHOTOGRAPH BY JANET PARKHURST, JANUARY 2005).

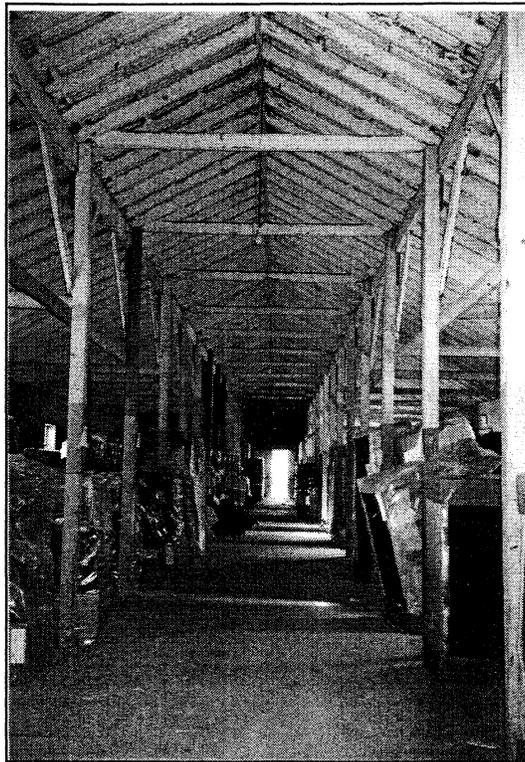
4. Structural system, framing: Much of the integrated, repetitious structural system is easy to study because it is exposed inside. Although non-original, interior cladding obscures the wall structure, it is a wood frame bearing wall system on continuous concrete foundations with two internal, longitudinally placed rows of regularly spaced posts along a central aisle. The posts are braced and tied to the walls, the sloping roof rafters and across the aisle by lateral, longitudinal, and diagonal members. It is interesting to note the elegant manner in which the rustic framing elements fit together to form an integrated structure that has survived since 1916. Posts, roof framing members, and nailing boards appear to be of redwood whereas wall studs and exterior board siding are probably of fir (Figure E.5).

The structure remains in remarkable condition considering its vintage, but there has been removal, with or without replacement, of some structural members. Six of the original posts have been replaced, along with related tie members. A number of longitudinal and latitudinal tie beams have been removed. Some are cracked, probably damaged by equipment such as fork lifts. There has been some replacement of tie members. To support the upper 3" x 10" beams, 2-inch-blocking was bolted to the wall side of each post at an unknown date. Posts are painted yellow at the base, then a band of gray with white above. At one time, roof framing and the underside of the ceiling were painted white.

FIGURE E.5. INTERIOR VIEW ALONG CENTRAL AISLE, SHOWING ORIGINAL STRUCTURAL POSTS AND FRAMING (PHOTOGRAPH BY JANET PARKHURST, JANUARY 2005).

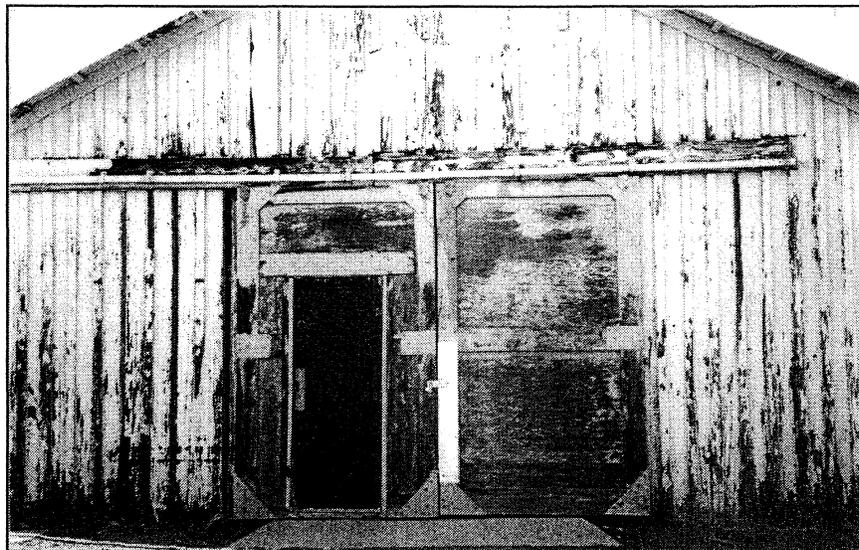
The east or principal entry has a pair of sliding doors over the original 8-ft, 8 ½-inch-wide by 9-ft, 5-inch-high opening. The doors are a non-original assembly of the same vintage as the doors on Building 30023, being more recent than 1941. A personnel door was later installed in the south door leaf. The sliding doors are suspended on metal brackets that slide in a steel track mounted to a board above. They are an assembly of plywood in grooved board stiles and rails. The corners are secured by diagonal sheet metal plates. The metal elements, which appear on both faces of the door, are through-bolted. The personnel door is a 2-ft, 8-inch by 6-ft, 8-inch swinging, flush-panel type, painted red brown (Figure E.6).

FIGURE E.6. NON-ORIGINAL EAST SLIDING DOOR WITH PERSONNEL DOOR INSTALLED IN ITS LEFT LEAF, A PLYWOOD AND BOARD ASSEMBLY OF THE TYPE SEEN ON SEVERAL OTHER STABLE BUILDINGS (PHOTOGRAPH BY JANET PARKHURST, JANUARY 2005).

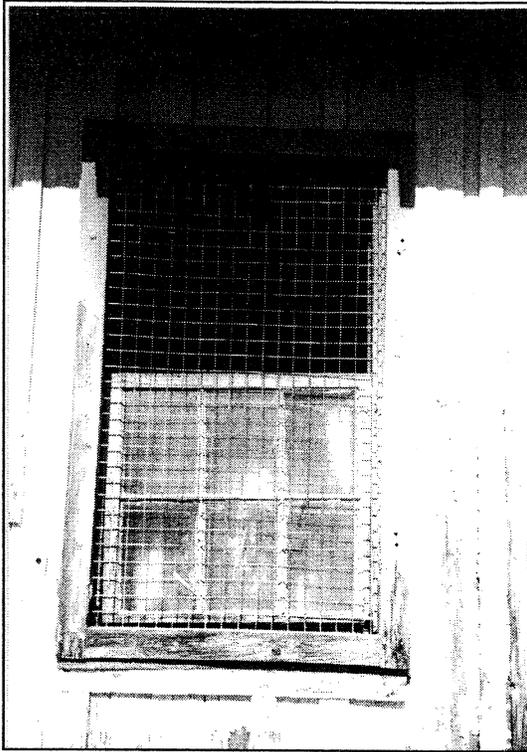
Identical, six-over-six, double-hung windows for the storage rooms are found on the east end. There are three double-hung windows on the south facade and two on the north facade installed in 2-ft, 8-inch by 5-ft, 2-inch rough openings. Identical, six-pane windows to serve former stalls are installed in 2-ft, 10-inch square rough openings. Originally up-swinging hoppers, later they were boxed inside with 1-inch-thick boards in the head and jambs to fix them. Both window types have ¾" x 3 ¾" casing and a 1 ¼" x 8" sill. Inside, a second layer of ¾-inch-thick casing was added after the open frame walls were sheathed (Figures E.7-E.8).

Currently all windows have exterior, wood-frame, square-wire mesh grills, either nailed or bolted to the casings. The last paint color on the grill frames was light brown. The windows, exterior casing, and grill frames are very weathered but repairable. Some stall windows are missing sash and are filled with plywood.

FIGURE E.7. ORIGINAL DOUBLE-HUNG WINDOW FOR THE SOUTH STORAGE SPACE, MISSING SASH. NOTE TYPICAL WIRE-MESH GRILL (PHOTOGRAPH BY JANET PARKHURST, JANUARY 2005).

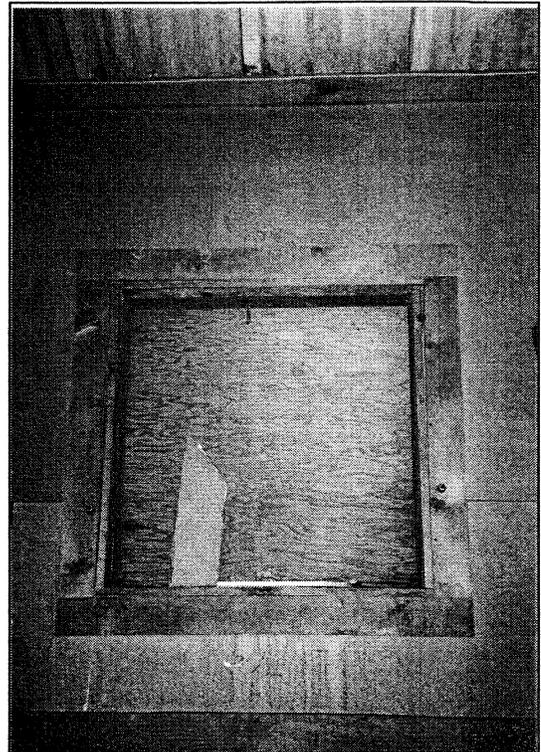
FIGURE E.8. INTERIOR VIEW OF A SOUTH STALL WINDOW SHOWING FRAME FILL AND NON-ORIGINAL CASING USED TO FIX A FORMER HOPPER. BOARDED UP BECAUSE SASH IS MISSING (PHOTOGRAPH BY JANET PARKHURST, JANUARY 2005).

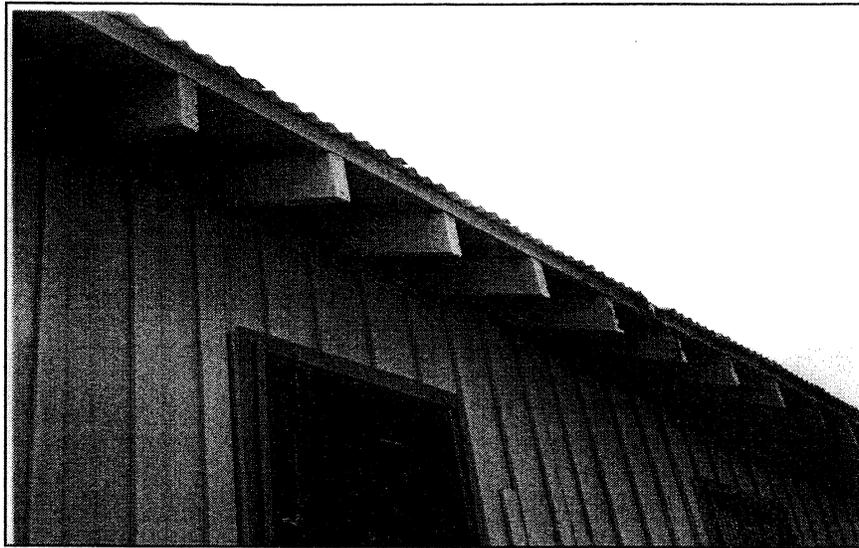
b. Eaves: Eaves comprise exposed 2" x 6" rafter ends that extend to form a 2-ft overhang. The gable rakes, supported by the nailing boards, extend approximately 1 ft. There is a cornice board at the rakes and eaves. Eaves are generally in fair condition because framing members have been painted. There is some weathering of rafter ends and paint peeling on the underside of the roofing (Figure E.9).

FIGURE E.9. EAVES WITH EXPOSED 2" X 6" RAFTERS, NORTH FAÇADE, IN FAIR CONDITION (PHOTOGRAPH BY JANET PARKHURST, JANUARY 2005).

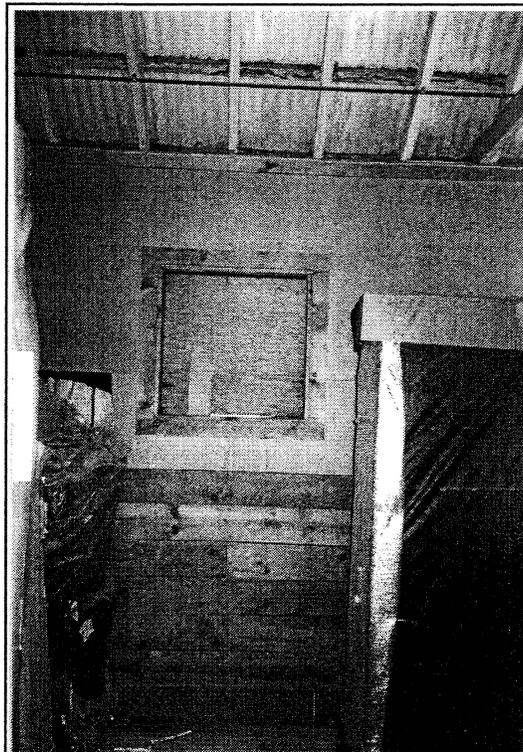
4. Wall and ceiling finish: The interior walls of the former stable area (originally unfinished, exposed structure) are clad in black building paper covered by an early vintage (probably early 1950s), unpainted, horizontal, 5 ½-inch wood board sheathing up to 3 ft, 10 ¼ inches above the slab. Above this band is an early type of 3/8-inch gypsum wallboard encased in brown paper. This material extends to the rafter level. There is a wood nail strip along its top edge. Black building paper is installed on the east and west gable walls, above the door lintels (Figure E.10).

FIGURE E.10. STABLE INTERIOR AREA, NON-ORIGINAL 1950S-ERA WALL CLADDING ON SOUTH WALL (PHOTOGRAPH BY JANET PARKHURST, JANUARY 2005).

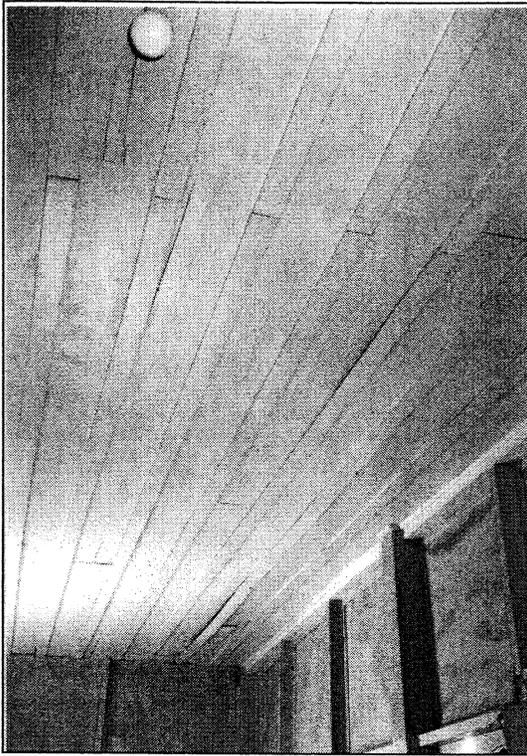
There are no ceilings in the open former stabling area, but they do exist in the former storage rooms and latrines. The north room or saddle shop retains its original board-and-batten ceiling. At approximately 10 ft above the floor, this ceiling consists of 1" x 9" boards with 1" x 2" battens running longitudinally east and west (Figure E.11).

FIGURE E.11. ORIGINAL BOARD-AND-BATTEN CEILING IN THE IN THE NORTH ROOM OF THE BUILDING (PHOTOGRAPH BY JANET PARKHURST, JANUARY 2005).

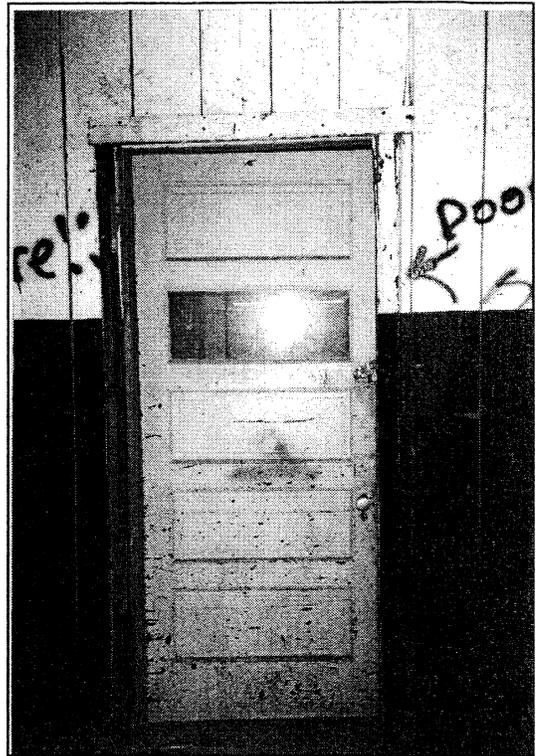
a. Doorways and doors: When first built, the stable had four interior doors, two for each storage room and located on the aisle. The easternmost saddle shop door has been closed and sealed with board-and-batten sheathing. The second door is missing from its 3-ft-wide opening. The south storage room is missing its door at the east end. This 3-ft, 0-inch by 6-ft, 8-inch door accessed the former harness room area (now lined with corrugated metal). The existing west door, which accesses the former grain and forage area, is a five-panel type modified with a pane of glass installed in the second panel from the top. This door appears to be early, if not original (Figure E.12).

FIGURE E.12. OLD FIVE-PANEL DOOR FOR FORMER GRAIN AND FORAGE ROOM AT SOUTHEAST END OF BUILDING (PHOTOGRAPH BY JANET PARKHURST, JANUARY 2005).
