FORT HUACHUCA, CAVALRY STABLE
(Building No. 30028)
(Building No. 90)
(Building No. 126)
(Building No. 3039)
Clarkson Road
Sierra Vista vicinity
Cochise County
Arizona

HISTORIC AMERICAN BUILDINGS SURVEY

FORT HUACHUCA, CAVALRY STABLE
(FORT HUACHUCA, BUILDING 30028)
(FORT HUACHUCA, BUILDING 90)
(FORT HUACHUCA, BUILDING 126)
(FORT HUACHUCA, BUILDING 3039)

HABS NO. AZ-210-F

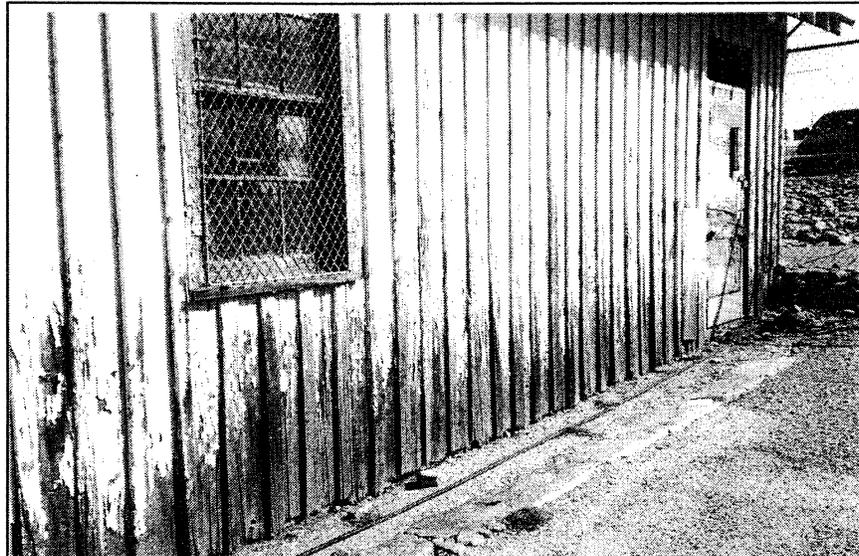
The condition of the exterior walls at this time ranges from fair to poor, with the poor condition largely on the south and west walls. There is paint peeling, some broken and dislodged boards and battens, and dislodging of nails. Deterioration is especially evident on the bottom half of the south wall (Figure F.4).

FIGURE F.4. DETERIORATED SOUTH WALL, SHOWING SERIOUS WEATHERING AT BASE (PHOTOGRAPH BY JANET PARKHURST, JANUARY 2005).

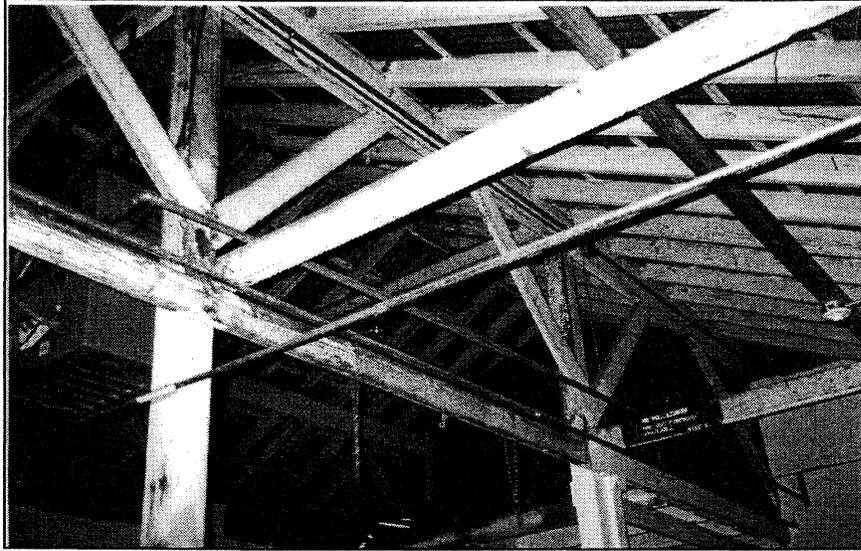
Although cladding obscures the wall structure, it is a wood frame bearing wall system on continuous concrete foundations with two internal, longitudinally placed rows of regularly spaced posts along a central aisle. The posts are braced and tied to the walls, the sloping roof rafters, and across the aisle by lateral, longitudinal, and diagonal members. It is interesting to note the elegant manner in which the rustic framing elements fit together to form an integrated structure that has survived since 1916. Posts, roof framing members, and nailing boards appear to be of redwood, whereas wall studs and exterior board siding are probably of fir (Figure F.5).

FIGURE F.5. ROOF STRUCTURE TYPICAL OF THE SEVEN STABLES, VISIBLE ONLY IN OPEN AREA AT WEST END OF BUILDING (PHOTOGRAPH BY JANET PARKHURST, JANUARY 2005).

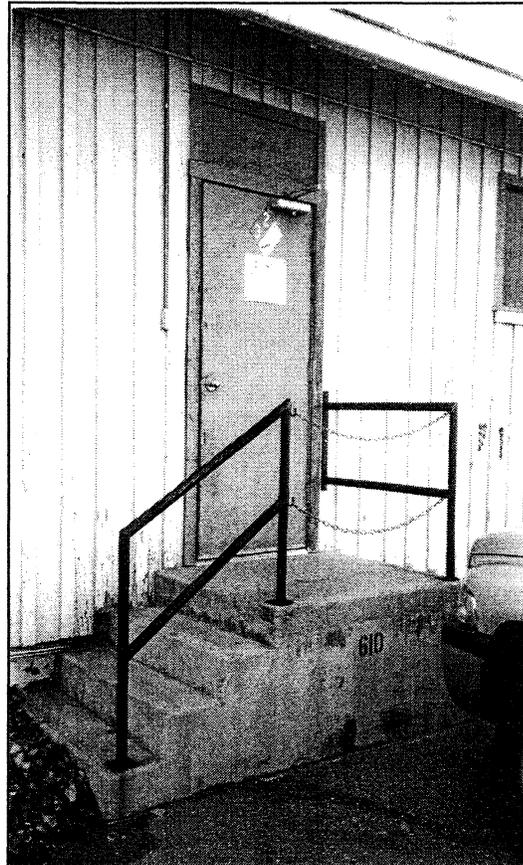
Today there are two concrete stair features, one for the north personnel door and one for the west personnel door. The north stair feature has a 4-ft, 0-inch by 4-ft, 9-inch concrete landing that is 2 ft, 4 ½ inches above the asphalt paving. There is a set of concrete stairs with four 7-inch risers and edge-grooved treads 11 ½ inches to 12 inches wide. There is a 2-inch-diameter pipe railing. The west feature has a 4-ft, 2-inch-square landing that is 3 ft, 7 ½ inches above the asphalt. There are six risers at 7 inches each, and edge-grooved treads 10 inches to 10 ½ inches wide. Pipe railing is installed here as well (Figure F.6).

FIGURE F.6. CONCRETE STAIRS TO NORTH PERSONNEL DOOR, CONSTRUCTION DATE UNKNOWN (PHOTOGRAPH BY JANET PARKHURST, JANUARY 2005).

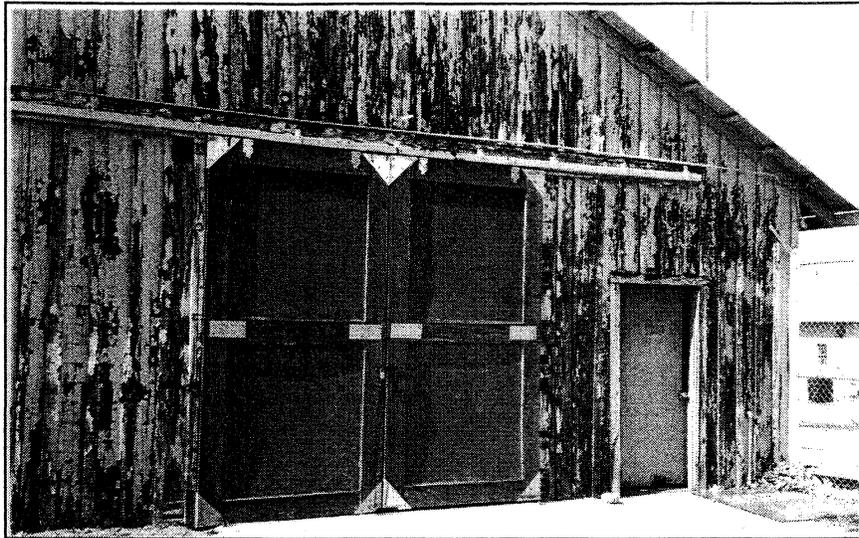
a. Doorways and doors: Currently, Building 30028 has six functioning exterior doors and two covered-over, former door openings. The east entry has a pair of sliding doors and a separate personnel door, for the north room. The original stable entry opening, 9 ft, 6 inches wide and 9 ft, 10 inches high, remains for the sliding doors. The doors are a non-original assembly of the same vintage as the doors on Building 30023, built sometime after 1941. Suspended on metal brackets that slide in a steel track mounted to a board above, they are an assembly of plywood in grooved board stiles and rails. The corners are secured by diagonal sheet metal plates. The metal elements, which appear on both faces of the door, are through-bolted. The east personnel door is a 3-ft, 0-inch by 6-ft, 8-inch metal door, undoubtedly installed in 1973 (Figure F.7). There was once a third door on the east façade.

FIGURE F.7. NON-ORIGINAL EAST SLIDING DOOR WITH PERSONNEL DOOR TO NORTH STORE ROOMS (PHOTOGRAPH BY JANET PARKHURST, JANUARY 2005).

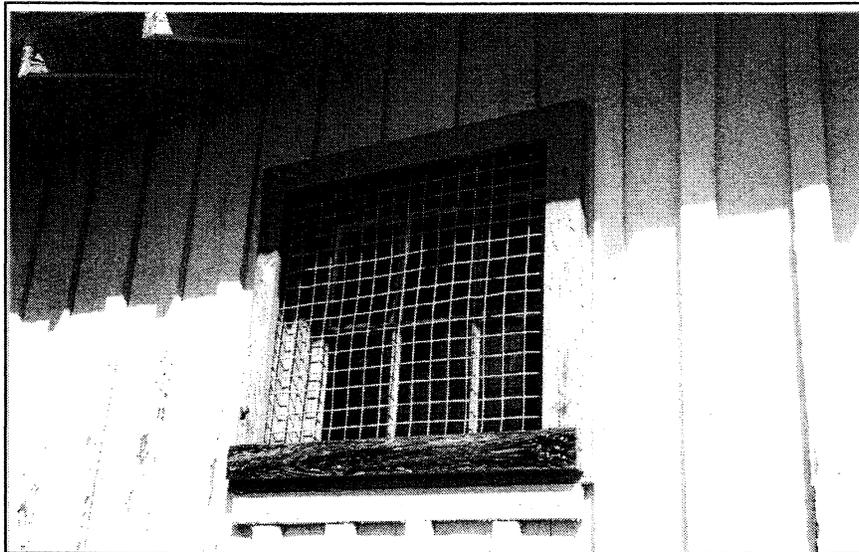
Identical, six-over-six, double-hung windows that originally served the storage rooms are found on the east end, except where replaced by doors. There are two original double-hung windows on the south façade and two on the north façade installed in 2-ft, 8-inch by 5-ft, 2-inch rough openings. Identical, six-pane windows to serve former stalls are installed in 2-ft, 10-inch-square openings. Most are up-swinging hoppers hinged inside on top with a latch below. A few stall windows are side-hinged casements, and a few are fixed. All windows have ¾" x 3 ¾" casing and a 1 ¼" x 8" sill. Inside, when 1950s wall cladding was added, casing appears to have been removed and reinstalled over the early gypsum wallboard (Figure F.8).

FIGURE F.8. ORIGINAL STALL WINDOW WITH FRAMED, WIRE-MESH WINDOW GRILL, SOUTH WALL. DATE OF GRILL UNKNOWN (PHOTOGRAPH BY JANET PARKHURST, JANUARY 2005).

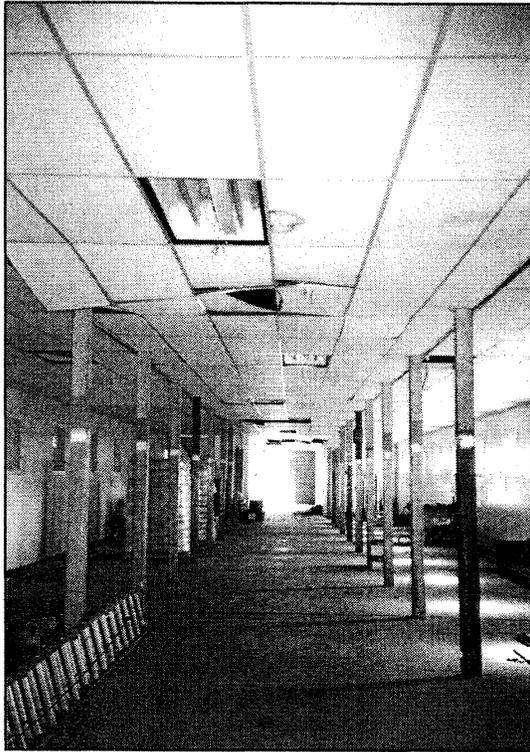
1. Floor plan: Today this single-story, elongated building is zoned so that rooms occupy the east end on either side of a 10-ft-wide aisle that, defined by posts, extends through an extensive area once devoted to stabling. The open-post, former stable area, which includes all but the west three bays of this building, has gypsum wallboard cladding and a suspended, acoustical tile ceiling that obscures roof framing above. Near the west end of the building is a wallboard-clad, frame partition (with an opening) that divides the building into two areas. West of the partition is a three-bay zone, mostly open-framed, that contains two rooms on its north wall (Figure F.9).

FIGURE F.9. OPEN-POST, FORMER STABLE AREA, SHOWING GYPSUM WALLBOARD WALL CLADDING AND SUSPENDED ACOUSTICAL CEILING INSTALLED IN 1973 (PHOTOGRAPH BY JANET PARKHURST, JANUARY 2005).

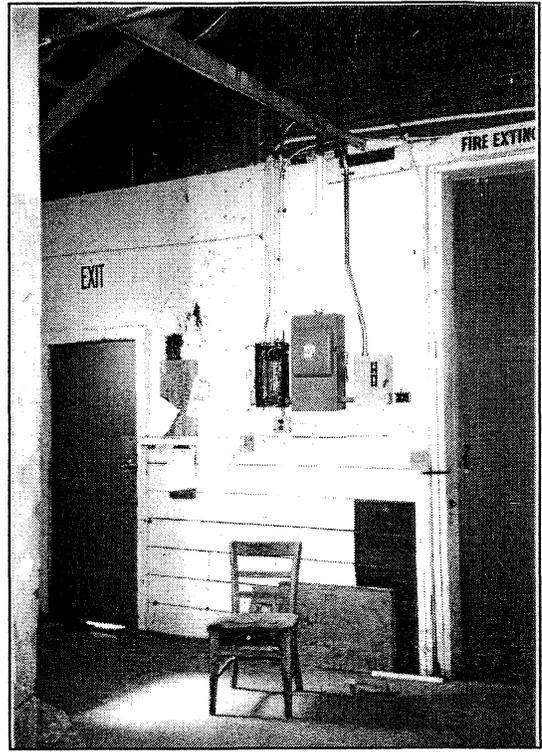
4. Wall and ceiling finish: The interior, perimeter-wall face of the former stable area, originally open framing, apparently was later clad in an early vintage, unpainted, horizontal, 8-inch wood board sheathing up to 4 ft, 6 inches above the slab. Above this band was an early type of 3/8-inch gypsum wallboard encased in brown paper. This system, which may have been installed around 1951, remains visible on the south and west walls in the three-bay, west zone (Figure F.10).

FIGURE F.10. EARLY WALL CLADDING SYSTEM, PROBABLY INSTALLED AROUND 1951, ON WEST PERIMETER WALL (PHOTOGRAPH BY JANET PARKHURST, JANUARY 2005).

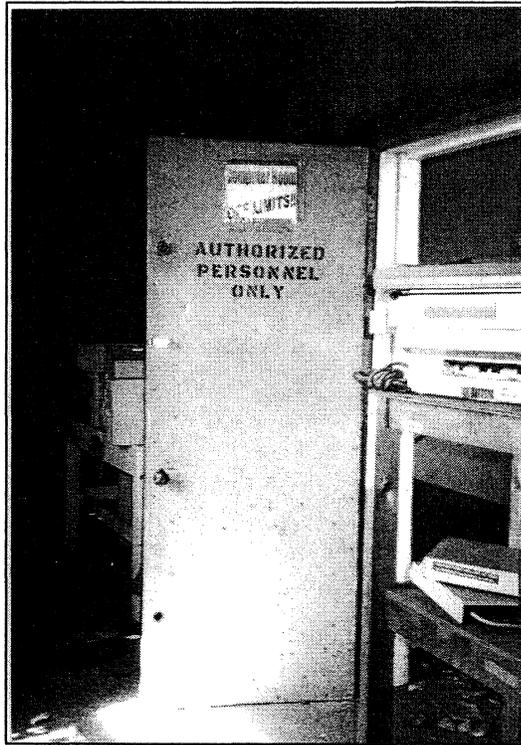
FIGURE F.11. NON-ORIGINAL, FLUSH PANEL, METAL-FACED WOOD DOOR, SOUTH STORAGE ROOM. DATE OF INSTALLATION UNKNOWN (PHOTOGRAPH BY JANET PARKHURST, JANUARY 2005).

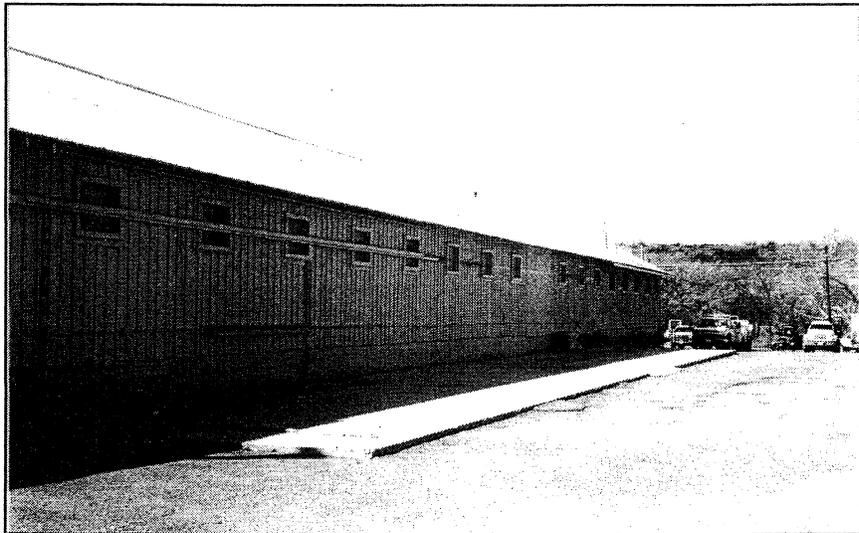
FIGURE F.12. LARGE SLAB IN NORTH FORMER PADDOCK AREA, INSTALLED IN 1973 FOR AN OPEN SHED SINCE REMOVED (PHOTOGRAPH BY JANET PARKHURST, JANUARY 2005).

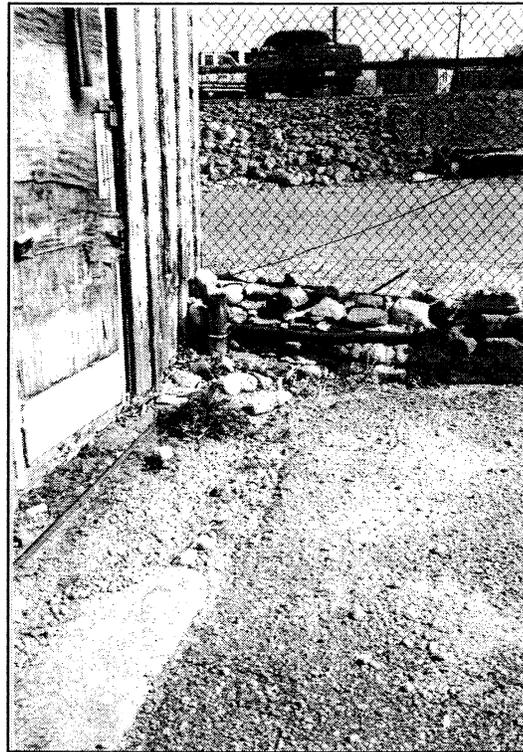
FIGURE F.13. STONE AND PIPE FEATURE, NEAR SOUTH WALL AT EAST END, OF UNKNOWN VINTAGE AND USE (PHOTOGRAPH BY JANET PARKHURST, JANUARY 2005).
