The Henry L. Russell House  
West Grove Township  
Davis County ↗ Bloomfield Vicinity  
Iowa

HABS No. IA-137

HISTORIC AMERICAN BUILDINGS SURVEY

Henry L. Russell House

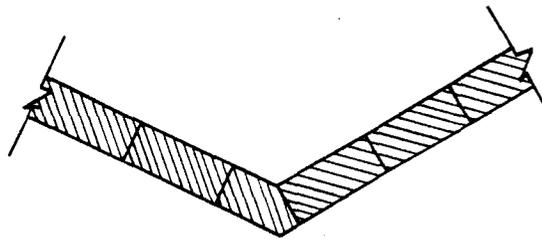
Fig. 1.

1. Dimensions: 13'2" average from corners, but inexact. For example, the southwest wall is 12'8".
2. Foundations: Full basement with brick walls and dirt floor. Inaccessible.
3. Walls: Soft brick laid up in a rather random 6-8 course common bond with flush joints, two bricks (approximately 9") thick, with corner pilasters. The bricks are of irregular size and coloring, the latter ranging from a cream or buff to orange-red and gray-brown. A few are partially glazed. The outer bricks are a fairly uniform orange-red. Bricks used at corners are shaped to triangular points at one end (Fig. 1). A date stone was inserted in the east wall, in the spandrel between the windows, that read "H.L. Russell . A D 1859".

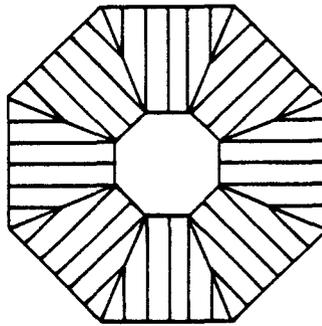
Fig. 2.

the second floor ceiling) consists of sawed rafters radiating from an octagonal "compression ring" around the central chimney. They are parallel to one another on each side, this achieved by a three-"pronged" rafter at each corner (Fig. 2). Machine cut square nails are used throughout the house; modern work uses round wire nails. There is no evidence of mortise-and-tenon construction.

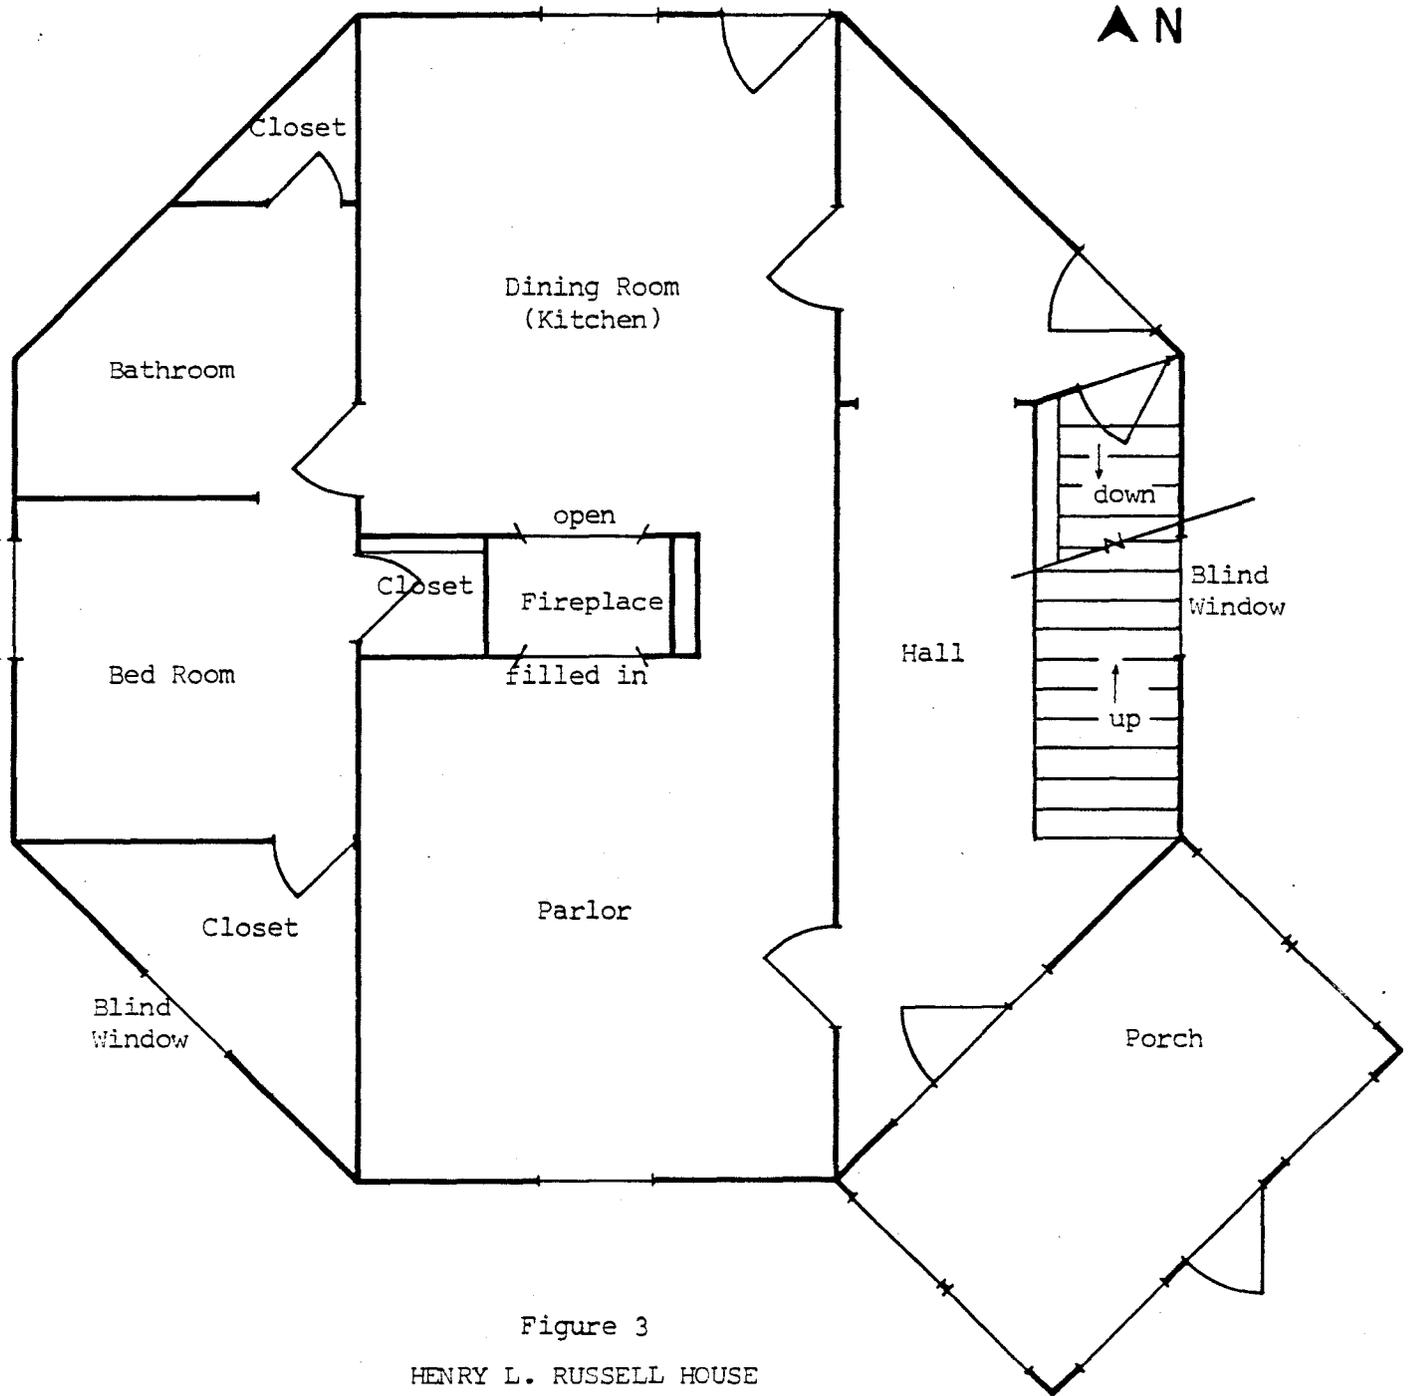
Figure 3  
HENRY L. RUSSELL HOUSE  
First Floor Plan  
Approx. 3/16 scale

- a. First Floor. As noted previously (B.4), two brick bearing walls run north-south through the house, dividing the interior into three major parts, the outer two of equal width but narrower than the center section. The main entrance opens directly into a hall, with staircase along the east wall. Toward the north end of this hall is a doorway leading to a small, triangular vestibule. The center section of the house features a nearly square parlor at the south end. On its north wall is a fireplace. A short passage on the east side

of the fireplace (as long as the fireplace stack is deep) leads to what is now the kitchen (originally the dining room). Here, there is a fireplace centered in the south wall, and beside it a built-in cupboard with drawers below, part of which may be original. On the west wall there was a built-in desk and cupboard which has been removed, leaving a hole about 4' wide and 6' high in the brick bearing wall.

The west side of the house has a triangular closet at the south end, a small bedroom off which is a very small rectangular closet set beside the fireplace chimney, and a polygonal bathroom and triangular cupboard in the north end.

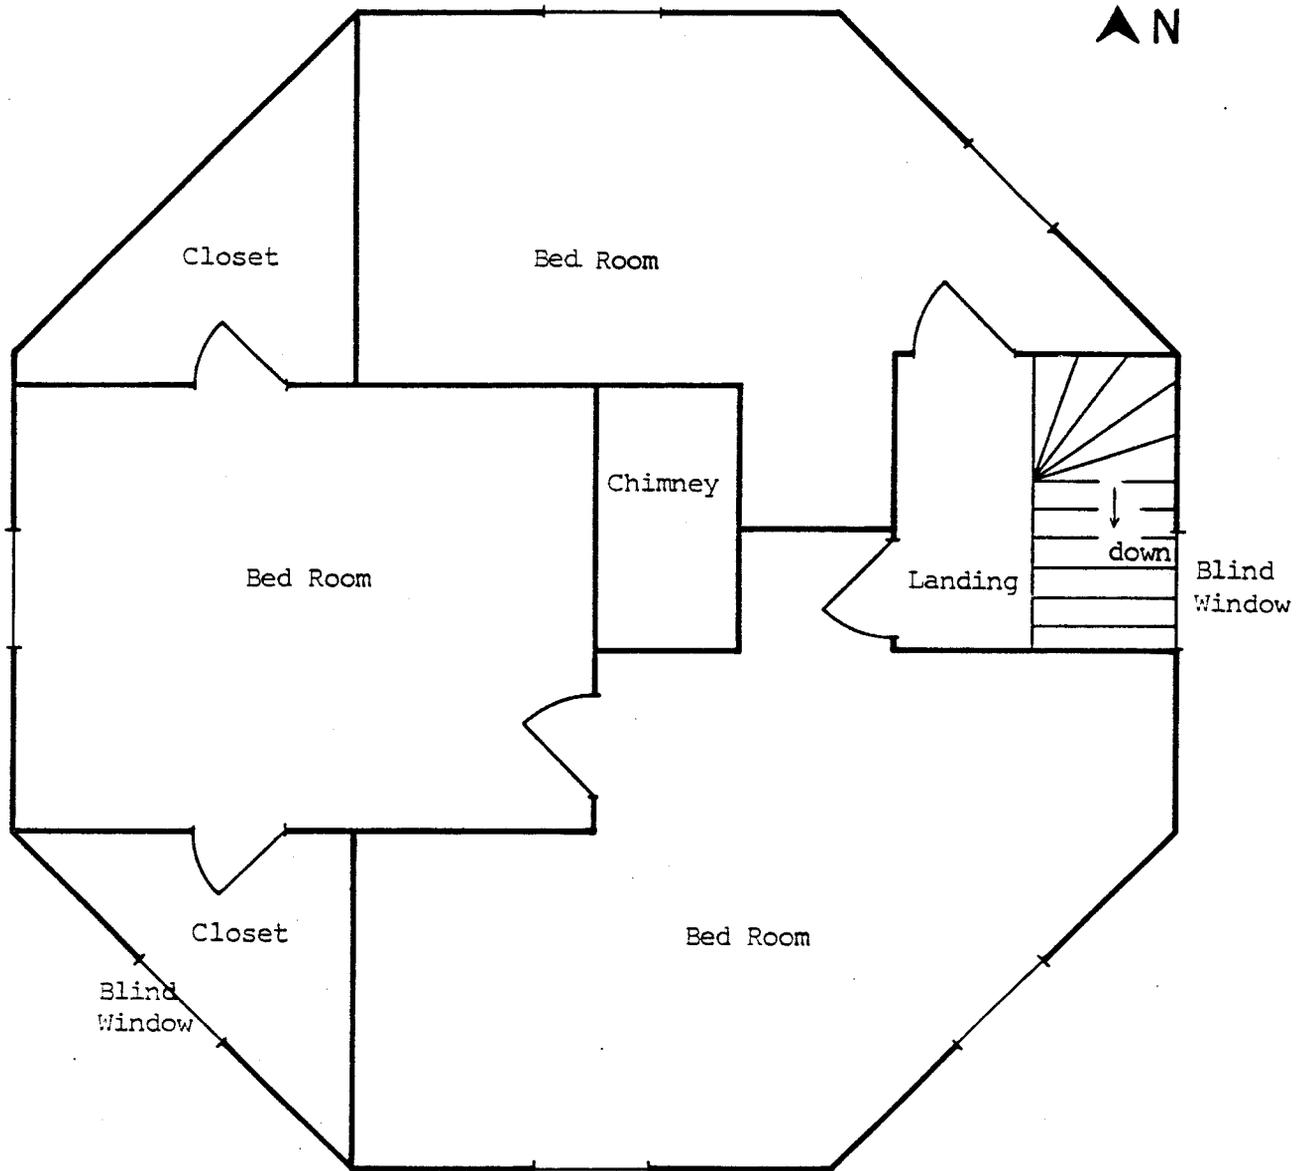
Figure 4  
HENRY L. RUSSELL HOUSE  
Second Floor Plan  
Approx. 3/16 scale

- b. Second Floor. While the main rooms on the first floor are all rectangular, this is not the case on the second floor. A short landing-hall leads to irregularly shaped rooms on north and south. Only the room on the west is rectangular. Triangular closets are located on either side of this room, along the southwest and northwest walls.
