JOHN DECKER LIVERY
(Ed's Auto Service)
Lafayette Square
1609 Lafayette Ave.
St. Louis
Missouri

HABS No. MO-1933

HISTORIC AMERICAN BUILDINGS SURVEY

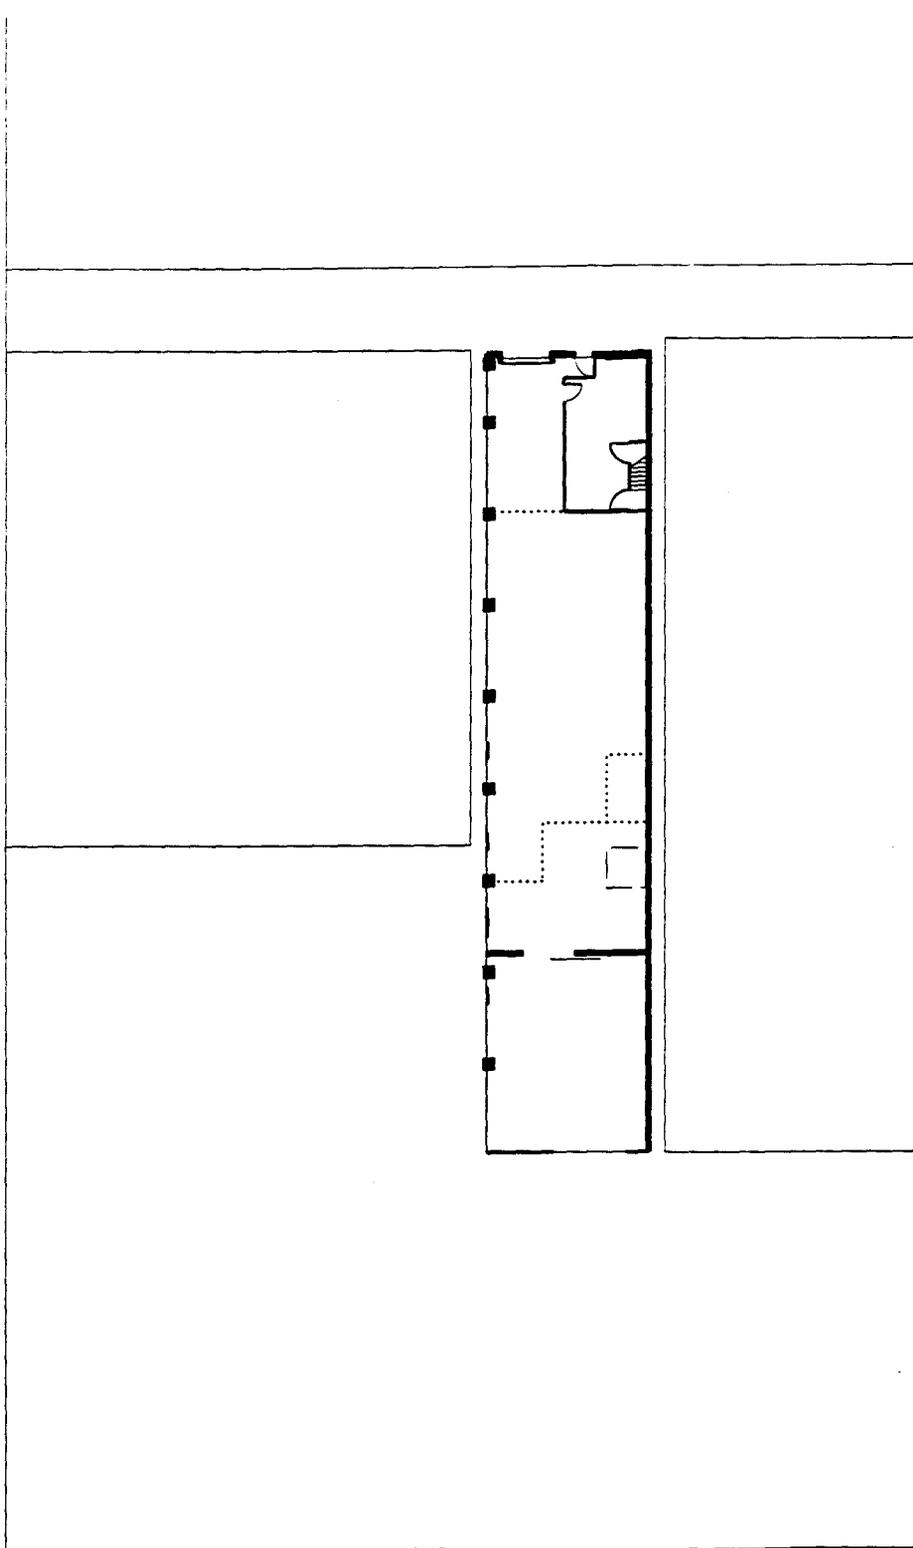
FLOOR PLAN OF FIRST FLOOR

1. Floor Plans: The building is primarily open plan (see page 12). It is divided only at its south end by an enclosed office area in the west bay, a recent addition, and at its north end by an interior cross wall, the original rear wall. A second-story apartment spans the area above the ground floor office and the drive-through which are both located on the southern end of the structure (see page 13). The second-story loft, located at the north end of the building, was haphazardly constructed and used primarily for storage space.

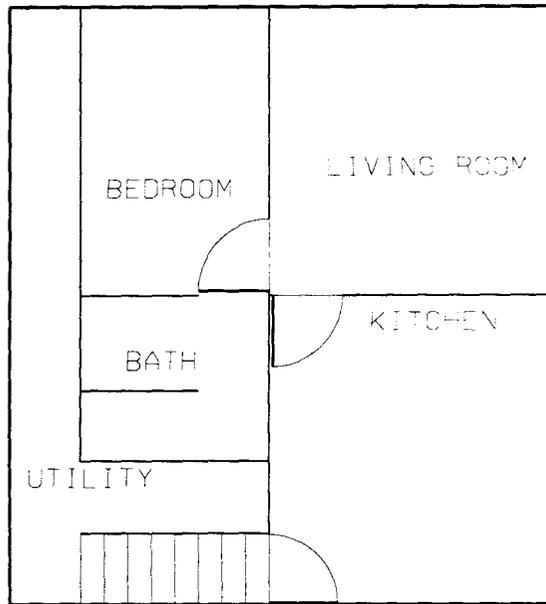
FLOOR PLAN OF SECOND FLOOR APARTMENT

5. Openings:
 - a. Doorways and Doors: The only interior doors in this building are to be found in the office and in the upper apartment. On the second floor, the fire damage was at it most severe consequently the door types and construction could not be determined. Doorway locations on the second floor are indicated on the plan. The ground floor office door appears to have been a pre-hung unit that is currently missing. In the northwest corner of the office, the stairway entrance has a 3' wide wood panel entry door.
