Morgan Van Wagoner House & Barn
Hosmer Road
Somerset
Niagara County
New York

HABS No. NY-5529

MORGAN VAN WAGONER HOUSE & BARN

HABS NO. NY-5529

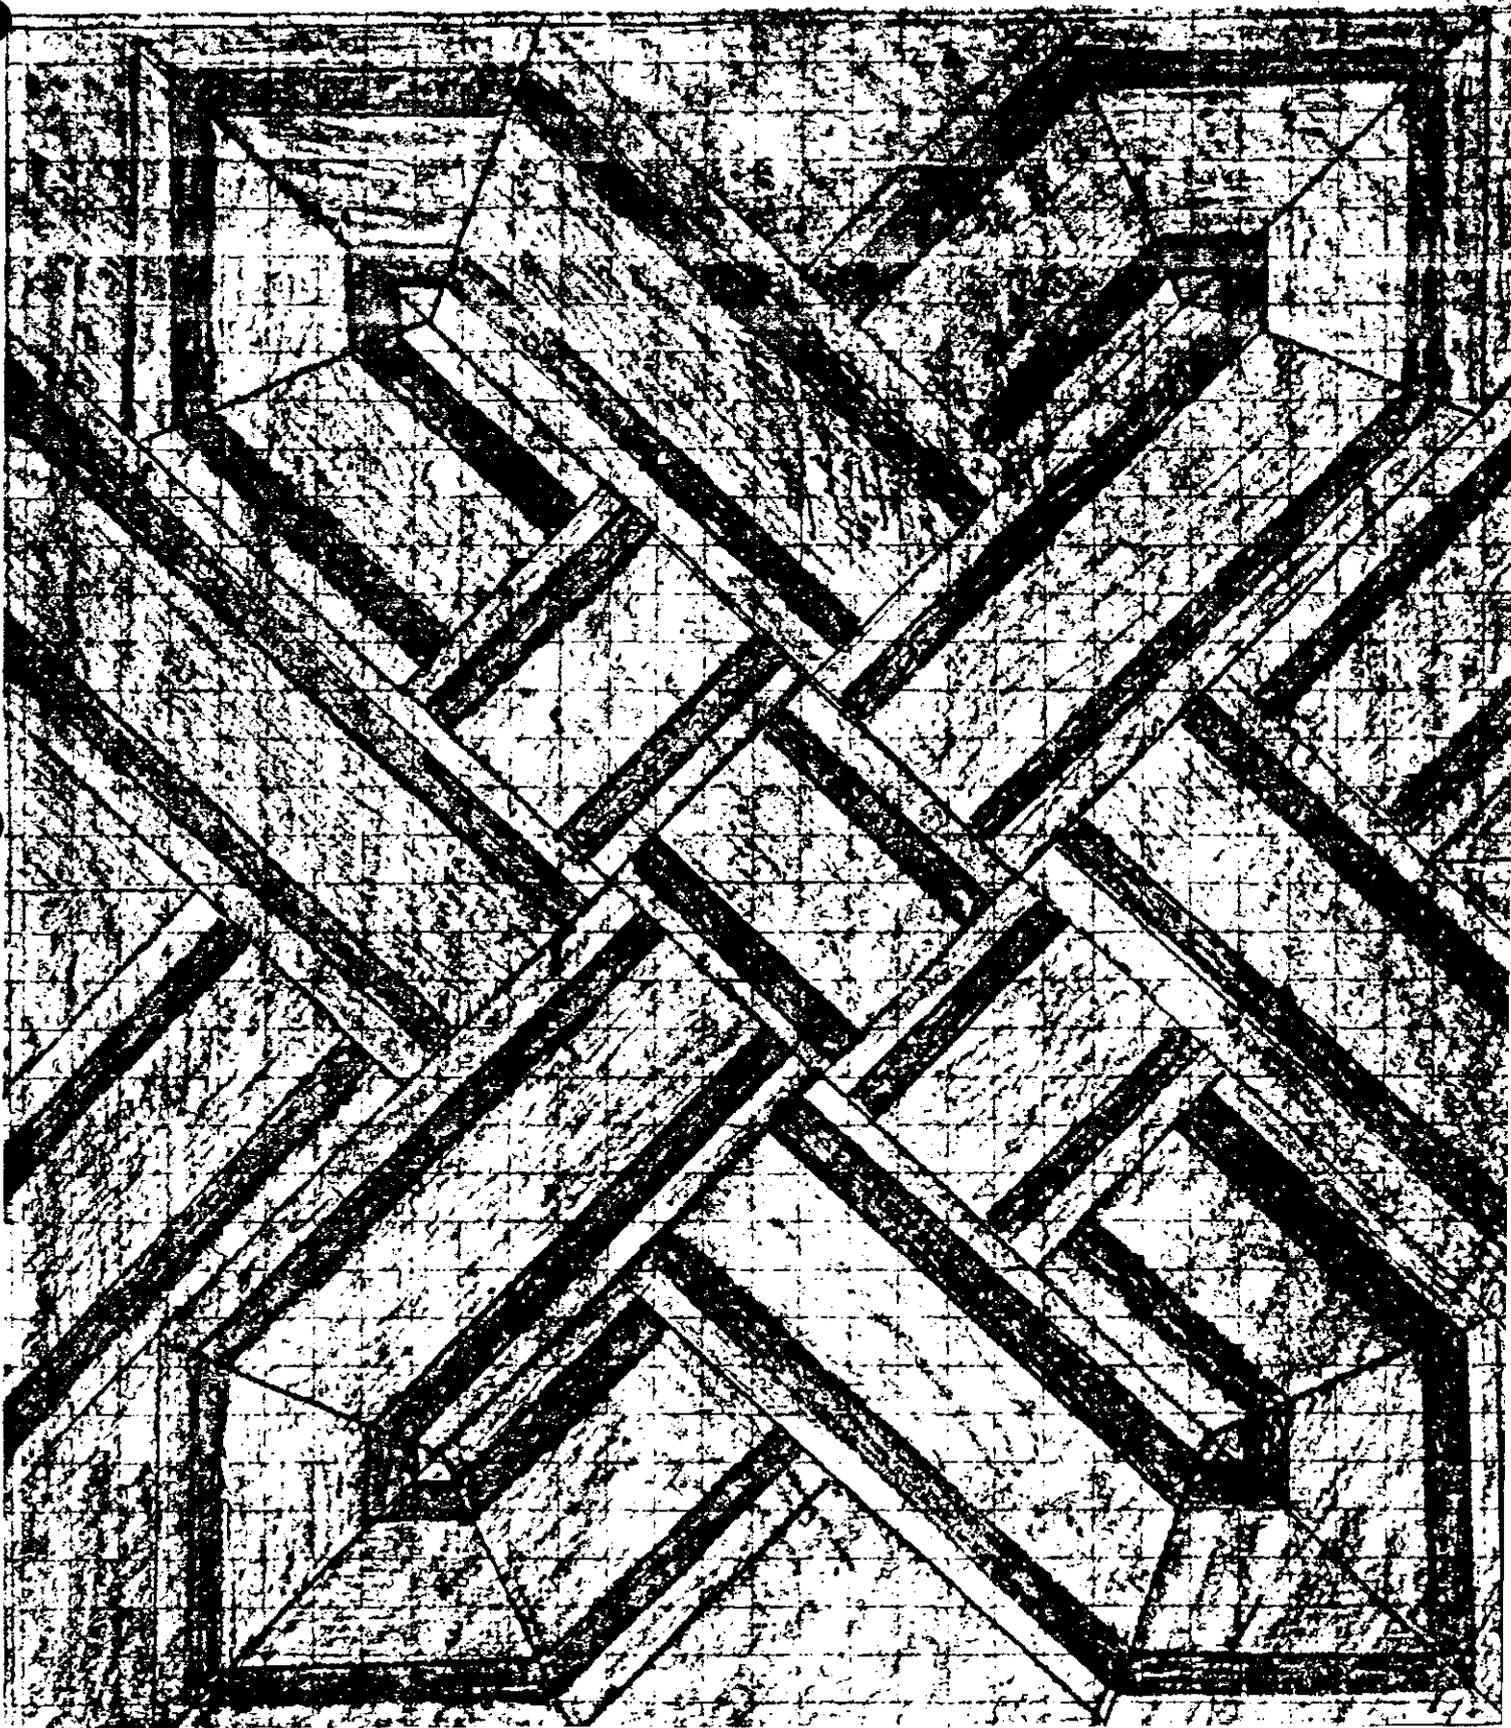
Figure 1 - Italianate Parquet Flooring

- Parlors: south parlor especially rich, large Greek Key blocks in door and window casings, high molded baseboard, hardwood center panel of floor surrounded with intricate marquetry border of three varieties of wood; broad elliptical arch connects this room to larger, north parlor (probably formed from a center hall and matching parlor, at the time the bay window was added to replace a front door, and center hall stairs were moved to the rear); moldings of arch Italianate, remainder of woodwork in north parlor Greek Revival, simpler than south parlor; hardwood flooring probably added with other Italianate alterations.

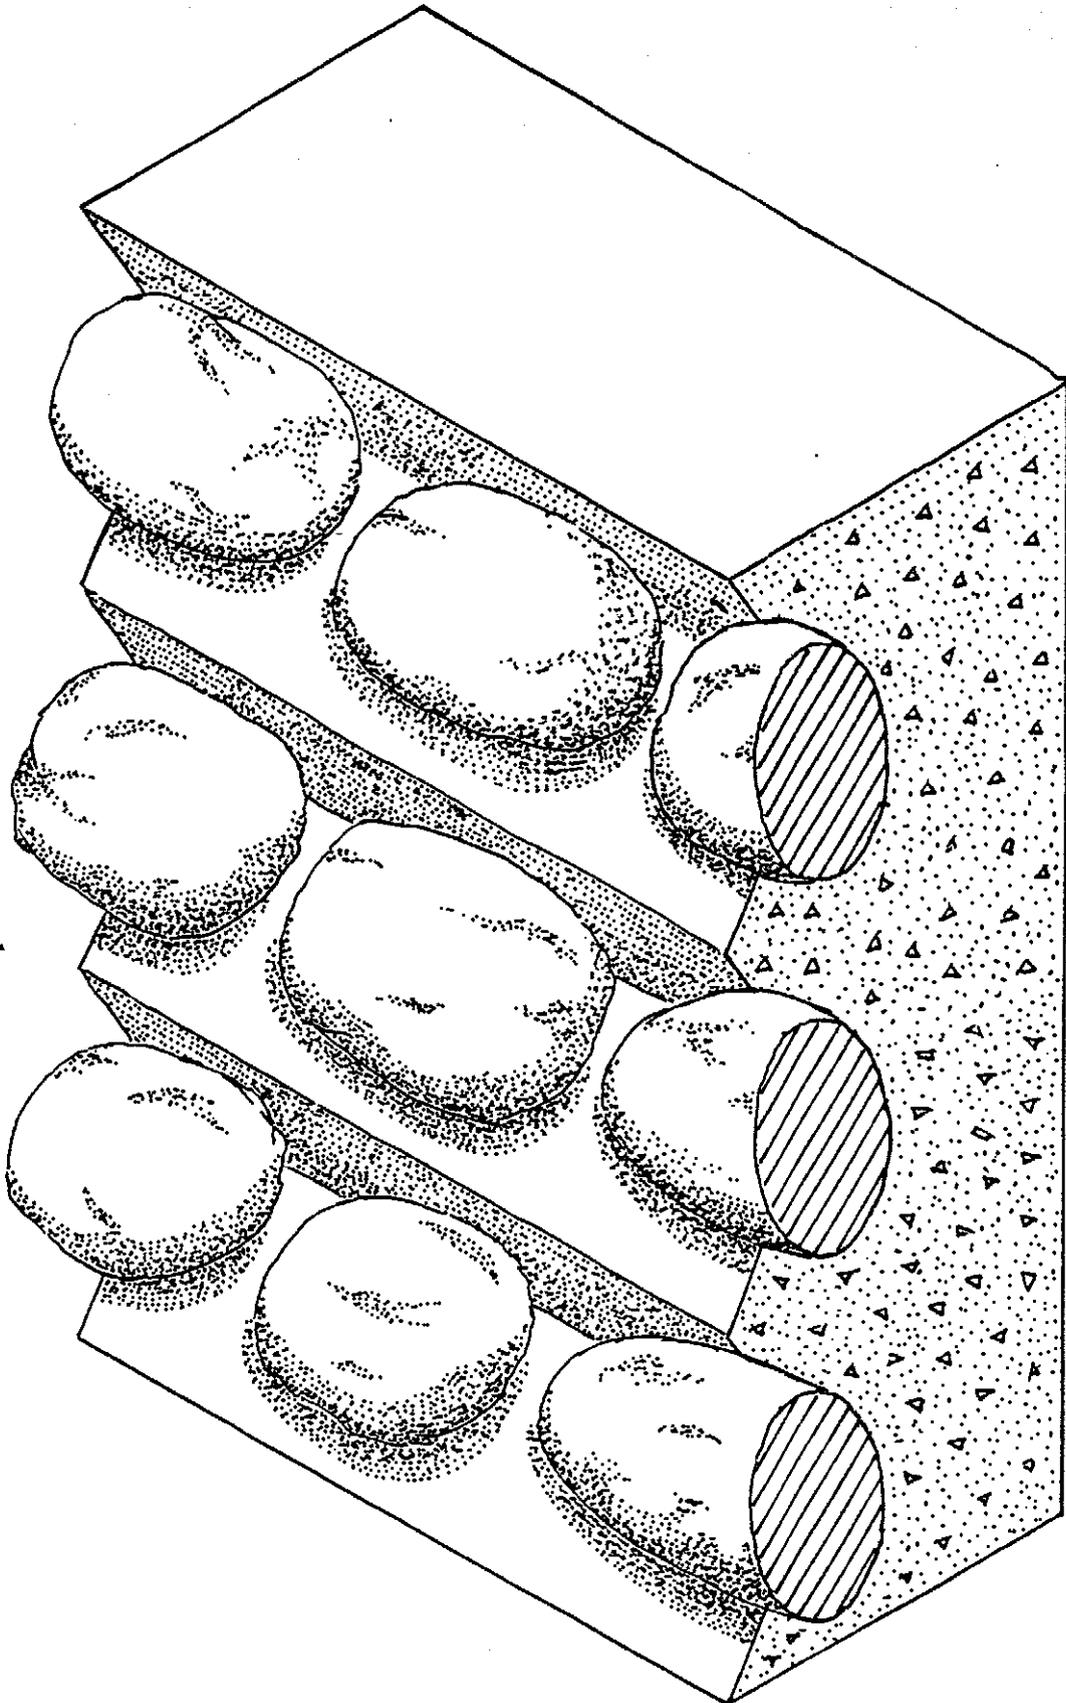
- B. Description of Exterior: The oldest portion of the house, its southern wing, is of Middle Period style having cobblestones 2-3" long in front. The stones are multi-colored and field cobbles, being therefore datable in style to the first half of the Middle Period (1835-1845). The number of courses to a quoin on the front of the house were four which also denotes the earlier half of the Middle Period as do the "V" horizontal mortar joints. Very rarely is there anything in the Van Wagoner house construction which suggests a vertical mortar joint. When these do occur they are of amorphous character. A schematic drawing of the stone placement in the front of the Van Wagoner house is shown in Figure 2.

FIGURE 2 - A Schematic Draing of the Cobble Placement
in "V" Horizontal Mortar Joints on the Front
of the Van Wagoner House.

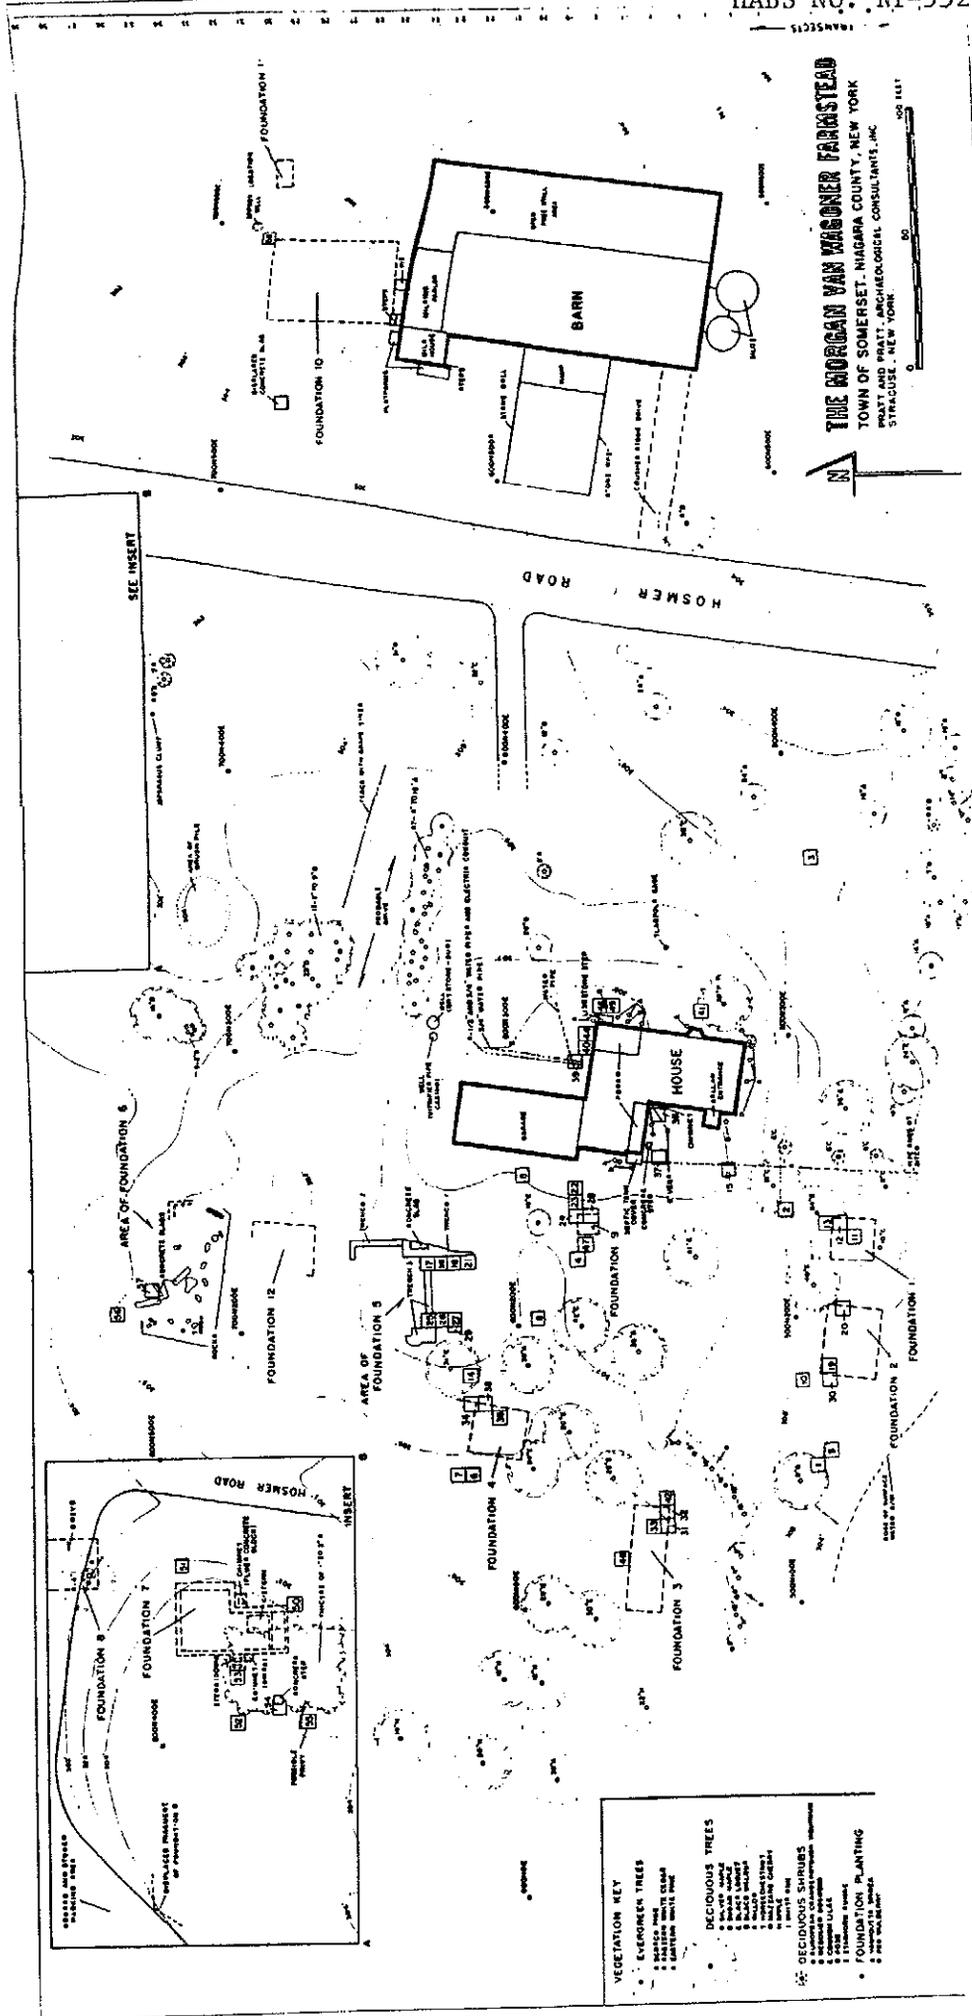
Sector B consists of the standing barn and an area surrounding the barn up to the edge of the cultivated fields. This area was divided into 10 transects which were located 20 feet apart. The transects were designated A through J. Test pits were dug at 20 foot intervals. In some locations test pits could not be dug because of the barn or gravel fill between the barn and Hosmer Road. A total of 40 test pits were dug (See Figure 3).

Sector C consists of an area outside of Sector A to the edge of the cultivated fields. Transects were located 10 feet apart and test pits were dug at 20-foot intervals. Transects 1 through 40 crossed parts of Sector C. A total of 356 test pits were dug in this sector (See Figure 3).

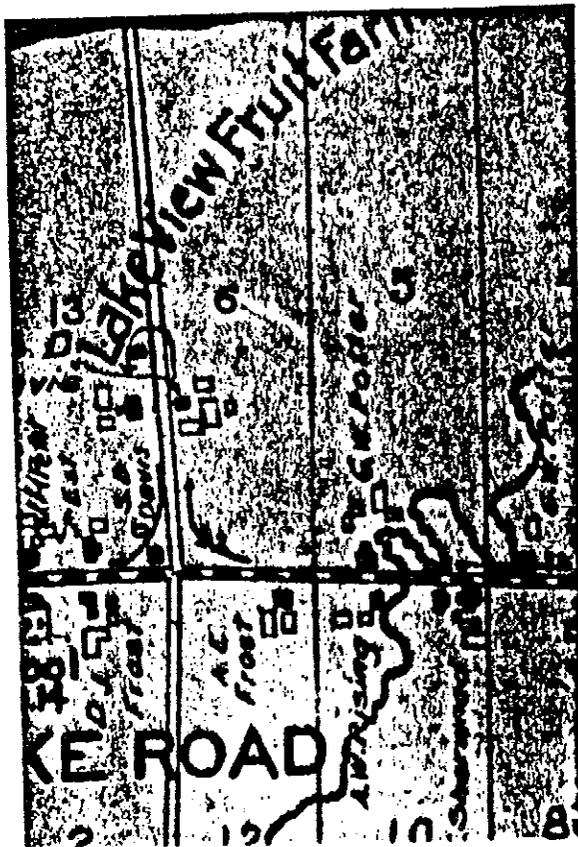
Foundation 10. This appears to also be one of the structures shown on the 1908 map (Figure 4). The foundation seems to relate to a barn 46 feet long and 32 feet wide. The foundation consists of a wall 29 inches wide and 16 inches deep.

FIGURE 4 - A section from the New Century Atlas
1908 map showing the Somerset
Site.
