STATUE OF LIBERTY NATIONAL MONUMENT EMPLOYEE
HOUSING, DUPLEX
(Statue of Liberty National Monument, Building No. 43A-B)
Statue of Liberty National Monument
Liberty Island

HABS NY-6397-B
HABS NY-6397-B

HABS No. NY-6397-B

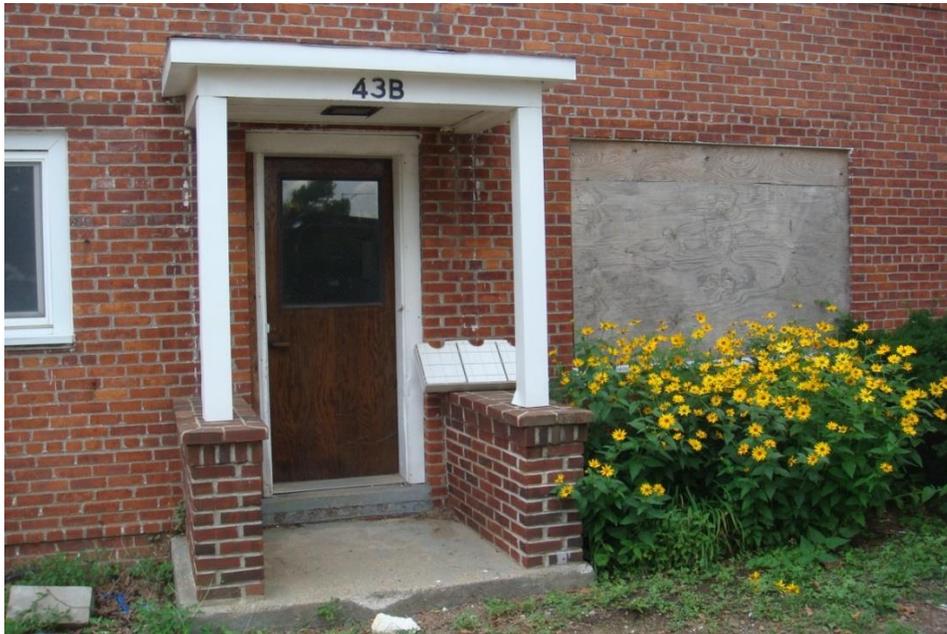
5. Porches and stoops: The front entry porches on the west elevation (facing the waterfront) were covered with flat roofs, but only the concrete block post bases remain. The outline of the flat roof is still visible against the brick wall above the doors. The brick stoop measuring 5 feet, 7 1/2 inches by 4 feet, 2 1/2 inches has three brick steps. The rear entrances of the Duplex (facing the courtyard) each have a small porch—measuring 5 feet by 4 feet—covered by a nearly flat roof supported by square wood posts resting on 24-inch high brick knee walls—these are later additions. The base of the porch is concrete accessed via one step (Figure 6).

Figure 6: Duplex, Unit 43B's rear entry porch on the east elevation, July 16, 2014.
Note the different color bricks used in the knee walls added later.
Source: Photograph by author.

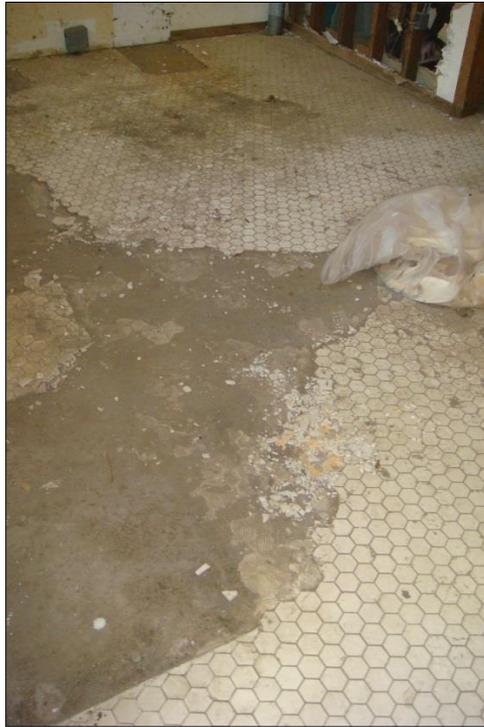
3. Flooring: The first floor rooms of both units (except the kitchens) have nine-inch square wood parquet flooring (now heavily damaged). The kitchen of Unit 43A has nine-inch square gray and white marble-patterned asphalt tiles. In Unit 43B the kitchen has two-inch white ceramic hexagonal tile (Figures 9 and 10). The second floor bedrooms and hall of both units have two and a quarter inch wide tongue and groove wood flooring. The bathrooms have ceramic tile floors in a pattern of gray squares with a white square tile at the center. Each bathroom floor includes a five-inch wide border of black one-inch square mosaic tiles. All flooring on the second floor appears to be original and is in good condition.⁷ (Figure 11)

Figure 10: Duplex, the kitchen floor of Unit 43B, June 18, 2014.
Note the two-inch hexagonal white ceramic tiles and the extensive flooding damage.
Source: Photograph by author.

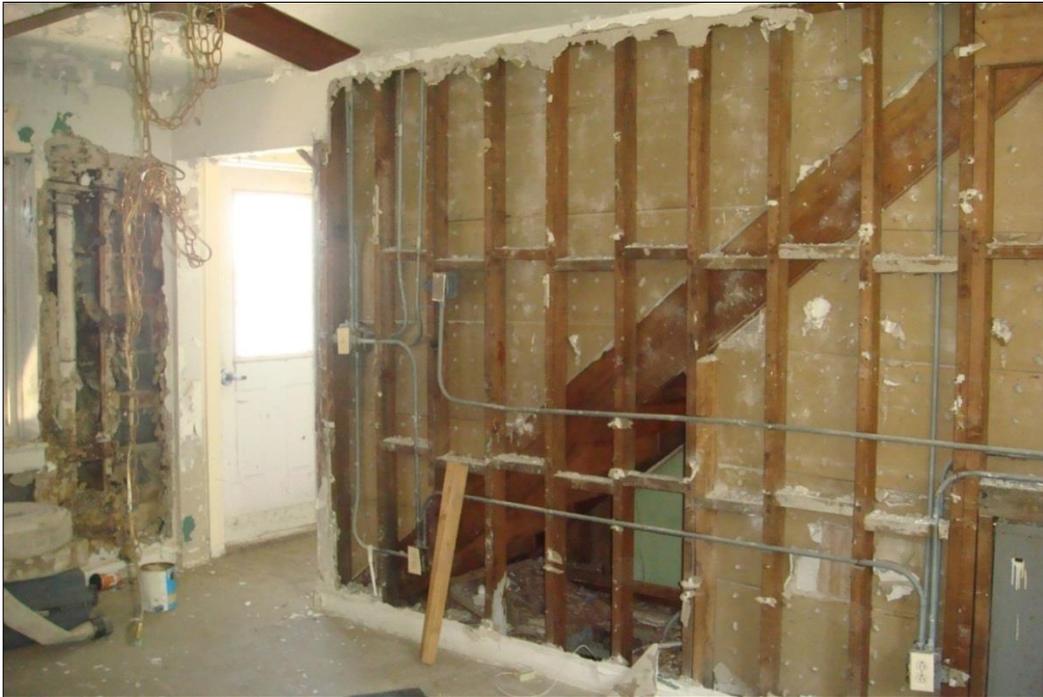
material, the plaster is applied to wallboard. With storm damage revealing the interior of walls, one finds patent no. 2,442,321 used by Newark Plaster in South Kearny, New Jersey on the wallboard, which has with circular perforated holes covered by a thick plaster layer (Figure 12). There is more typical metal lath behind the ceramic bathroom tiles as well as around corners and window openings. All walls (except for in the tiled bathrooms) have a white baseboard with a toe molding and an ovolo molding above.

Figure 12: Duplex, the living room wall/staircase of Unit 43B, June 18, 2014.
Note the small circular holes in the wallboard acting as a lath for plaster.
Source: Photograph by author.
