OKLAHOMA STATE UNIVERSITY, BOYS DORMITORY
(Oklahoma State University, Crutchfield Hall)
Northwest corner of Hester Street & Athletic Avenue
Stillwater
Payne County
Oklahoma

HABS No. OK-57-A

OKLAHOMA STATE UNIVERSITY, BOY'S DORMITORY
(Oklahoma State University, Crutchfield Hall)

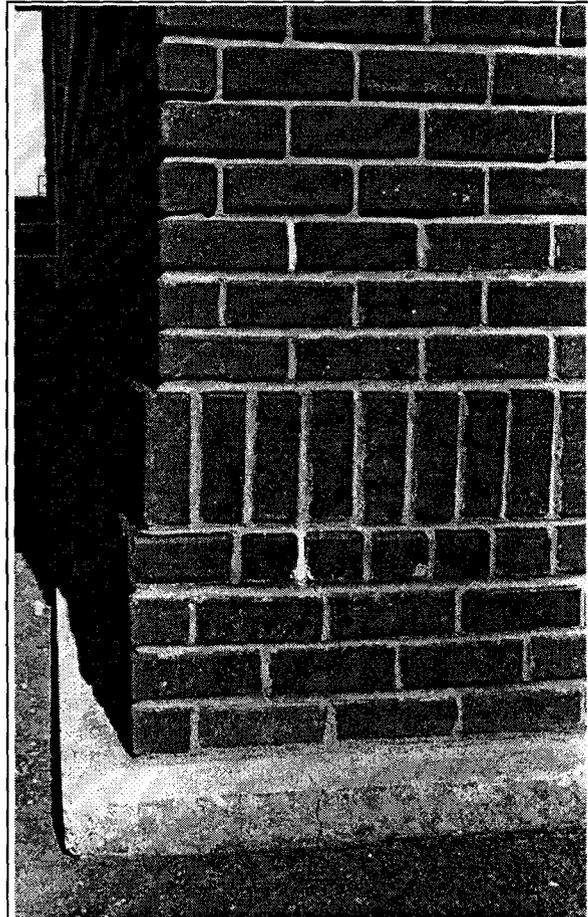
Figure 8 - Base of Southwest
Exterior Wall

1. Architectural character: Crutchfield Hall is a three story masonry structure that is an outstanding example of modified Italian Renaissance Revival architecture.
2. Condition of fabric: The facility is in remarkably good condition considering it is in excess of 80 years of age. The concrete spread footings and exterior brick are sound. There is no evidence of settlement with the exception of the southwest corner. A shear crack extends from the roof line

near the southwest corner to a point between the first and second story. All mortar appears to be in good condition and shows evidence of repointing and other maintenance in the recent past.

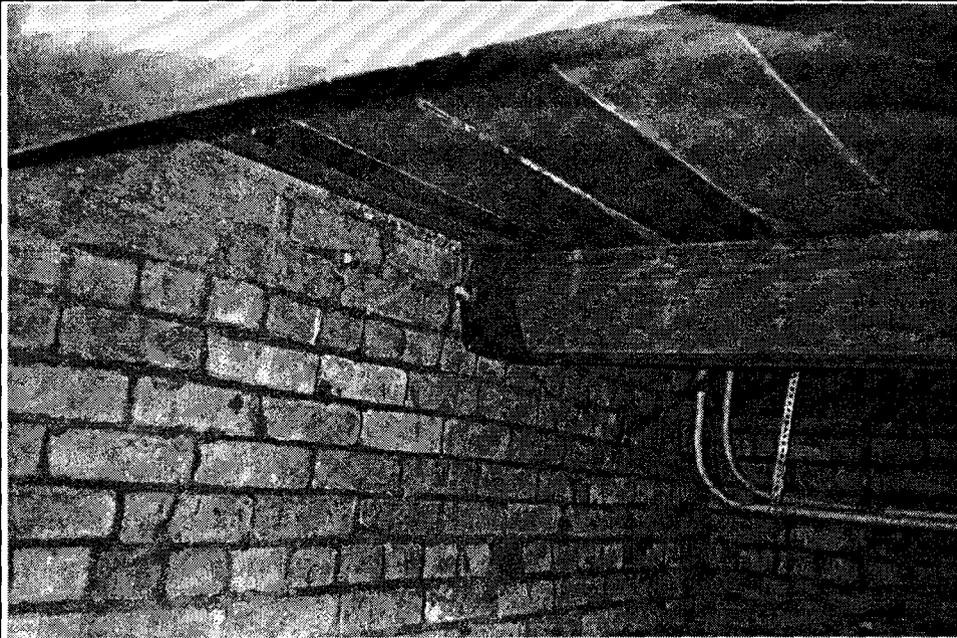
Figure 9 - Typical Floor Joists and Subflooring

4. Structural system, framing: All wooden floors, with the exception of the center corridor floors, are supported by 6"

x 8" wood joists placed on 48" centers. Two inch subflooring is placed on the joists. See Figure 9. The corridor floors are supported by smaller wood members resting on the corridor wall projections with two inch flooring installed perpendicular to the building main axis. See Figure 4 for the details of each corridor floor level.

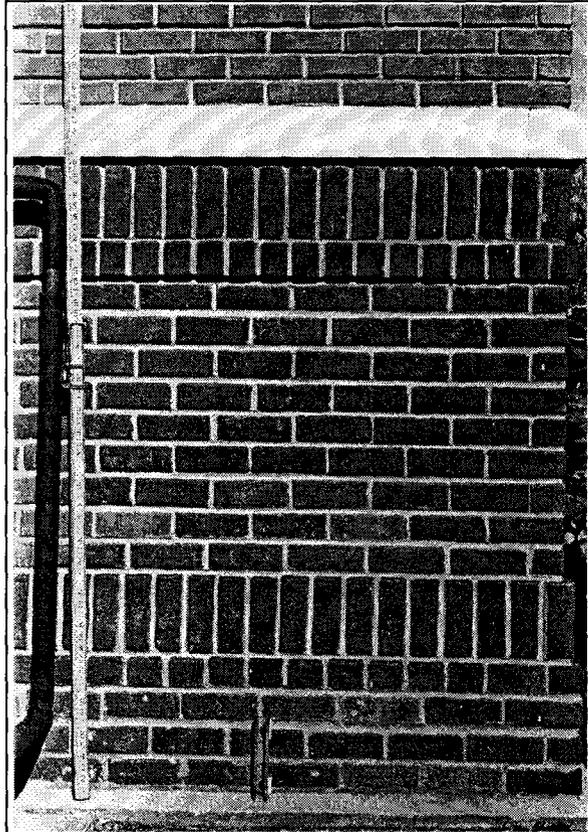
Figure 10 - Lower Exterior Southeast Wall

The north, east and south elevations have the same brick and stone details including window treatments²⁰. These are described as follows. Numbering brick courses from the foundation, courses 1 through 3 have one half running bond courses. Course 4 is a Flemish course. Course 5 is a soldier course. See Figure 10.

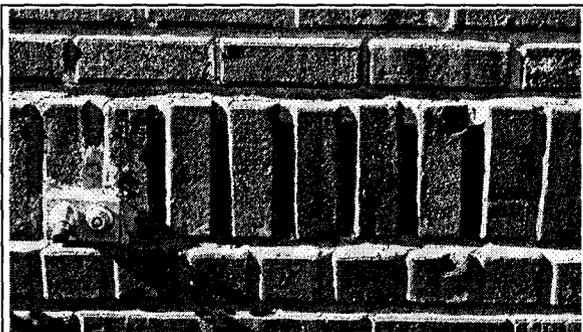
Figure 11 - Crawl Space Vent

The soldier course has several crawl space ventilation openings where the mortar has been omitted from the brickwork. See Figure 11. Courses 6 through 14 are one half running courses. Course 15 is a corbelled Flemish course and course 16 is a soldier course. See Figure 10 for this detail. Course 16 is capped with a white limestone stone band around the entire building. The stone

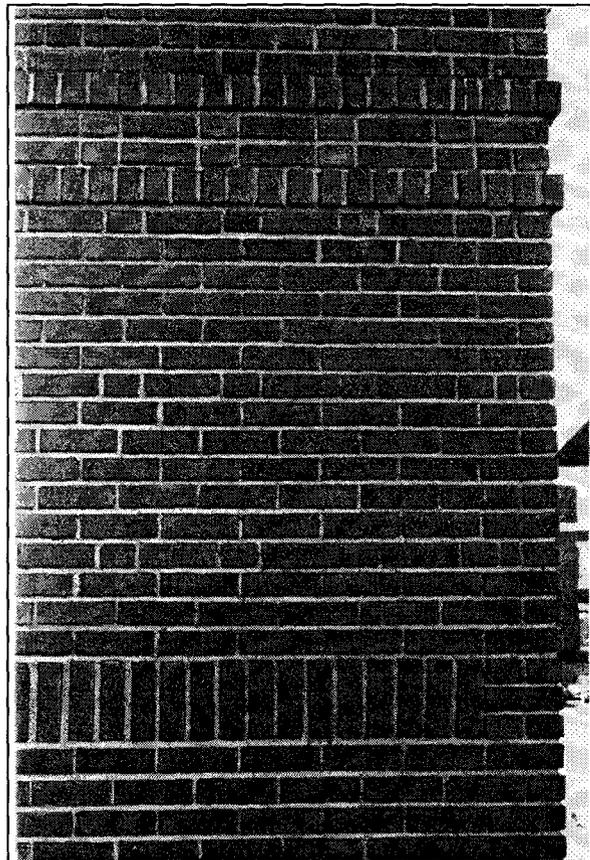
Figure 12 - Exterior Wall,
Northwest Corner

Above the stone band on the east, north and south elevations, brick work to the 73rd course are laid in a common bond pattern using "6th Course Flemish Header" detailing which is also referred to as "American Bond". The 74th course is a soldier accent course. See the lower portion of Figure 12.

Courses 75 through 90 are Flemish Bond courses with English corners. See the center portion of Figure 12. Shade No. 7 bricks were used for all courses above the stone course²².

Courses 91 and 94 are corbelled Flemish header courses and courses 92 and 93 are common bond with single course Flemish headers as shown in the upper part of Figure 12.

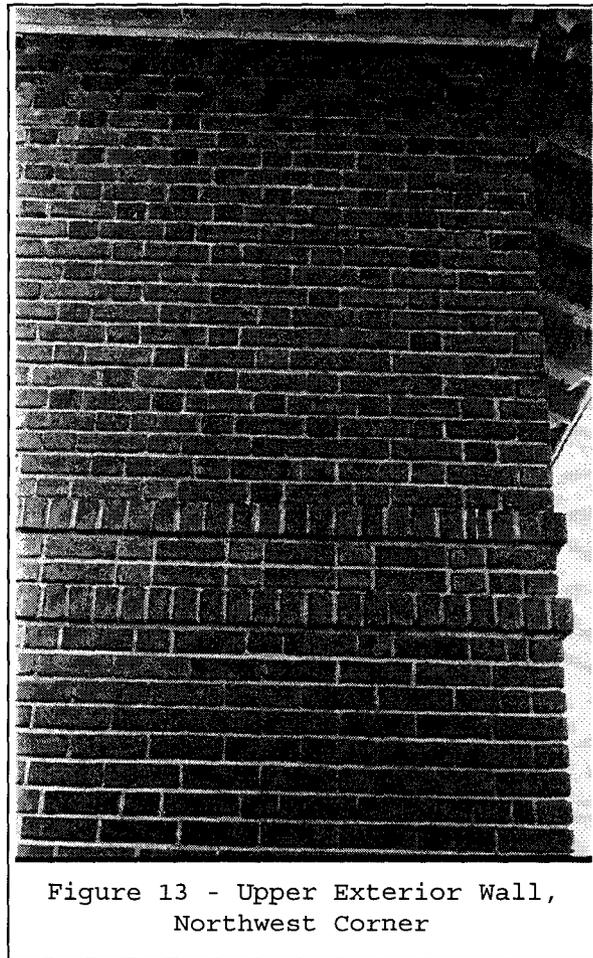
Figure 13 - Upper Exterior Wall,
Northwest Corner

Brick courses 95 through 118 (the top course) were Flemish bond with Dutch corners. See Figure 13. These bricks were to have been "granolithic", however all brick work above the stone course was Shade No. 7.

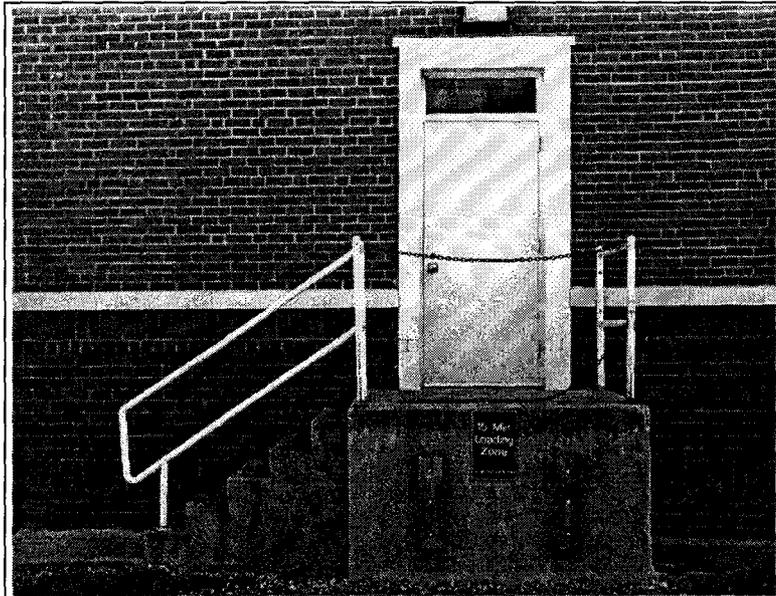
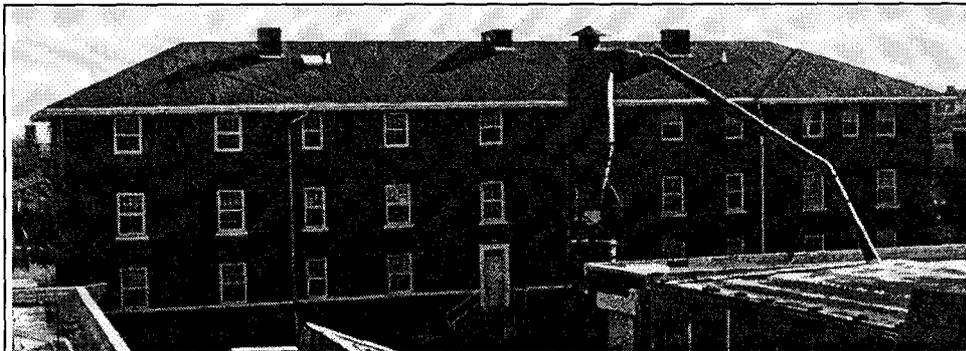
An entrance to this building was constructed near the middle of the west side of the building in 1989 to give an access to the first floor from that side. See Figures 14 and 15.

Sometime before Summer 1921, a doorway to the Crutchfield's living quarters was developed from an existing window. This door is presently used as a rear exiting door and it is located on the exterior wall of Room 110. See Figures 14 and 15.

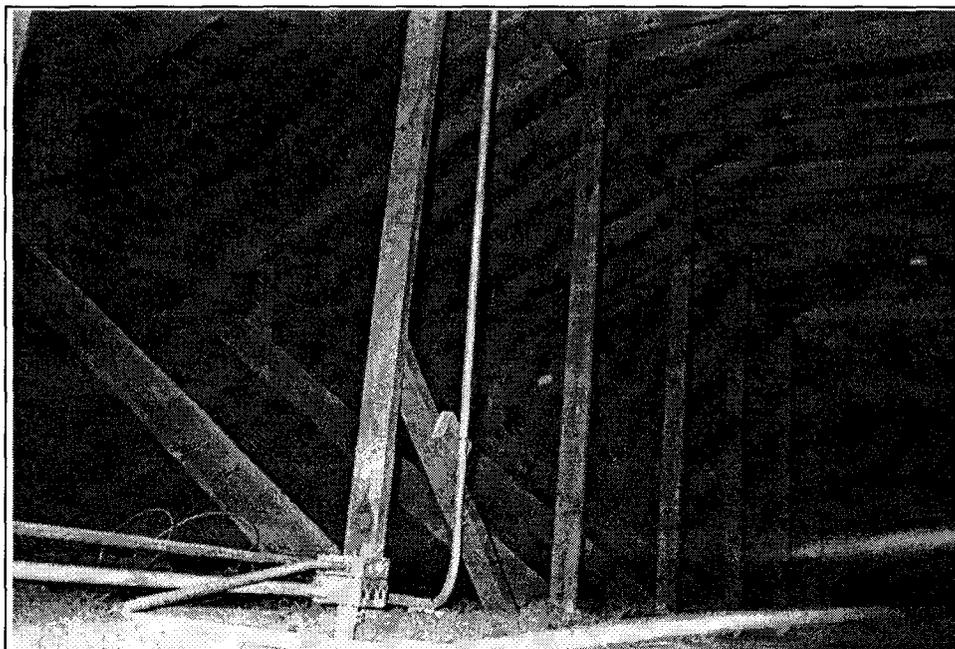
Figure 19 - Attic Truss System

- a. Shape, covering: The roof is constructed in a hip roof configuration with a slope of 3:1. The wooden truss system was constructed on site using clear pine members. The rafters are sheathed with 1" wood material of random lengths. The roof was originally finished with composition shingles. Currently the roof has a rolled asphalt covering. See Figures 15 and 19.

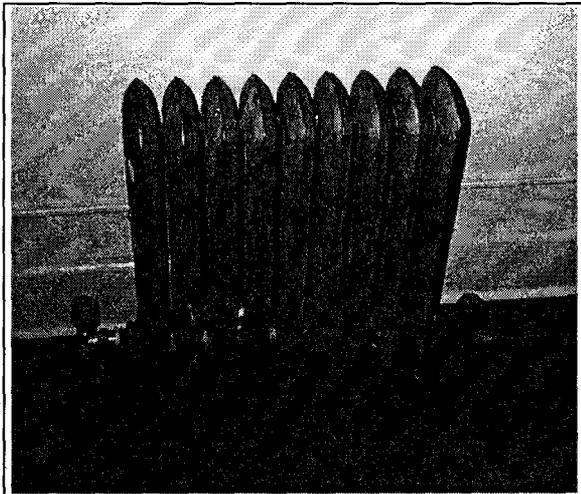
Figure 24 - Typical Cast Iron Steam
Radiator

to be heated. The original drawings indicate radiator sizing in square feet of radiation.³⁰ The individual room radiators are hand controlled.

See Figure 24. Temperature control is maintained by manual shutoff valves on each individual radiator.

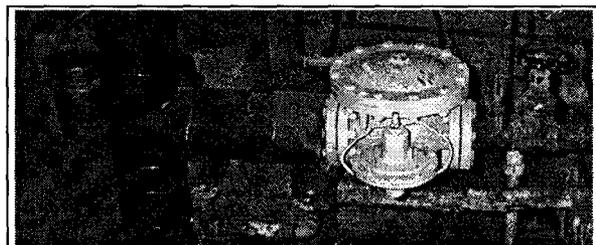
Figure 28 - Steam Utility Entrance - Pressure Reducing Station

Steam from the central University power plant enters the building through the west foundation into the original boiler room. See Figure 28. A pressure reducing station

reduces the pressure to below 5 psig for distribution to the original cast iron radiators within each room.
