ROCKFIELD GROCERY
(Rockfield Country Store)
Albemarle County Country Stores Survey
Off of Route 250
Charlottesville
Virginia

HABS No. VA-1381

ROCKFIELD GROCERY

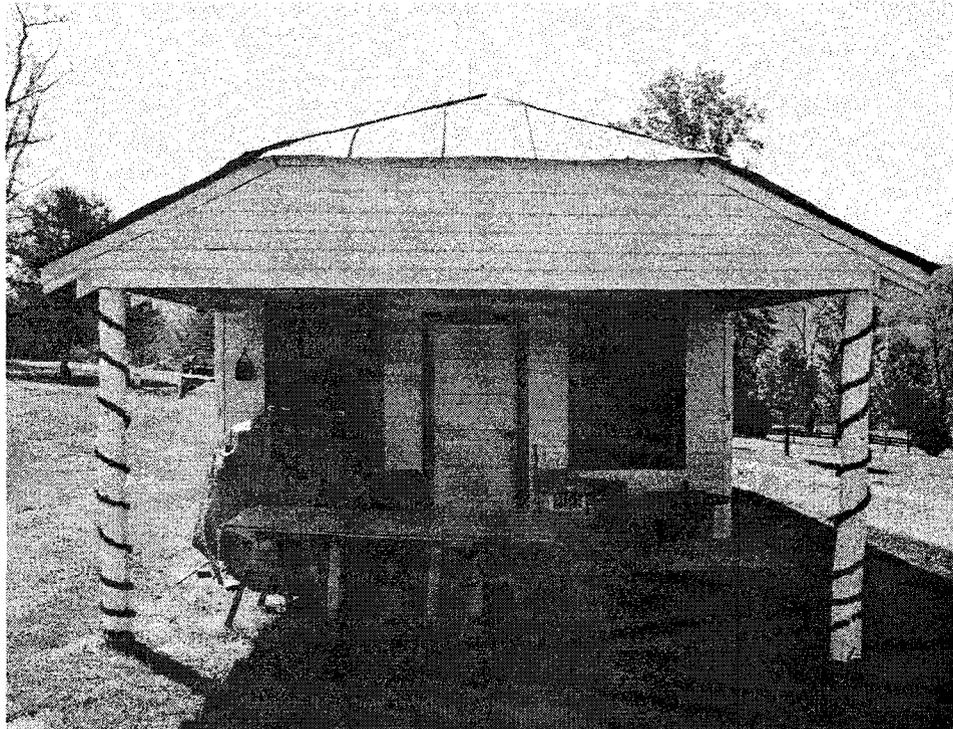
Fig. 1
Rockfield Grocery
North Elevation

The front facade of the building features an entrance canopy supported with log columns. The columns support a gambrel roof which is covered in standing-seam metal. The only entry to the building is located on this facade and is raised off the ground with two steps. The entry is flanked by two windows covered with shutters.

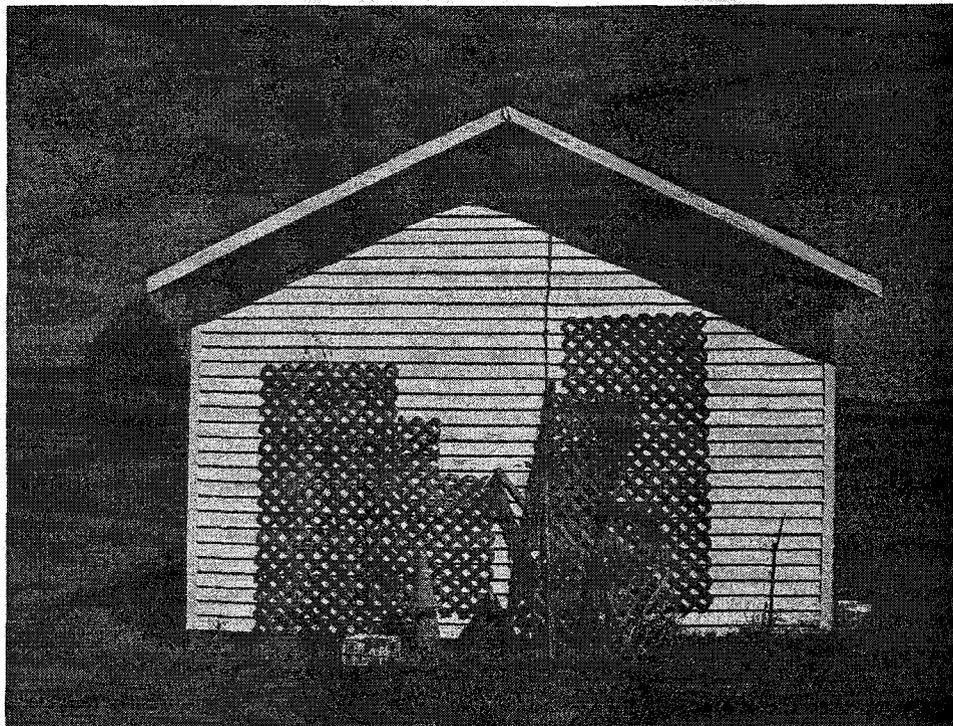
Fig. 2
Rockfield Grocery
South Elevation

The rear facade of the building has no doors or windows. It features the clapboard siding that is used on the entirety of the building.

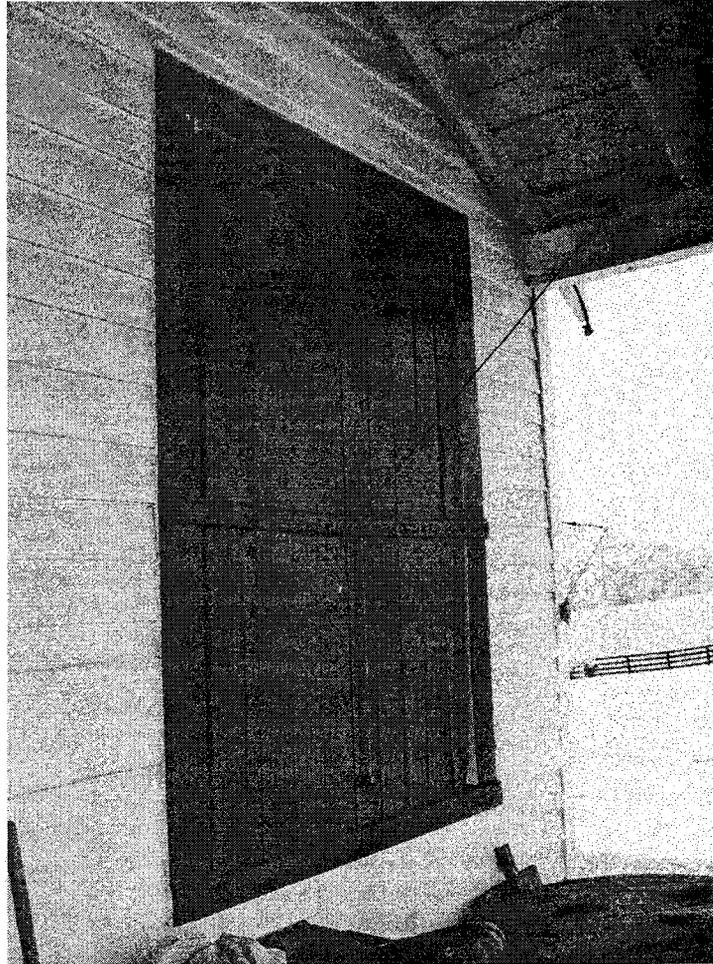
Fig. 3
Rockfield Grocery
Detail of Shutter
The shutters that cover the two windows on the North Elevation have an awning-type operating mechanism.

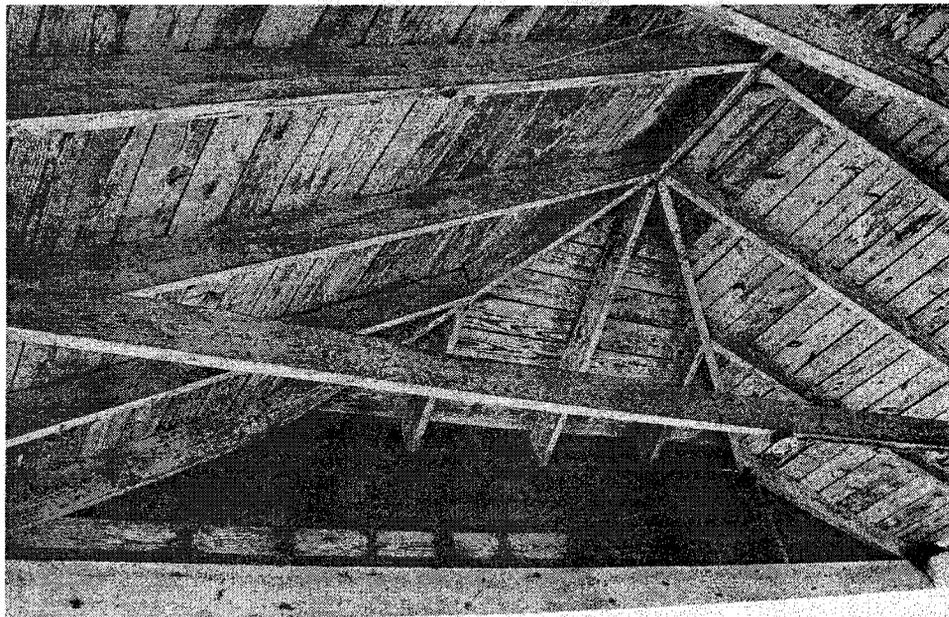
Fig. 4
Rockfield Grocery
Framing of Entrance Canopy
The roof framing of the porte cochere is visible, and is simple wood framing painted white. A portion of the wood appears to be replacement wood, as it is unpainted.

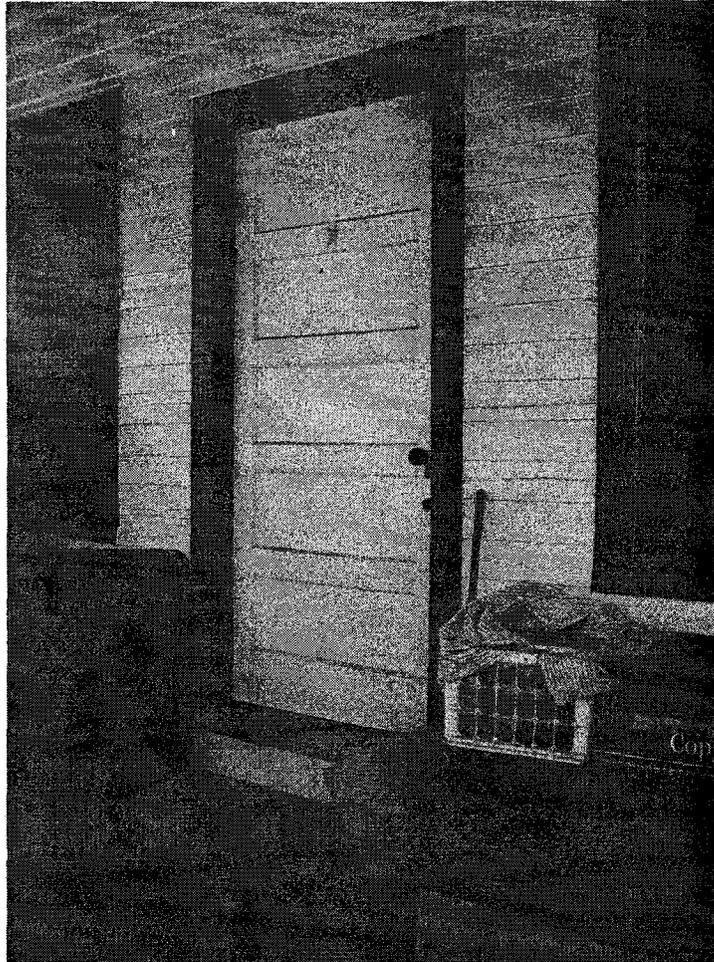
Fig. 5
Rockfield Grocery
Detail of Entry
The entry is raised above the ground level of the porte cochere. There is a concrete step and a wood threshold.

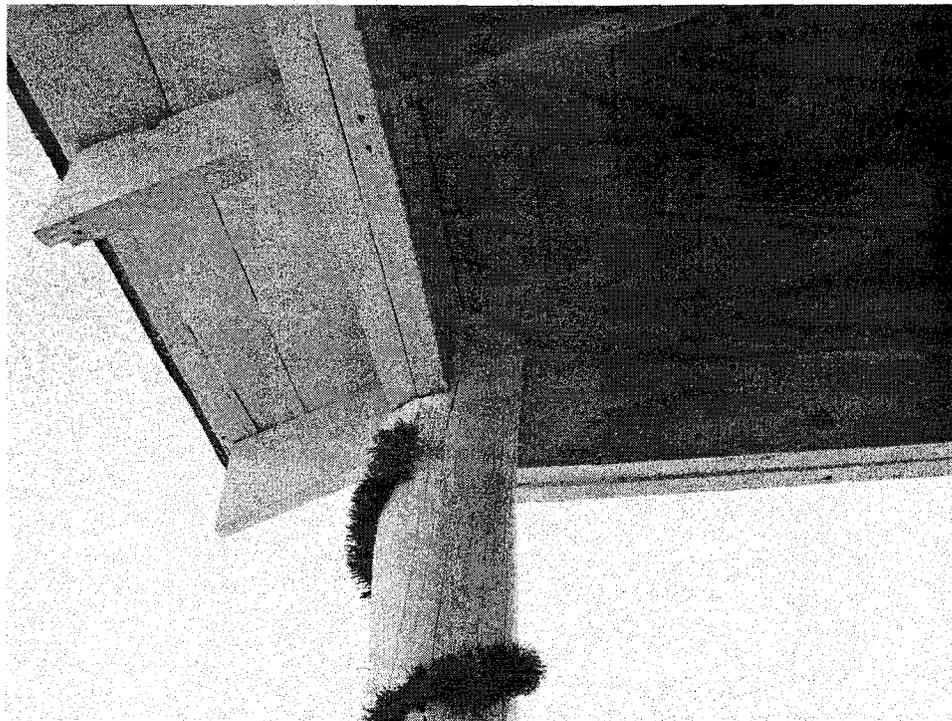
Fig. 6
Rockfield Grocery
Detail of Log Column
The log columns at the porte cochere are notched to receive the roof framing. The columns are painted white.

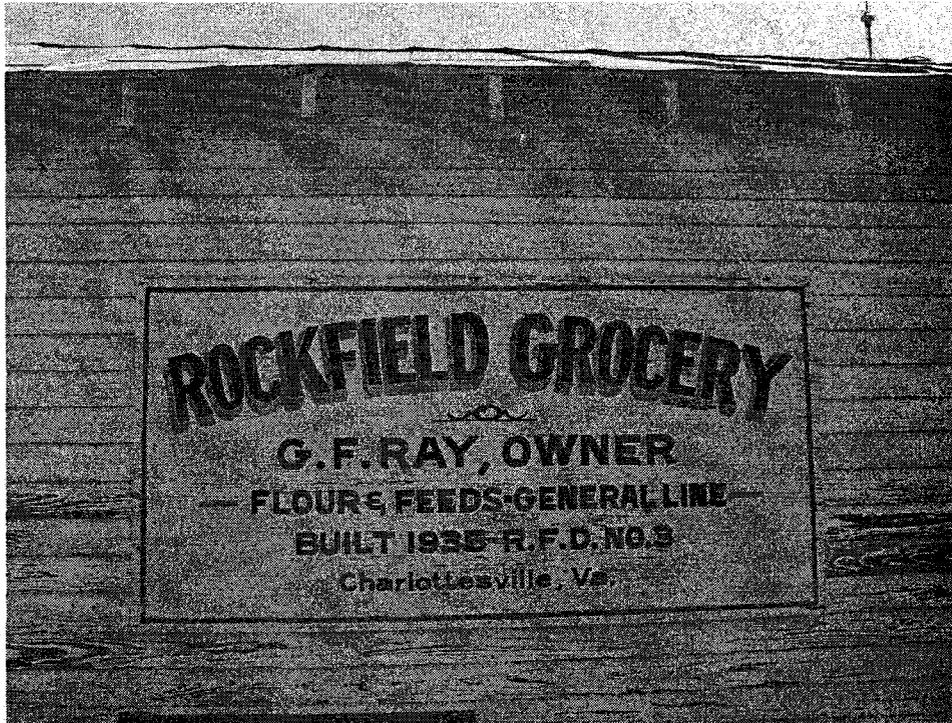
Fig. 7
Rockfield Grocery
Detail of Signage

The signage affixed to the West Elevation is painted wood. The verbiage on the sign indicates that the store was built in 1935.

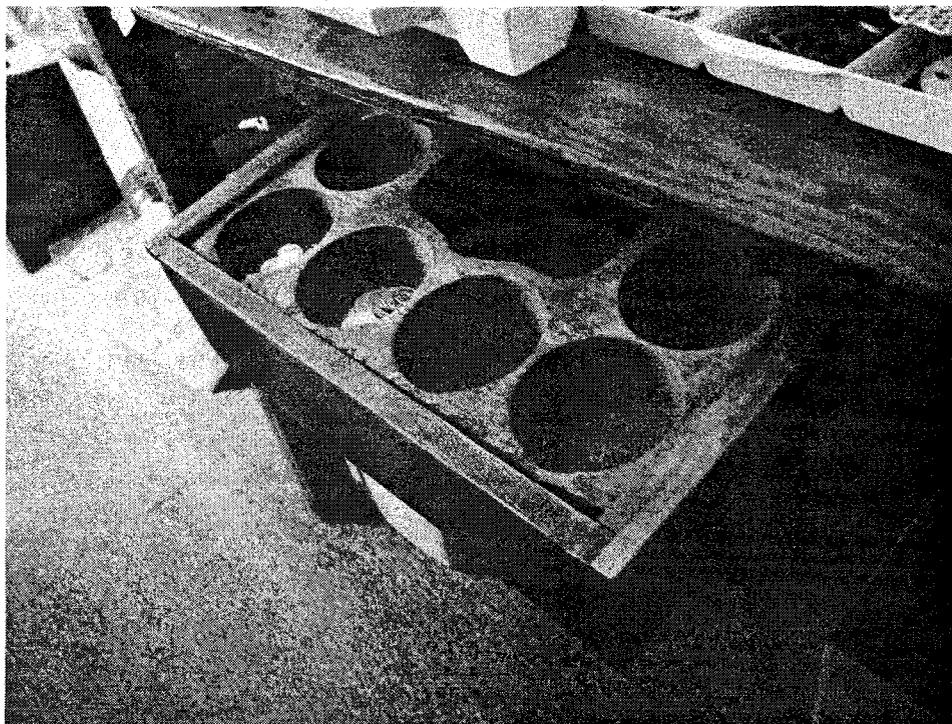
Fig. 8
Rockfield Grocery
Detail of Cash Register

The cash register is an integral component of the built in counter on the interior of the store. It slides out from underneath the countertop and features carved basins for money.

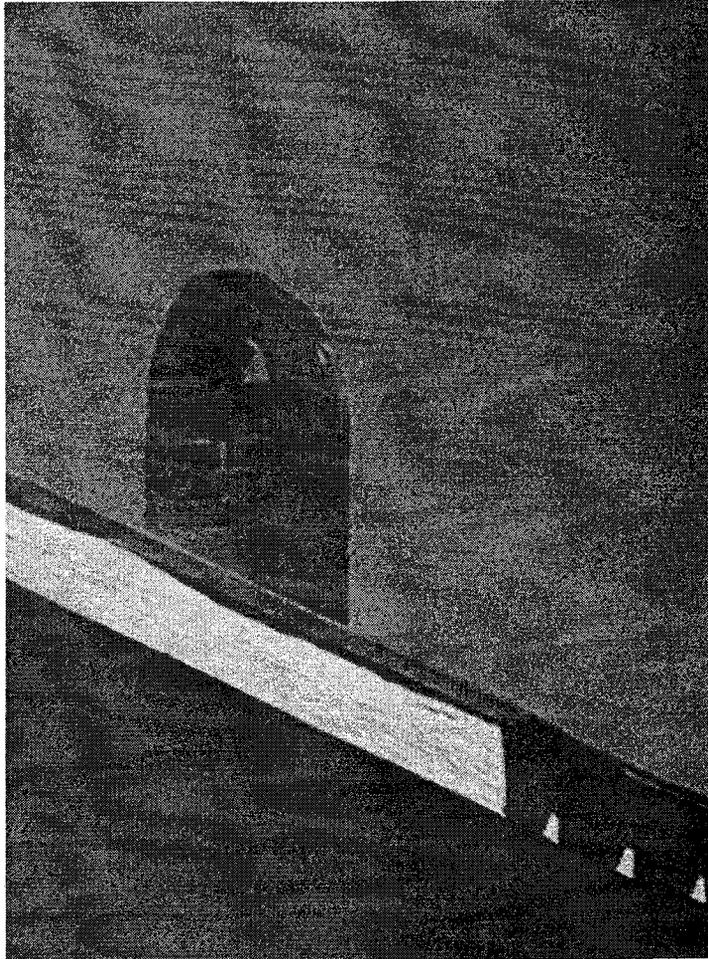
The interior of the building is also well maintained. The original wood counters and built-in shelving are intact. The counters have a nice finish and the shelves have been recently painted. Like the exterior, suggested renovations are cosmetic. The modern carpeting could be taken up to expose the (original ?) wood flooring below. More of a concern than aesthetics is the water damage visible in the ceiling around the stove pipe (fig. 10). The source of this water should be identified and steps taken to correct the problem; likely the water is coming in through the chimney, which is no longer in use (fig. 9).

Fig. 9
Rockfield Grocery
Detail of Chimney
The brick chimney is no longer functional, but black charring on the brick suggests it was well-used at one time.

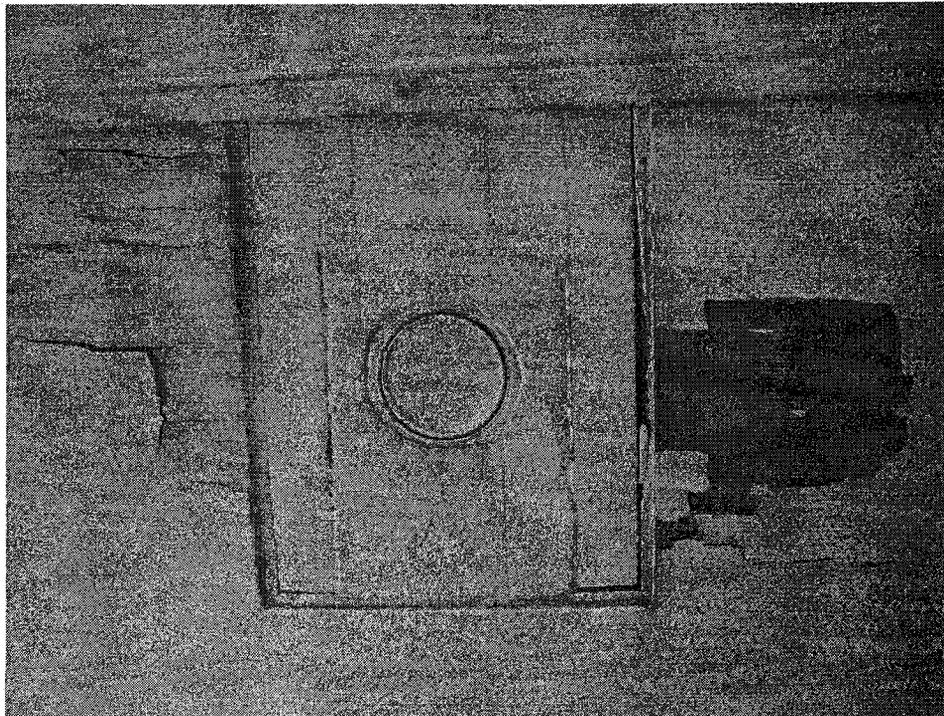
Fig. 10
Rockfield Grocery
Interior Ceiling with Stove Pipe
The store no longer features a stove, but the stove pipe remains visible in the ceiling. The chimney appears to be the source for the water damage surrounding the stove pipe.
