ARRINGTON FARM HOUSE
(Brightwood Farms)
Route 29, north of the Intersection of Route 634 & Route 29
Madison
Madison County
Virginia

HABS No. VA-1385

WRITTEN HISTORICAL AND DESCRIPTIVE DATA
REDUCED COPIES OF MEASURED DRAWINGS

ARRINGTON FARM HOUSE (Brightwood Farms)

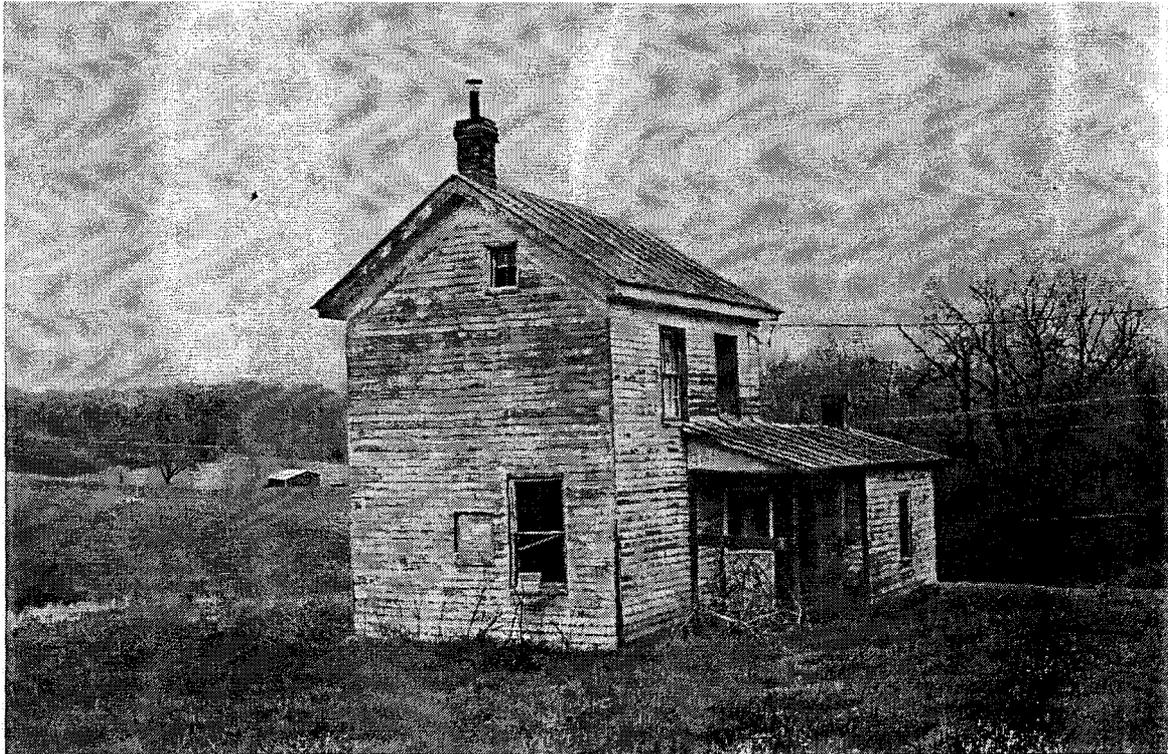
- Figure 1 Exterior view of the west and south walls.
- Figure 2 Exterior view of the west and north walls.
- Figure 3 Exterior view of the east and north walls.
- Figure 4 Exterior detail of damaged clapboard at the northeast corner at the sill level.
- Figure 5 Exterior detail of circular-sawn clapboards and square-headed nails at the southwest corner of the west section.
- Figure 6 Interior view of the first floor west room looking north and east at partition wall and closets.
- Figure 7 Interior view of the south room of east addition looking east.
- Figure 8 View of the roofing system in the attic of the west section.
- Figure 9 Interior detail of lock on the exterior door of the southeast room.
