FARR COTTAGE
(Blenheim)
Main Street
Fairfax
Independent City County
Virginia

HABS No. VA-1388

WRITTEN HISTORICAL AND DESCRIPTIVE DATA

HISTORIC AMERICAN BUILDINGS SURVEY
National Park Service
U.S. Department of the Interior
1849 C St. NW
Washington, DC 20240

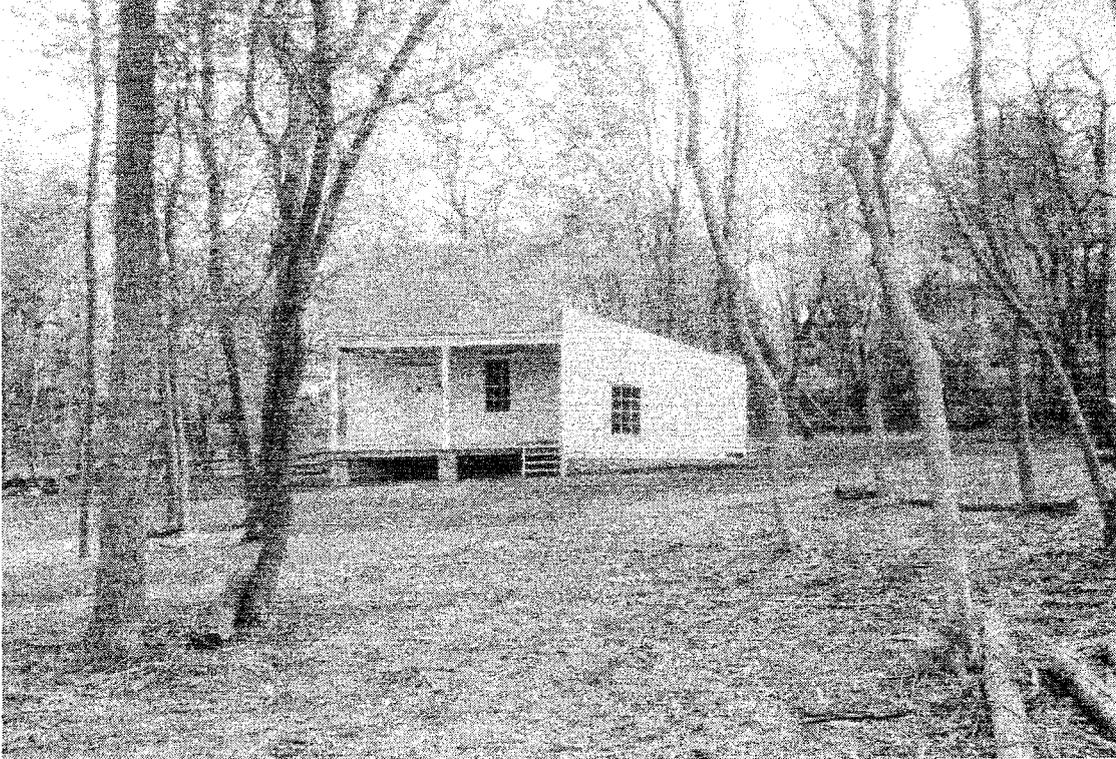
Exterior: In its present orientation, the house faces east and west, with later additions to the south and east (fig. 1). The original portion of the house is 1 ½ stories and measures 17'4" x 20'1" with a pair of porches on the long sides measuring 8' x 20'10". The core of the original house is covered by a side gable roof. The roof ridge is centered over the core and was extended to create covered porches on the front and back. The exterior is covered with beveled wood siding.

Figure 1. Front view of Farr Cottage

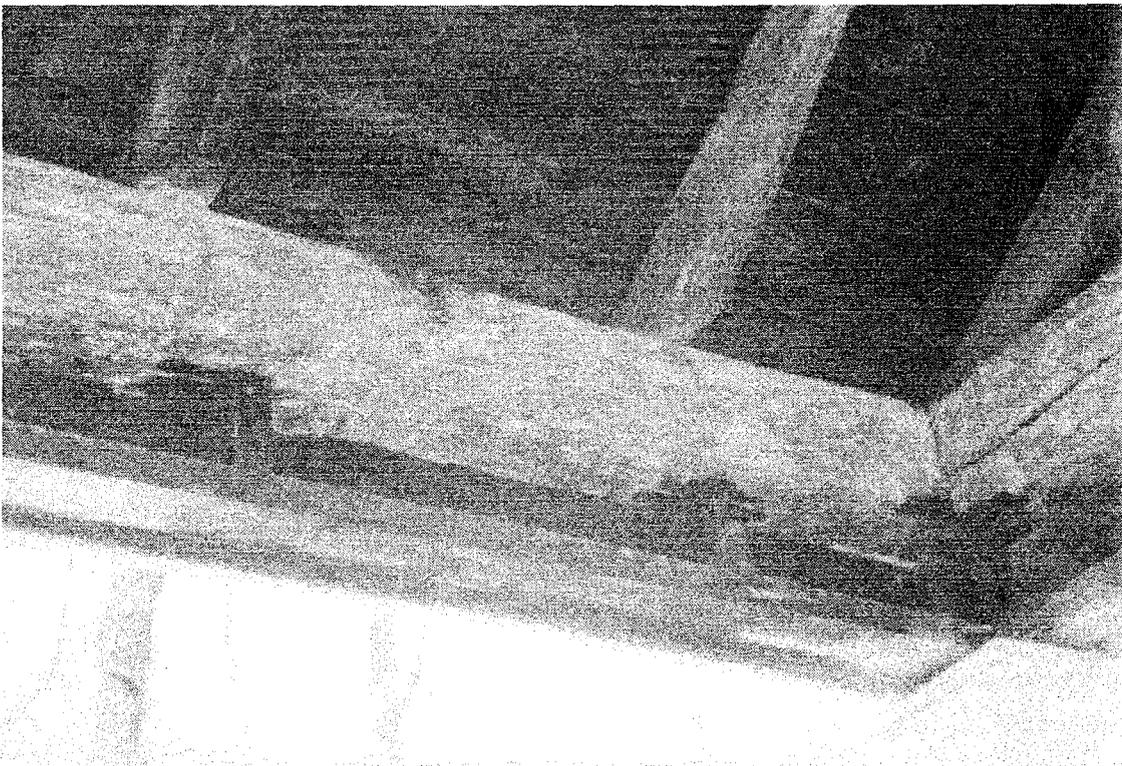
The front facade has one door and one window that appear to be in their original positions. The front porch, facing west, is supported by three square posts with a molded cornice and base. The third post, to the south, has been partially subsumed by the shed addition and may be the only original post still in place. The porch rests on modern brick pillars, while both the house and shed sit on a fieldstone foundation which was replaced after the 2001 move. There is also an exterior door opening off of the porch and leading to the shed addition. The porch roof has hand-hewn logs as the major supports (fig. 2). Several of the rafters are shaped logs, one with the bark still in place. Even so, these rafters are not from the initial construction period.

Figure 2. Hand-hewn timber posts on porch roof

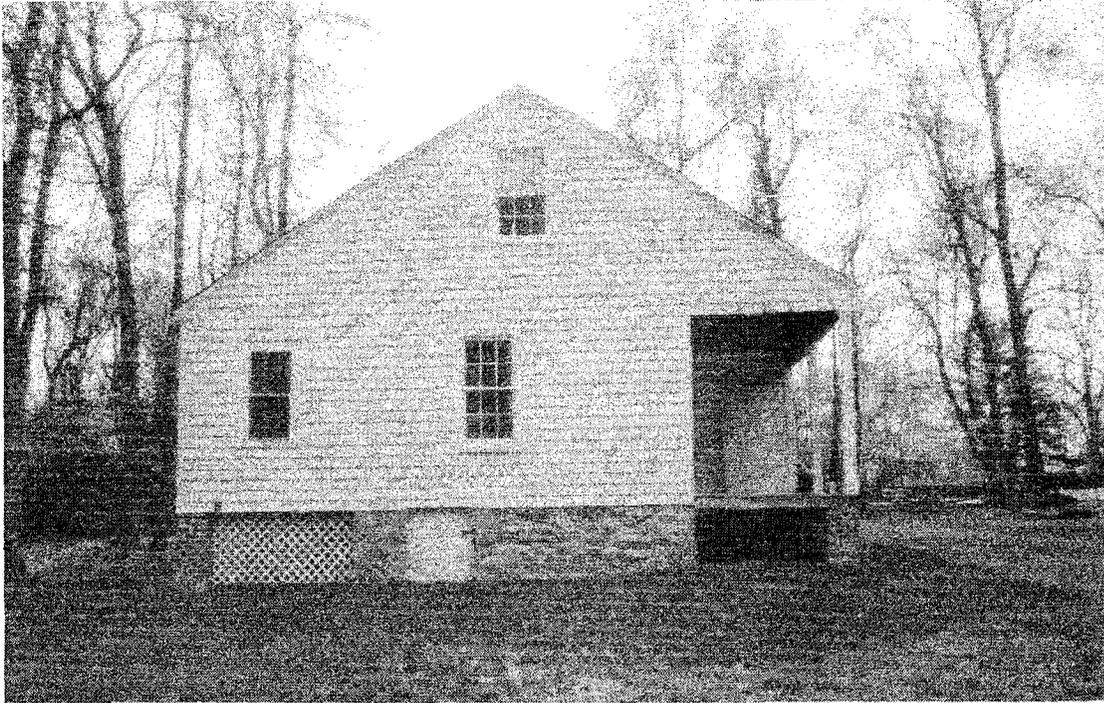
with six-over-six lights (fig. 3). There is an additional window, also glazed with six-over-six lights, in the gable end of the half-story. A small door provides access to the cellar (below grade) with a modern trellis around the crawl space.

Figure 3. North side showing the original house's roof-line

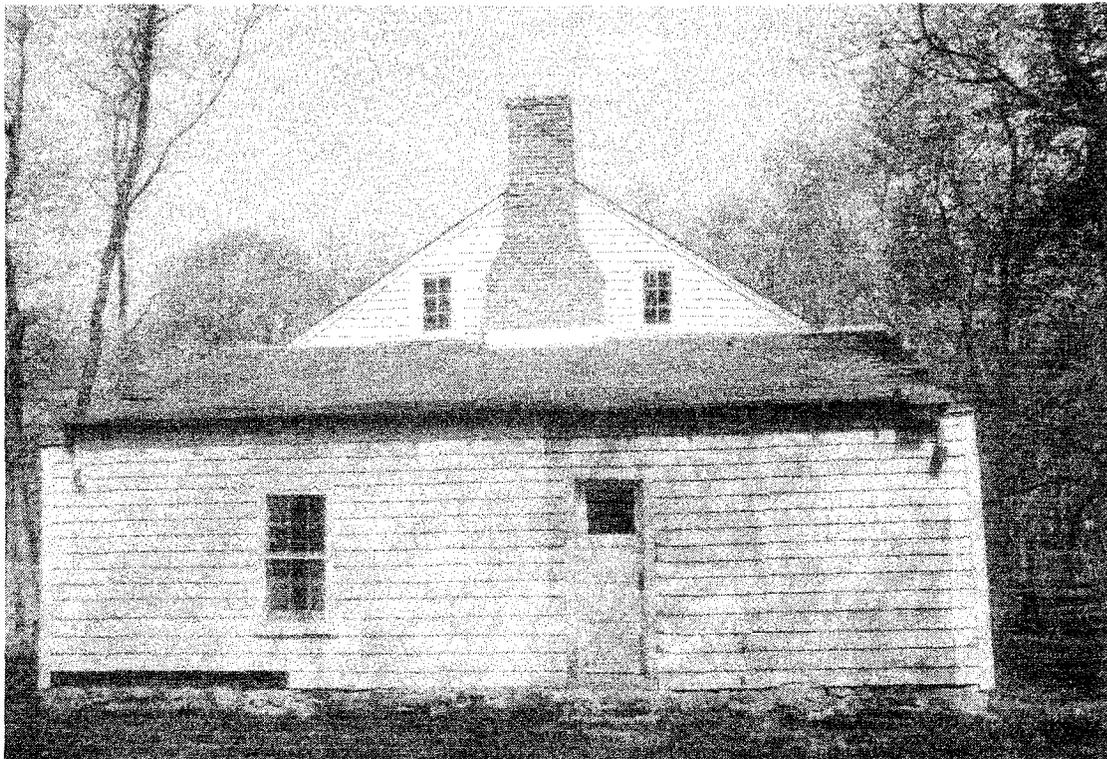
The south facade reveals the original house's gable end, seen above the shed roof, and reveals a central chimney stack made of brick masonry in a stepped diagonal profile (fig. 4). Two small casement windows flank the chimneystack at the half-story gable level. The south side of the shed addition has one window, glazed with six-over-six lights, and has one door. An addition that held the modern kitchen and entrance porch has been removed, but ghosts of their presence remain.

Figure 4. South end of shed addition with chimney stack of the original house

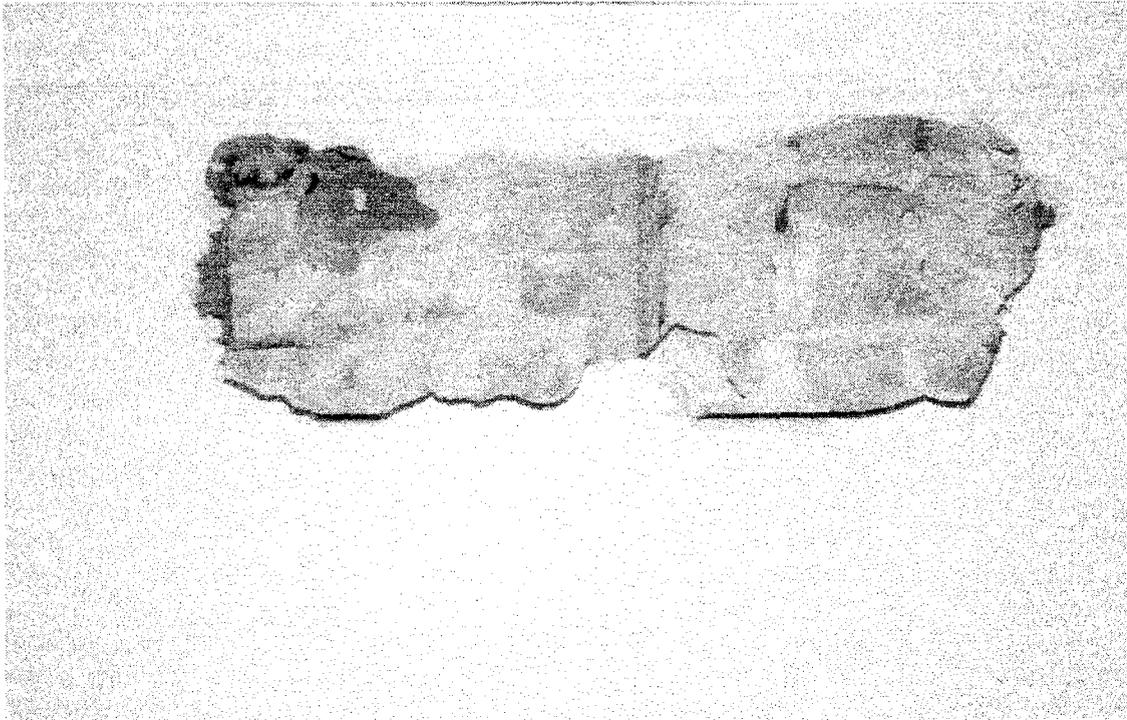
The upper bedroom has 2" flooring running east to west. The north and east walls have brick nogging placed within the studs (fig. 5). On the north wall there is a sash window glazed with six-over-six lights. On the south wall there are two casement windows glazed with two by three lights. The stair guardrail has one end post and one corner post with three horizontal guardrails.

Figure 5. Brick nogging between studs in second floor bedroom, east wall
