WRITTEN HISTORICAL AND DESCRIPTIVE DATA

ROANOKE, TOWN OF  
(Cutright Log House)

HABS No. WV-209-0

Location: Highway 38 (Brownsville Road), Lewis County, West Virginia.

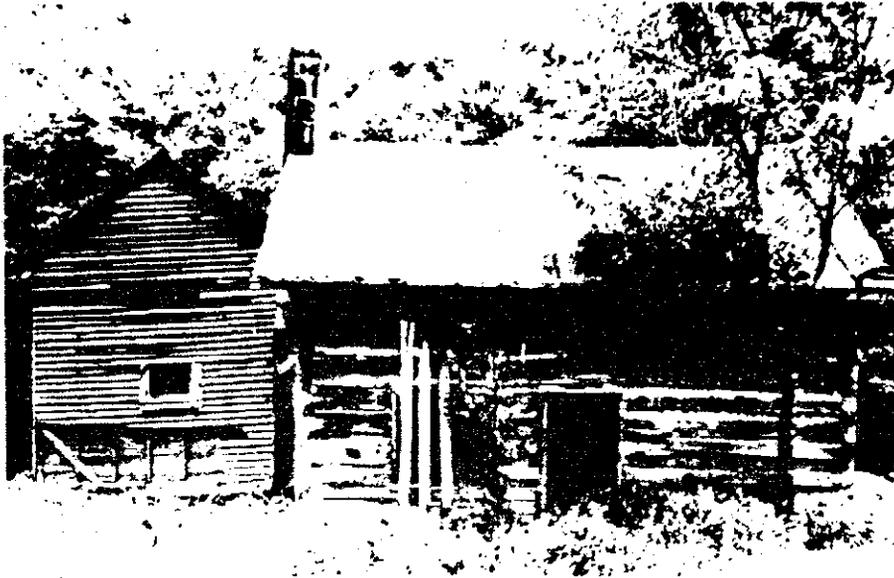
Perspective control photograph of the west elevation of the Cutright log and frame dwelling/barn in 1981. Before West Virginia County Route 38 was relocated such that it paralleled this elevation, this was probably the "rear" of the structure

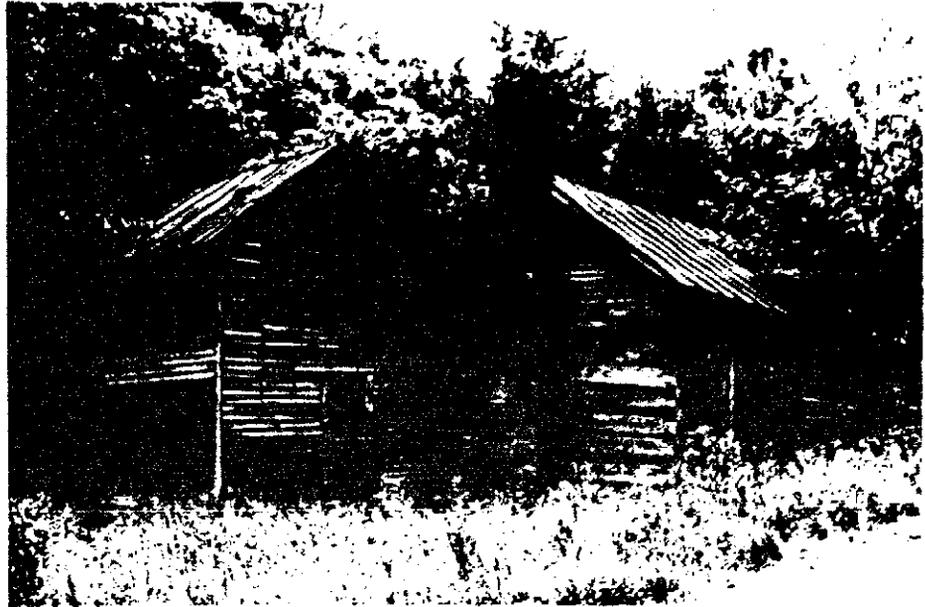
Perspective control photograph of the west and north elevations of the Cutright log and frame dwelling/barn in 1981. Note the sandstone chimney.

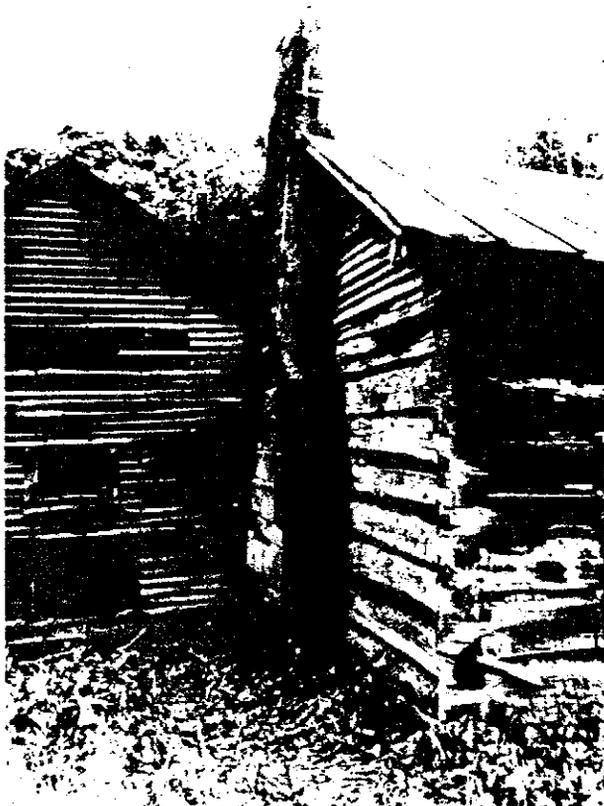
Close-up of west side of the sandstone chimney attached to the north elevation of the log component of the Cutright log and frame dwelling/barn in 1981. Note also the half dovetail corner notching.

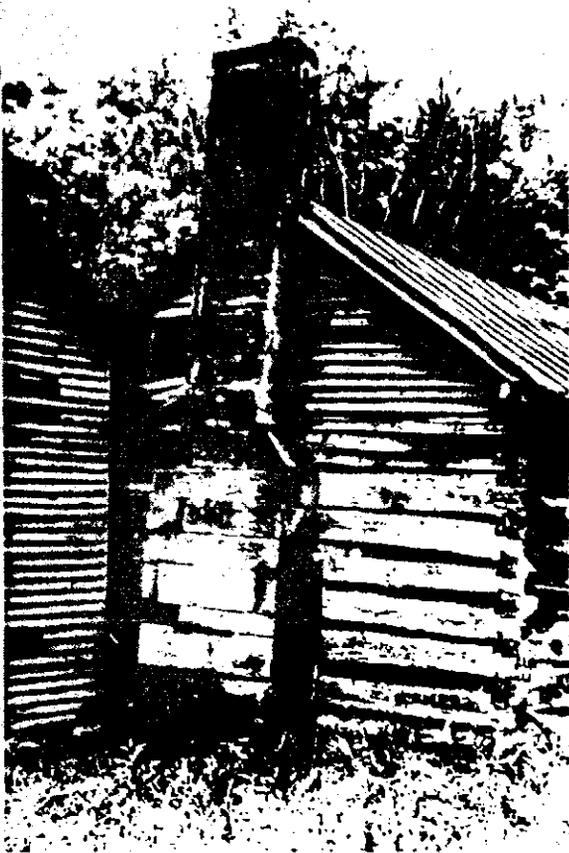
Close-up of north side of sandstone chimney attached to the north elevation of the Cutright log and frame dwelling/barn in 1981.

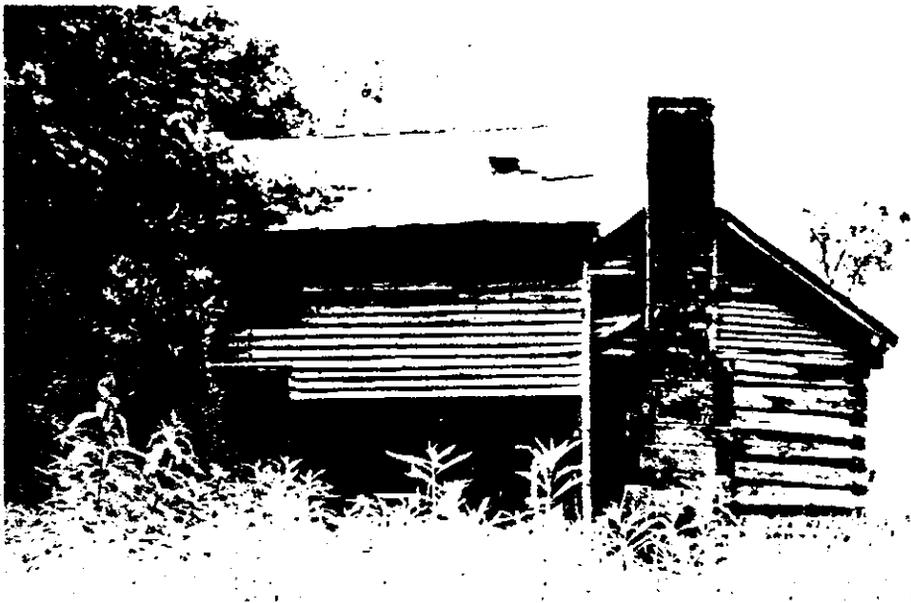
Perspective control photograph of the north elevation of the Cutright log and frame dwelling/barn in 1981.

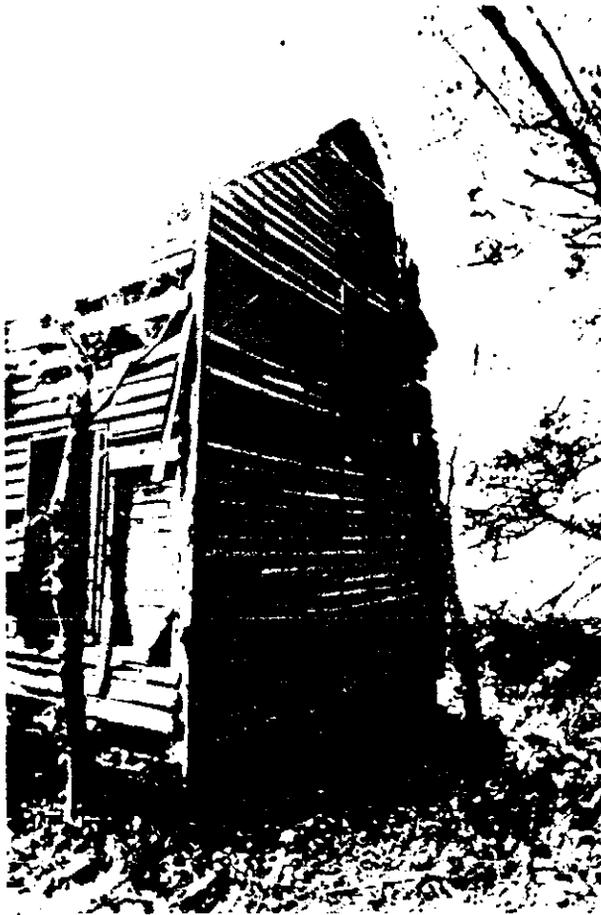
Close-up of east elevation of the frame component of the Cutright log and frame dwelling/barn in 1981. The proximity of the West Fork River as well as dense vegetative growth prohibited the taking of a perspective control photograph of the east elevation of the structure.

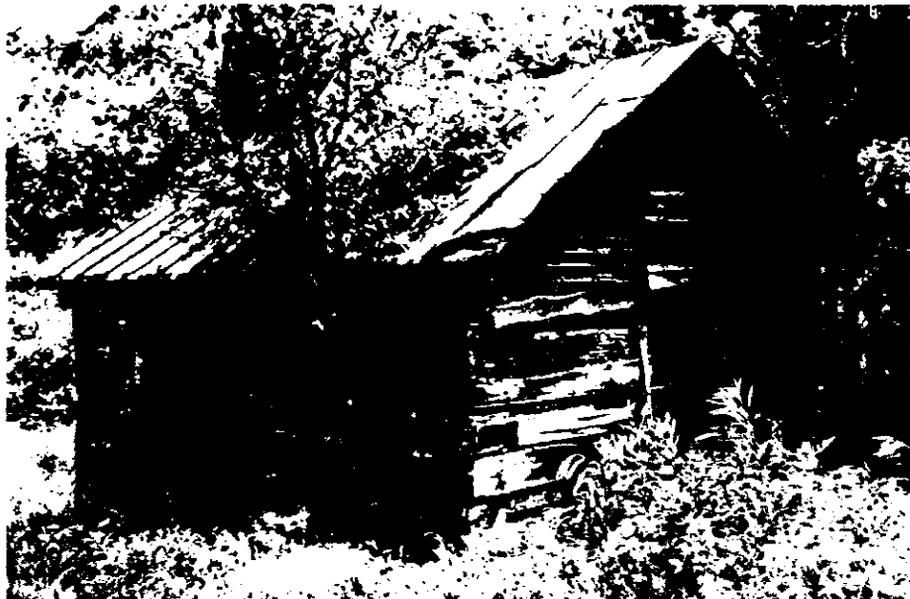
Perspective control photograph of the south and west elevations of the Cutright log and frame dwelling/barn in 1981. Directly in front of the door in this elevation, a small portion of West Virginia County Route 38 can be seen.

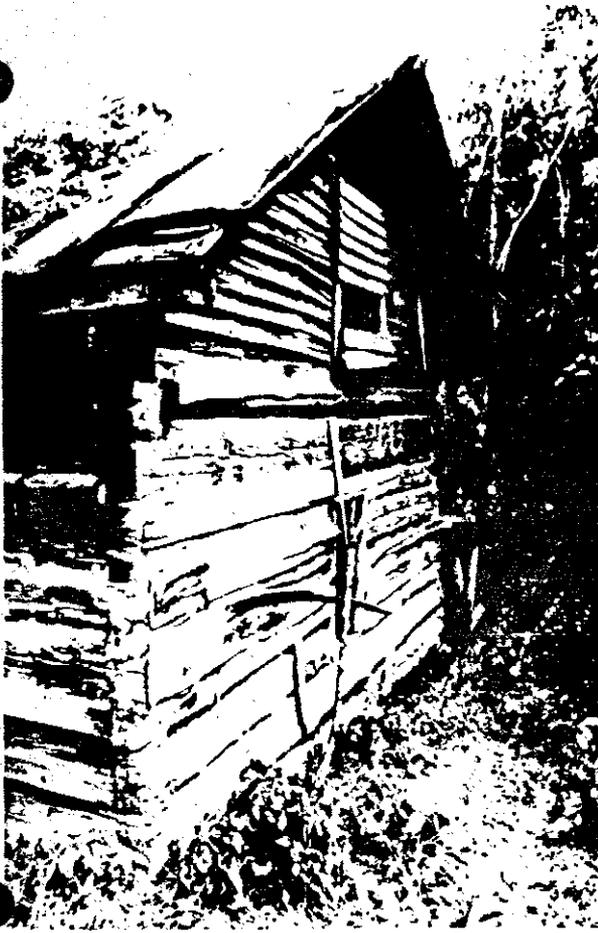
chinking between the logs consists of small pieces of riven boards and red clay; above the plates on the gable ends, the wall is constructed of clapboards attached to studs with cut nails. There is some indication on the south elevation that clapboarding may have been placed over the logs at one time and that horizontal board battens may have been used (at least on some portions of the log structure) over the interstices between the logs.

Close-up of the southwest corner of the Cutright log and frame dwelling/barn in 1981. Note remnants of clapboards over the logs on the south elevation as well as the half dovetail corner notching. The cantilevered log plates also can be seen in this photograph.

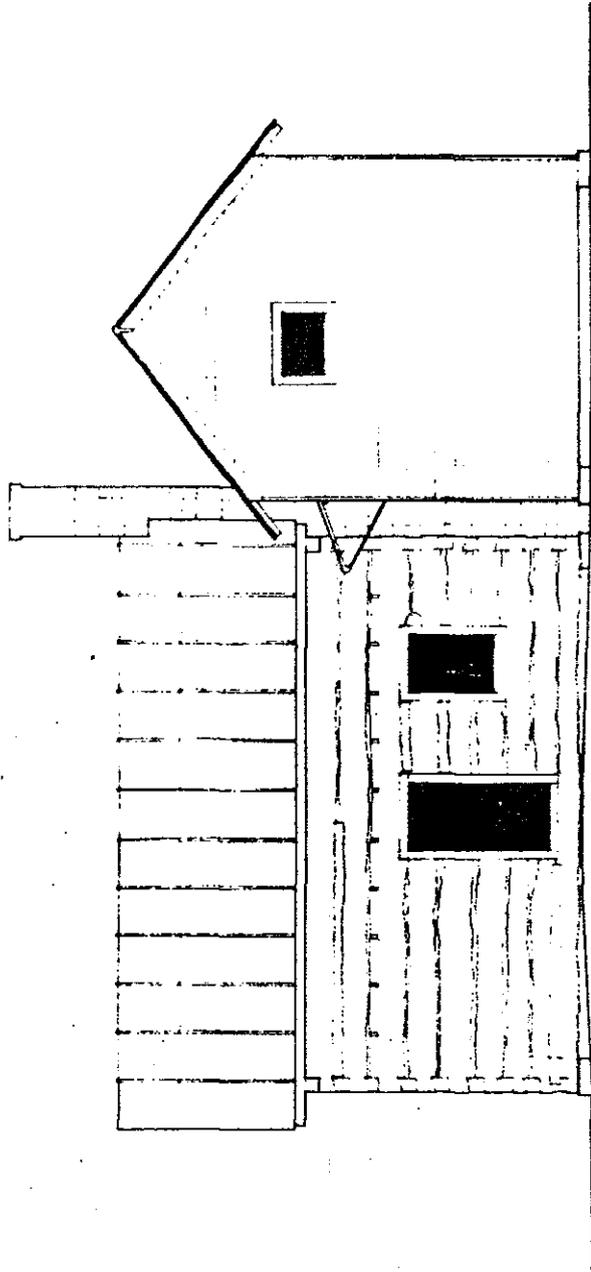
EAST ELEVATION

East elevation of the Cutright log and frame dwelling/barn. The window in the log portion of the structure is covered by a wooden shutter nailed in place. The shutter is not shown in the elevation drawing.
