FORT HUACHUCA, CAVALRY STABLE  
(Building No. 30031)  
(Building No. 91)  
(Building No. 127)  
(Building No. 3040)  
Clarkson Road  
Sierra Vista vicinity  
Cochise County  
Arizona

FORT HUACHUCA, CAVALRY STABLE  
(FORT HUACHUCA, BUILDING 30031)  
(FORT HUACHUCA, BUILDING 91)  
(FORT HUACHUCA, BUILDING 127)  
(FORT HUACHUCA, BUILDING 3040)

HABS NO. AZ-210-G

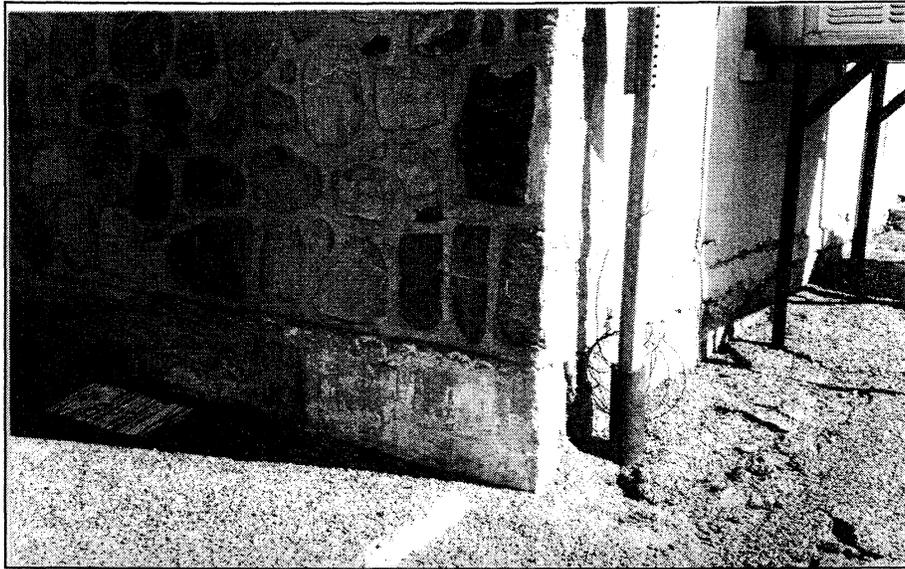
**2. Foundations:** Foundations are hand-poured, board-formed concrete and comprise an 8-inch-thick stem wall. It is unlikely there is any steel reinforcing in this foundation. Due to the site slope and the 1954 installation of concrete aprons, the stem wall is not visible except at the west end of the building, where it shows a maximum of 1 ft, 3 inches above the asphalt paving. Its hand-poured quality is seen in occasional voids and seams from uneven board placement (Figure G.3).

**FIGURE G.3.** FOUNDATION AT SOUTHWEST CORNER (PHOTOGRAPH BY JANET PARKHURST, JANUARY 2005).

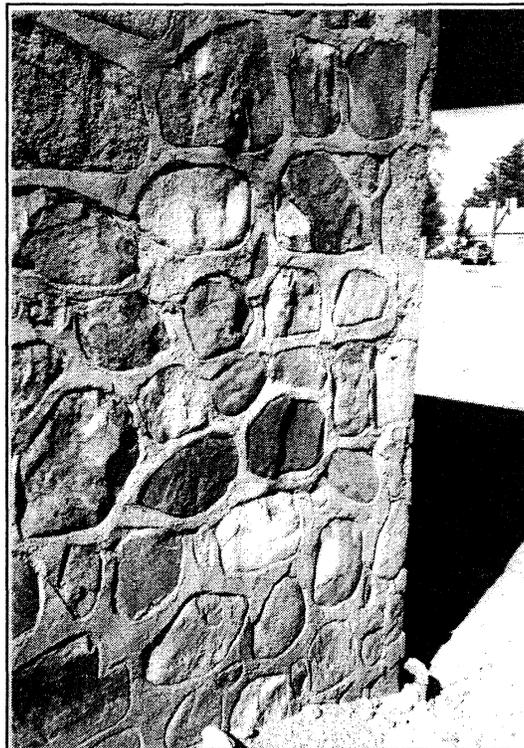
**FIGURE G.4.** DETAIL OF THE STONE MASONRY WALL CONSTRUCTION, NORTHEAST CORNER OF BUILDING. THE MASONRY WORK IS TYPICAL OF THE WORKS PROGRESS ADMINISTRATION (W.P.A.) ERA AT FORT HUACHUCA (PHOTOGRAPH BY JANET PARKHURST, JANUARY 2005).

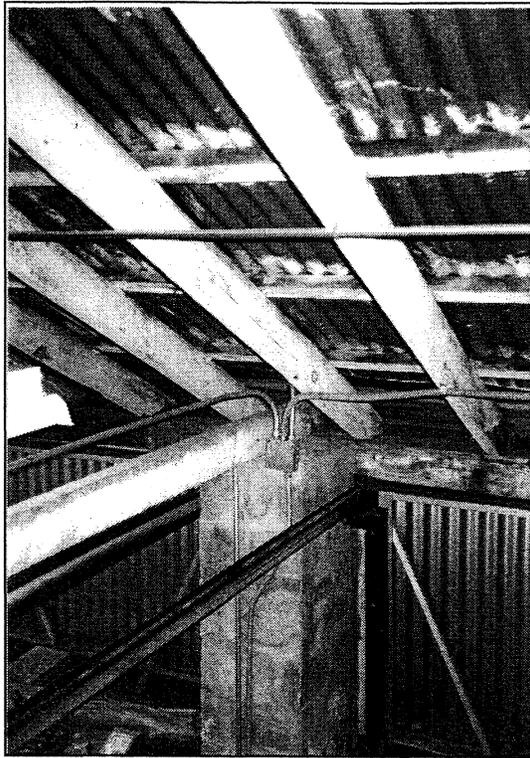
Where visible, posts are braced and tied to the perimeter beams, the sloping roof rafters, and across the aisle by lateral, longitudinal, and diagonal members. Posts, roof framing members, and roofing nailing boards appear to be of redwood, whereas wall studs and exterior board siding are probably fir (Figure G.5).

**FIGURE G.5.** ORIGINAL ROOF FRAMING TIED INTO A PERIMETER BEAM IN A TOOL CRIB (PHOTOGRAPH BY JANET PARKHURST, JANUARY 2005).

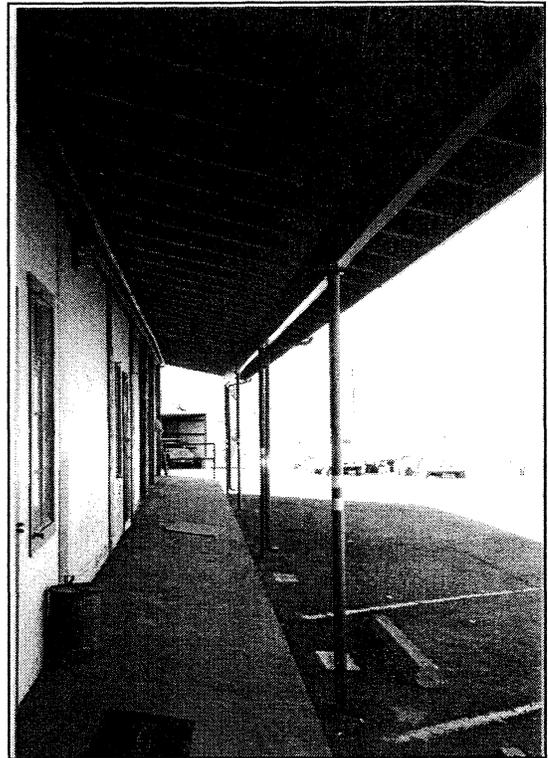
Of unknown vintage, the north porch is a full-length appendage with a shed roof attached to the building by a ledger at the eave. The porch roof is supported on 3-inch-diameter steel pipes with saddle connectors on top that hold a 4" x 12" beam to which rafters and sheathing in plywood are attached. The pipes are installed 5 ft, 7 inches from the stone piers, in the asphalt pavement beyond the concrete apron. The porch roof is clad in roll roofing (Figure G.6).

**FIGURE G.6.** VIEW TO WEST OF FULL-LENGTH, NORTH PORCH WITH FRAMED SHED ROOF ON STEEL PIPE COLUMNS. CONSTRUCTION DATE UNKNOWN (PHOTOGRAPH BY JANET PARKHURST, JANUARY 2005).

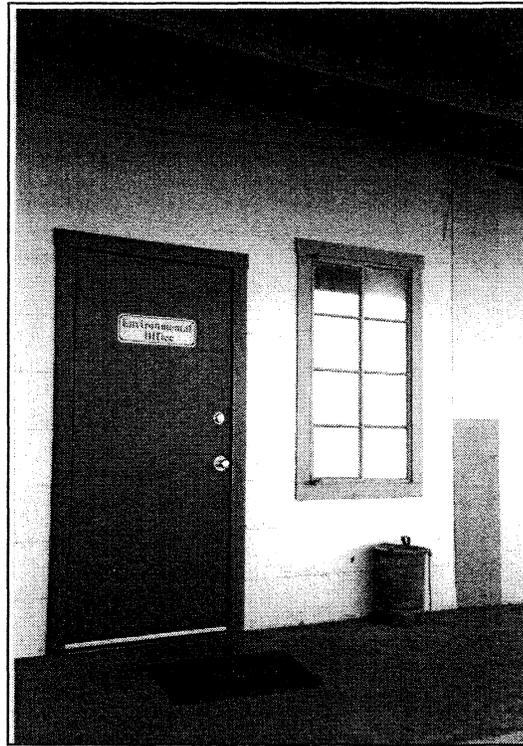
Personnel doors are mostly single, flush panel types with casing. In the easternmost bay of the north facade is a pair of flush panel doors. Some doors have a single light. Casing is either  $\frac{3}{4}$ " x 3" straight-jointed wood or  $\frac{3}{4}$ " x 2" mitered wood. The doors with straight-jointed casing probably pertain to the 1954 work. Those with mitered casing may be later. There are 10 personnel doors on the north facade and two on the south facade. They are painted red-brown (Figure G.7).

**FIGURE G.7.** TYPICAL FLUSH PANEL PERSONNEL DOOR, NORTH FAÇADE, INSTALLED IN 1954 (PHOTOGRAPH BY JANET PARKHURST, JANUARY 2005).

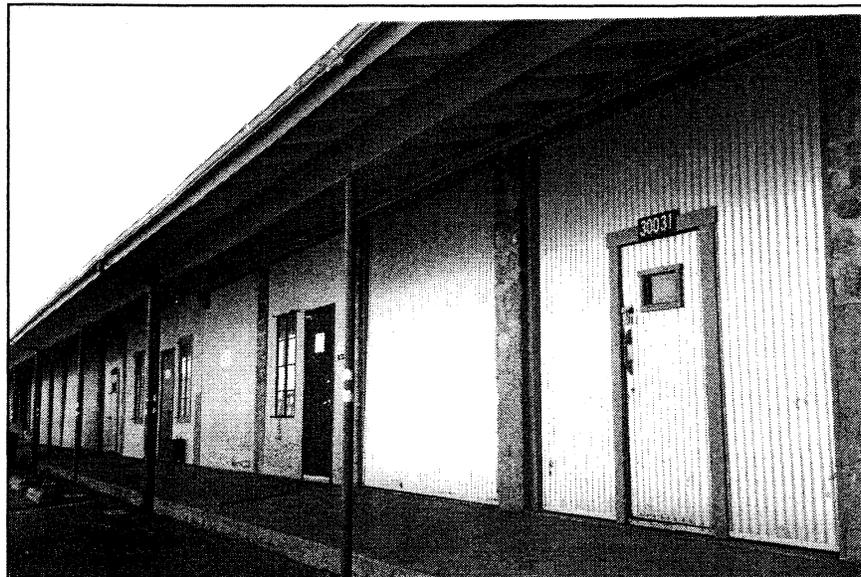
Swing-up doors of corrugated aluminum fill an entire bay. Installed in 1954, they operate not by rolling up but by tilting up without bending and then engaging on a pair of horizontal steel tracks aligned along the inner face of the stone piers. Not all are operable today, and they function as metal walls. There are nine aluminum doors on the north facade and seven on the south facade (Figure G.8).

**FIGURE G.8.** CORRUGATED ALUMINUM SWING-UP DOORS, NORTH FAÇADE, INSTALLED IN 1954 (PHOTOGRAPH BY JANET PARKHURST, JANUARY 2005).

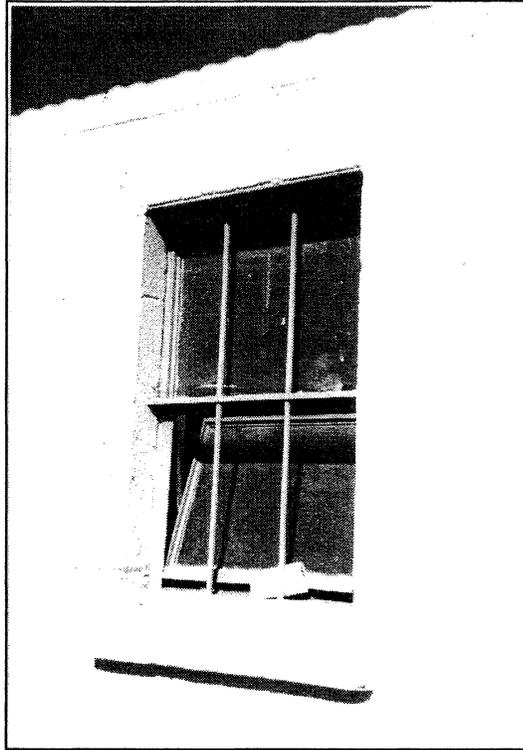
façade. The latrines have small hoppers with obscure glass and steel rod security grills. Two aluminum sliding windows, a later installation, appear near the east end of the south façade. Some windows have straight-jointed casing, others have mitered casing, and some are without casing (Figure G.9).

**FIGURE G.9.** DETAIL OF STEEL HOPPER WINDOW FOR LATRINES, SOUTH FAÇADE. (NOTE STEEL ROD SECURITY GRILL. INSTALLED IN 1954) (PHOTOGRAPH BY JANET PARKHURST, JANUARY 2005).

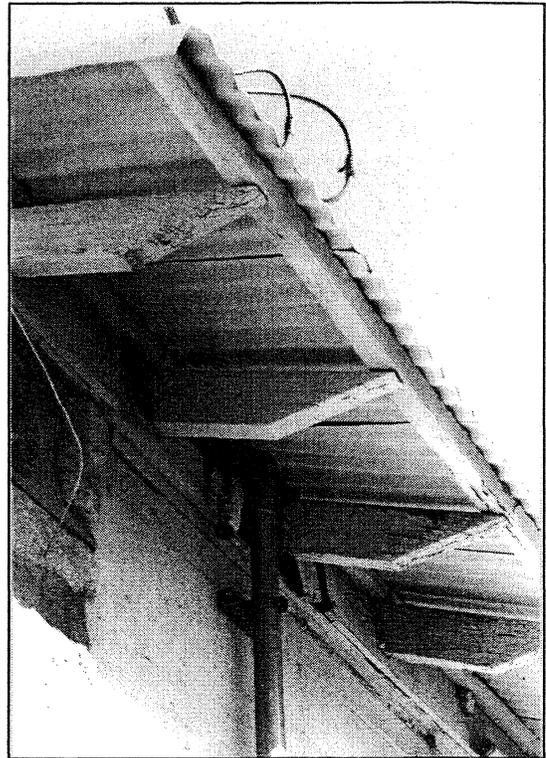
**b. Eaves:** Eaves comprise exposed 2" x 6" rafter ends that extend to form a 2-ft overhang. The corrugated metal roofing is exposed at the eaves. Rafters have been modified by a diagonal cut that renders the ends parallel to the ground (Figure G.12). The gable rakes are supported by nailing boards over which board sheathing has been added. The rake ends overhang approximately 1 ft. There is a cornice board at the rakes and eaves. Eaves are generally in fair condition, because framing members have been painted. There is weathering of rafter ends, some deformed or torn roofing, and paint peeling.

**FIGURE G.12.** MODIFIED RAFTER ENDS CUT SO THEY ARE PARALLEL TO THE GROUND (PHOTOGRAPH BY JANET PARKHURST, JANUARY 2005).
