OVERHILLS, BLACK SERVANTS' QUARTERS  
(Building No. 44)  
Overhills Historic District  
West of Thurman Road & East of Overhills golf course  
Fort Bragg  
Harnett County  
North Carolina

HABS  
NC-407-Y

HISTORIC AMERICAN BUILDINGS SURVEY  
OVERHILLS, BLACK SERVANTS' QUARTERS  
(Building No. 44)

HABS No. NC-407-Y

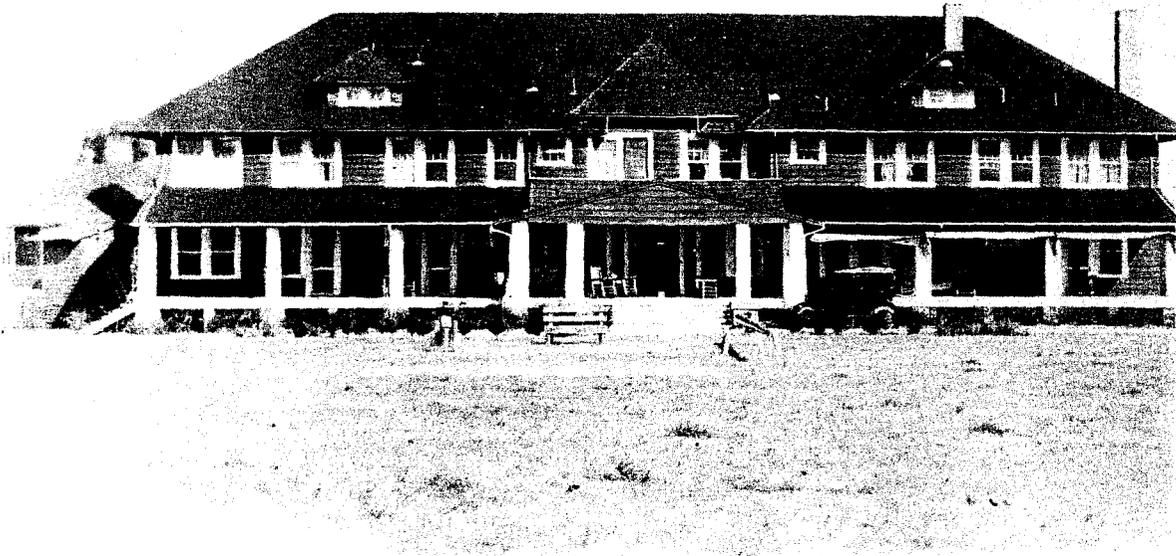
Figure 1: The Black Servant's Quarters was directly behind the Overhills Country Club (courtesy NC SHPO).

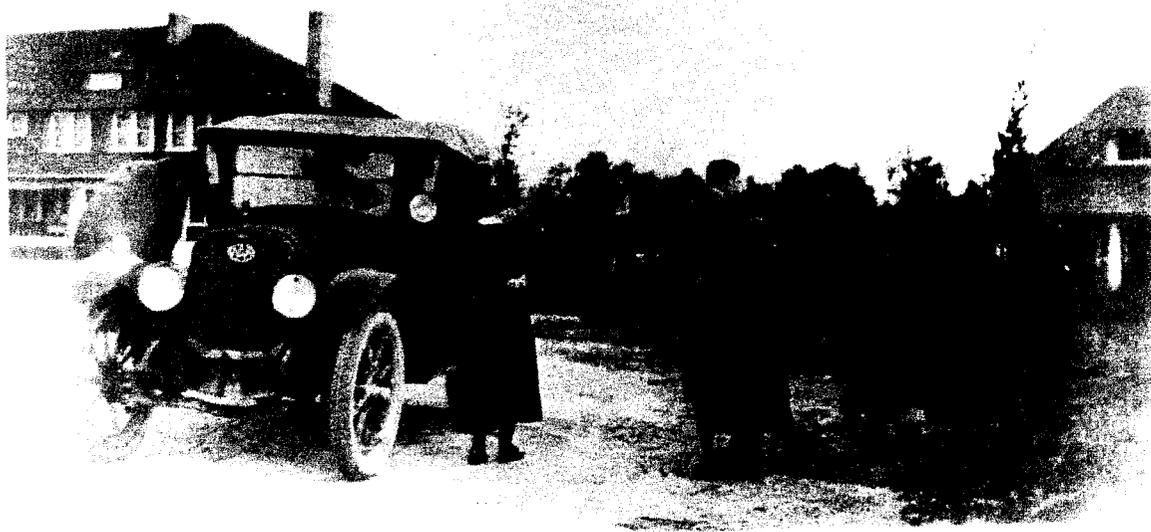
Figure 2: The White Servants' Quarters (similar to the Black Servants' Quarters) can be seen in the middle of the photograph, view to the northeast Ca. 1920s (courtesy NC SHPO).
