NEW YORK STATE BARGE CANAL, WASTE WEIR (MAYBEES)  
(Erie Canal, Waste Weir (Maybees))  
0.13 miles west of Bolton Road  
Royalton Center  
Niagara County  
New York

HAER NY-506  
*HAER NY-506*

WRITTEN HISTORICAL AND DESCRIPTIVE DATA

#### HAER No. NY-506

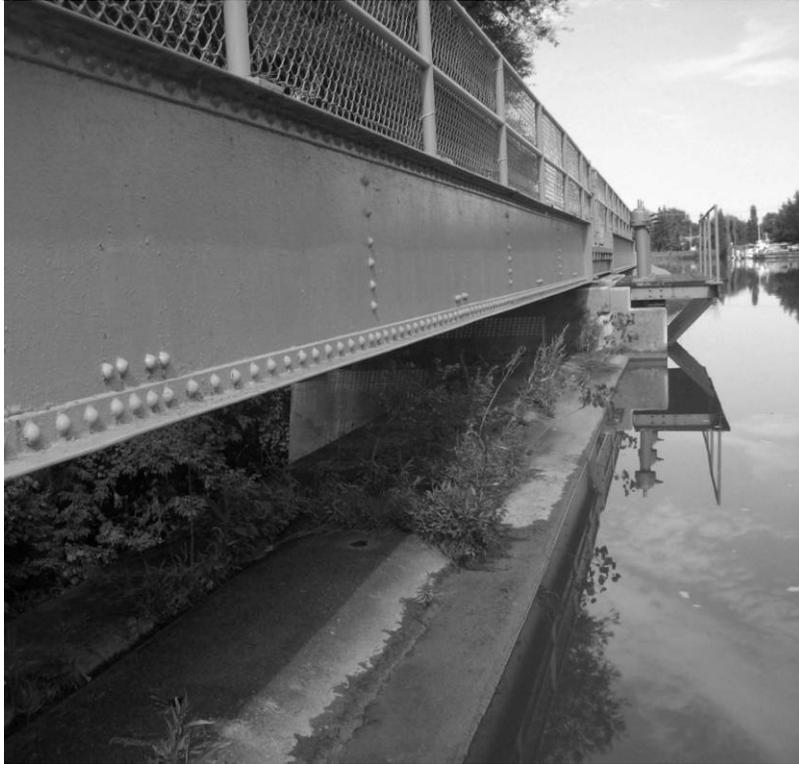
**Description:** The waste weir is located on the north bank of the canal.<sup>1</sup> The weir consists of three central sluice gates flanked by approximately 42'-long concrete spillway segments. The structure is in good condition.

**Image 1:** Concrete spillway and waste weir in background with bridge spanning both structures. Field photograph taken by HAER recording team, summer 2009.

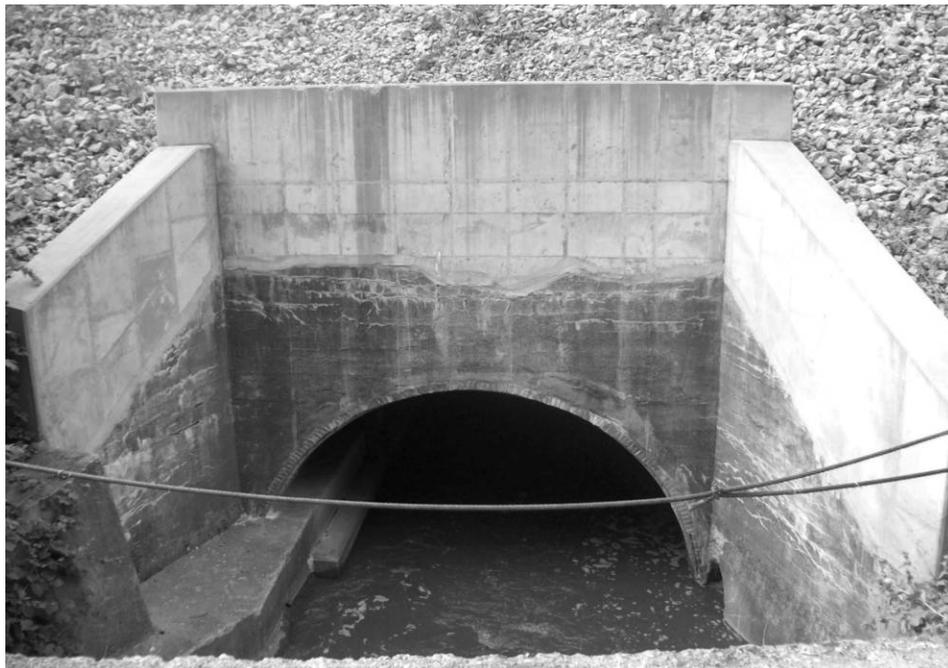
Culvert 113 is located east of Maybees Waste Weir. The original culvert is stone and there are concrete extensions, which are noted on a site map.<sup>2</sup> The arched headwalls are concrete, and the pipe is corrugated metal. The culvert is in good condition.

**Image 2:** Culvert 113. Field photograph taken by HAER recording team, summer 2009.
