NEW YORK STATE BARGE CANAL, SECTION 7 MAINTENANCE
SUB-HEADQUARTERS (LOCKPORT)
(Erie Canal, Section 7 Maintenance Sub-Headquarters (Lockport))
Access off Exchange Street
Lockport
Niagara County
New York

WRITTEN HISTORICAL AND DESCRIPTIVE DATA

HAER No. NY-514

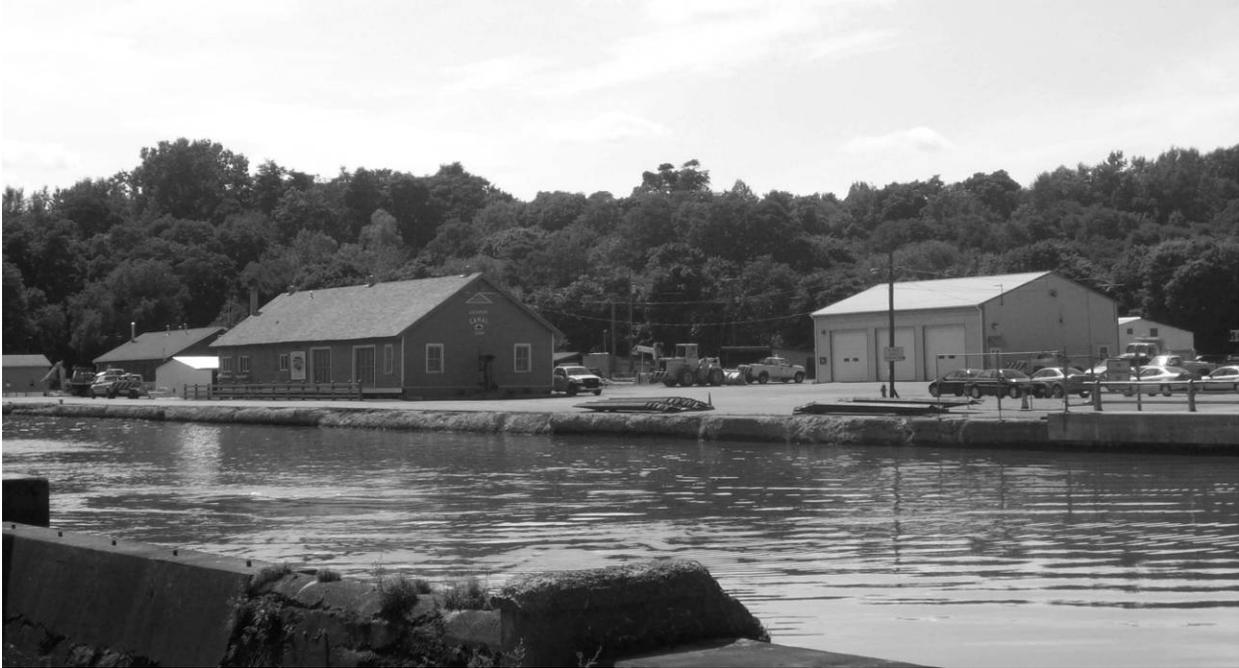
Fronting the canal is the freighthouse, a single-story 32' x 100' elongated frame building on timber beams set on concrete footings. The gable roof has asphalt shingles with exposed rafter tails. The building is clad in shiplap siding and has modern vinyl casement windows, modern pane-and-panel doors, and wood freight doors. The window and door bays have been altered. The freighthouse is in fair condition.

Image 1: Lockport Sub-Maintenance Headquarters site overview with warehouse at foreground. Field photograph taken by HAER recording team, summer 2009.

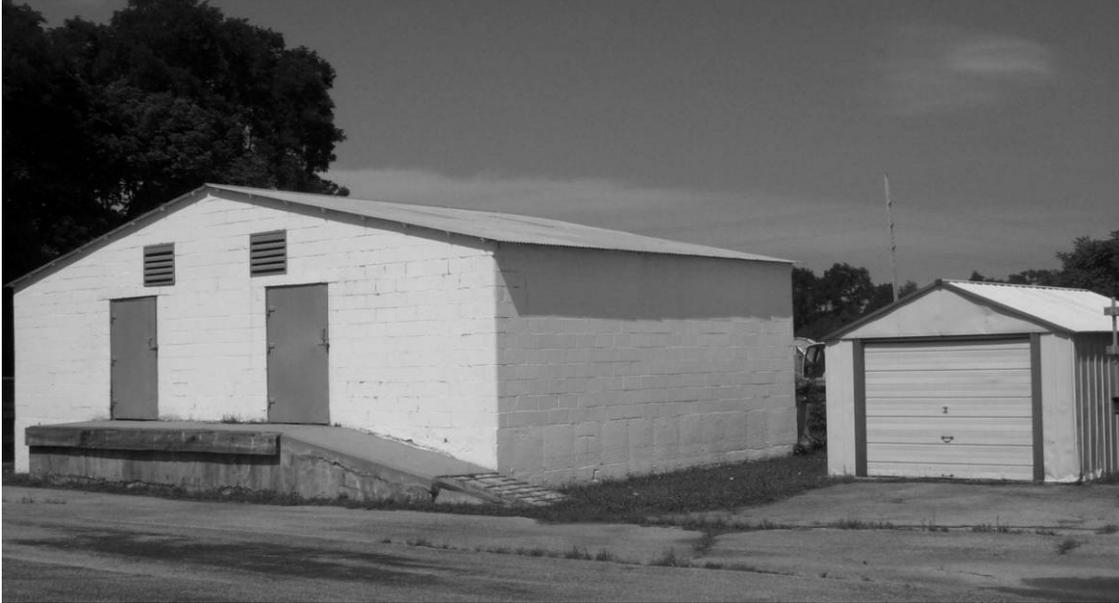
Other buildings include the lube house, a single-story concrete block building on a concrete foundation with a ramp at the front façade. The gable-front roof is covered in corrugated metal, and there are steel entrance doors. This building is in good condition. A modern garage is located between the lube house and mechanics' building. A single-story standing-seam metal structure with a gable roof and modern garage doors serves as the mechanics' building. It is in good condition but is non-contributing due to its recent construction. The carpenter shop is a single-story frame building clad in standing-seam metal with a concrete addition at the rear. The main building has a gable roof and steel door, while the addition has one-over-one-light windows. It is in fair condition. The sandblasting building is a single-story frame structure with vinyl siding and an asphalt-shingled gable-front roof. The fenestration is comprised of one-over-one-light vinyl windows, and there is a modern garage door as well as a pane-and-panel one. This building is in good condition. The gable-roof brick carpenters' shop on the west end of the yard has multi-light steel sash windows and roll-up doors at either end. The shop is in good condition.

Image 3: Lube house at left and garage at right. Field photograph taken by HAER recording team, summer 2009.

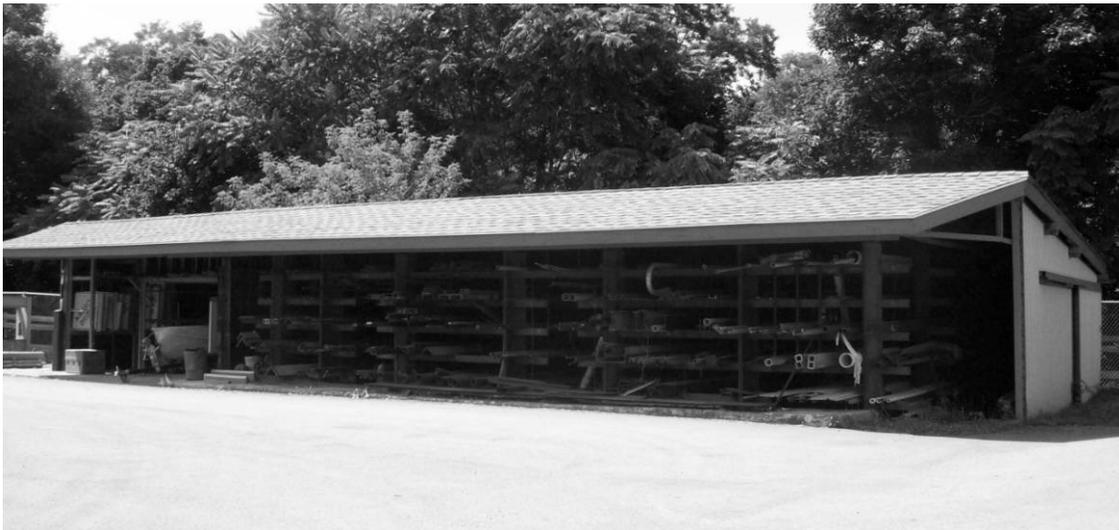
Image 6: Steel bar shed. Field photograph taken by HAER recording team, summer 2009.

bar shed is a single-story frame structure clad in standing-seam metal siding. The side-gable roof is covered with asphalt shingles. It is in fair condition. A tractor shed is a single-story open bay frame building clad in standing-seam metal with an asphalt-shingled shed roof. The tractor shed is in good condition.

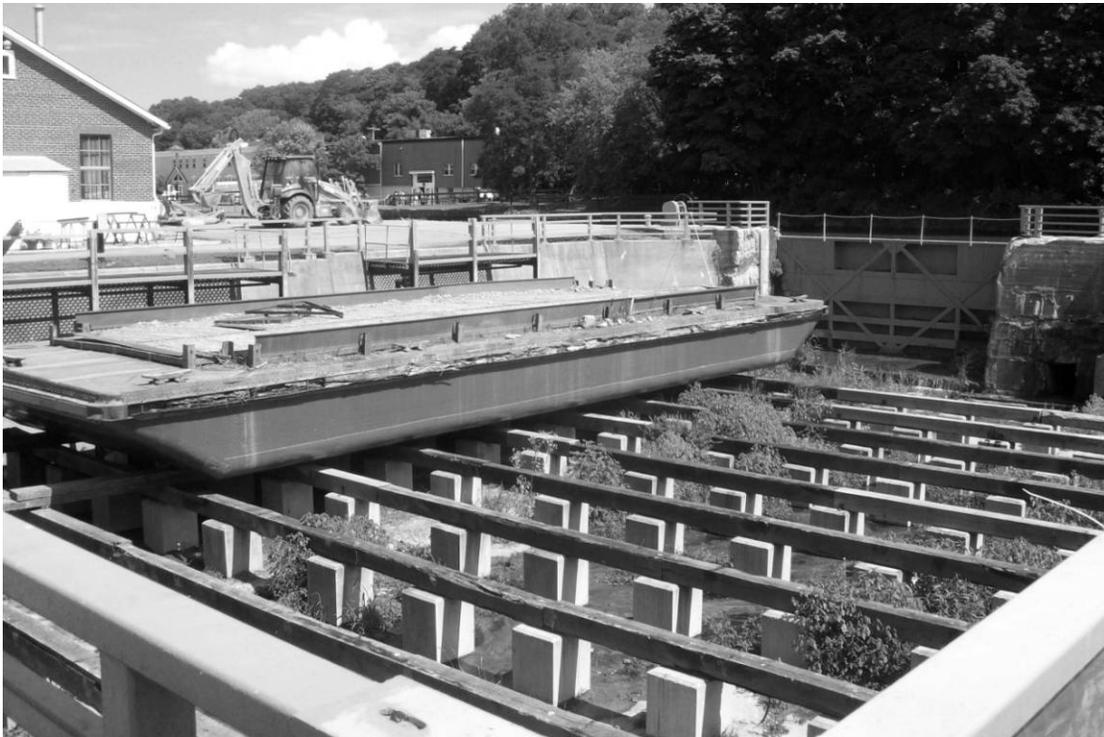
Image 8: Dry dock. Field photograph taken by HAER recording team, summer 2009.

The dry dock is located west of the facility. The chamber has stone walls capped with concrete. A hinged steel gate is located at the eastern corner, and there are steel sluice gates and operating stands at either end. Timbers on concrete piers are ranged along the bottom of the dry dock chamber, which is overall in fair to poor condition due to heavy spalling and breaking.
