NEW YORK STATE BARGE CANAL, LOCK O2
(Oswego Canal, Lock O2)
East Broadway at South First
Fulton
Oswego County
New York

HAER NY-530
HAER NY-530

WRITTEN HISTORICAL AND DESCRIPTIVE DATA

HAER No. NY-530

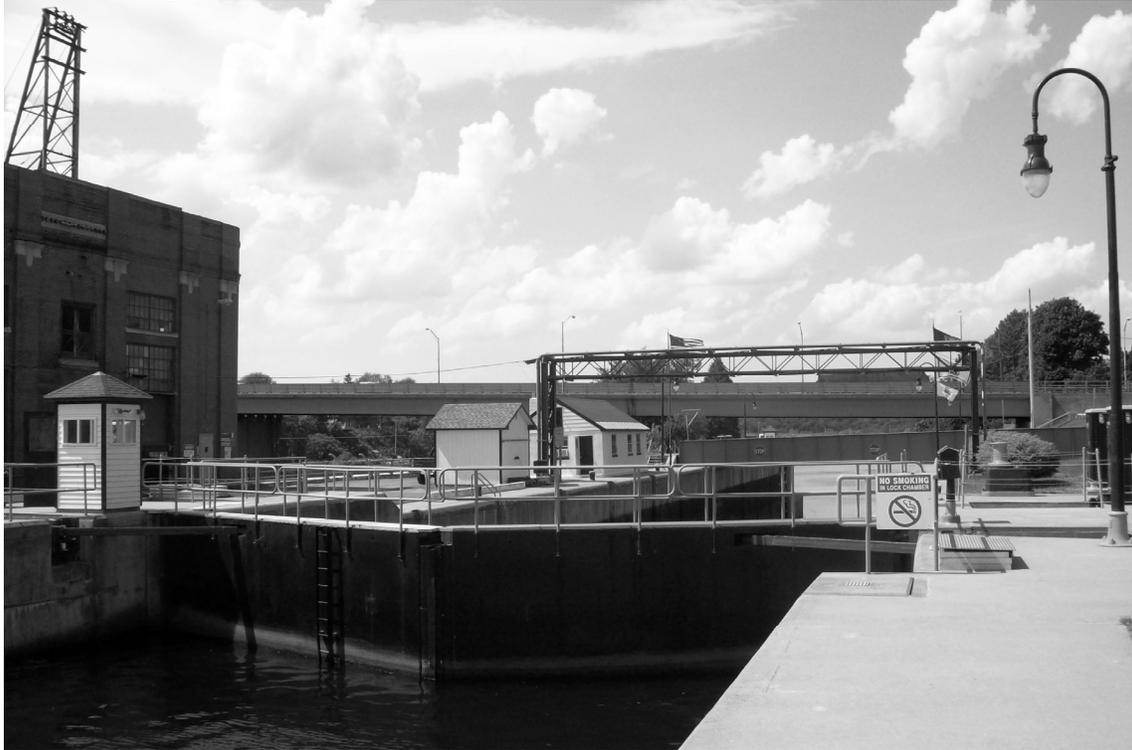
Located on the downstream end of the lock on the riverside chamber wall, the lockhouse is a single-story concrete block structure with a concrete chimney that sits on a concrete foundation. The gable-front roof is covered with asphalt shingles with metal panels at the edges. The gable ends have horizontal board infill. Two-over-two-light wood windows punctuate the gable ends while the rest of the building has one-over-one-light aluminum windows. The entrance is a wood pane-and-panel door. The lockhouse is in good condition.

early installation under a different contract. There are riveted-steel electrical cabinets at each corner of the lock chamber. The capstans are located on a raised concrete platform surrounded by steel railing and open-grates. Concrete-filled cast-iron bollards on concrete pads line either side of the chamber. Chain-link fencing and pipe railings surround the public access side of the lock chamber, and either historic or reproduction (fieldwork could not verify this) light fixtures illuminate the site. The lock appears to be in good condition.

Control stand shelters are located at the upstream and downstream ends on the river side of the lock chamber. Each is a single-story frame structure with horizontal wood siding and a pyramidal asphalt roof. The walls are punctuated by vinyl sliding windows and a single-paned door. The shelters are in good condition.

Image 1: Lock overview with control stand shelter at left of chamber in the foreground and lockhouse at left in the background. Field photograph taken by HAER recording team, summer 2009.

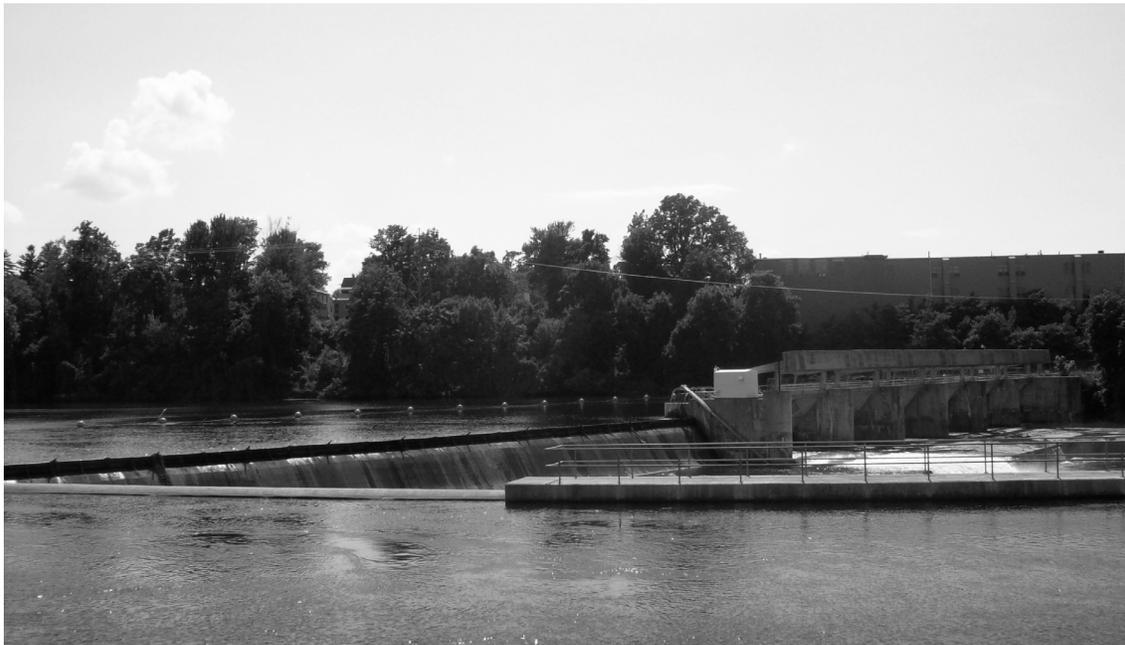
Spanning the Oswego River is the fixed and movable crest Oswego Falls Dam. Built in a vaguely U-shaped plan, the fixed crest section parallels the river bank. The middle section consists of a 186' spillway and six Tainter gates between concrete piers operated by a cable system with concrete counterweights. The east fixed crest dam section is 282' long. The dam is in good condition.

Image 2: Overview of Oswego Falls Dam with Tainter gates at right. Field photograph taken by HAER recording team, summer 2009.
