NEW YORK STATE BARGE CANAL, LOCK O3
(Oswego Canal, Lock O3)
Corner of Oneida and First streets
Fulton
Oswego County
New York

HAER NY-532
HAER NY-532

WRITTEN HISTORICAL AND DESCRIPTIVE DATA

HAER No. NY-532

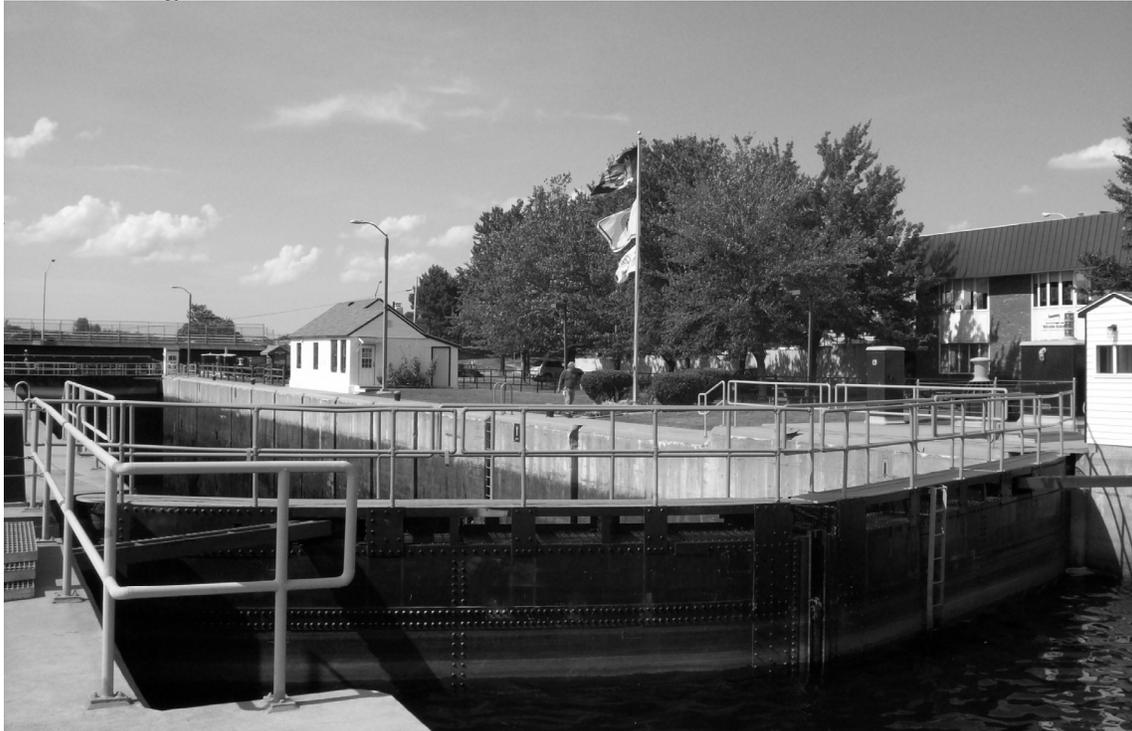
The lockhouse is on the east side of the lock chamber. The single-story concrete building with a concrete chimney sits on a concrete foundation. The gable-front roof is covered with asphalt shingles, with the gable ends having horizontal board infill. It has modern one-over-one-light vinyl windows with steel mesh coverings. The entrance is a wood pane-and-panel door. A generator extension is located to the north, and a shed addition built of concrete block is attached to the side of the extension. The lockhouse is in good condition.

The lock has a 27' lift to the south with normal pool elevations of 308' below and 335' above. The chamber walls are scored concrete with cast-iron quarter-round coping. Vertical cutouts with cables inside are located in the chamber walls. There are double-leaf, steel miter lock gates at each end of the chamber, operated by spars and gear trains powered by the original DC electro-mechanical gate machinery. This machinery, along with the valve operating machinery used to control the flow of water through the culverts in the chamber walls, is covered by open-grate machine covers. Riveted-steel machinery electrical cabinets are located at each corner of the lock. The capstans are on a raised concrete platform surrounded by a steel railing and open grates. Concrete-filled cast-iron bollards on concrete pads line each side of the lock chamber. Post-and-rail fencing and pipe railing surrounds the public access side of the lock, and the site is illuminated by modern light fixtures. The lock is in good condition.

Image 1: Overview of lock chamber with lockhouse to the right of the chamber. Field photograph taken by HAER recording team, 2009.

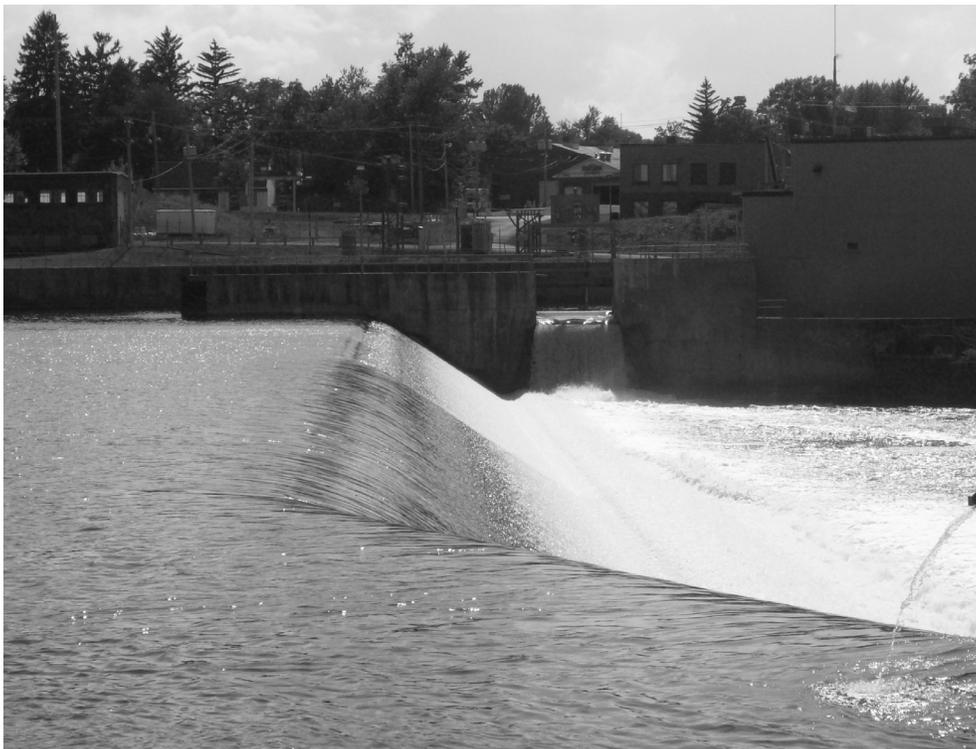
Spanning the Oswego River is the concrete, fixed crest Fulton Dam. The dam appears to be in good condition.

Image 2: View of Fulton Dam. Field photograph taken by HAER recording team, 2009.
