St. John's Church, Waldrop  
Boswell's Tavern vicinity  
Louisa County  
Virginia

HABS No. VA-1202

REDUCED COPIES OF MEASURED DRAWINGS  
WRITTEN HISTORICAL AND DESCRIPTIVE DATA

ADDENDUM TO:  
ST. JOHN'S CHURCH, WALDROP  
(Blenheim)  
State Route 22, .5 mile West of U.S. Route 15  
Boswells Tavern vicinity  
Louisa County  
Virginia

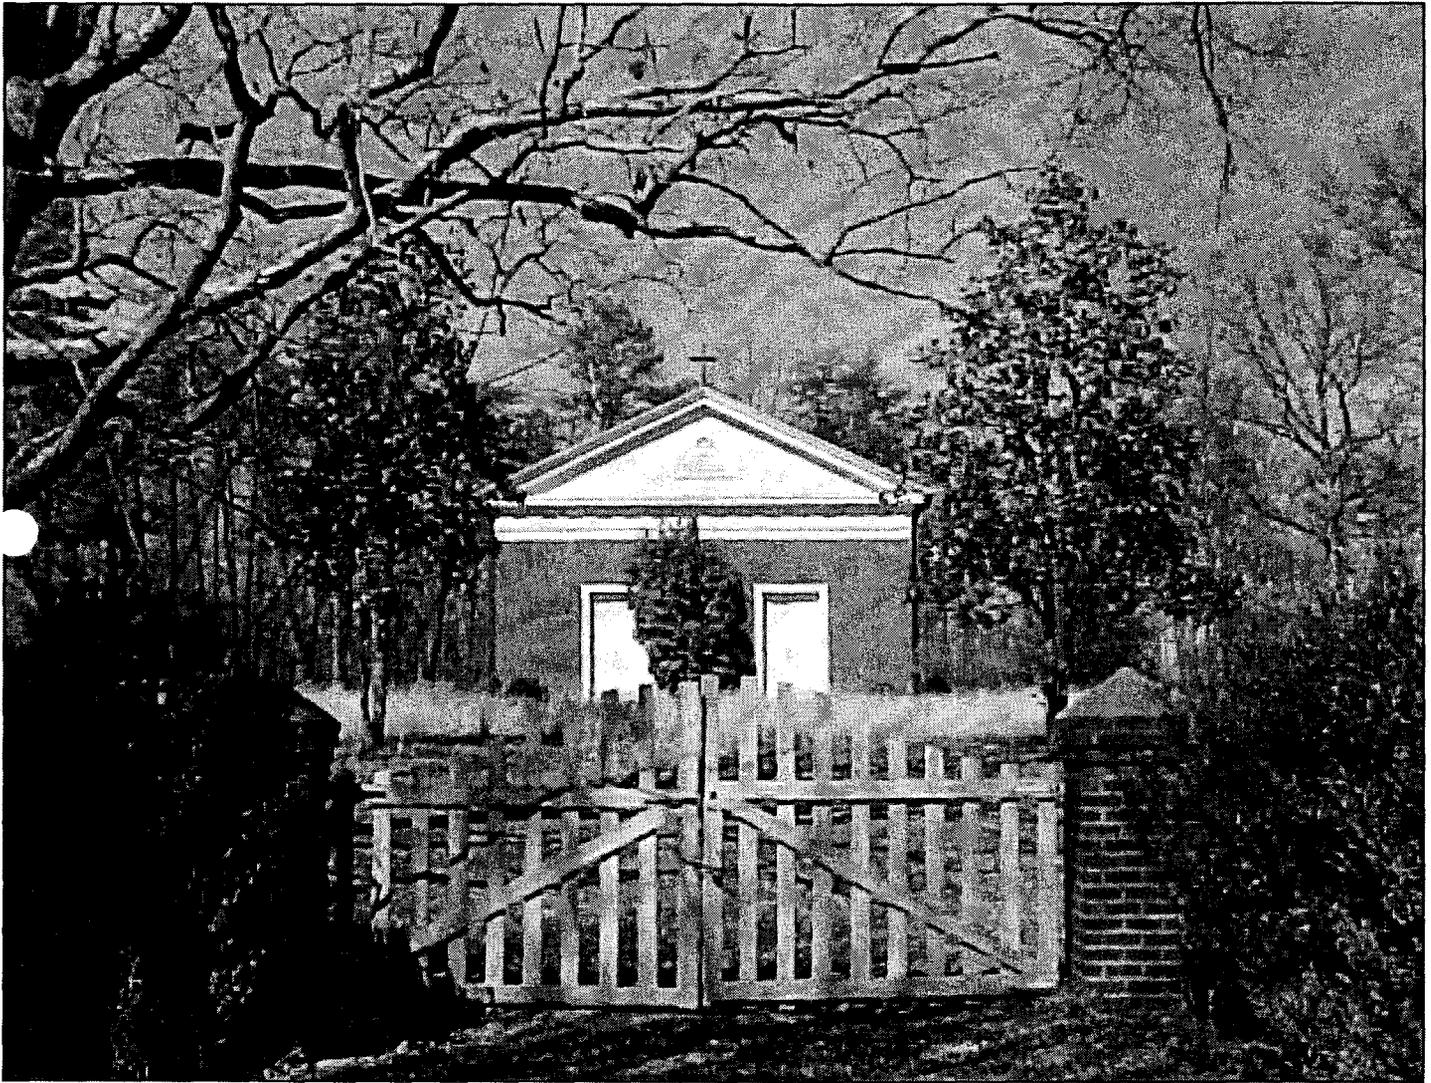
A front gate provides access to the site (fig. 1). Aligned with the building's left front door, the two wood gate doors swing to the south and are each attached to a 2' x 2' brick pillar. At the entrance gate one can see the remains of a circular driveway. Although not original to the site, the circular driveway most likely provided access from the front gate to the church entrance located on the building's south facade. Due to the site's overgrowth, the gravel driveway is barely identifiable in its current state.

*Figure 1: Looking at South Elevation from Perimeter of Site*

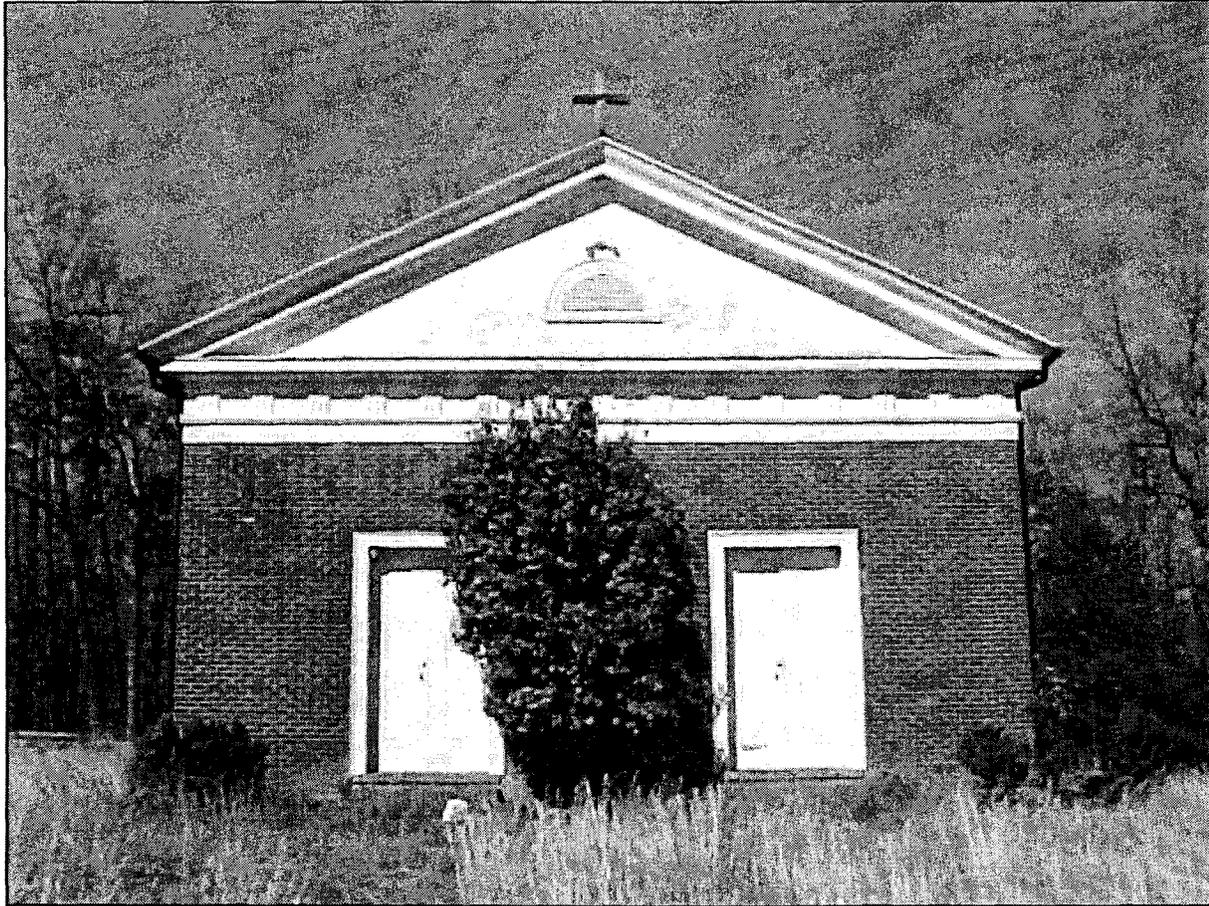
Exterior: The building is built of brick and displays three different bond types. The south facade (fig. 2), which serves as the front entrance of the building, and the west facade (fig. 3) are constructed of common bond. In contrast, the east facade is built of Flemish bond and the north facade (fig. 4) is built of English common bond. Each of these bond types was popular during different periods of time. The oldest of the three, English common bond, was popular in the early eighteenth century, whereas Flemish bond became popular around 1750 and continued to be into the nineteenth century. Common bond emerged as a popular method of construction after the 1830s.

*Figure 2: South Elevation*

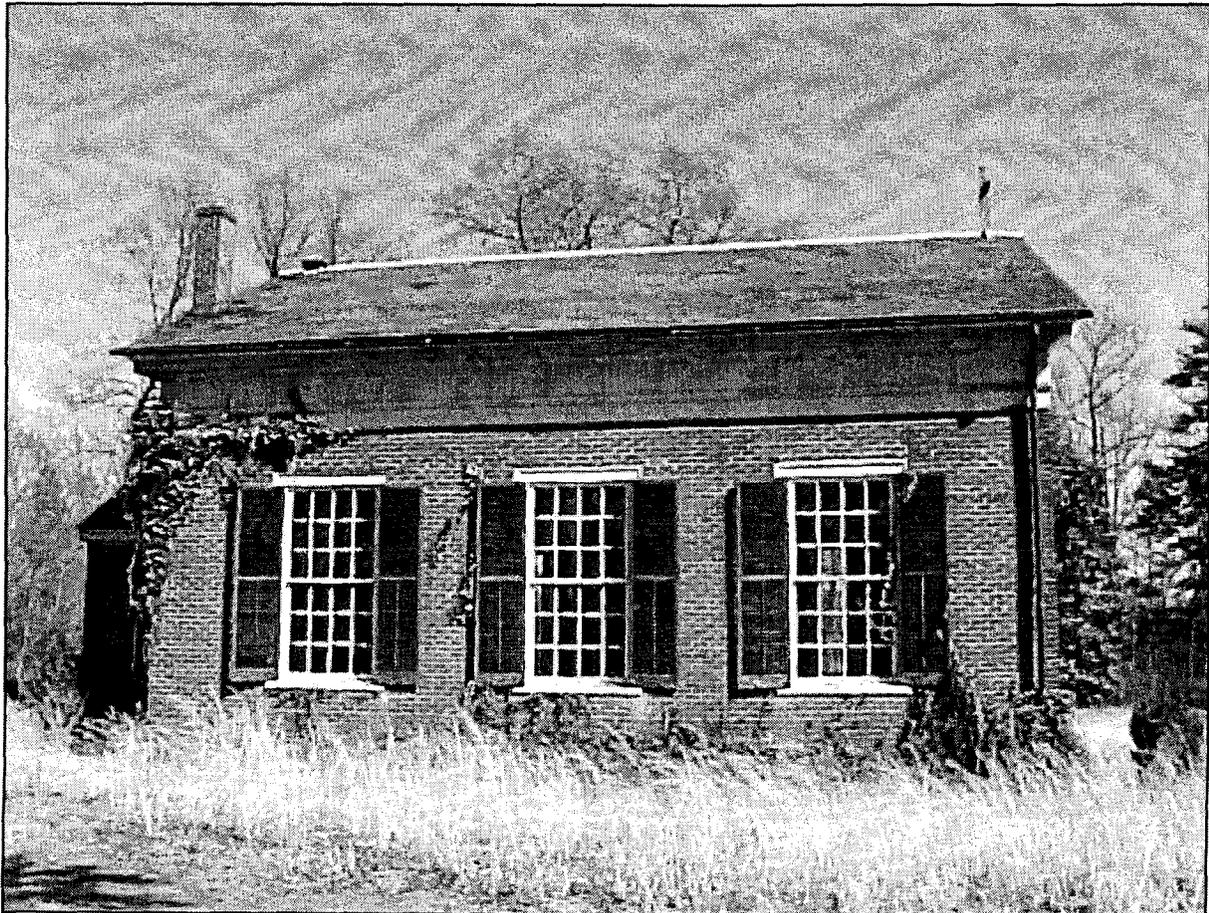
*Figure 3: West Elevation*

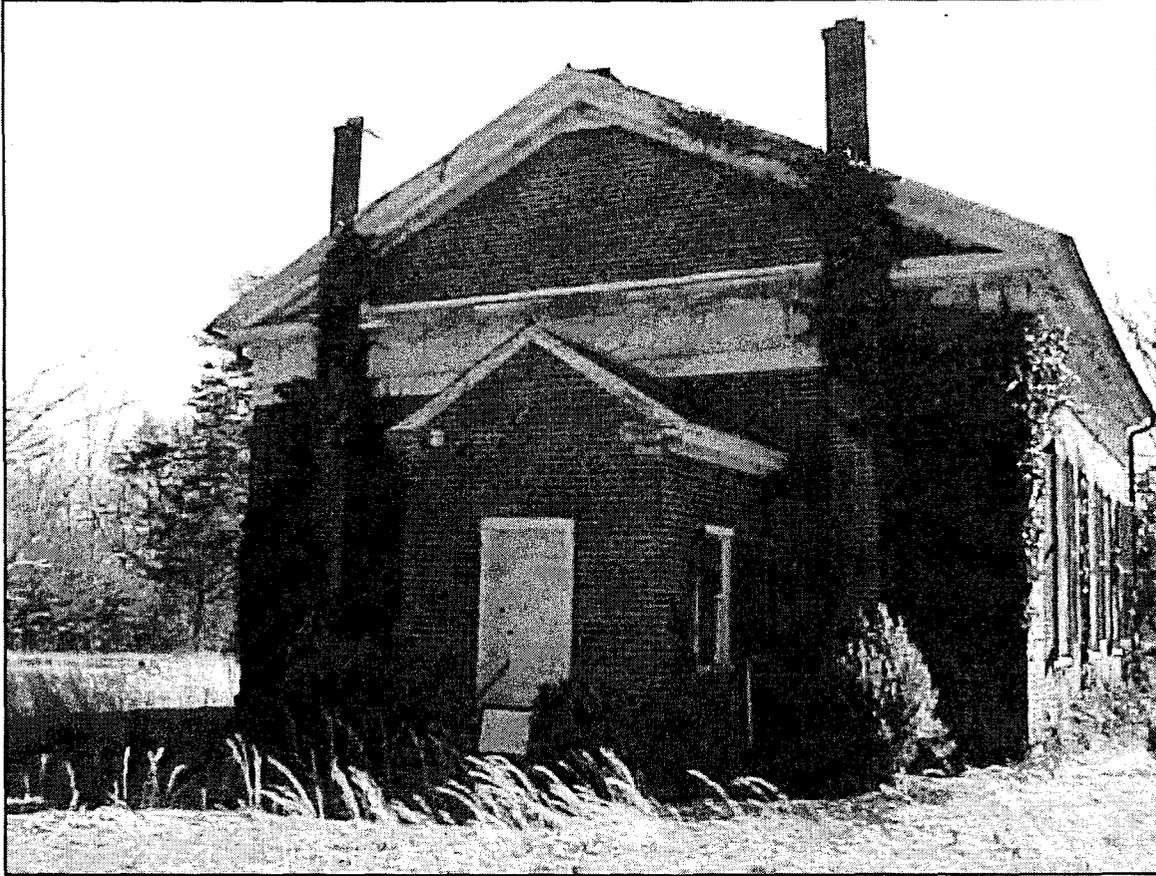
Also seen from the brick construction, the 10' x 10' rear portion of the building is clearly a later addition. Although both the north facade and the addition exhibit English common bond, the two walls do not interlock which indicates that the 10' x 10' portion was not part of the initial building campaign.

There are also two other minor additions to the building. On the north side, two chimneys were added to either side of the 10' x 10' structure. These chimneys are constructed of 2 1/4" x 8" x 3 1/4" smooth, red bricks. The other minor addition consists of two sets of brick stairs at the south side entries. Because of the type of brick used, both the chimneys and the steps were constructed sometime during the twentieth century.

Figure 4: North Elevation

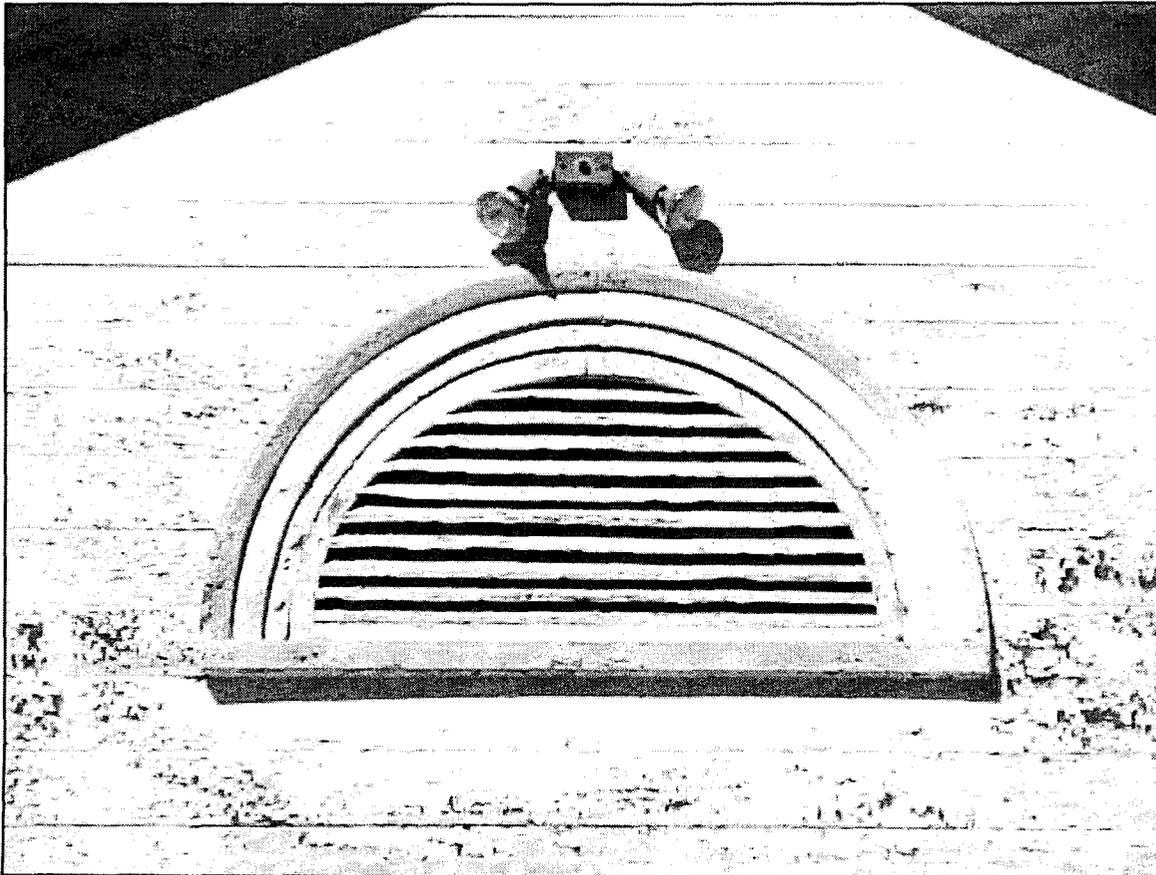
The bottom edge of the pediment includes a cornice and frieze, which wrap around the entire building. The cornice, which is representative of all the molding on the exterior and interior of the main building, is Greek Classical and includes a cyma recta detail. The Doric frieze below the cornice consists of alternating triglyphs and metopes. Also included in the pediment is a semi-circular vent for the attic space (fig. 5).

Figure 5: Attic Vent Within the Pediment on the South Elevation

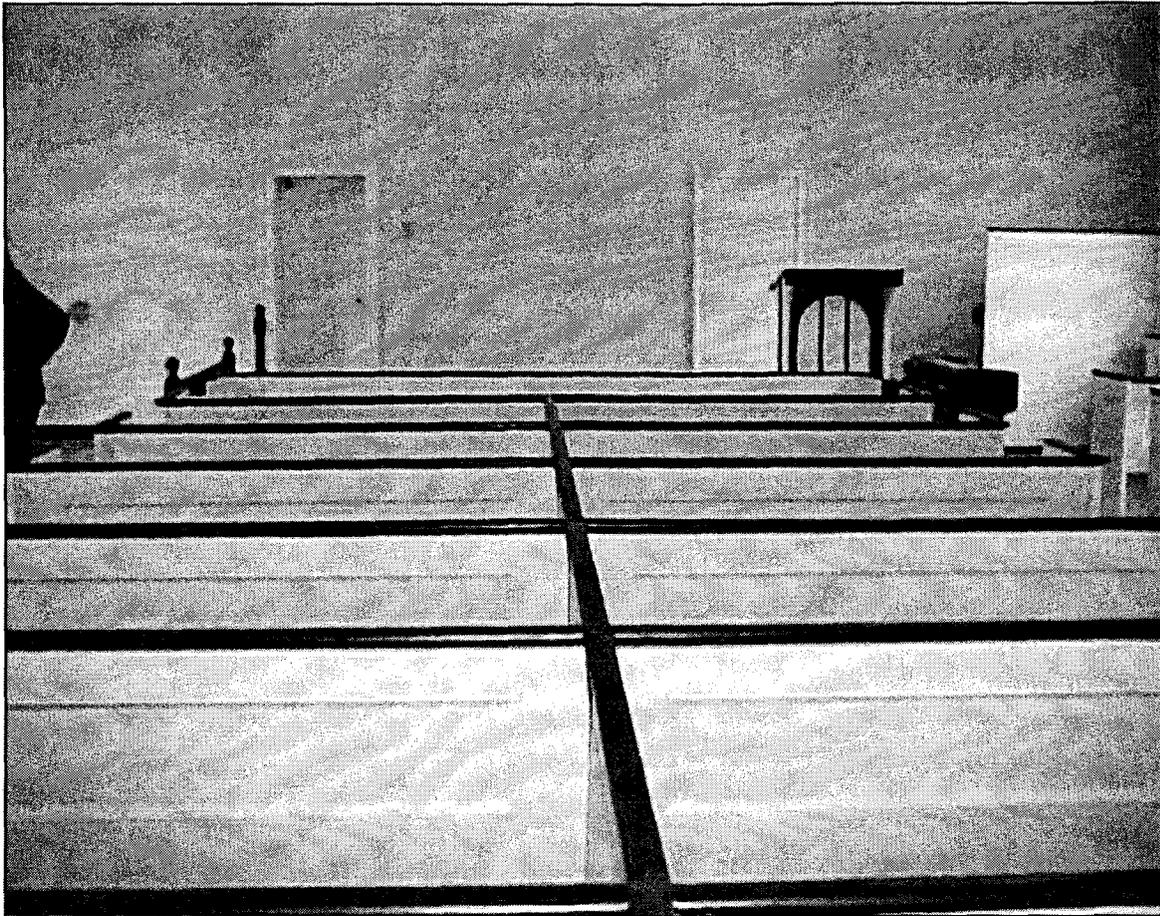
walls show several changes that occurred at some point during the church's history. The three prominent scars are located at the front of the chapel, on the north wall. Two are circular and laid out symmetrically on the north wall. One is above the door to the church addition and the other above the false door, which was probably constructed at the same time as the addition to maintain symmetry (fig. 6). There is no evidence of these scars on the exterior, due to the addition, so it is assumed that they may have been original windows. The third scar is rectangular and centered on the north wall. The dimensions of this scar match the dimensions for the interior doorways, but it is located too high on the wall for the opening to have been a door. Since it is centrally located on the north wall, perhaps it, too, was a window.

Figure 6: Interior Looking Towards Front of Chapel (North Wall)

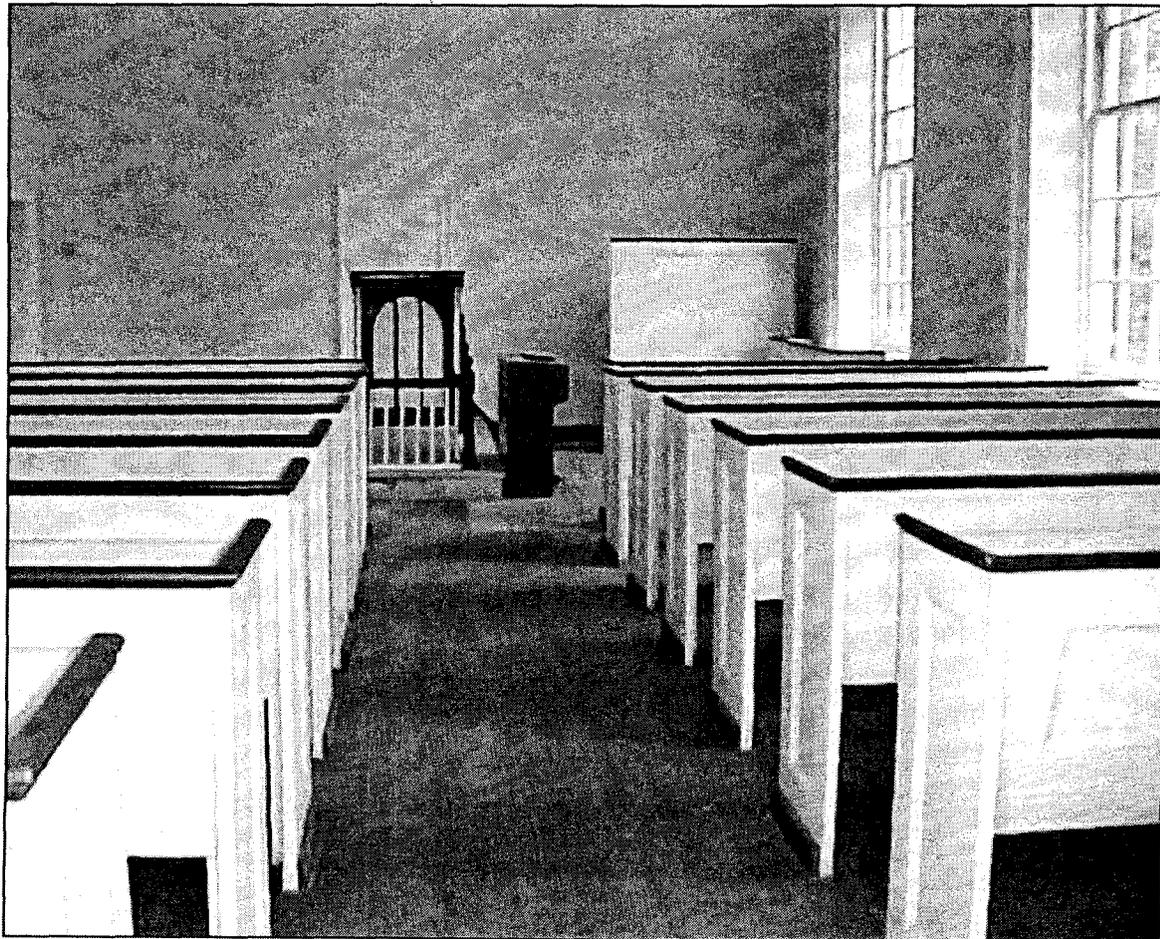
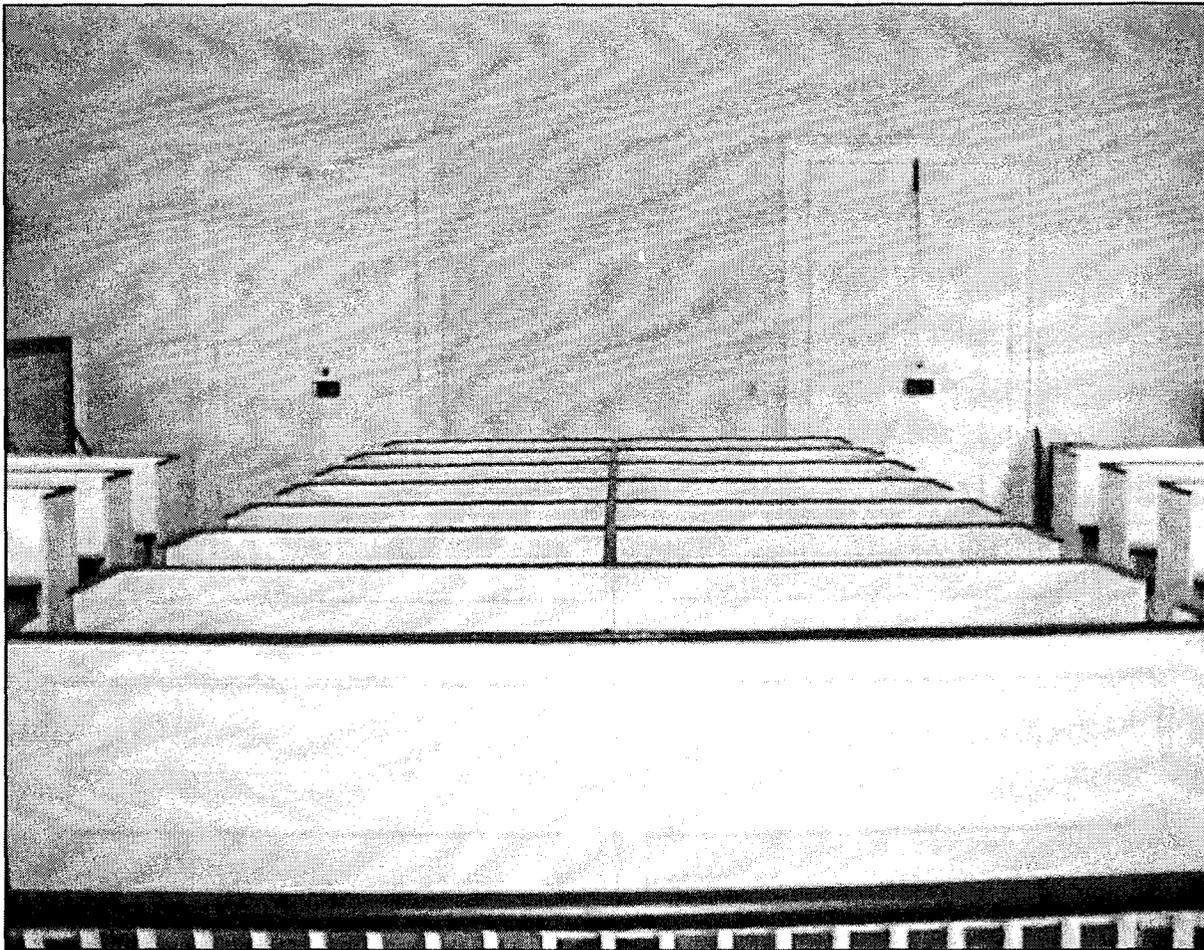
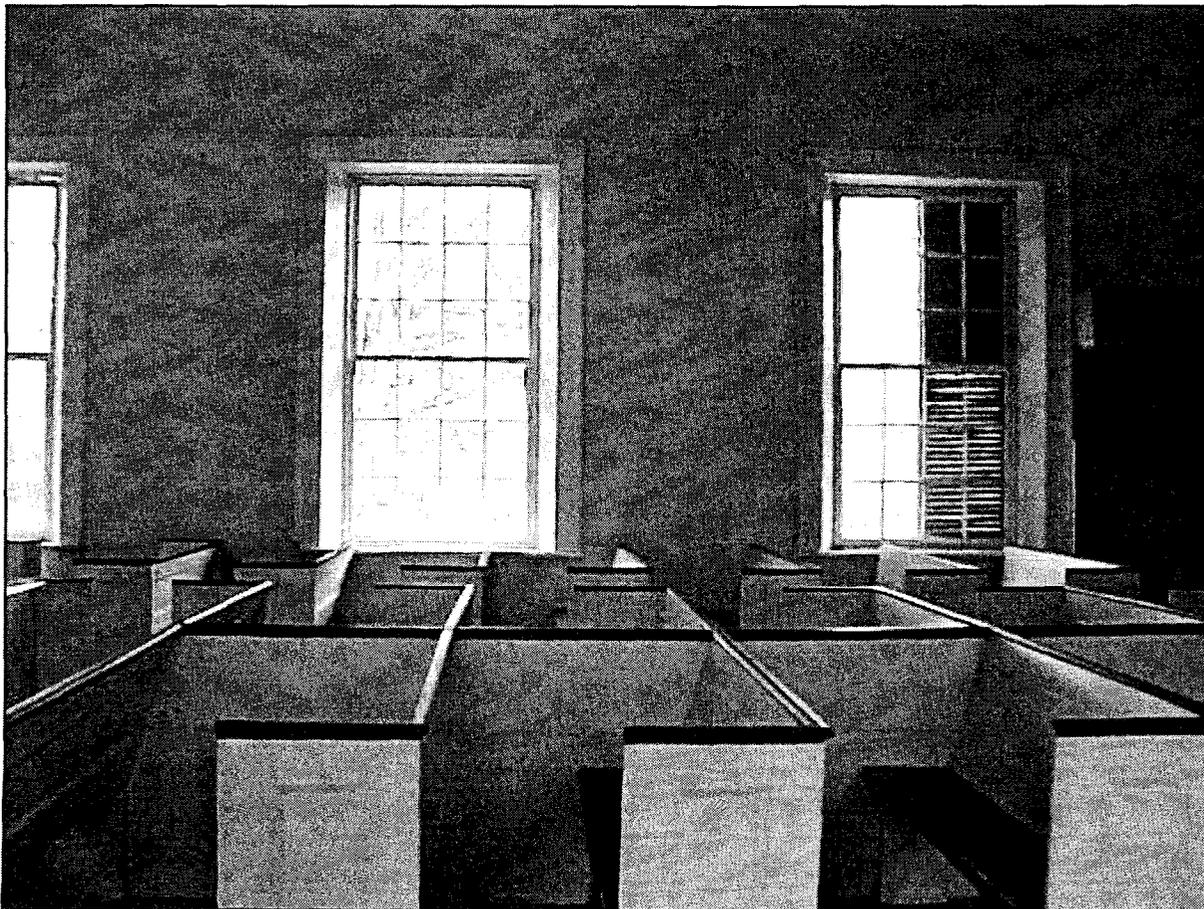
The wood pews, themselves, are simple in construction but have wonderful detail (figs. 7-9). The rail, bench, and baseboard are painted dark brown, and all of the panels are painted white. The aisle panel is pieced together with mortise and tenon joints. The molding within the panels are Greek Classical and similar to the molding throughout the church.

Figure 8: Interior Looking Toward Back of Chapel (South Wall)

Figure 9: Interior Looking Toward East Wall
