ALASKA RAILROAD, TRESTLE MP 200.9 (CASWELL CREEK)
Track Mile Post 200.9, spanning Caswell Creek
Willow vicinity
Matanuska-Susitna Borough
Alaska

HAER AK-68
HAER AK-68

WRITTEN HISTORICAL AND DESCRIPTIVE DATA

HISTORIC AMERICAN ENGINEERING RECORD

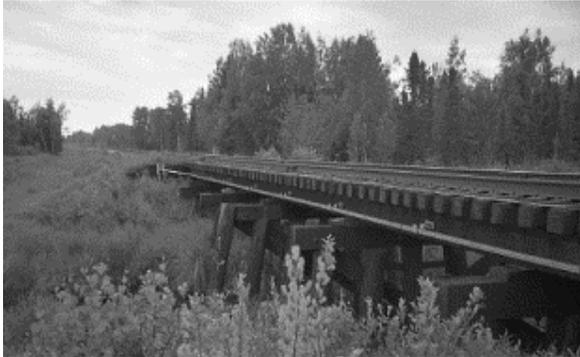
Figure 1: View south of bridge's eastern side. Michael Yarborough, photographer, July 1, 2002.

1. Architectural Character: The current bridge is a six-span, 84'-long timber trestle that runs north-south, carrying railroad tracks over Caswell Creek. It is supported by two end and five intermediate bents.

2. Description: Alaska Railroad, Trestle MP 200.9 (Caswell Creek) is primarily supported by creosoted timber piles driven into the creek bed. The piles are arranged in seven rows of five piles each, perpendicular to the tracks above. Each row of piles is capped by a beam and diagonally braced on both sides, forming structural bents. The outer piles in each of the bents are battered to increase lateral stability, and the diagonal members are through-bolted to each pile and to the beam ends, which cantilever beyond the structure above. Remnants of at least two previous generations of wood piles are visible in the creek below the bridge.

At each end of the bridge, a bulkhead of horizontal timbers retains the soil adjacent to the first bent. Two composite beams, each made up of four rows of beams through-bolted together, rest on the bents and support evenly spaced ties. The butt joints in each row within the composite beam occur at every other bent and are staggered to occur in every

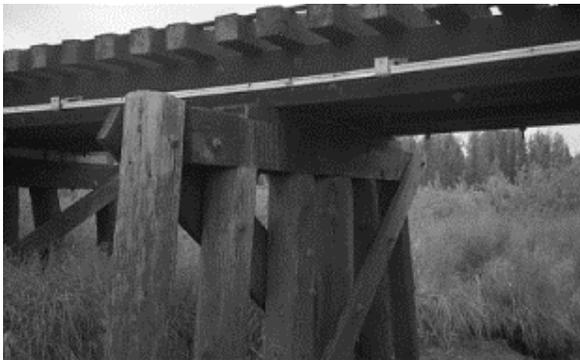
Figure 2: Detail of bent. Michael Yarborough, photographer, July 1, 2002.

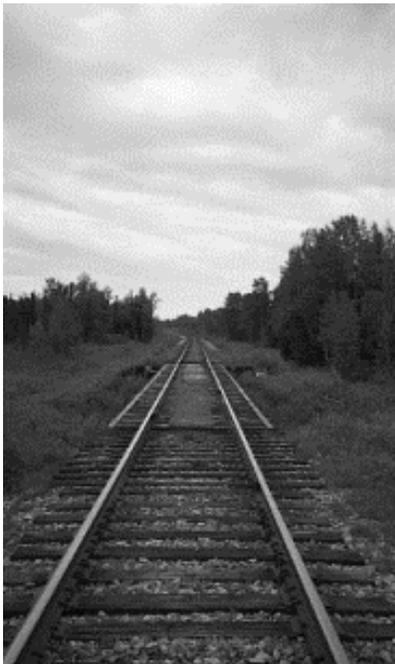
Figure 3: View south. Michael Yarborough, photographer, July 1, 2002.

other row, allowing the composite to act as a continuous beam for the length of the bridge. A fiber optics cable installed in 1997 runs along the outer face of the eastern berm. On top of the bridge, flat steel straps (a change from the original 4" x 8" timbers) are bolted to the ties along the top edge of each side of the bridge, and steel tracks are located on the ties directly above the beams. Plywood laid between the tracks in the 1990s provides moose running down the tracks in front of a train a better surface for crossing the bridge.

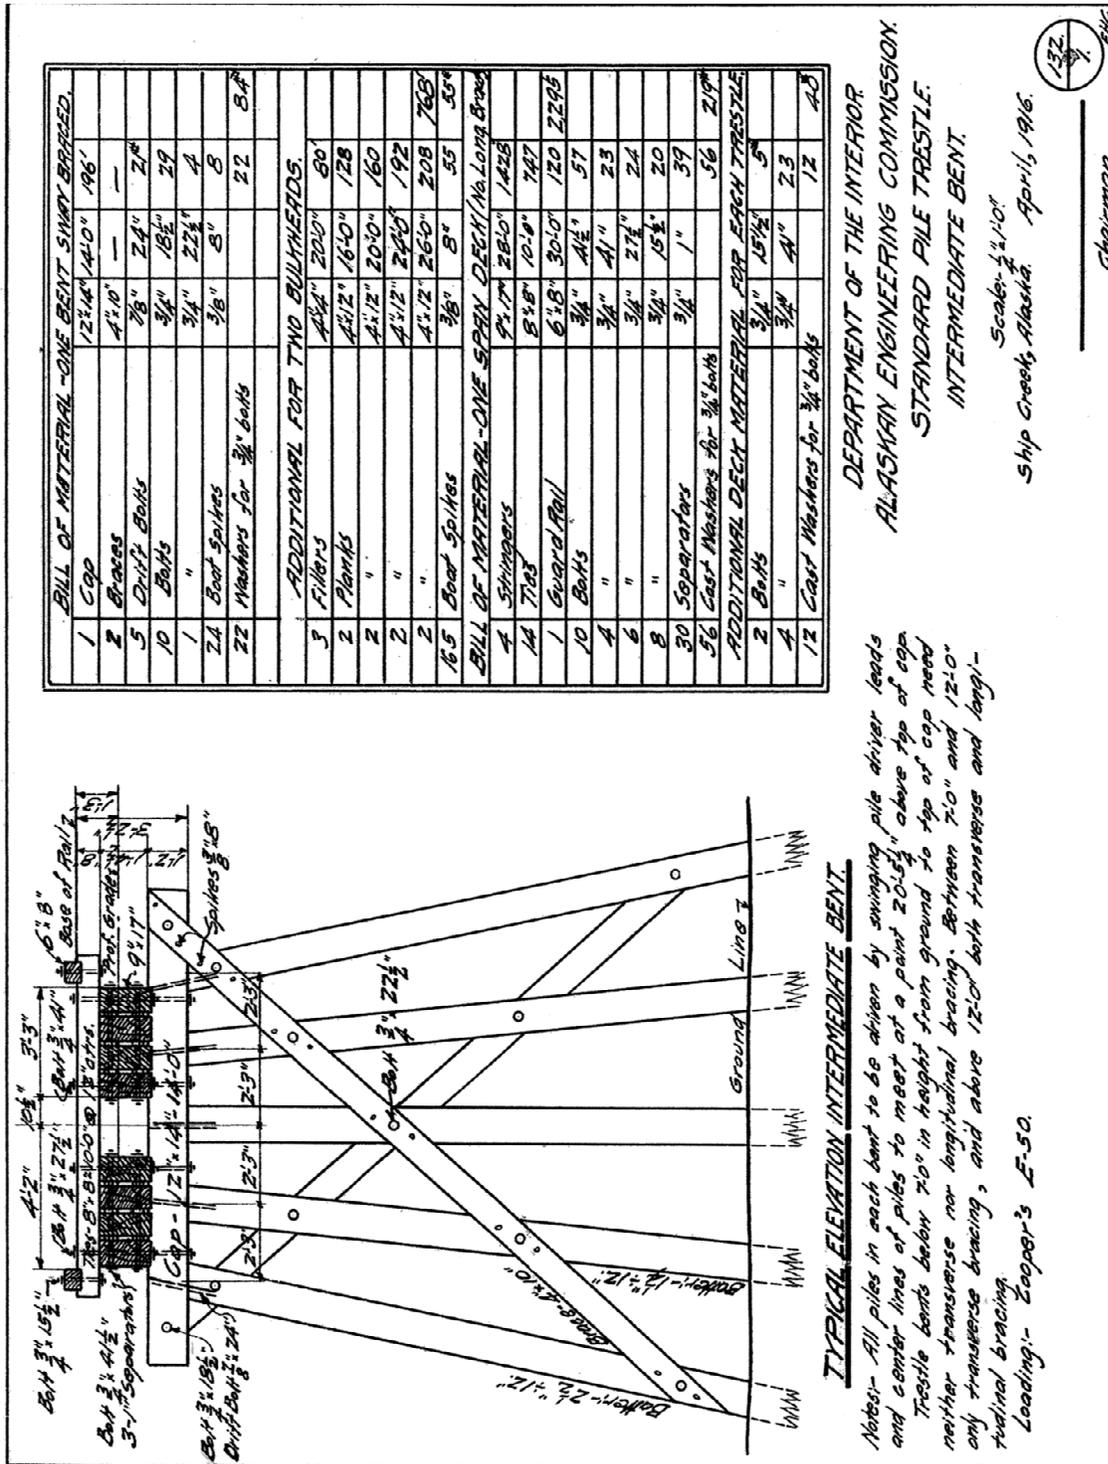
Figure 4: Standard Pile Trestle, Intermediate Bent, April 1916, Sheet 132.1.

132.1: Intermediate Bent

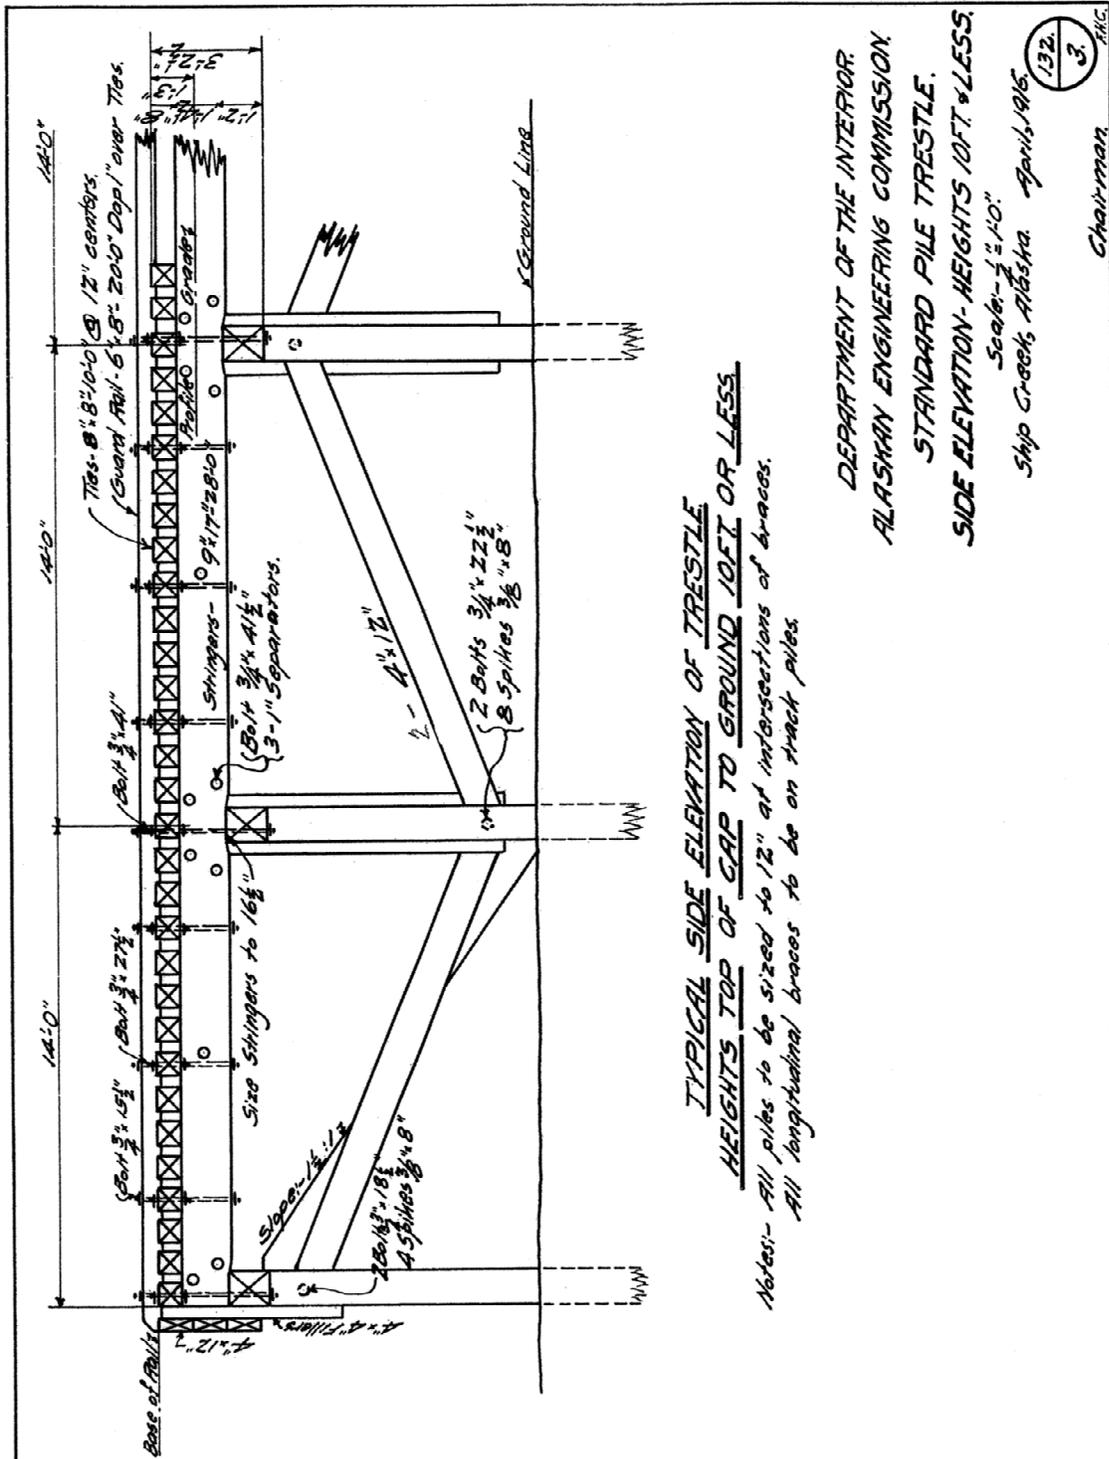
Figure 6: Standard Pile Trestle, Side Elevation – Heights of 10 Ft. and Less, April 1916, Sheet 132.3.

132.3: Side Elevation. Heights of 10 Ft. and less

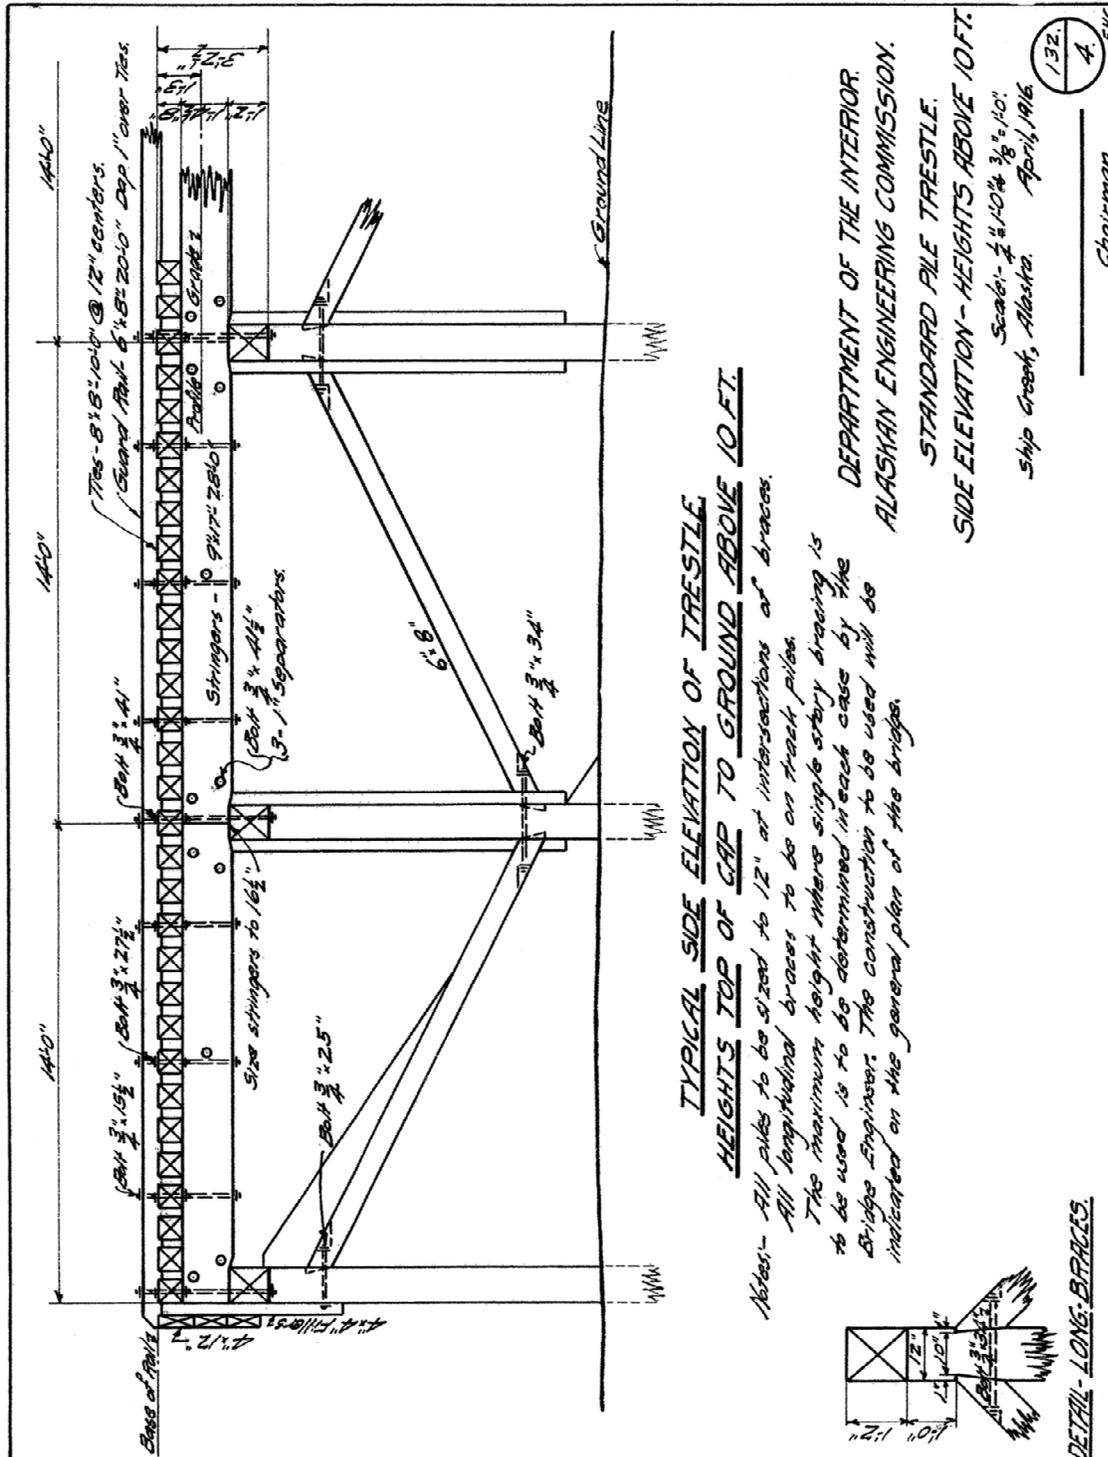
Figure 7: Standard Pile Trestle, Side Elevation. Heights Above 10 Ft, April 1916, Sheet 132.4.

132.4: Side Elevation. Heights above 10 Ft.

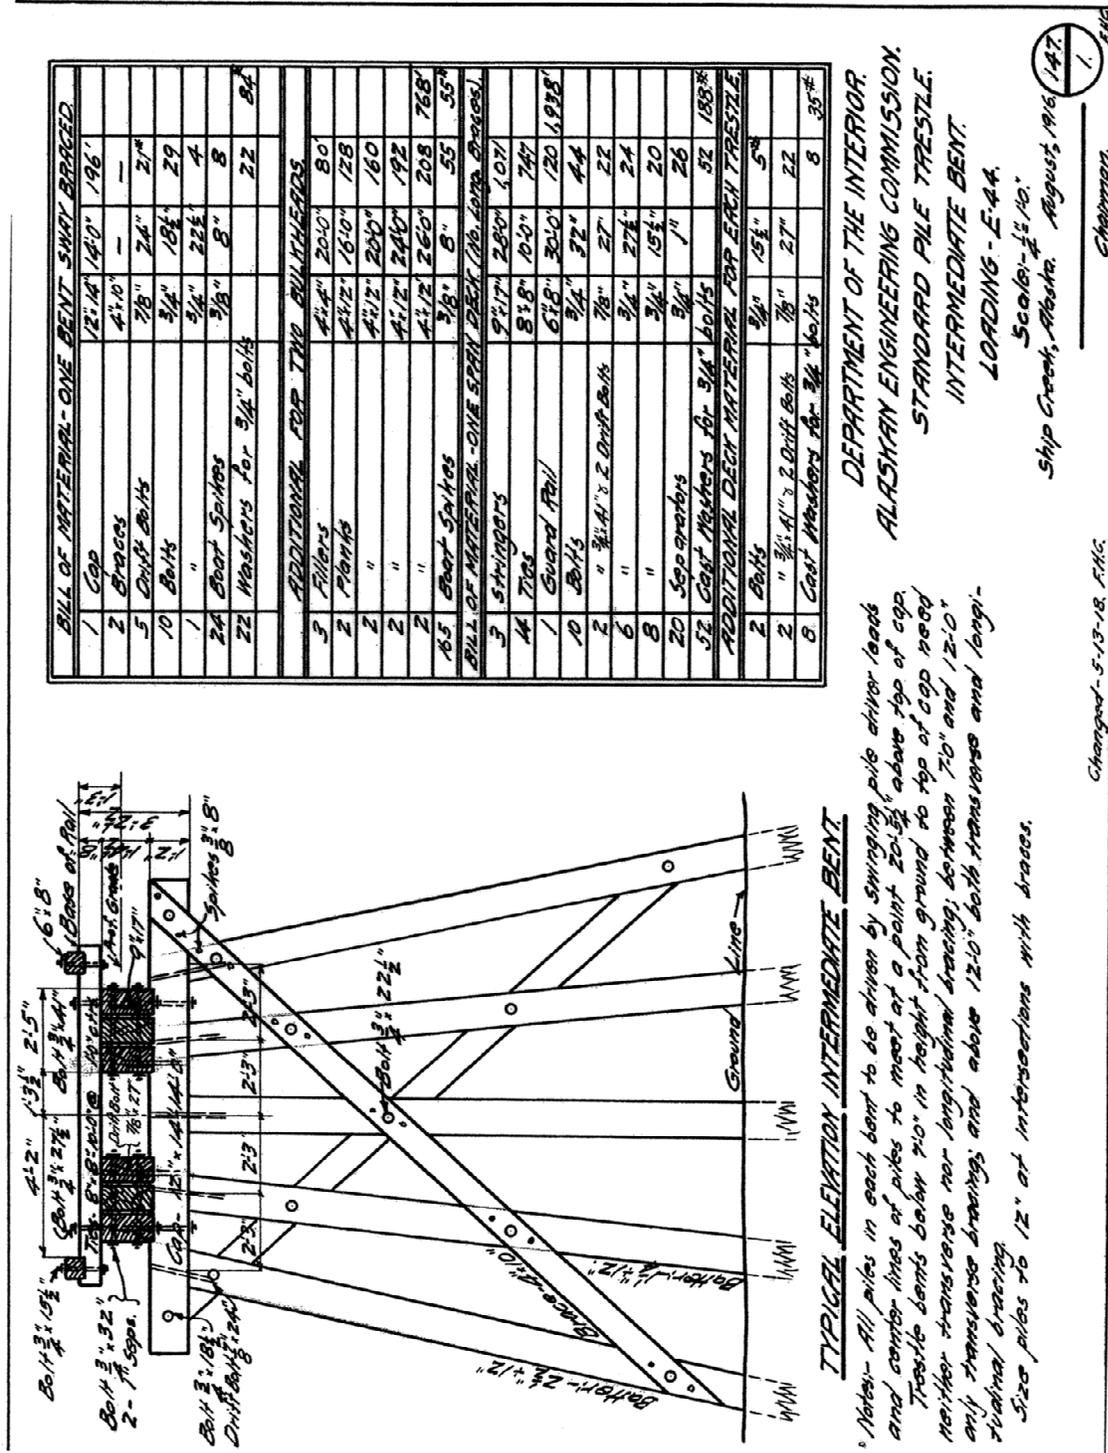
Figure 9: Standard Pile Trestle, Intermediate Bent, Loading E-44, August 1916, Sheet 147.1.

147.1: Intermediate Bent, Loading E-44

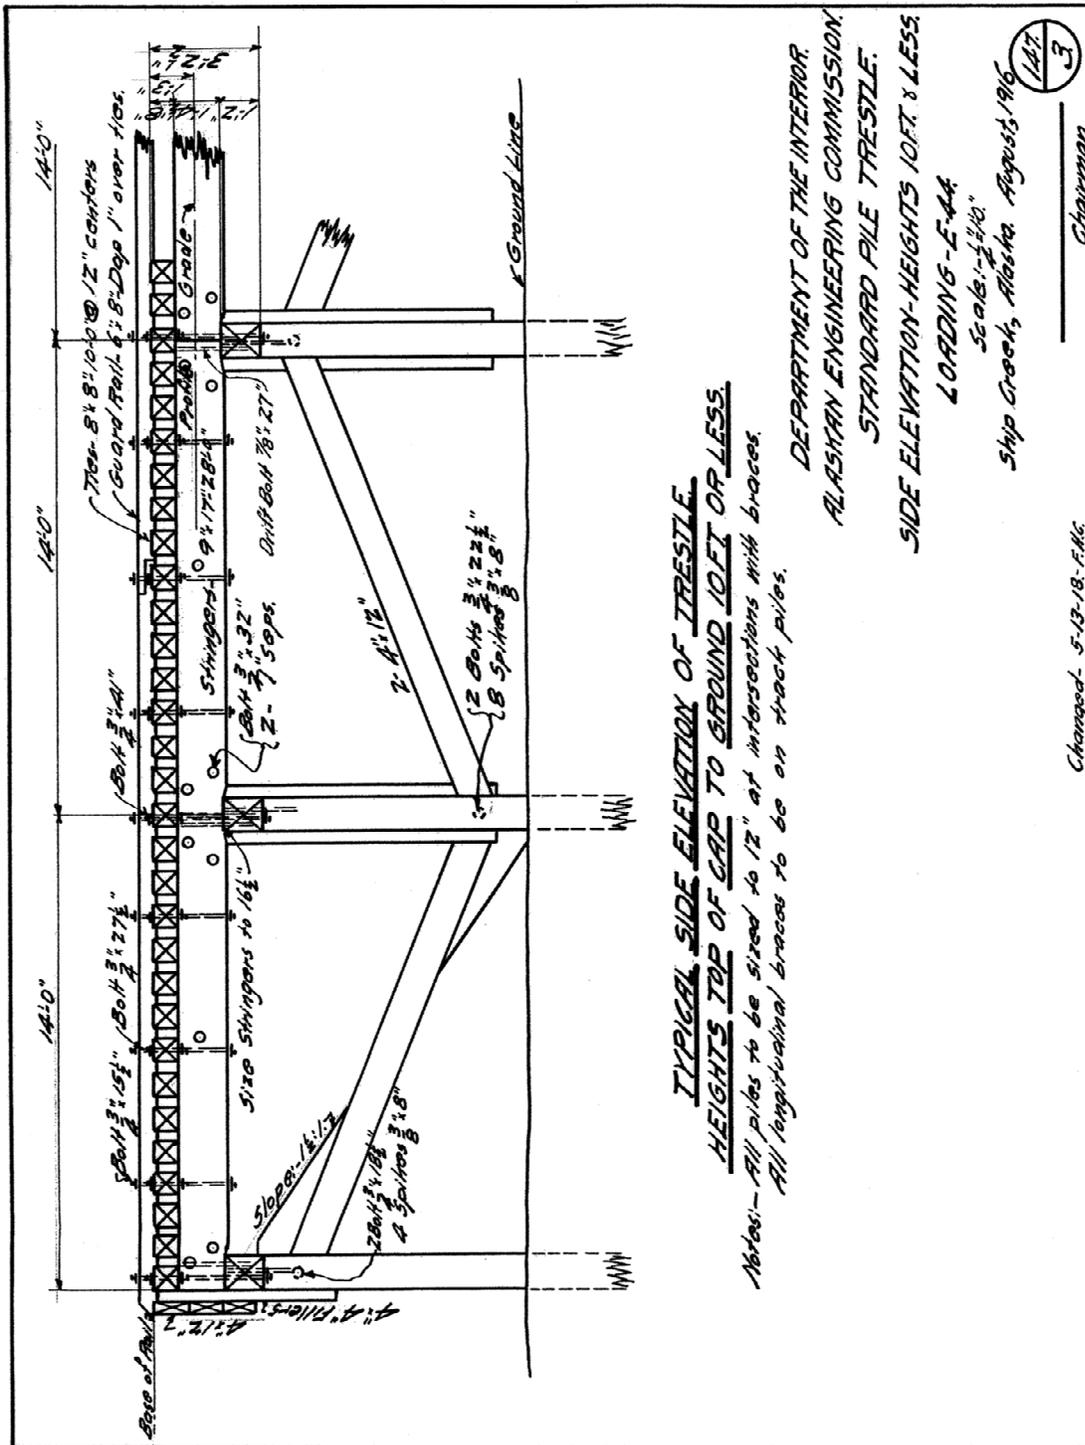
Figure 11: Standard Pile Trestle, Side Elevation – Heights of 10 Ft. and Less, Loading – E-44, August 1916, Sheet 147.3.

147.3: Side Elevation—Heights of 10 Ft. and Less. Loading- E-44

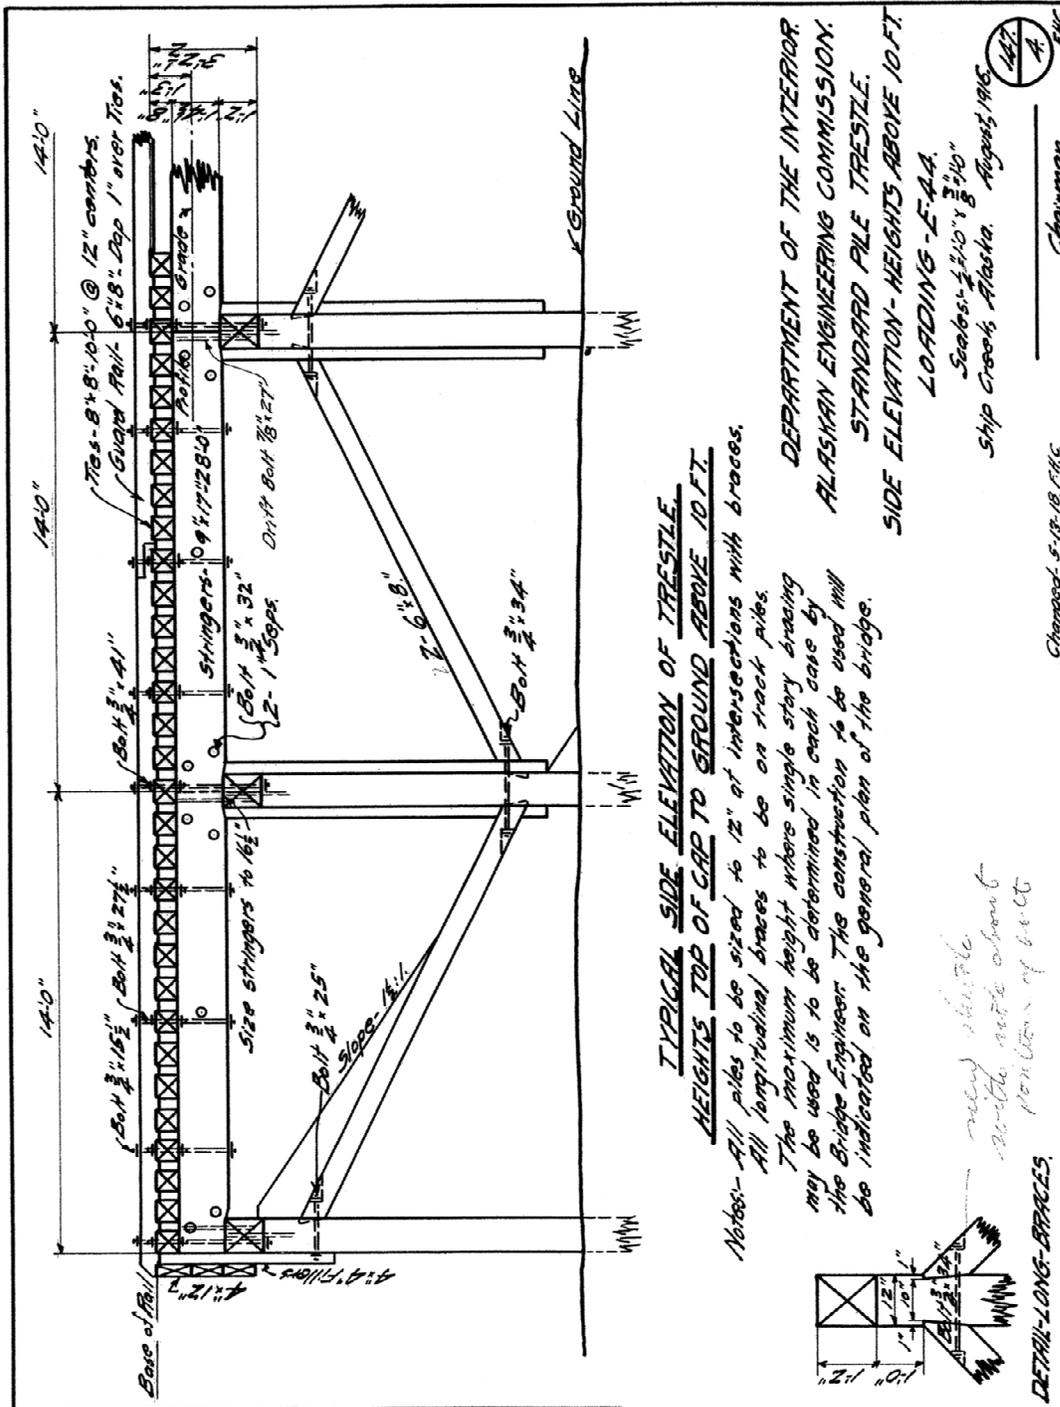
Figure 12: Standard Pile Trestle, Side Elevation – Heights above 10 Ft., Loading E-44, August 1916, Sheet 147.4.

147.4: Side Elevation—Heights above 10 Ft. Loading- E-44
