NORTH ENTRANCE ROAD
(Grand Canyon Route #4)
Between Little Park and Bright Angel Point
Grand Canyon National Park
Coconino County
Arizona

HAER No. AZ-43

NORTH ENTRANCE ROAD
(Grand Canyon Route #4)
HAER No. AZ-43

Project Information: Documentation of North Entrance Road is part of the NPS Roads & Bridges Recording Project, conducted in summer 1994 under the co-sponsorship of GCNP and GABS/HAER. This report was researched and written by Michael F. Anderson, HAER historian, September 1994.

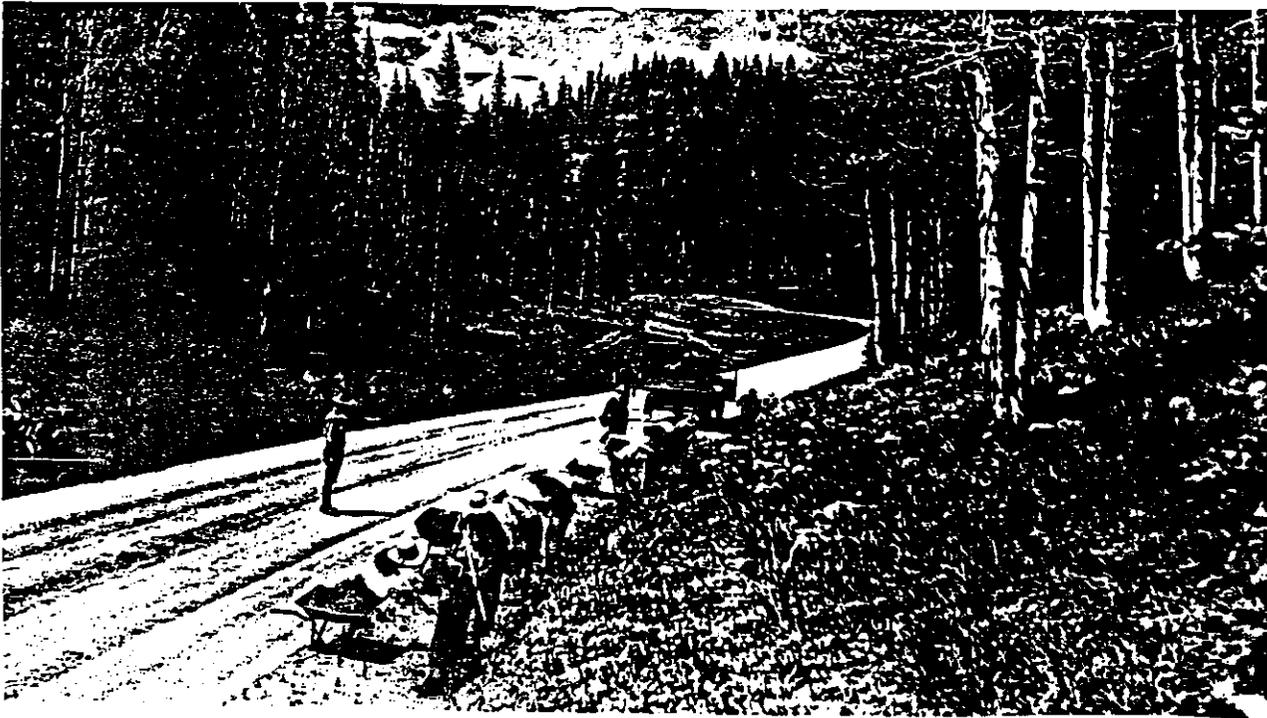
Figure 7. CCC ditch clearing along North Entrance Road, 1935.
(GRCA Image #2940C, GCSC)

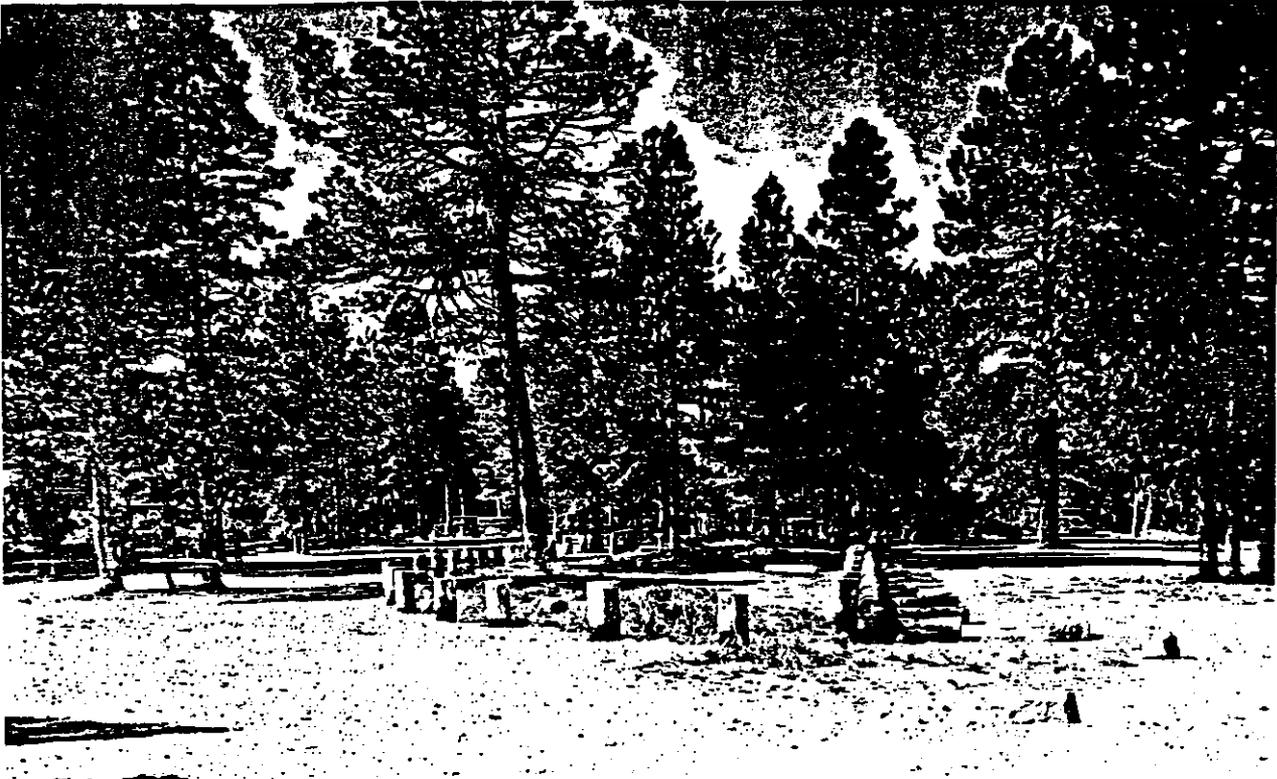
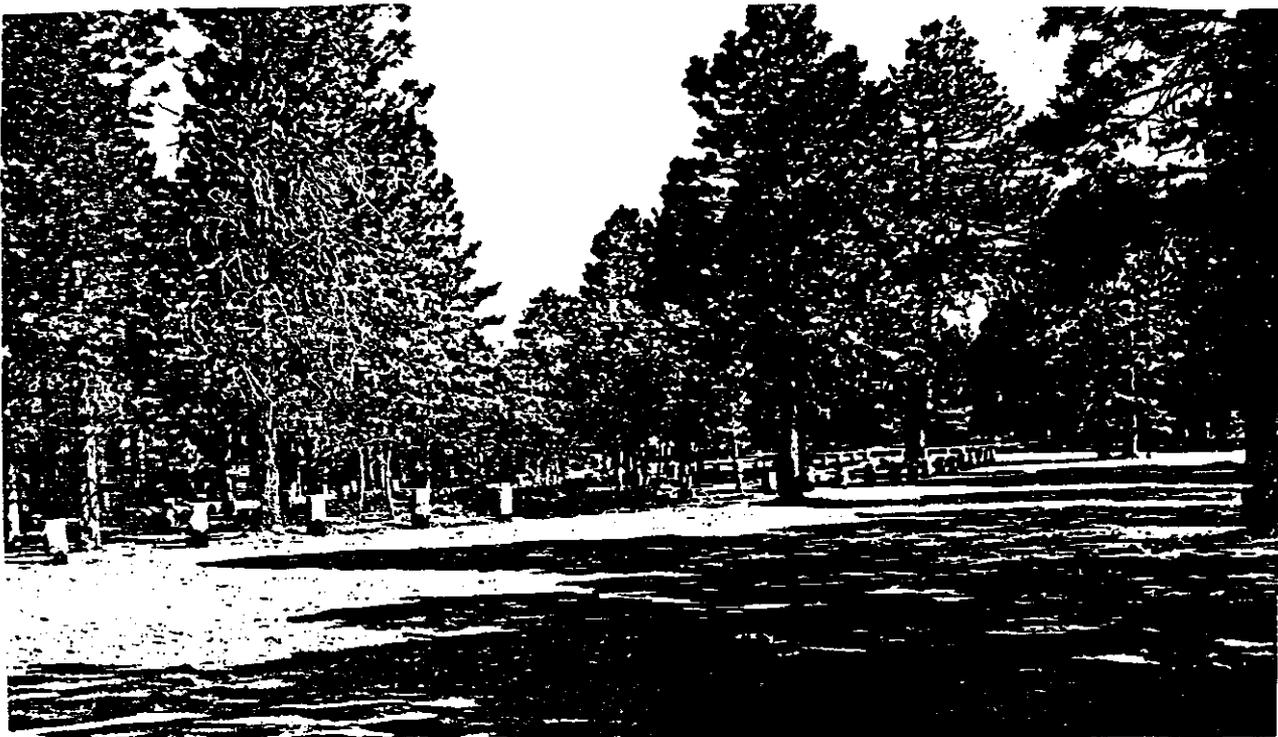
Figure 8-9. CCC Bright Angel Point parking lot project ca. 1935.
(Construction report, GCSC)

An early project completed over a five-year period and of lasting effect entailed construction of the north rim parking lot adjacent to North Entrance Road near Grand Canyon Lodge. In 1935, CCC crews began grading the parking area and installing interior log guardrails to protect islands of trees and sparse shrubbery. In 1936, they added the cement rubble masonry walls and stair steps seen today along the northern-most segment of the parking area. In 1939, they built a 100-car, crushed-rock surface addition to the lot because visitors had been parking along the roadside near the lodge which required a full time ranger to keep traffic moving. CCC men invested 4,783 man days on this project, but the NPS spent only \$833.90 for materials. Some of the parking lot's CCC features, including the masonry wall and steps, survive today.²⁰

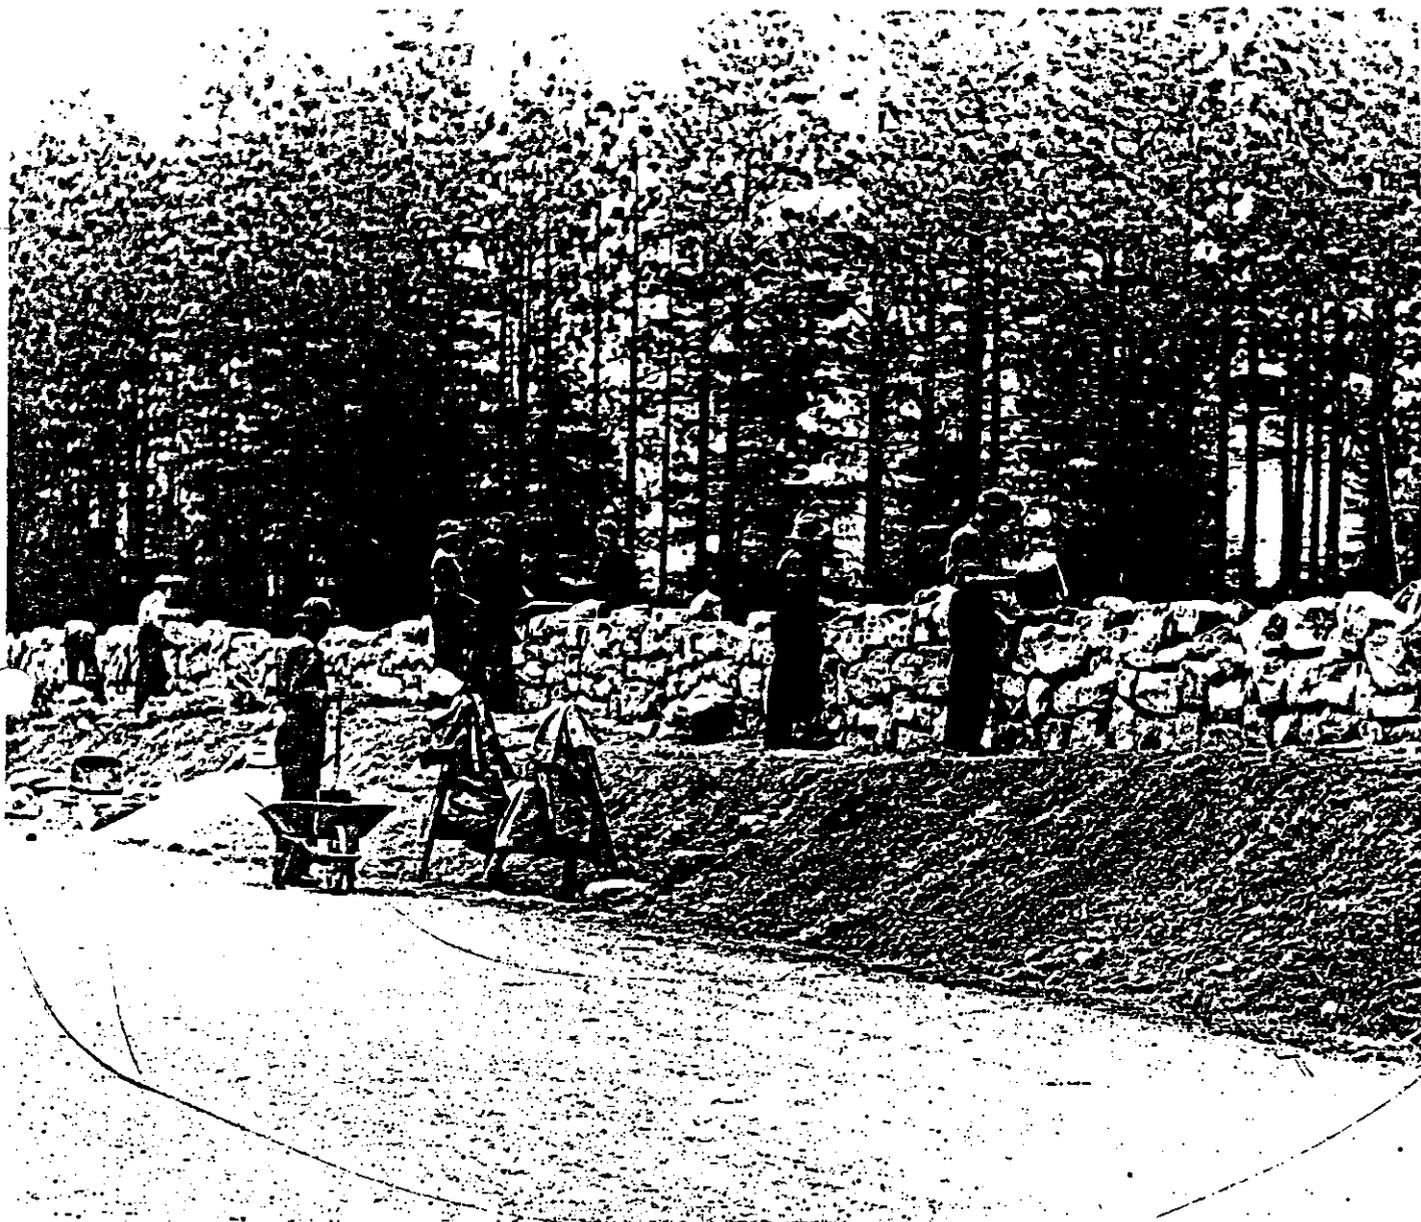
Figure 10. CCC building the Bright Angel Point parking lot wall
in 1936. (GRCA Image #14044, GCSC)

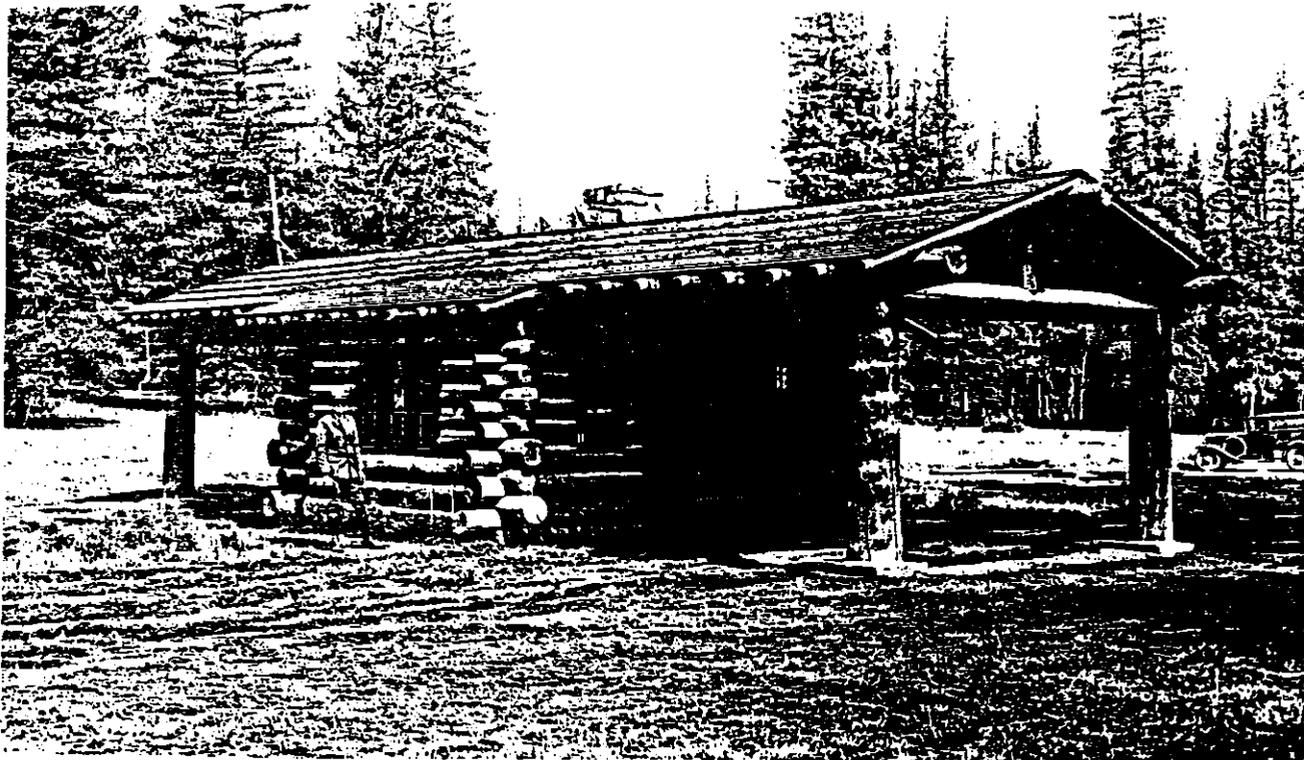
Figure 15. The 1928 north entrance station. This photo taken 14 July 1930 with NPS ranger Ed Laws on the left. (GRCA Image #3824, GCSC)

As constructed in 1928, the entrance station reflected the "trapper variation" (much favored by Stephen Mather) of rustic style architecture with rough-hewn whole logs of variable lengths overlapping at each of its four corners. Carports over both the entrance and exit sides of the structure formed a continuous line with the original shake shingle roof and were supported by massive peeled logs at each corner. The earliest photograph found during research for this project depicts Ranger Ed Laws standing in front of this remarkable structure two years after construction.¹⁵ Its covered entrance concept remained unique at Grand Canyon until construction of the new South Entrance Station in the late 1980s.

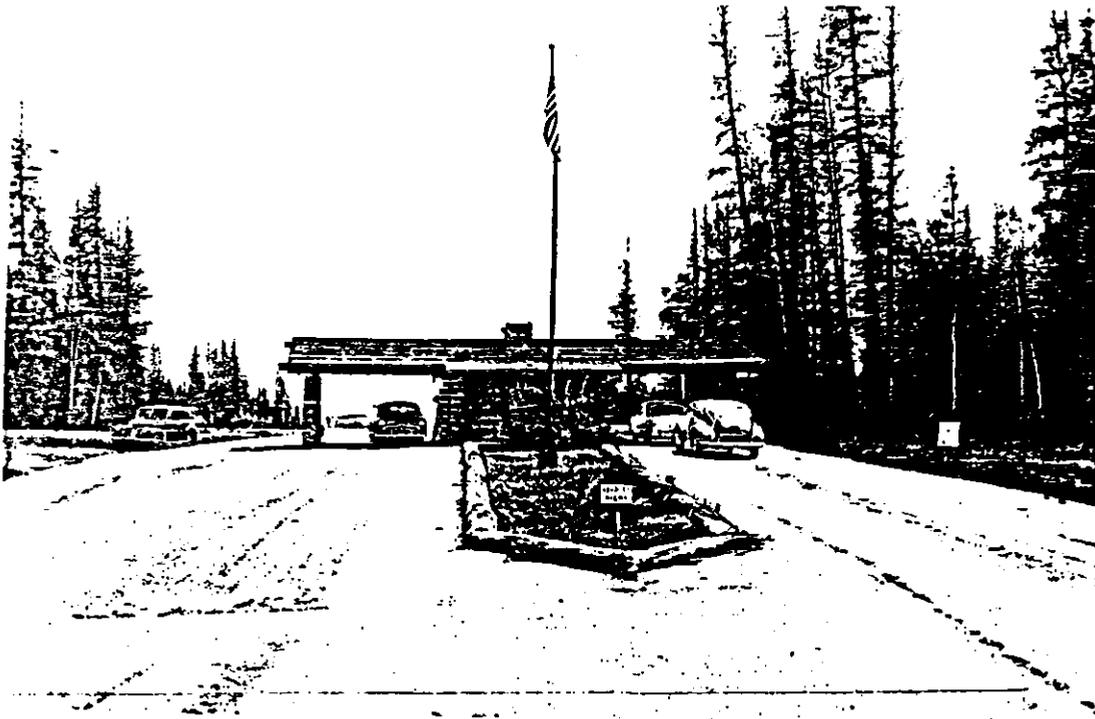
Figure 17. Entrance station, June 1949. (GRCA Image #1767, GCSC)

the all-wood station basically stood alone in what in 1935 could be called a near wilderness, free of distracting structures. With CCC crews keeping the site swept and clear of debris, the station and its rustic-appearing, oil-mixed gravel road surface made for an appealing north entrance portal.¹⁶

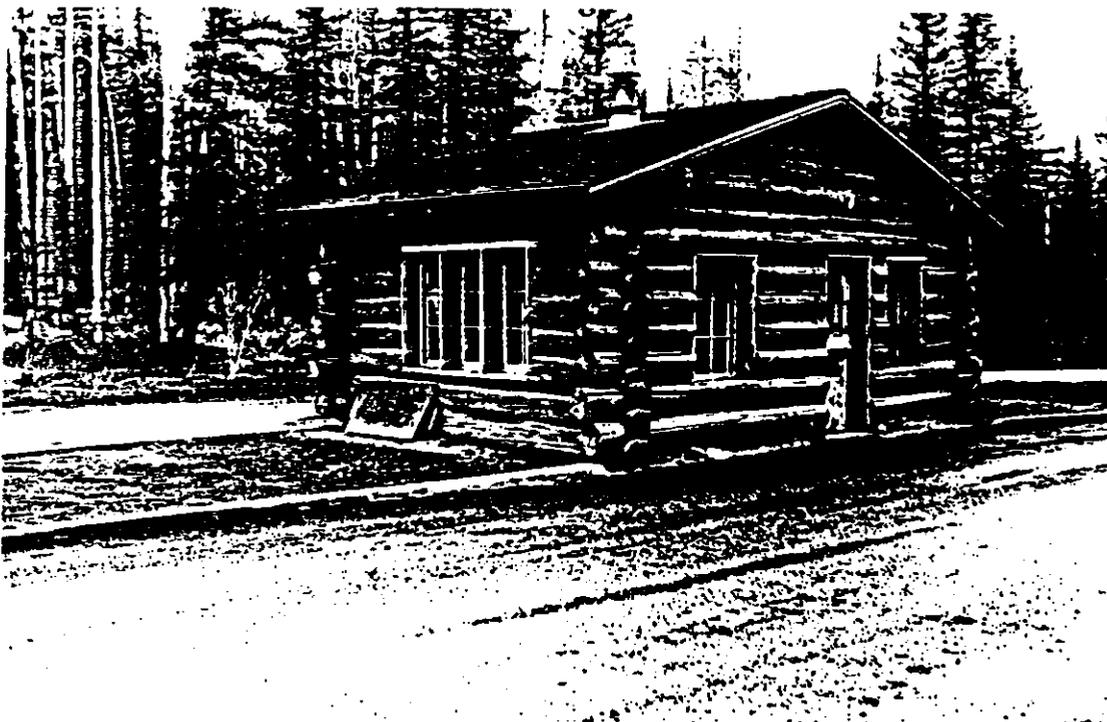
Figure 18. Entrance station in 1950s or 1960s, but date unknown.
(GRCA Image #10018, GCSC)

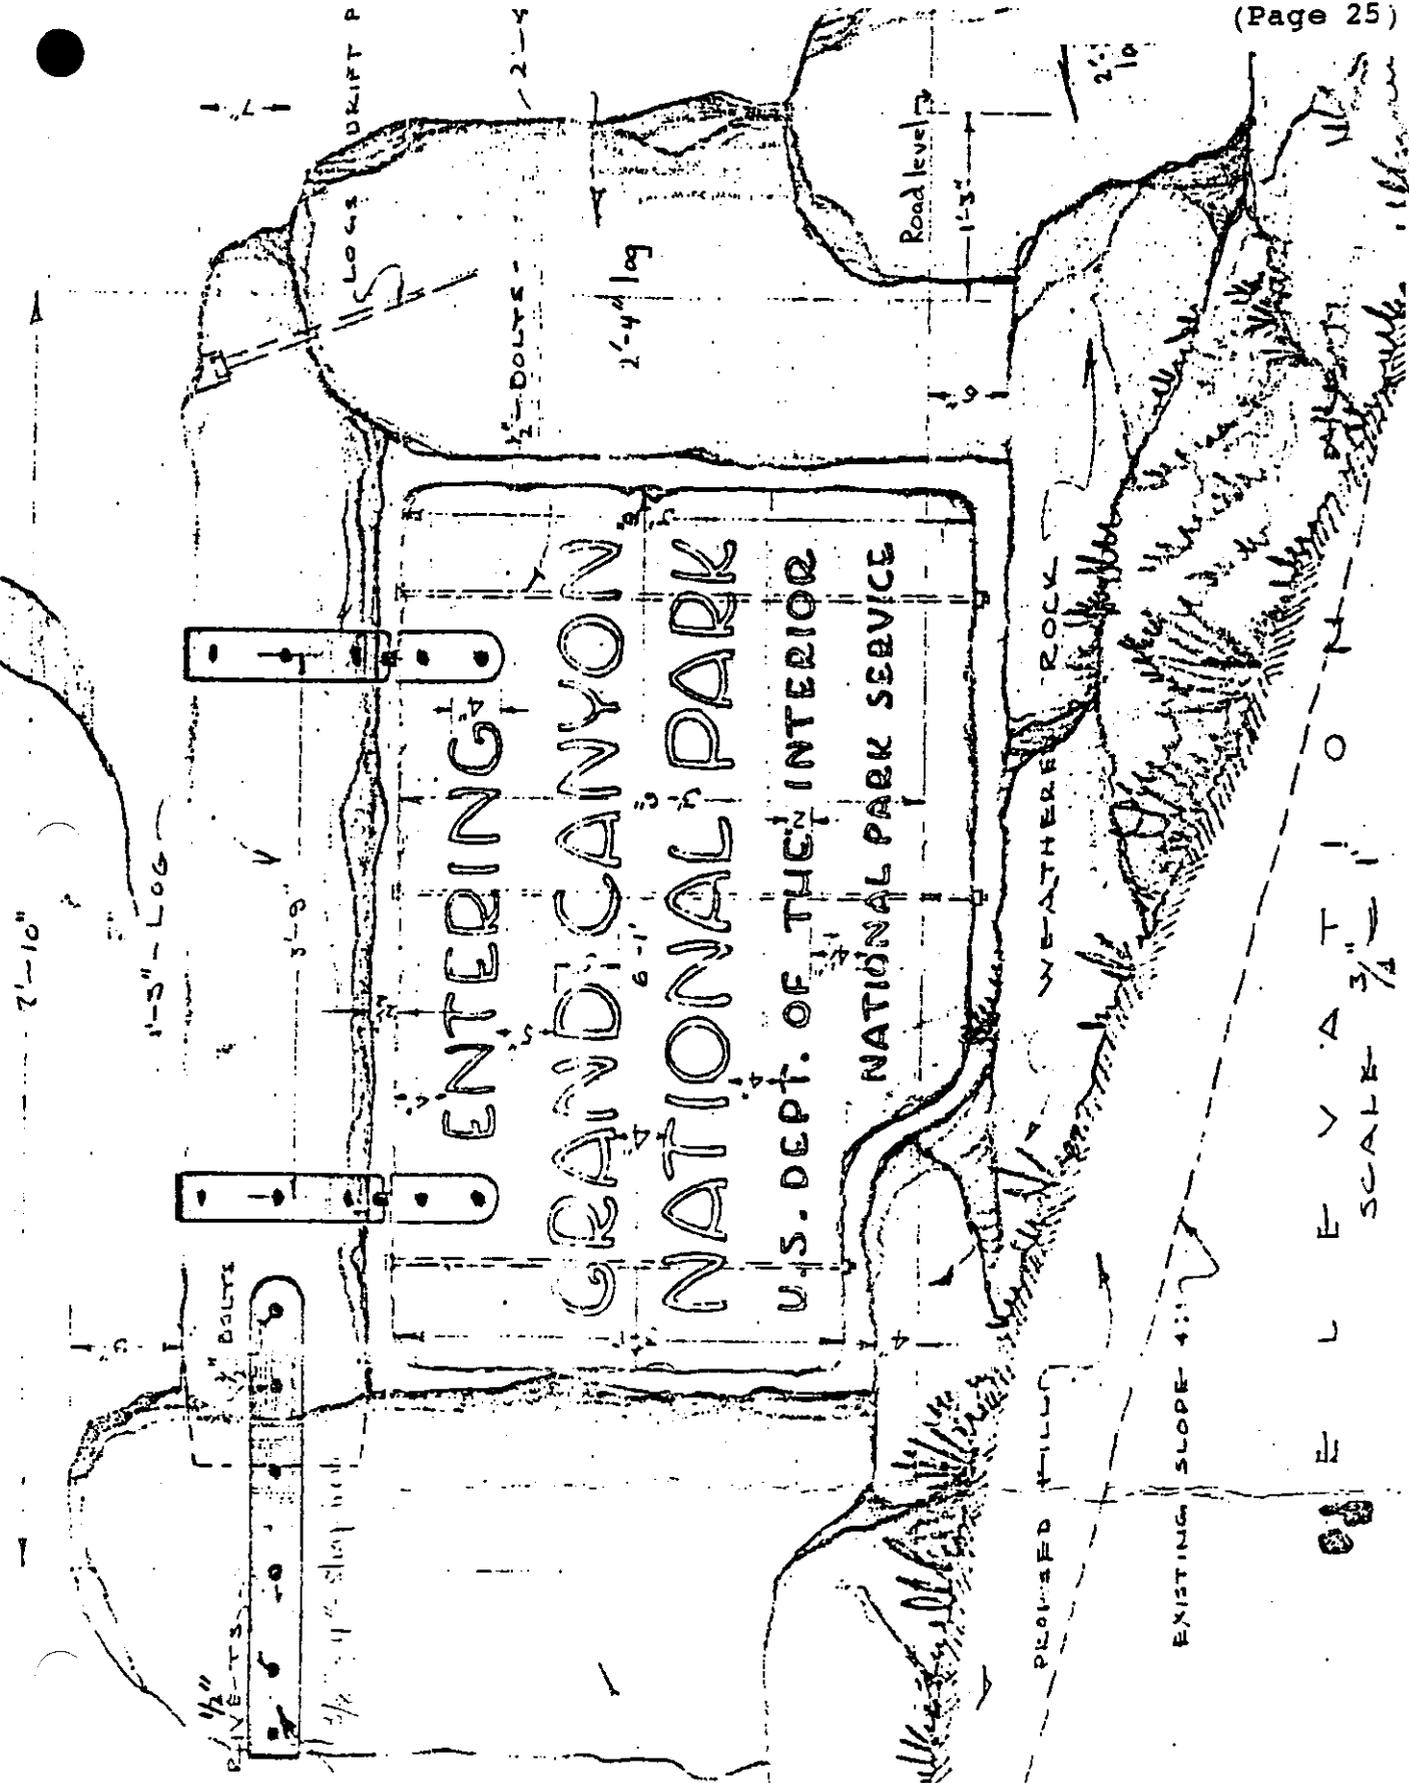
Figure 20. 1938 architect's drawing for north entrance sign, built in 1939. (NPGC-2041)

Another early addition to the North Entrance Road environment is the North Entrance Sign, designed with an elaborate construction drawing in 1938 and constructed by CCC crews in October 1939 at a cost of 46 man days and \$31.67. The sign seen today is no doubt original, but varies somewhat from its design. The massive peeled whole log posts, horizontal beam, heavy metal straps, masonry base of weathered stone (now buried slightly), sign, and wording are identical to 1938 drawings, but a few features such as a third, shorter massive log fronting the west post are missing.¹⁹ The appeal of this unusual rustic entrance sign is untarnished by its brown painted surface today; it may, in fact, have been painted immediately upon construction.

North Entrance Road and most of its visible associated features today bear the imprint of the early 1980s projects, but a few of the more important historic elements remain, beginning with the North Entrance sign. As noted earlier, the sign displays significant elements identified in the 1938 architect's drawings, especially massive posts, heavy iron straps, substantial wooden sign, and masonry base. Modern aspects of this rustic-style sign which detract from the historic feel are several, including the glossy brown paint over all, burial of the masonry base beneath a gravel shoulder, the sloppily-poured asphalt pullout immediately north which appears as a construction afterthought, and the small post and larger 45 mph speed limit sign beside and immediately behind the structure. The sign is placed at the park boundary, approximately 500 feet north of the entrance station."

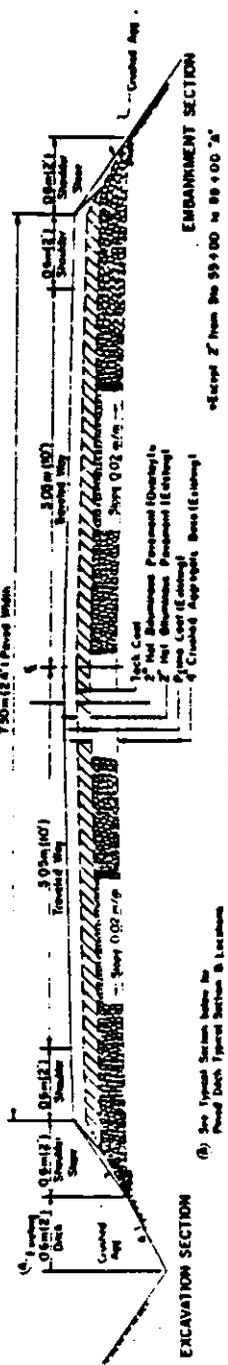
TYPICAL SECTION
ROWY A, B, (EXCEPT FOR BICYCLE TRAIL,
AND E

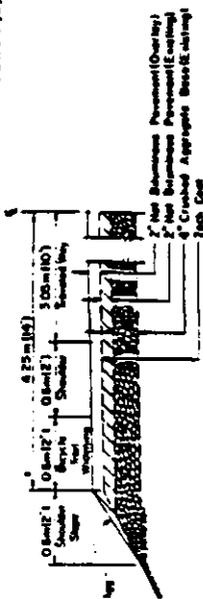
TYPICAL HALF SECTION
BICYCLE TRAIL WIDENING, ROWY B
STA. 28150 TO 45162.07
