Howard Road Historic District
Thomas Sparks House
1003 Howard Road
Washington
District of Columbia

HABS No. DC-395-A

ARCHITECTURAL DATA FORM

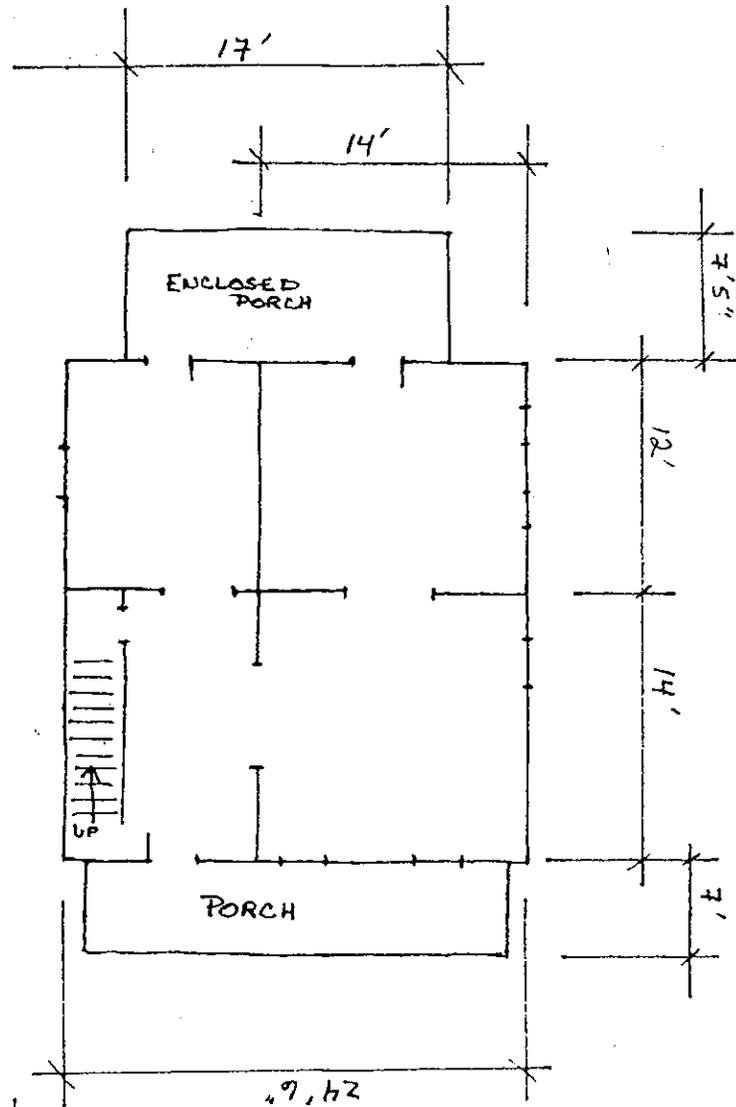
FIRST FLOOR

SHAPE AND DIMENSIONS OF STRUCTURE (SKETCHED FLOOR PLANS ON SEPARATE PAGES ARE ACCEPTABLE) (see sketched floor plan); two-story I-house with full-height rear ell, overall dimensions 26' x 26' with rear infill giving square plan; three-bay facade with entrance to left		
EXTERIOR FEATURES OF NOTE 6/1 wooden double hung sash in flat surrounds; triangular gable centered above facade		
INTERIOR FEATURES OF NOTE (DESCRIBE FLOOR PLANS, IF NOT SKETCHED) interior doors have five horizontal panels; window and door surrounds have shallow moldings and bulls'-eye corner blocks; staircase has square balusters and square newel with applied moldings		
MAJOR ALTERATIONS AND ADDITIONS WITH DATES Rear re-entrant angle filled in for kitchen area; roof of ell altered from gable to flat, with slope to rear; exterior covered with synthetic shingling; two-story rear porch added and brick piers installed on front porch (dates unknown)
