ADDENDUM TO:
ST. ELIZABETHS HOSPITAL, HITCHCOCK HALL
(Building No. 37)
2700 Martin Luther King Jr. Avenue, Southeast, 588-604 Redwood
Street, Southeast
Washington
District of Columbia

ST. ELIZABETHS HOSPITAL, HITCHCOCK HALL (BUILDING 37)

HABS NO. DC-349-S

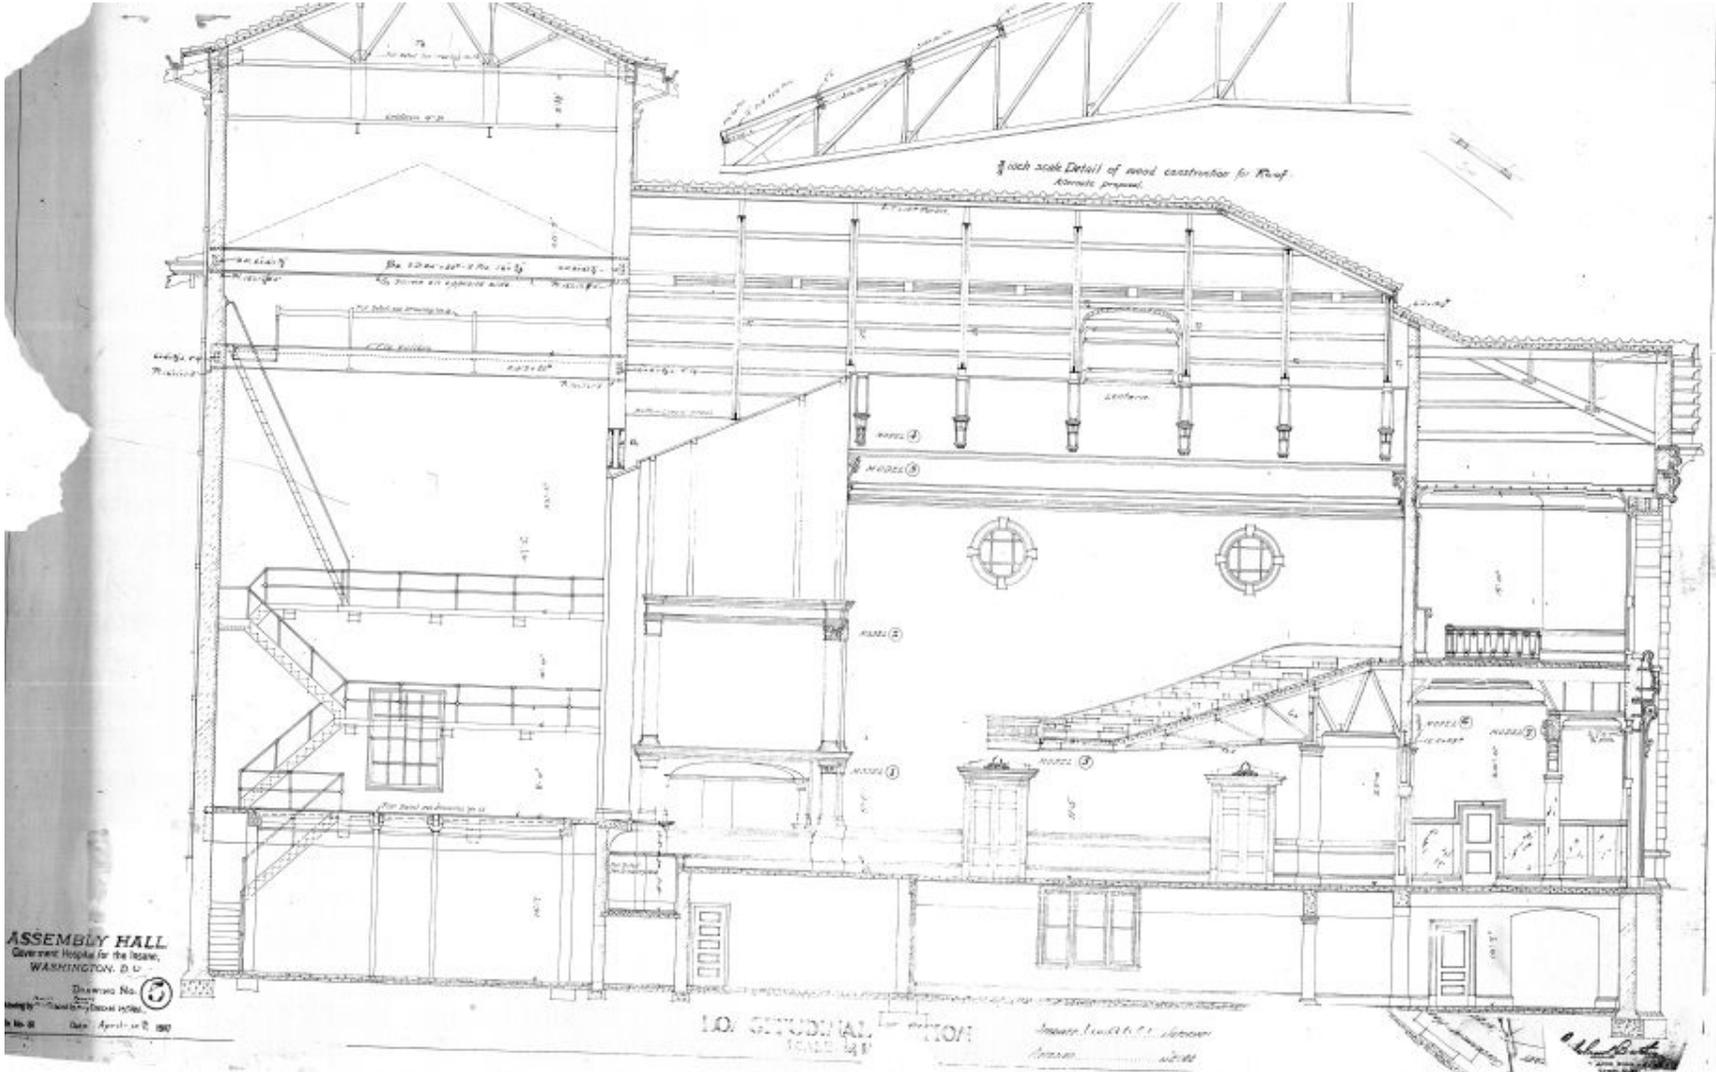
Figure 24. Source: GSA archives, image DC1344SE0110.

ASSEMBLY HALL
Government Hospital for the Insane,
WASHINGTON, D. C.
Drawing No. 5
Scale: 1/8" = 1'-0"
Date: April 10, 1907

10. STRUCTURAL SECTION
JAMES H. WOOD & CO. ARCHT.
WASHINGTON, D. C.
