ST. ELIZABETHS HOSPITAL, WEST WING  
(Building No. 3)  
539-559 Cedar Drive, Southeast  
Washington  
District of Columbia

HABS DC-349-X  
*HABS DC-349-X*

ST. ELIZABETHS HOSPITAL, WEST WING (BUILDING 3)

HABS NO. DC-349-X

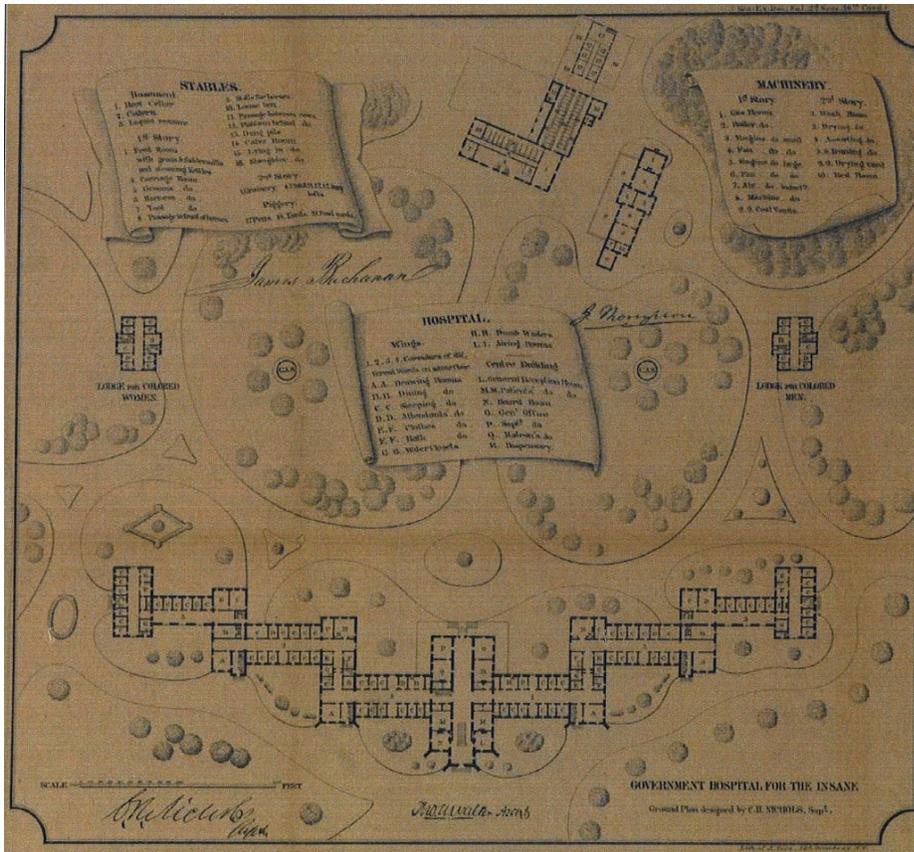
Figure 3. 1860 Ground Plan designed by Charles Nichols and signed by Architect Thomas U. Walter and President James Buchanan. Source: Library of Congress.

The West Wing was originally constructed as two wings, oriented east-west and separated by three cross-wings, situated north-south, creating the echelon plan. The wings consisted of a central corridor that provided access to single patient rooms, attendants’ quarters, dining rooms, and common areas. Stair halls were located at the north end of the cross-wings. Each floor of each wing of the building housed a different patient ward. The Gray and White Ash wards occupied the westernmost section of the West Wing, while the Oak, Beech, and Sycamore wards comprised the easternmost wing.<sup>20</sup>

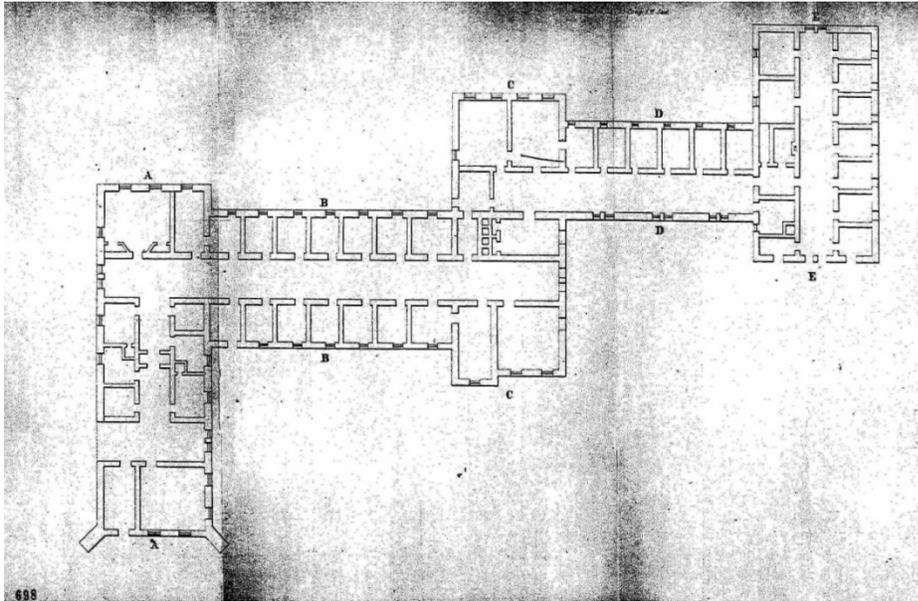
Figure 4. Initial plan of construction for the West Wing component, 1852. Source: 1854 Annual Report.

For construction purposes, the West Wing was divided into five sections correlating with the differentiation of wings and cross-wings. Section A was a four-story building, sections B and C were designed as three-story wings, while sections D and E stepped down to two-stories. Construction was started at section E, the westernmost section, and continued east. By February 1854, the initial \$100,000 appropriation had been designated for the acquisition of land and construction of the first three sections (E, D, and C) of the West Wing building. An additional \$22,512 was provided for the completion of the last two sections of the West Wing (sections A and B).<sup>16</sup> The 1855 *Annual Report* noted:

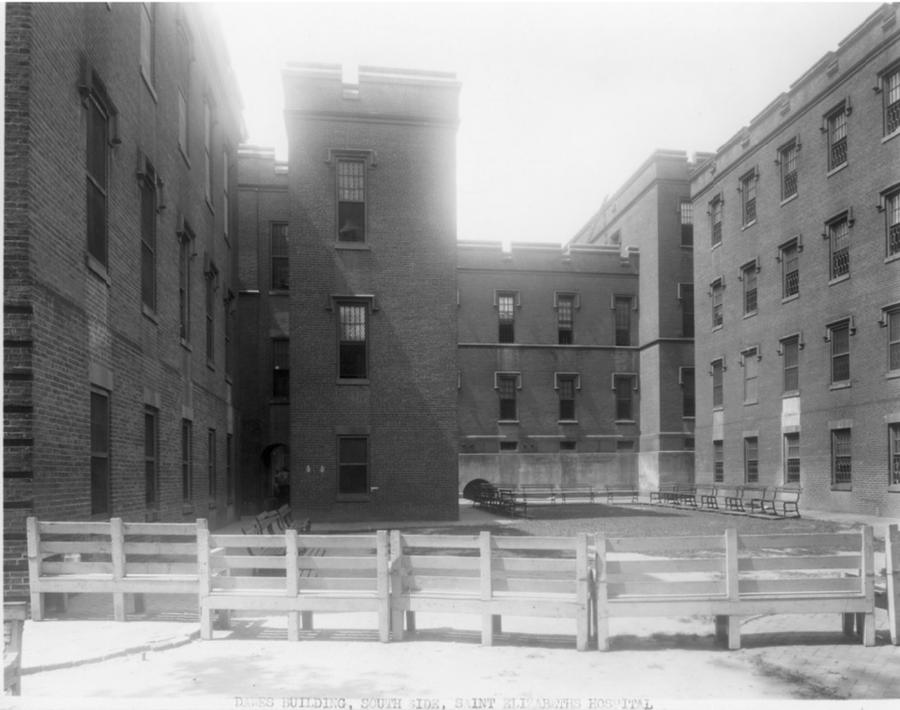
Figure 6. South facade of the West Wing with the 1895 lavatory addition. Garfield is at left, and Dawes is at right.  
Source: GSA archives, image DC0066SE0P086.

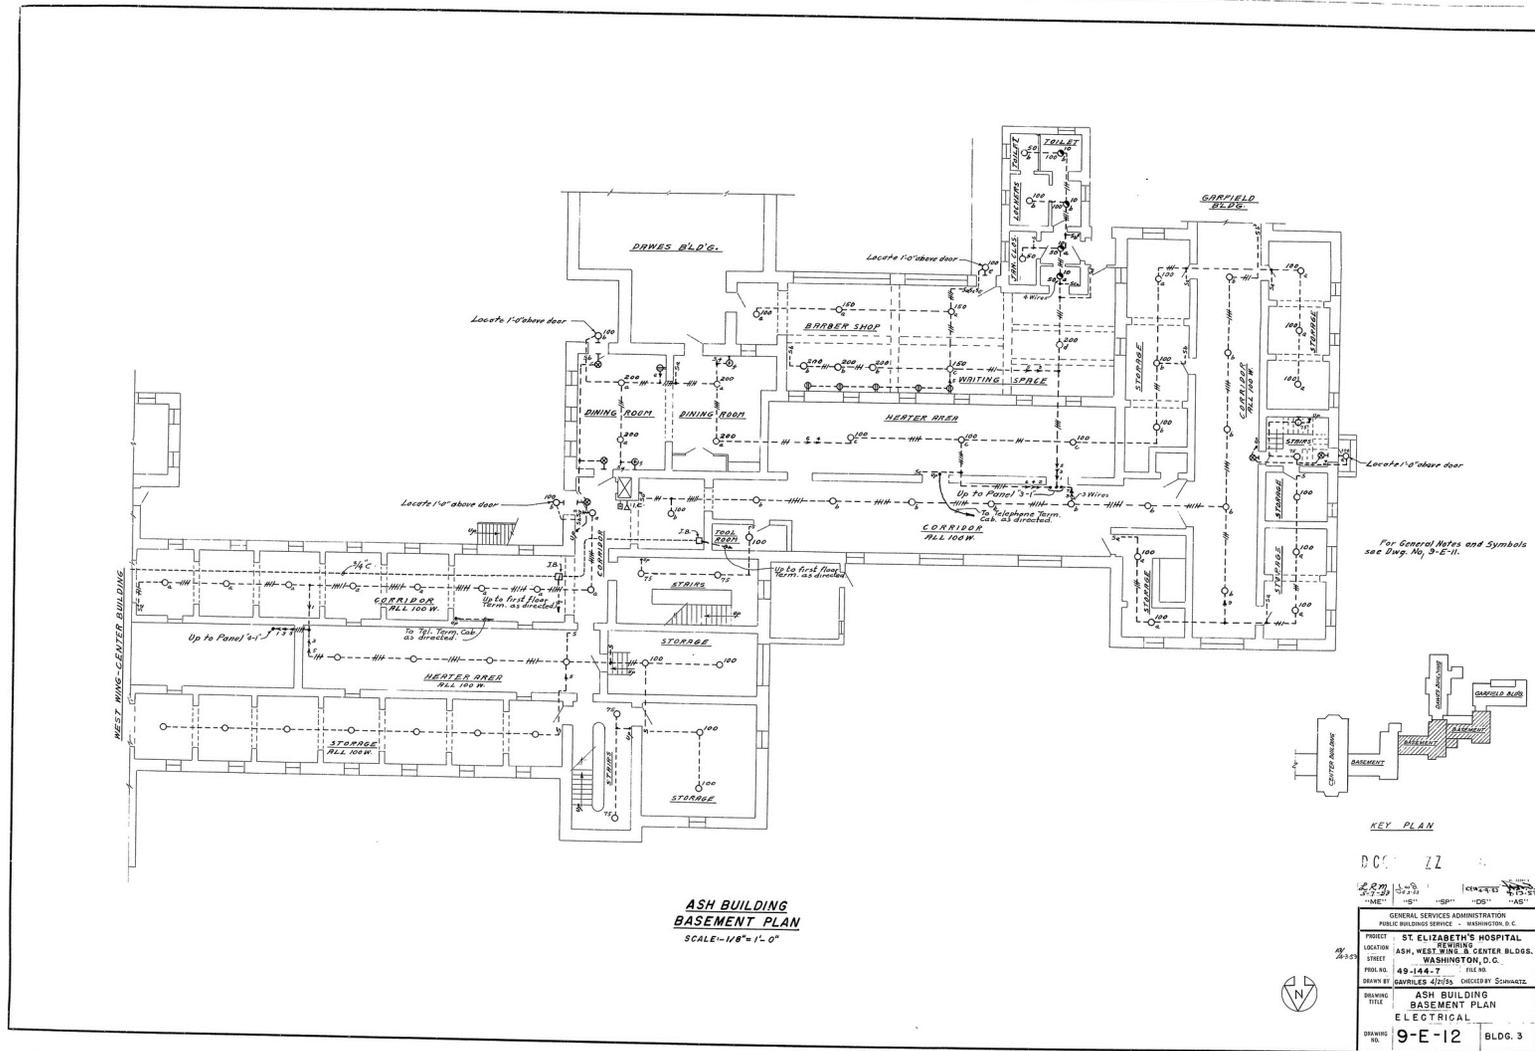
Figure 15. Basement plan of West Wing, outlining improvement to the electrical system, 1953. Source: GSA archives, image DC0070SE0004.

Between 1938 and 1953, a one-story electrical transformer room was constructed on the north side of the building at the intersection of the Oak, Beech, and Sycamore wards and the Gray and White Ash wards. The brick addition had a concrete foundation, metal-framed door on the west facade, and openings with louvered vent screens.<sup>41</sup>

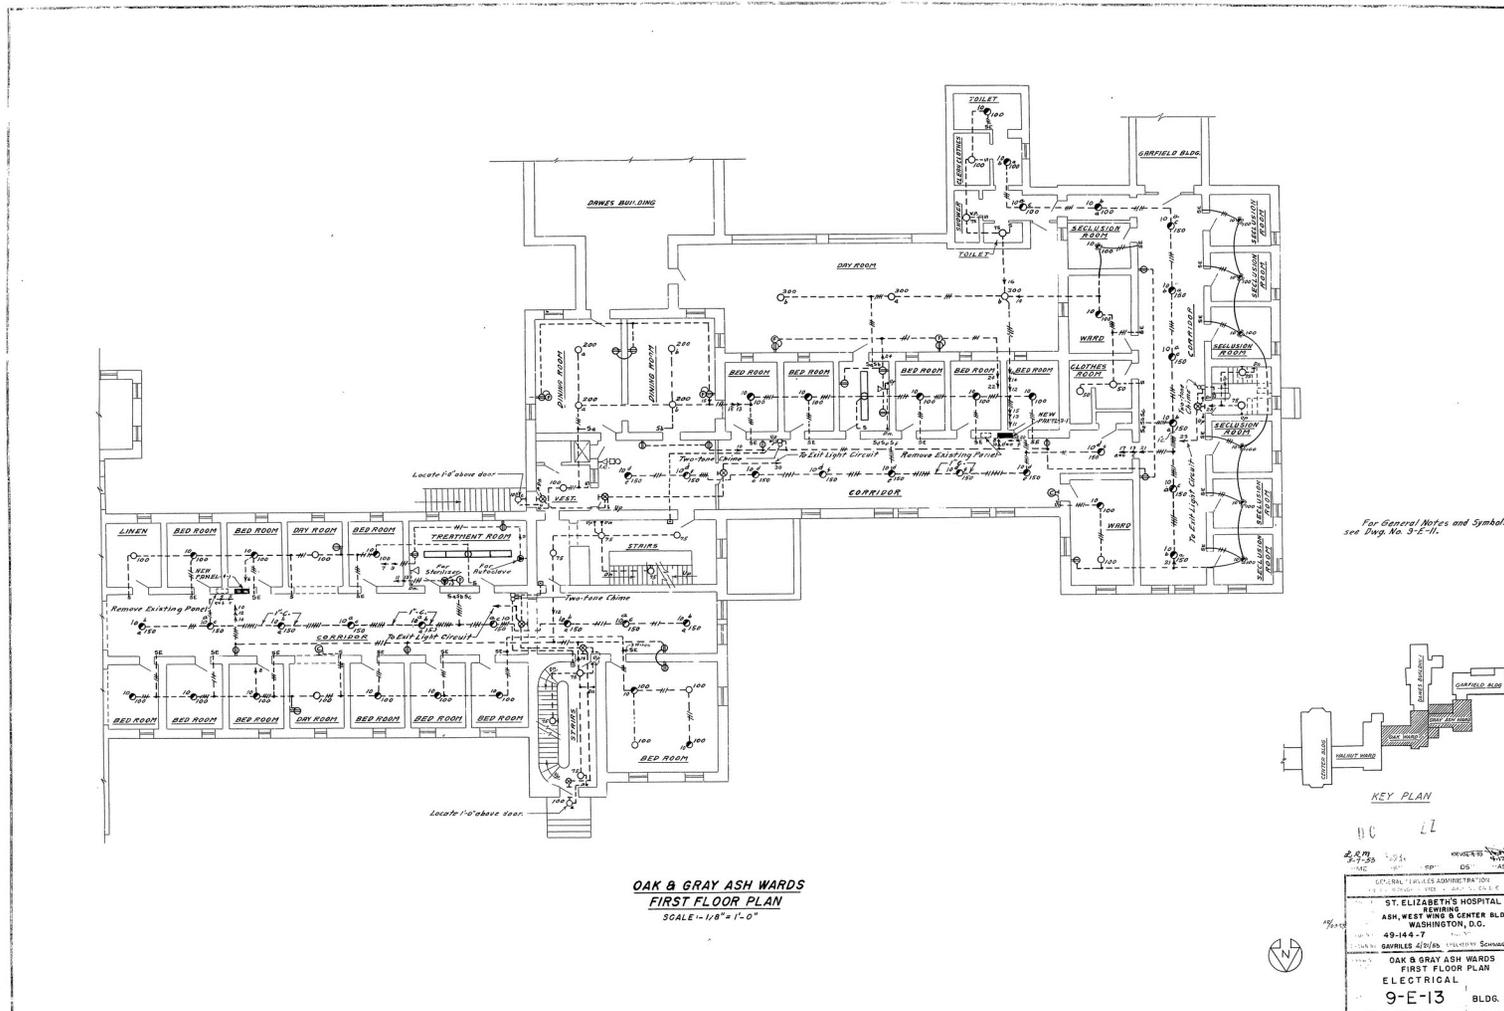
Figure 16. First floor plan of the West Wing, Oak and Gray Ash wards, outlining improvements to the electrical system, 1953. Source: GSA archives, image DC0070SE0005.

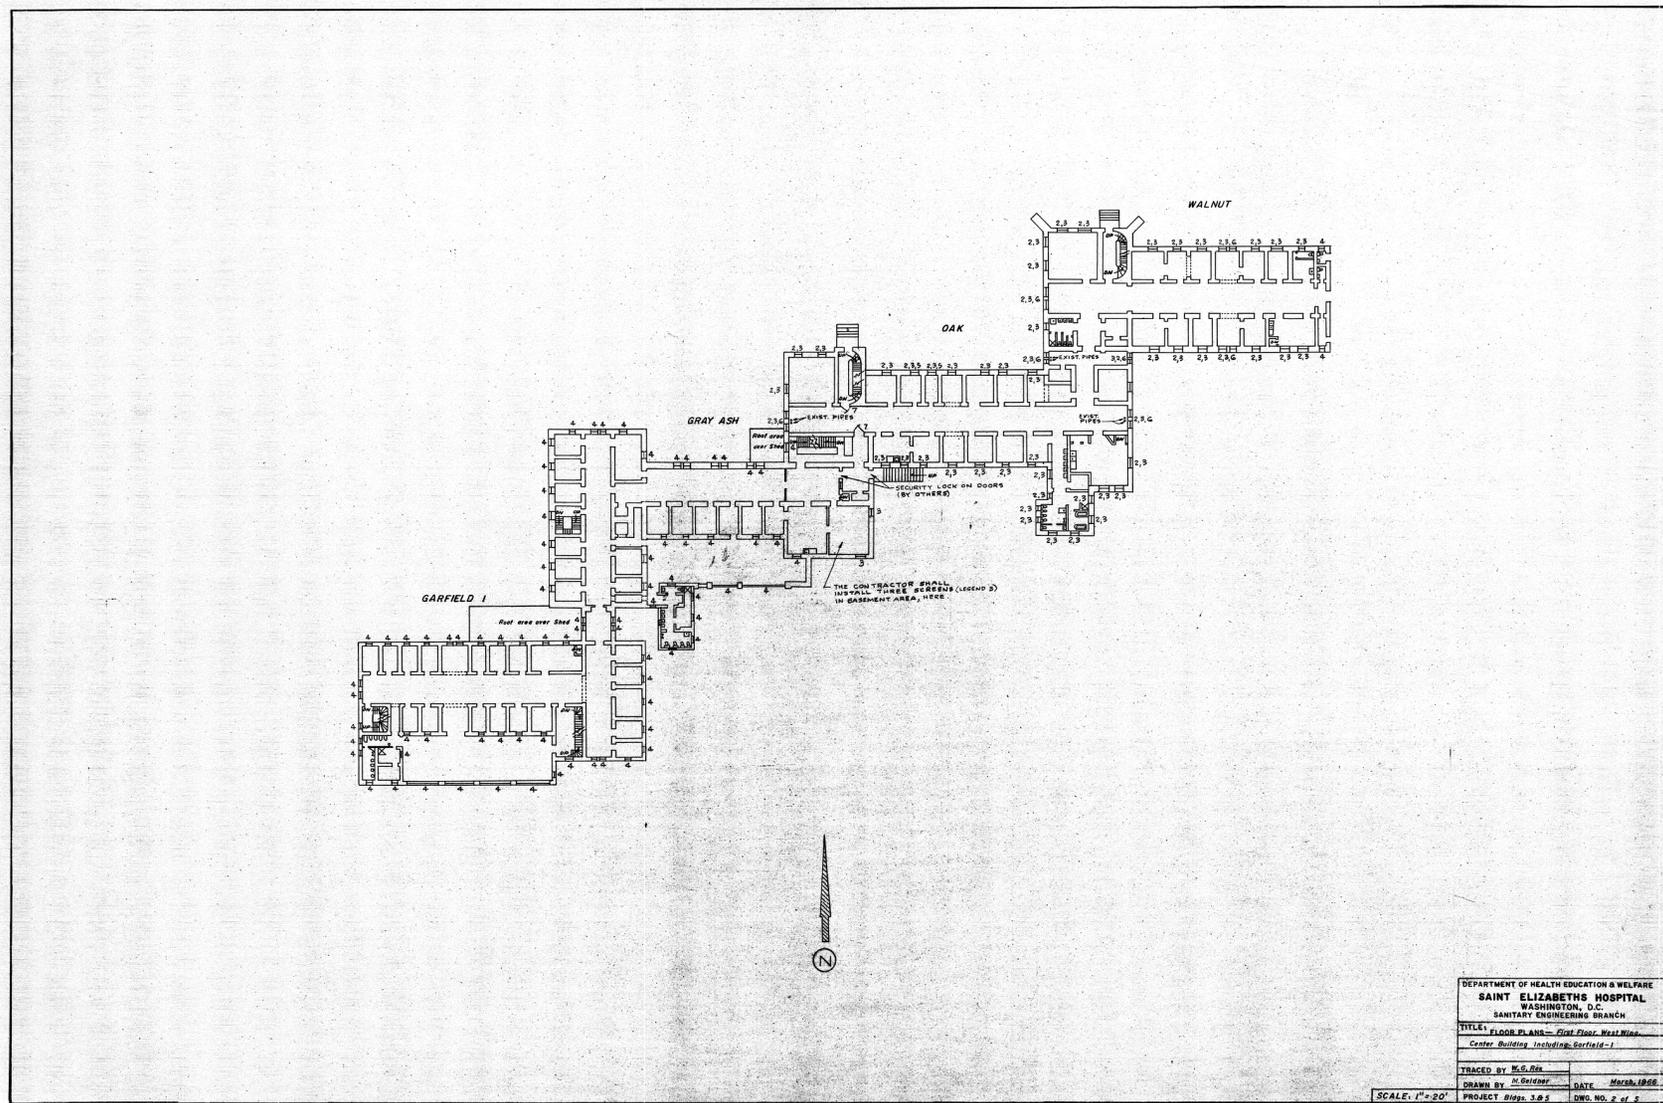
Figure 19. First floor plan of the West Wing, Oak and Gray Ash wards, 1966. Source: GSA archives, image DC0070SE0108.

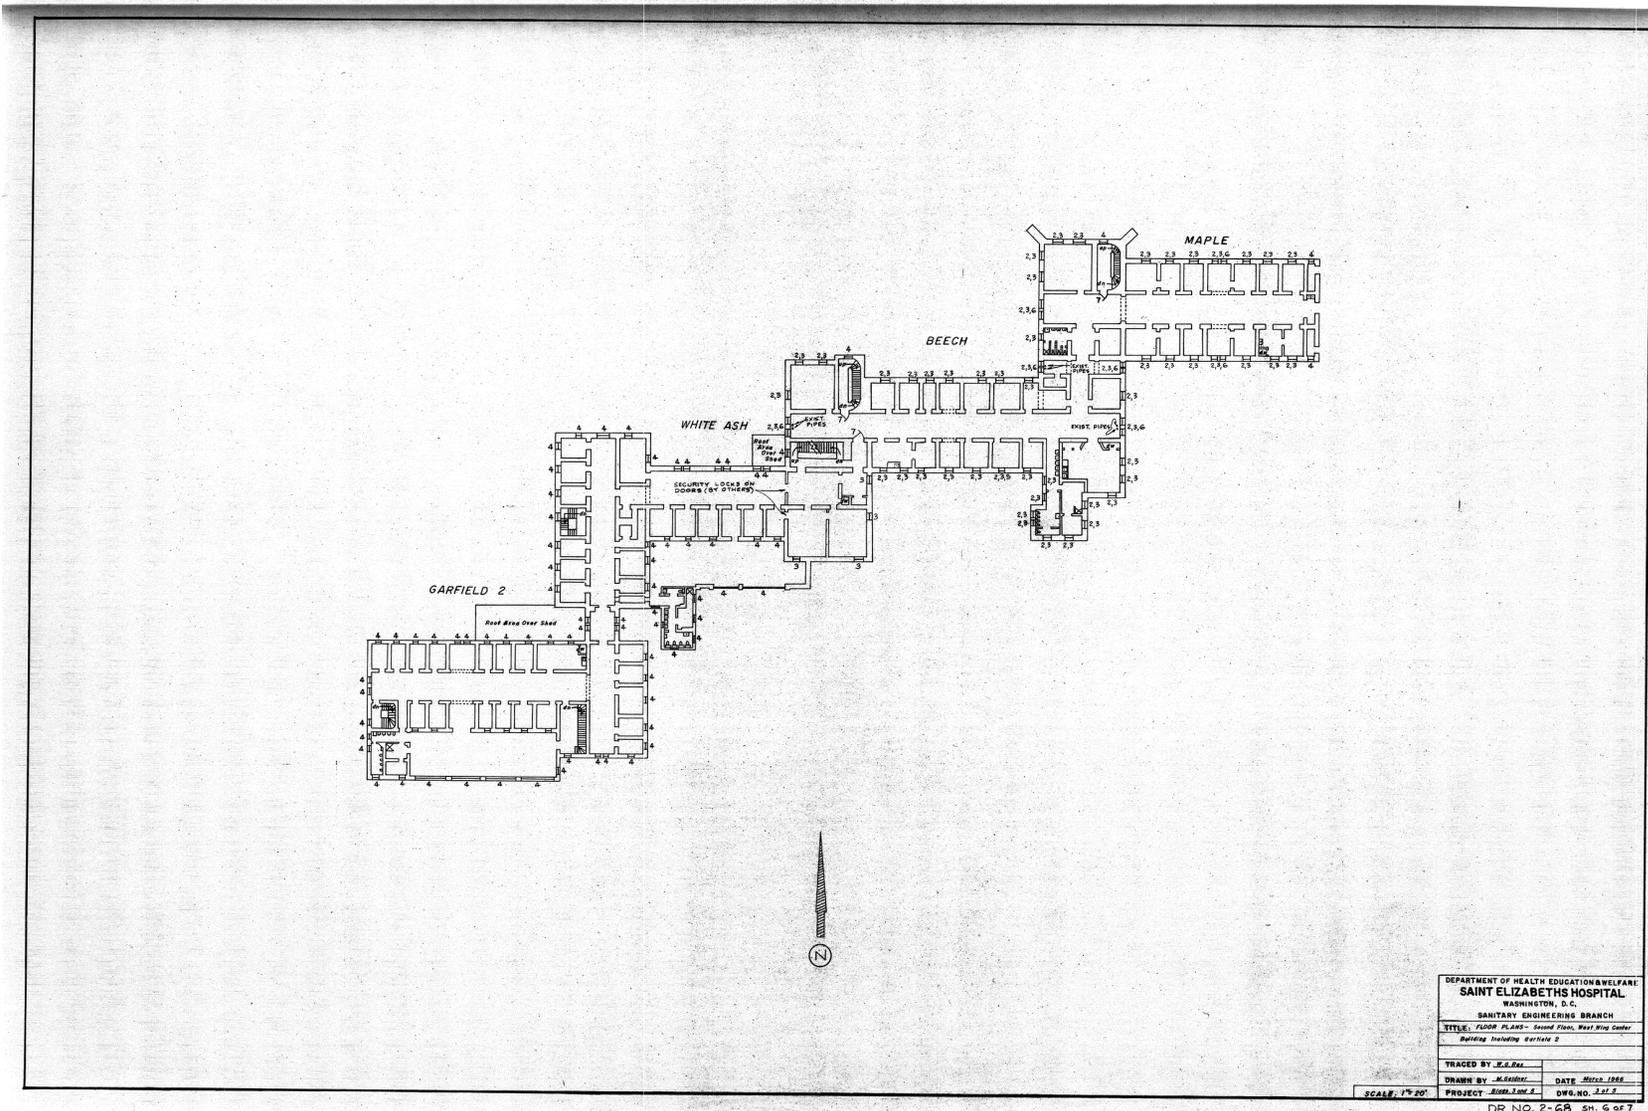
Figure 20. Second floor plan of the West Wing, Beech and White Ash wards, 1966. Source: GSA archives, image DC0070SE0109.

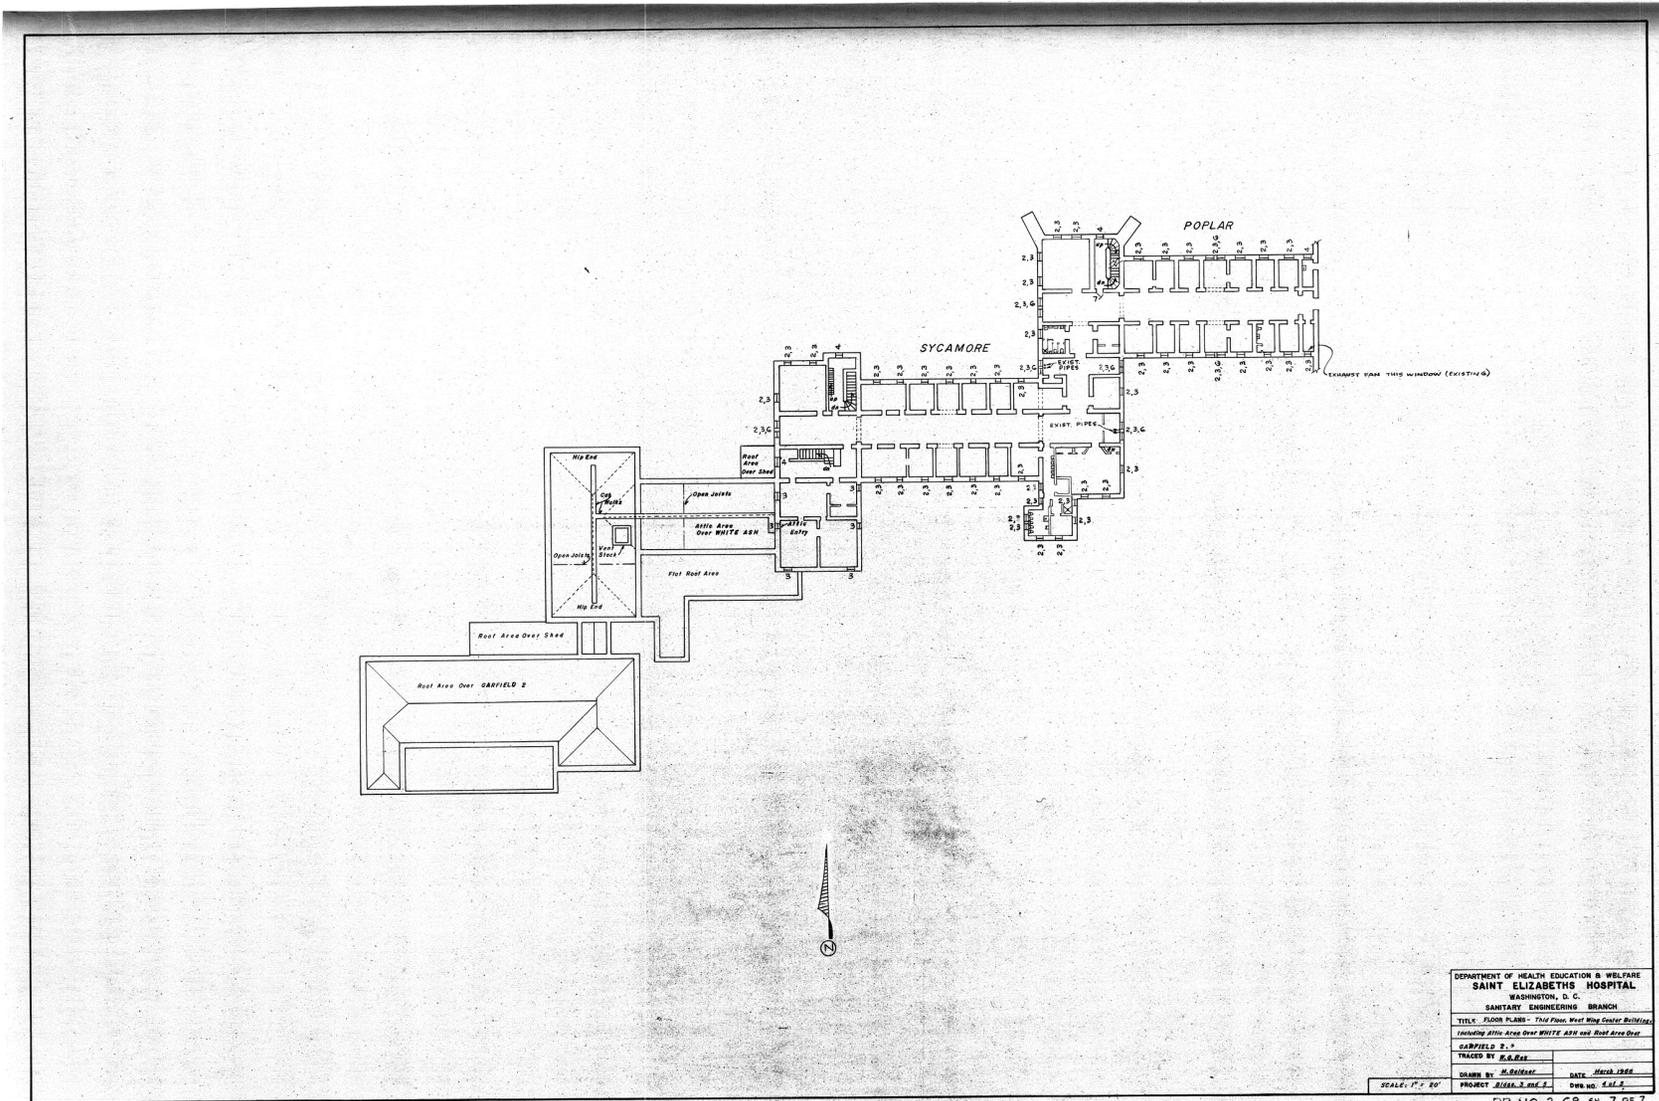
Figure 21. Third floor plan of the West Wing, Sycamore ward, 1966. Source: GSA archives, image DC0070SE0110.

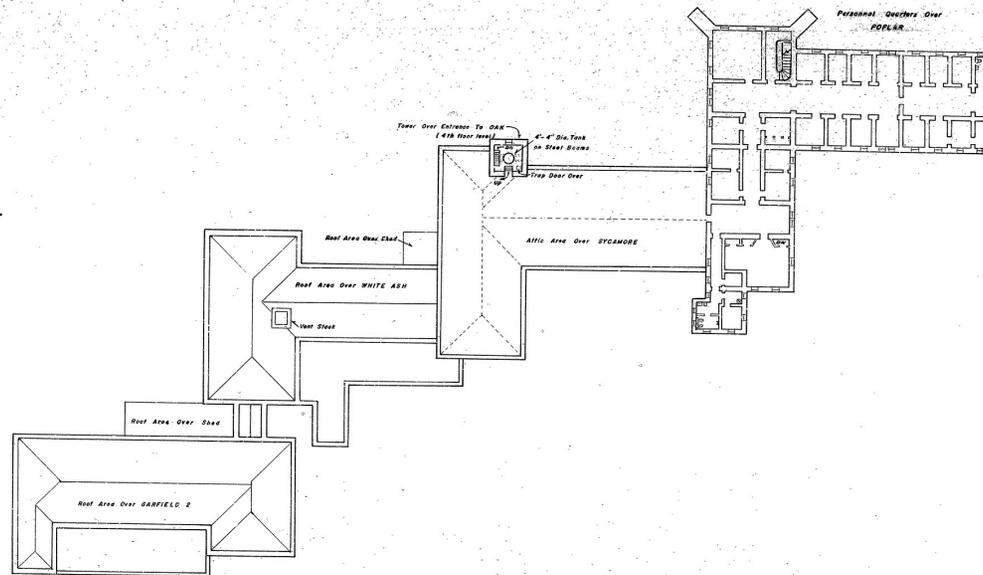
Figure 22. Roof and attic plan of the West Wing, 1966. Source: GSA archives, image DC0070SE0104.
