ST. ELIZABETHS HOSPITAL, GATEHOUSE NO. 1  
(Building No. 21)  
2695 Martin Luther King Jr. Avenue, Southeast  
Washington  
District of Columbia

HABS DC-349-AV  
*HABS DC-349-AV*

### ST. ELIZABETHS HOSPITAL, GATEHOUSE NO. 1 (BUILDING 21)

HABS NO. DC-349-AV

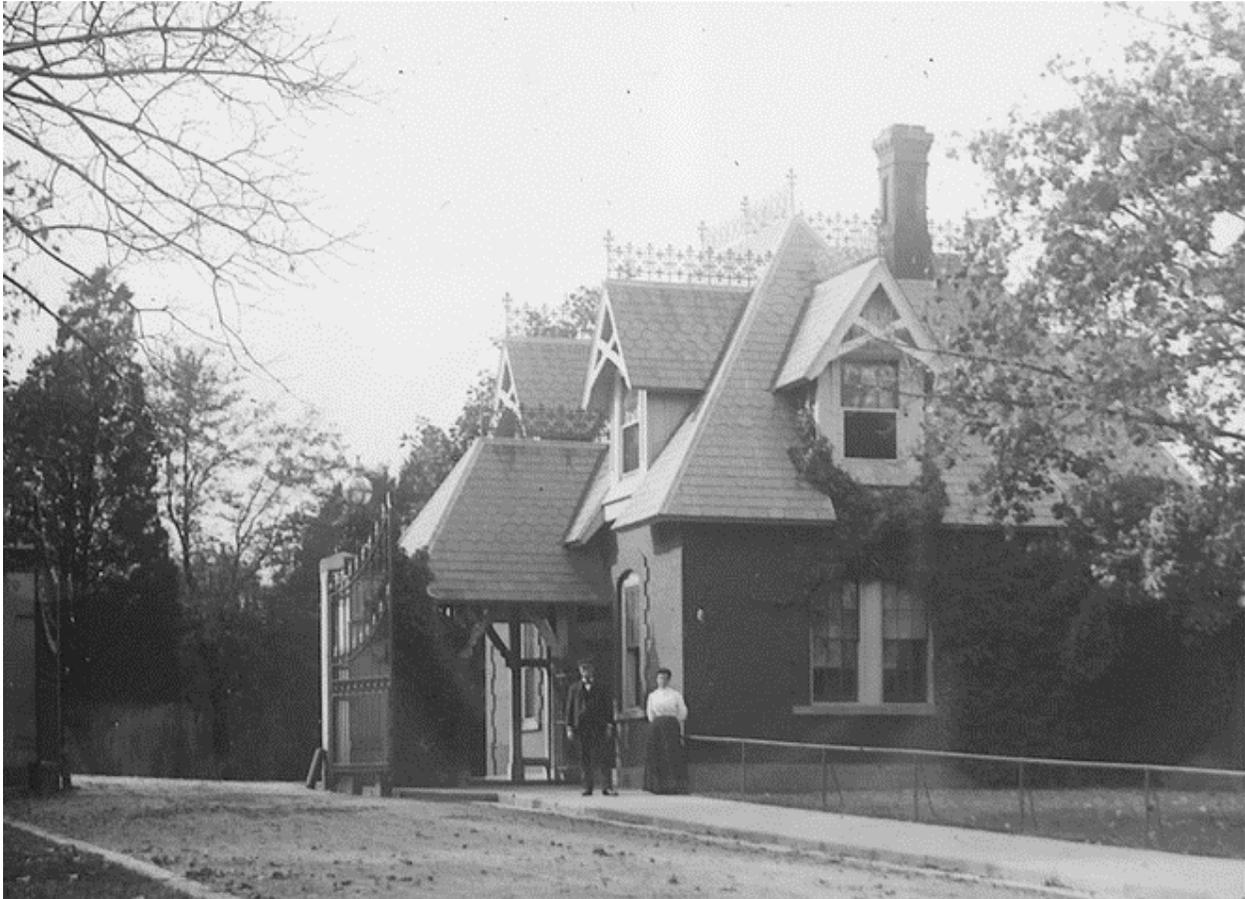
*Figure 1. View of the gatehouse from the east. Source: General Services Administration, file DC0167SE0P005.*

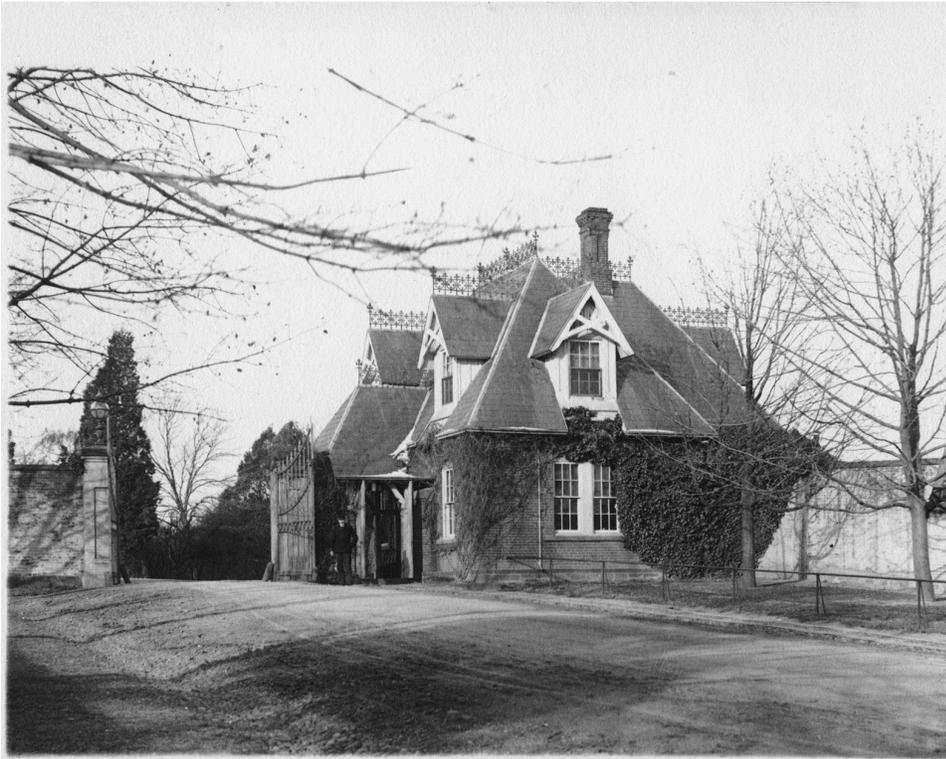
*Figure 2. View from the east of the gatehouse, 1897. Source: General Services Administration, file DC0167SE0P003.*

<sup>8</sup> The building description is based on existing physical evidence and corroborated in part by archival photographs. The existence of an outbuilding is first seen in an 1897 archival photograph. The form is more clearly seen in a 1945 archival photo.

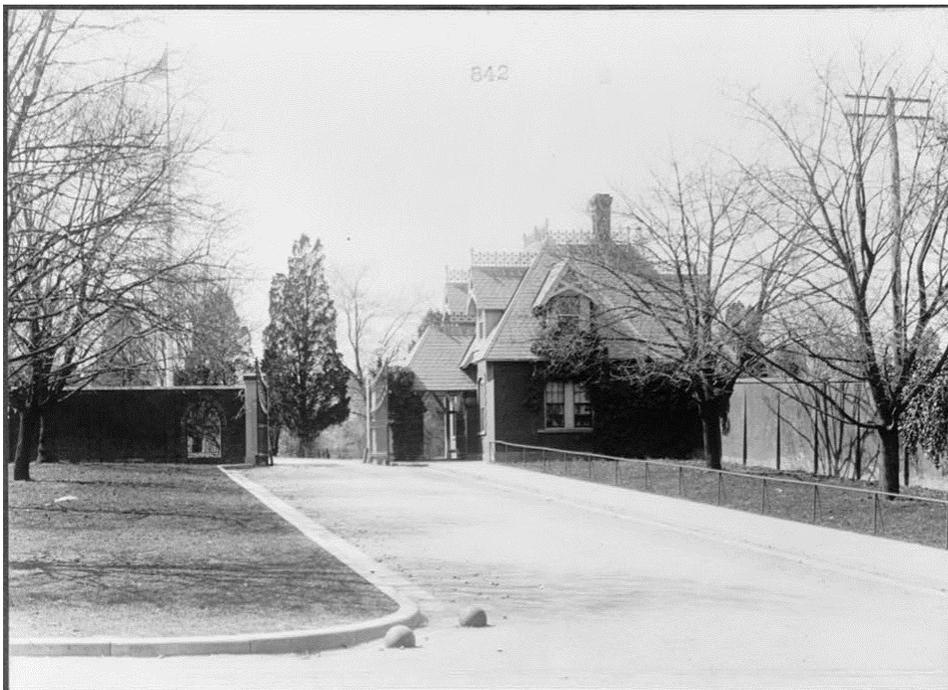
*Figure 3. View from the east, sometime between 1909 and 1932. Source: Library of Congress.*

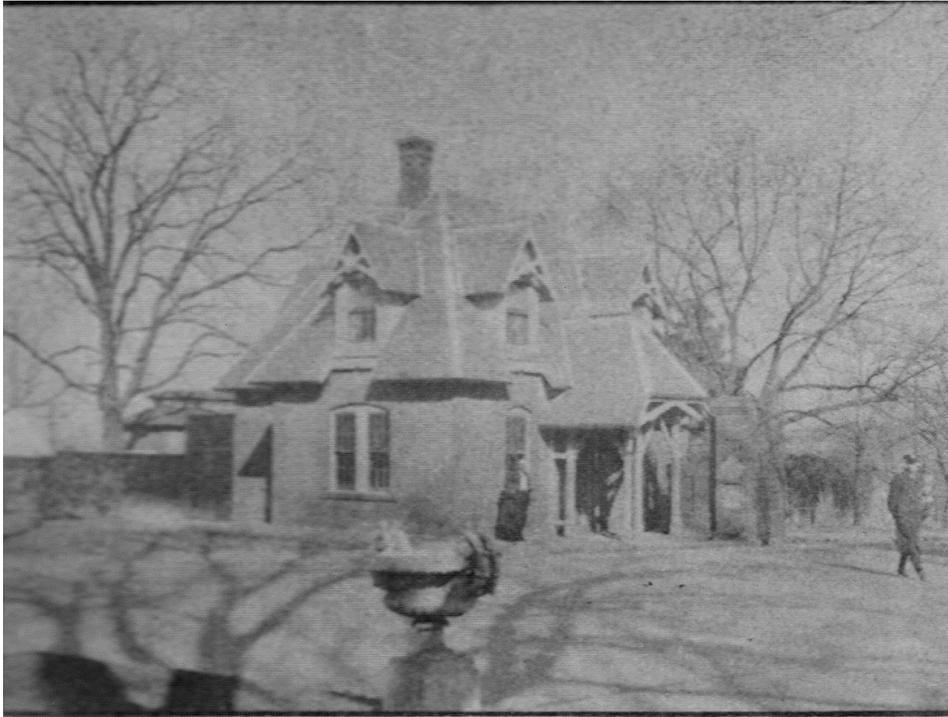
*Figure 4. View of the gatehouse from the southwest, 1945. Source: 1945 building survey (excerpt).*

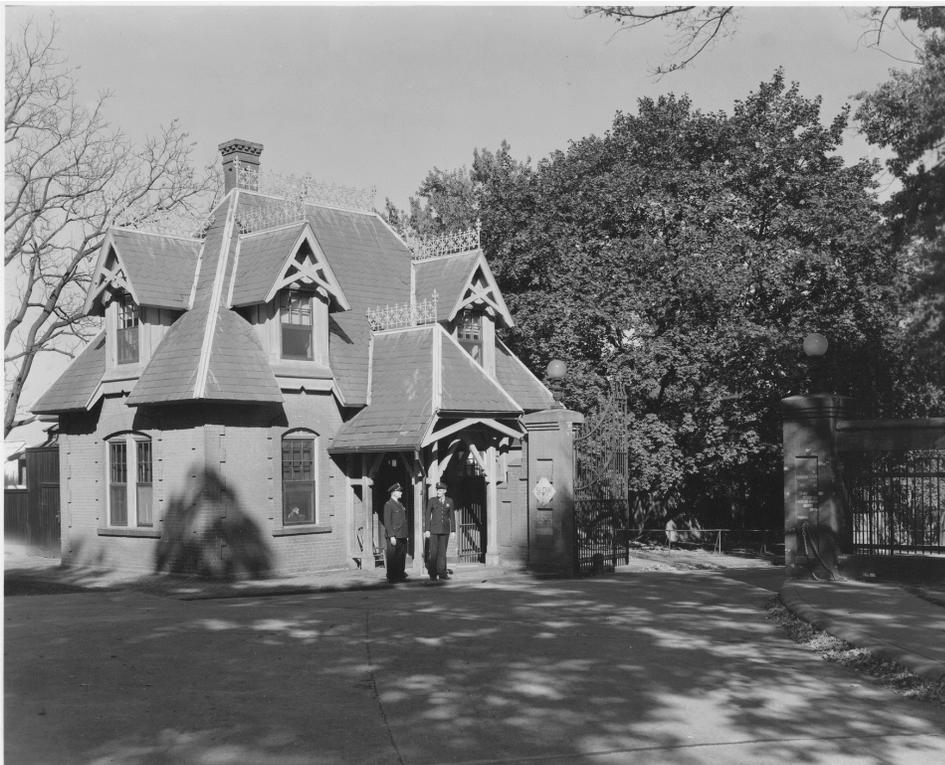
*Figure 5. View from the southwest, 1944. Source: General Services Administration, file DC0167SE0P004.*

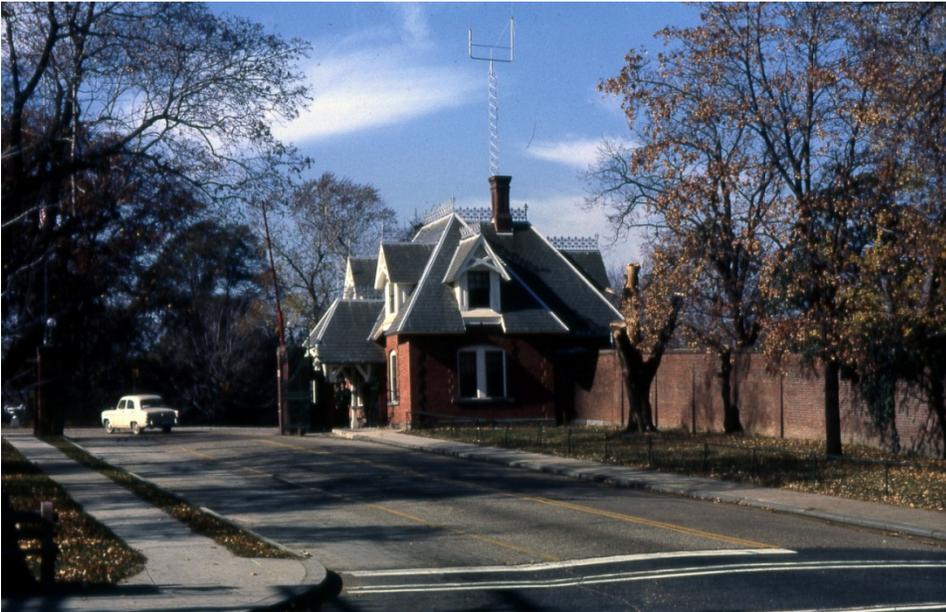
*Figure 6. View from the east, 1960s. Source: General Services Administration, file DC0167SE0P007.*

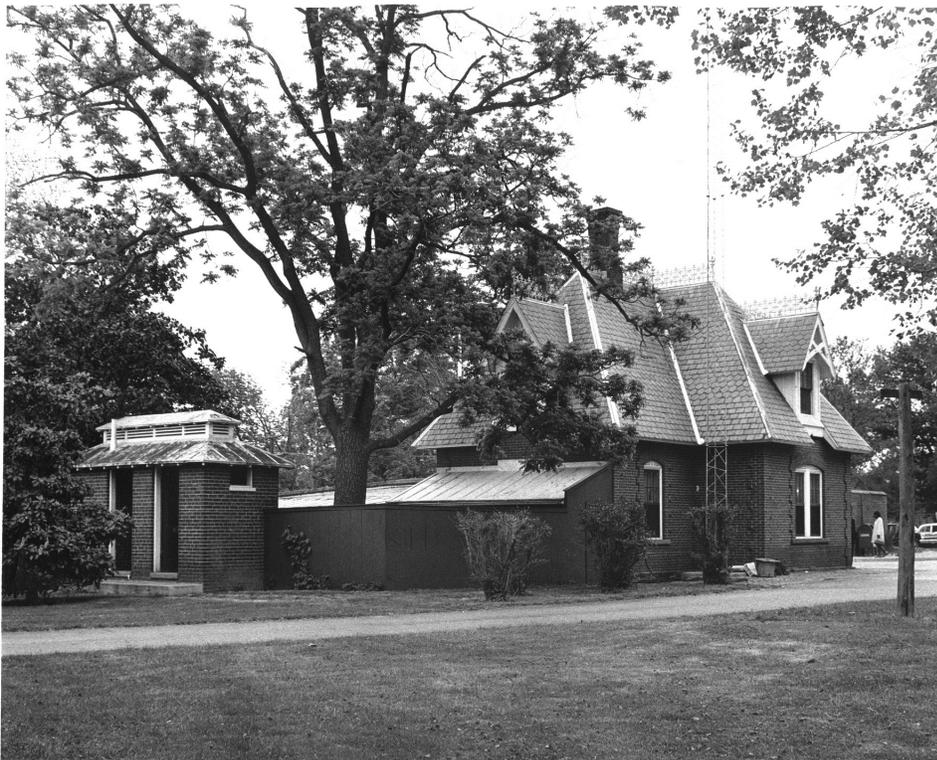
*Figure 7. View from the northwest, 1968. Source: General Services Administration, file DC0167SE0P001.*

<sup>13</sup> The addition first appears in an archival photograph from 1968 and is identified as an "existing shed" to remain in 1972 construction documents.

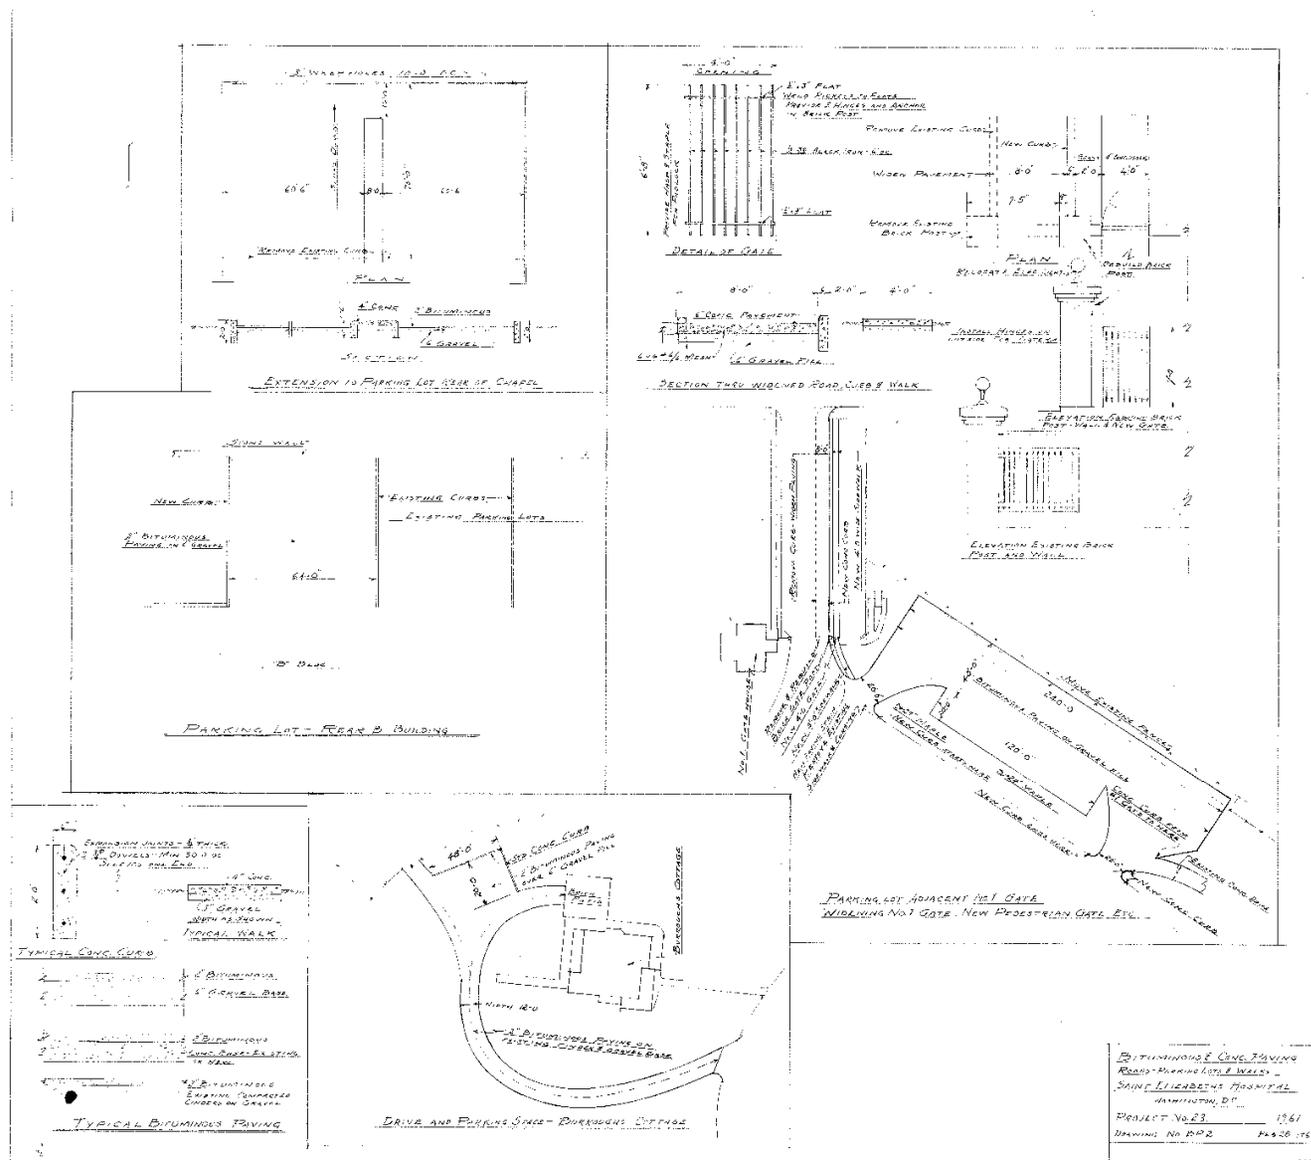
Figure 9. Source: General Services Administration, file DC1472SE0598, drawing dated 1961.

Improvements were made to Cedar Drive, which included widening the access road 8 feet at the point of entrance. Plans for modifying the roadway were outlined in 1961 but actual construction occurred between 1964 and 1972. The expansion of the roadway resulted in the removal of the brick gate piers and associated wrought iron gate. Although construction documents specified replacement with similar iron gates and brick piers, archival photographs and existing conditions indicate the installation of a chain-link guard fence with metal support post.<sup>18</sup>

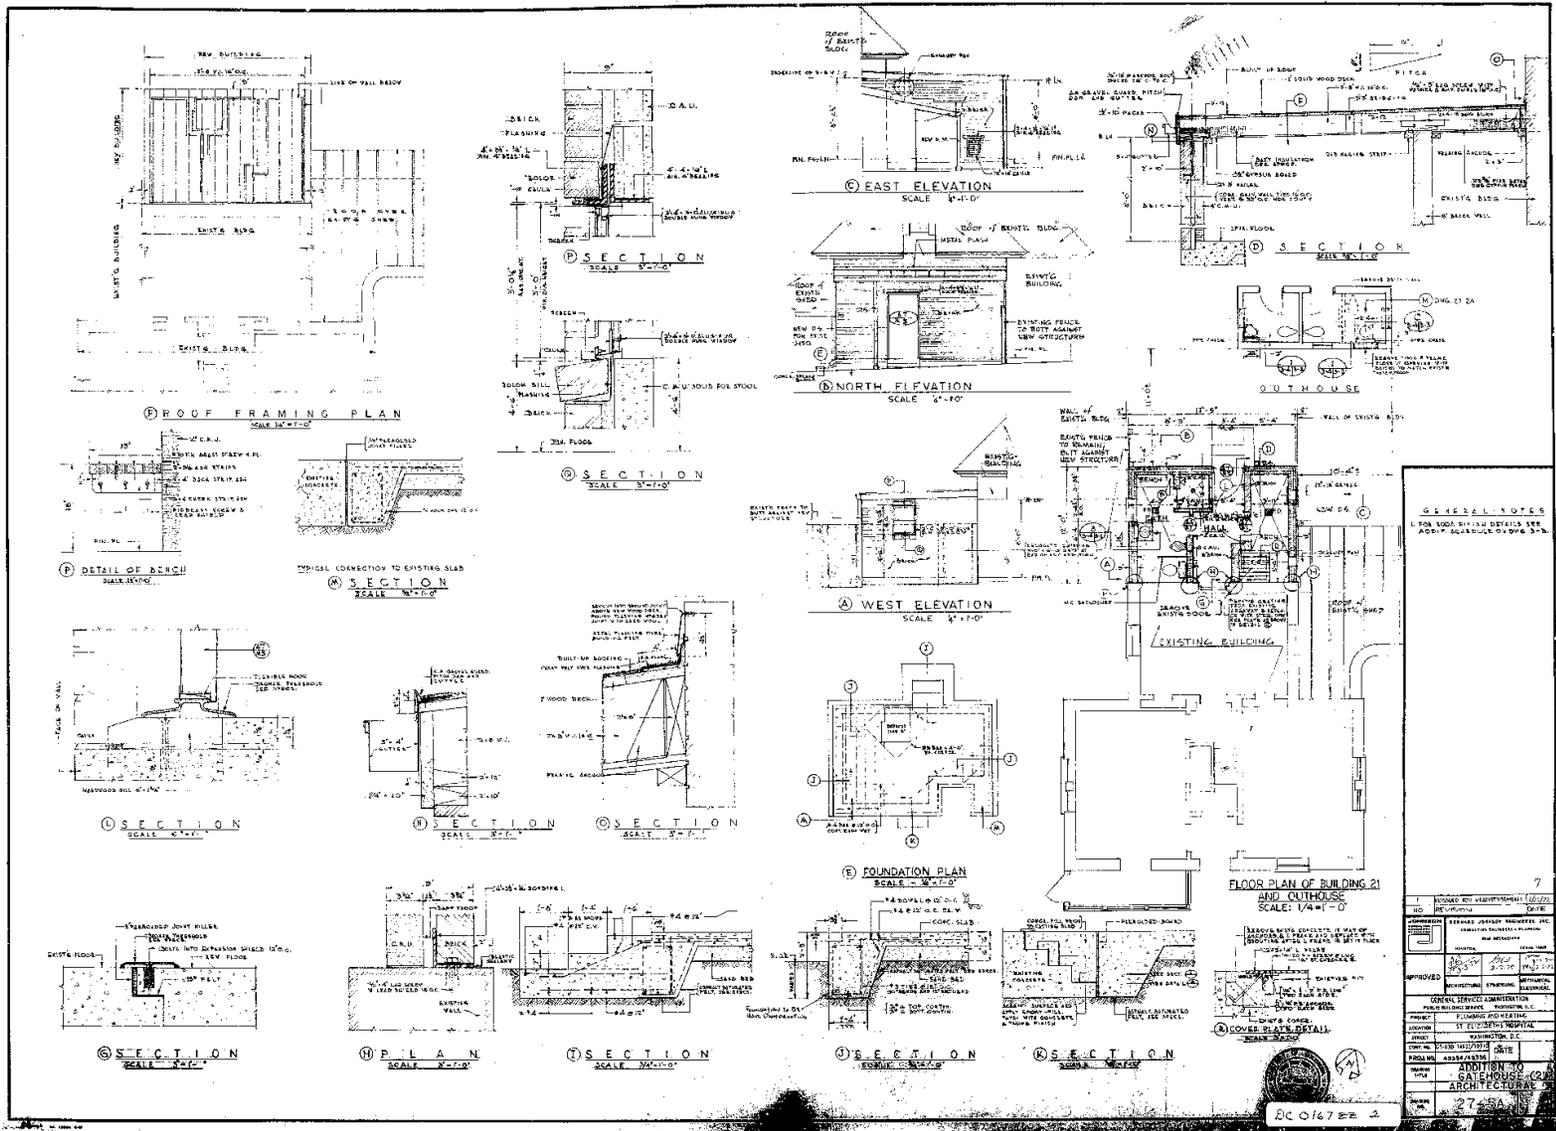
Figure 10. Source: General Services Administration, file DC0167SE0002, drawing dated 1972.

By 1972, the wood-framed structure on the north elevation of the gatehouse was demolished.<sup>19</sup> The structure was replaced by a one-story brick addition with a concrete foundation and flat roof. The 12-foot by 18-foot addition provided updated restrooms facilities and a mechanical room. Improvements were made to the heating and electrical systems of the gatehouse, including the installation of a radiant heating system and fluorescent light fixtures throughout the building.<sup>20</sup> Between 1972 and 2002, a carport was constructed on the west facade of the gatehouse. The date of construction of this structure is unknown.<sup>21</sup>

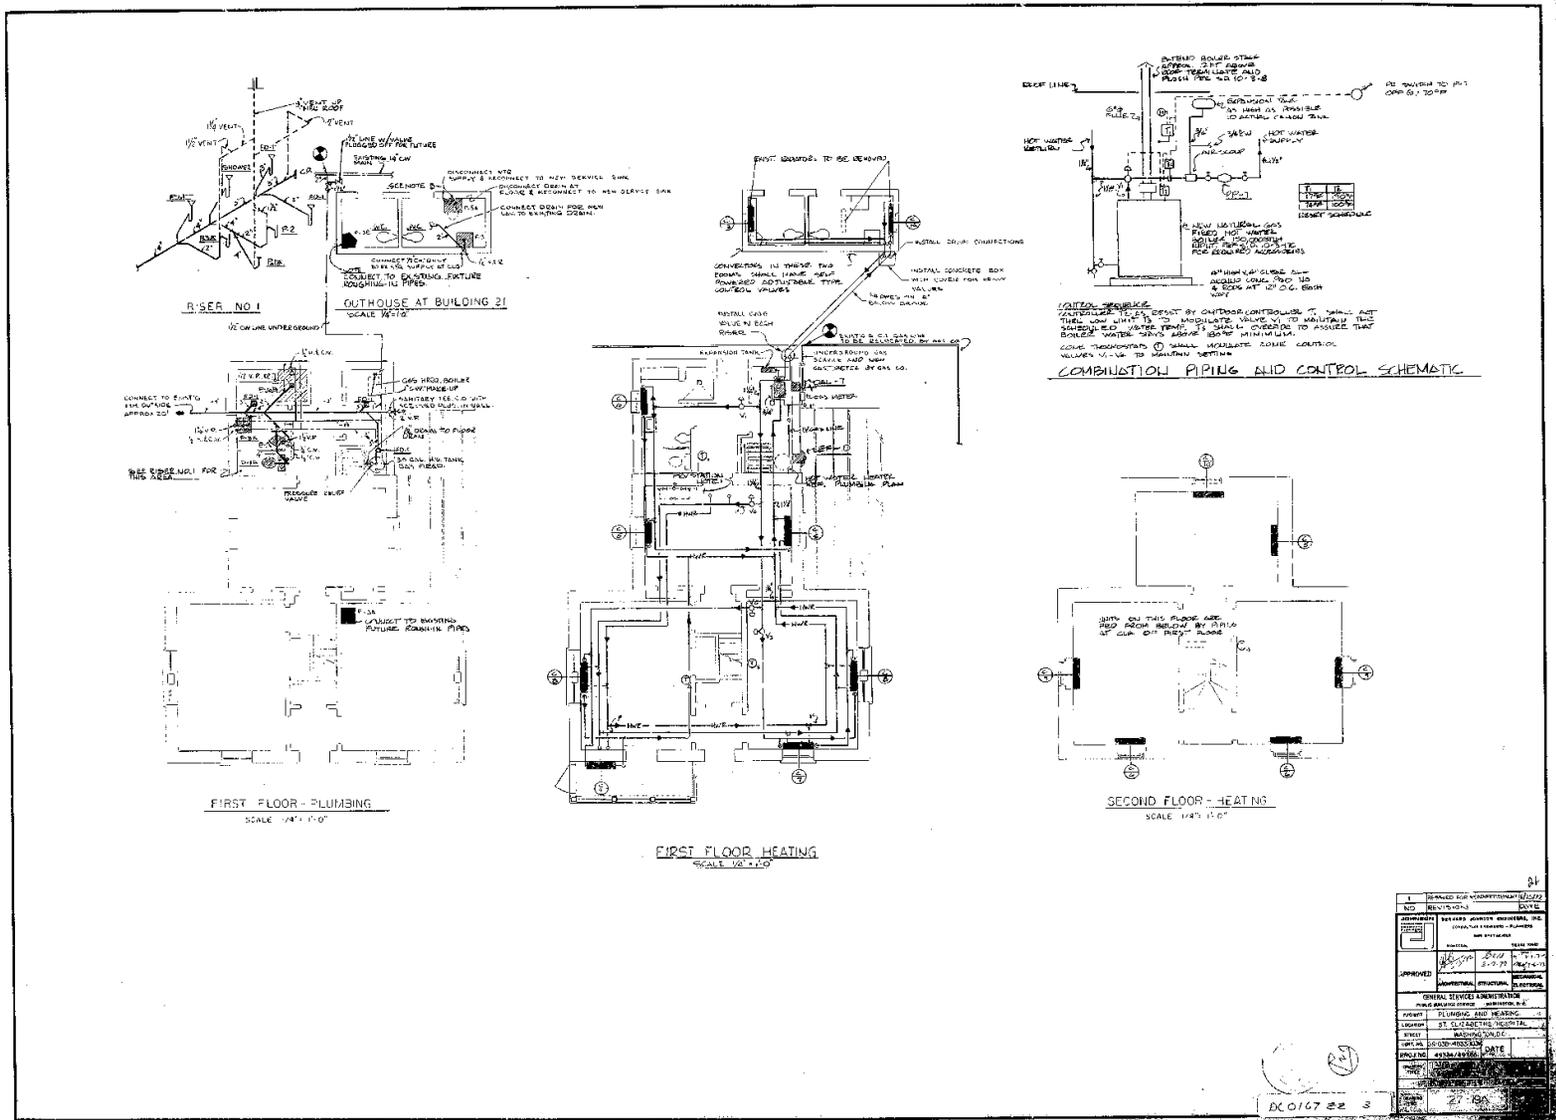
Figure 11. Source: General Services Administration, file DC0167SE0003, drawing dated 1972.
