ST. ELIZABETHS HOSPITAL, GREENHOUSES
(Building Nos. 20A-H)
2675-2689 Martin Luther King Jr. Avenue, Southeast
Washington
District of Columbia

HABS DC-349-AY
HABS DC-349-AY

ST. ELIZABETHS HOSPITAL, GREENHOUSES (BUILDING 20A–H)

HABS NO. DC-349-AY

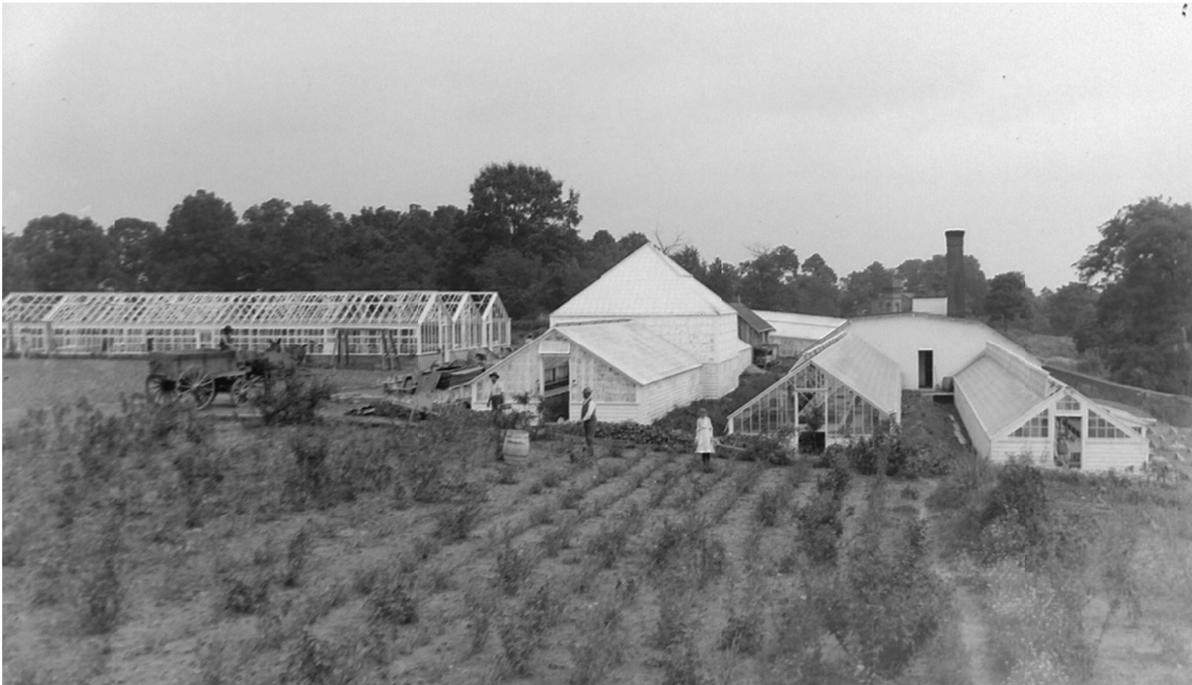
Figure 11. View from the south, 1903. Source: GSA archives, image DC1449SE0P004.

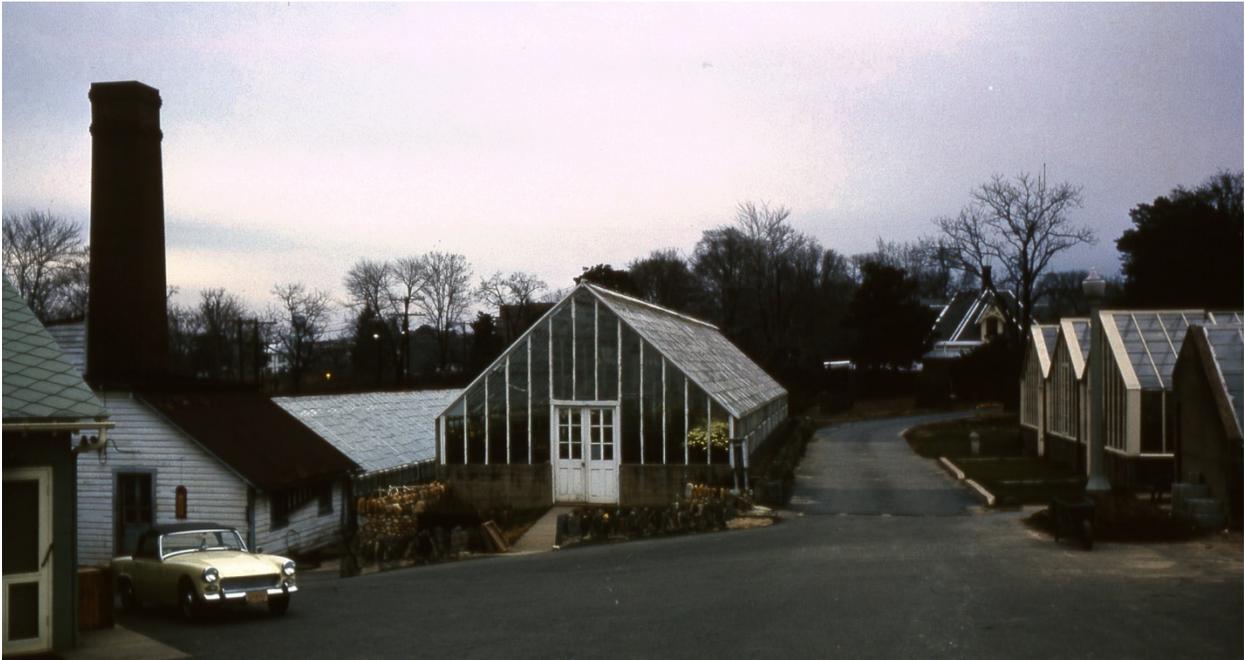
Figure 12. View from the north, 1964. Source: GSA archives, image DC1449SE0P013.

⁷ Based on comparison of 1955 aerial photograph and 1964 archival photograph (GSA archive database no. DC1449SE0P013).

¹⁷Based on comparison of 1955 aerial photograph and 1964 archival photograph (GSA archive database no. DC1449SE0P013).
