ST. ELIZABETHS HOSPITAL, STOREROOM
(Building No. 44)
2700 Martin Luther King Jr. Avenue, Southeast, Birch Street,
Southeast
Washington
District of Columbia

HABS DC-349-BB
HABS DC-349-BB

ST. ELIZABETHS HOSPITAL, OLD STOREROOM (BUILDING 44)

HABS NO. DC-349-BB

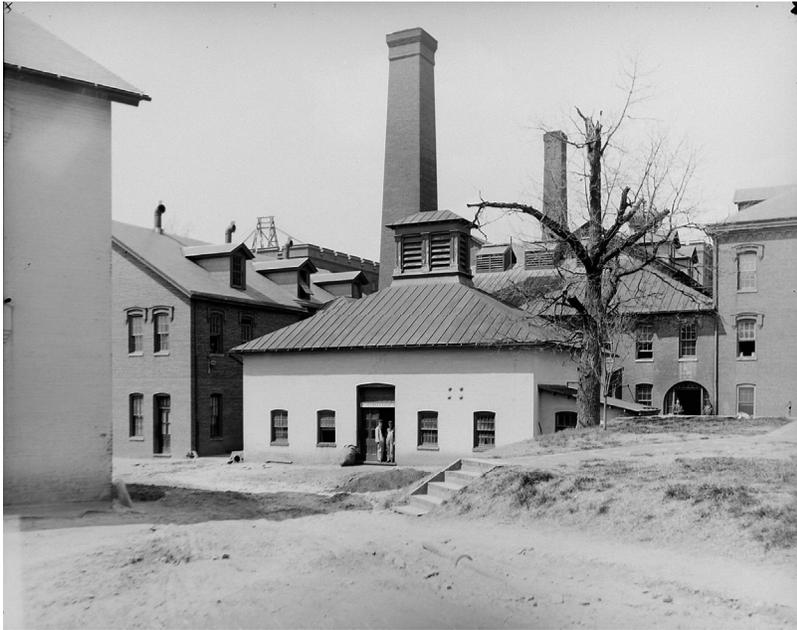
Figure 1. The boiler building that predated the Old Storeroom on this site, 1890s. Note the connection from the boiler building to the underground fuel vault, at right in this view. A portion of the brick fuel vault still exists, connected to the Old Storeroom basement. Source: GSA archives, image DC1336SE0P004.

The foundation vault is connected to the southeast corner of the building, beyond the footprint of the upper levels. This vault is apparently a fuel storage bunker associated with the boiler building that stood on the site of the Old Storeroom in the nineteenth century. The vault is approximately 38 feet wide (north-south) by 40 feet long and is constructed with brick masonry columns that are approximately 22 inches square. The columns support an arcade that in turn carries a series of four barrel vaults that are approximately 12 feet tall near their mid-spans. This vault area is accessible via the basement and an exterior stair located to the south of the building.

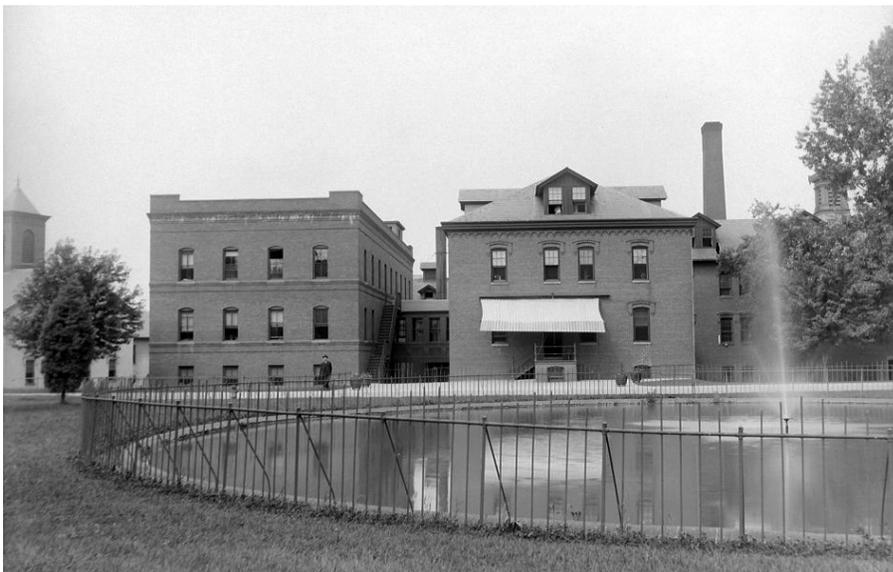
Figure 2. View of the east elevation of the Old Storeroom (on the left) and General Kitchen (on the right), 1905. Source: GSA archives, image DC1458SE0P002.

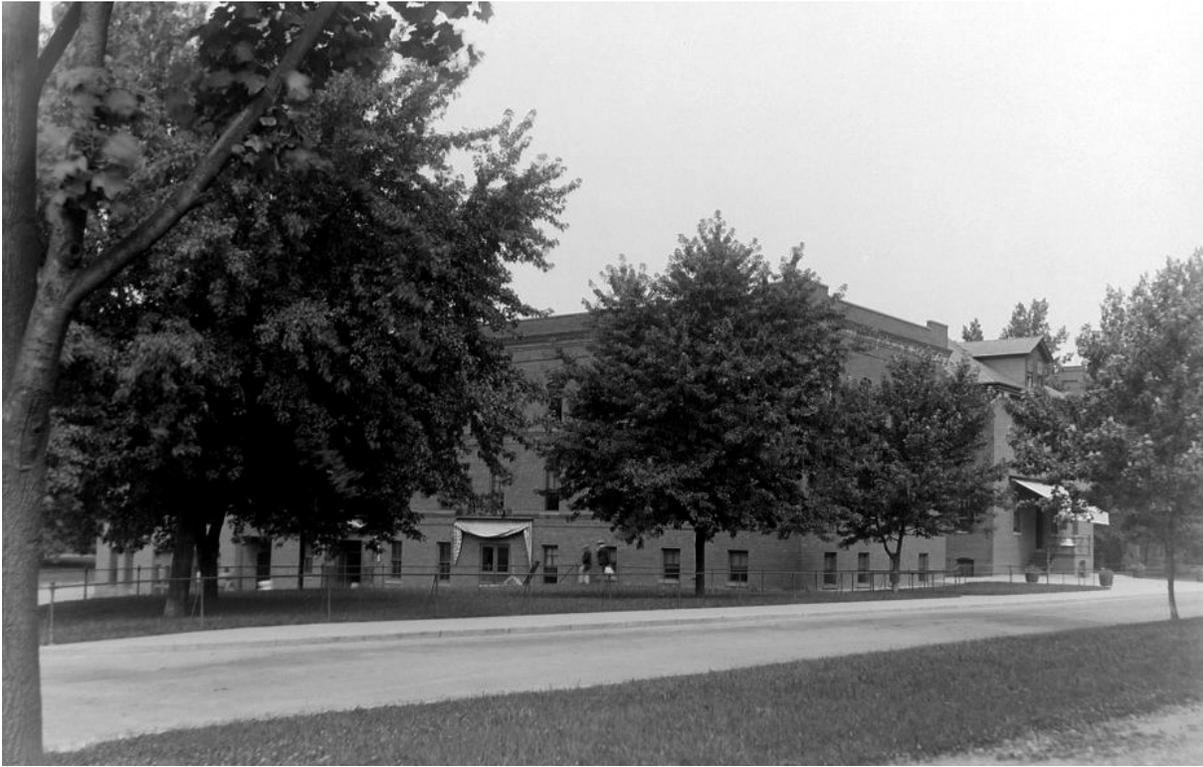
Figure 3. South elevation of the Old Storeroom, 1907. Source: GSA archives, image DC1458SE0P003.

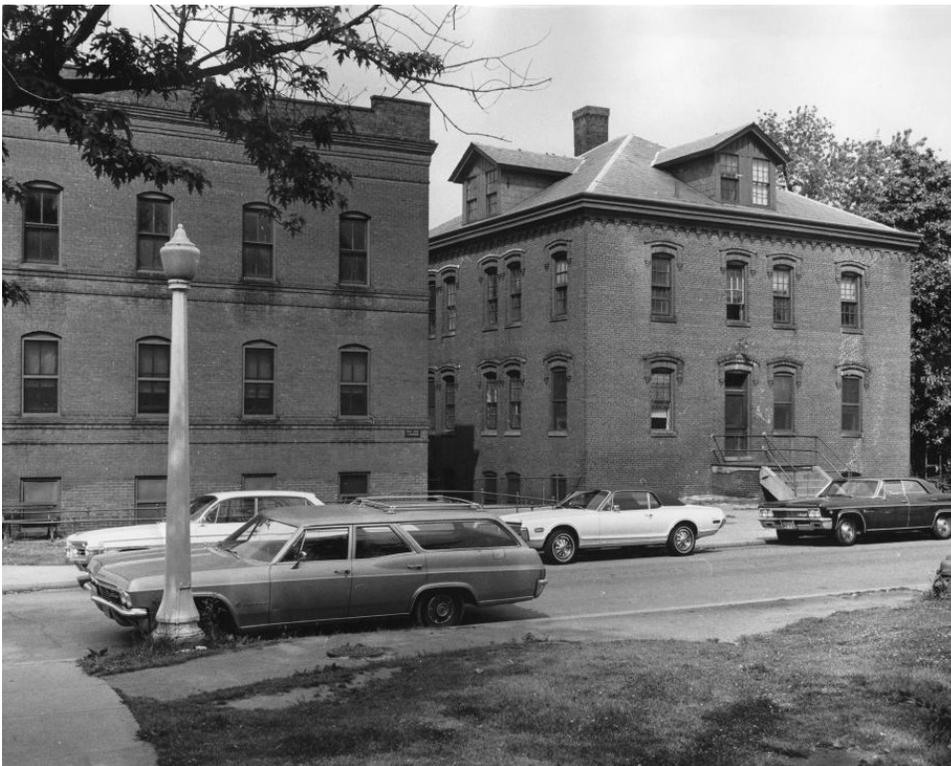
Figure 4. East facade of the Old Storeroom (on the left) and General Bakery (on the right), 1968. Source: GSA archives, image DC1458SE0P001.

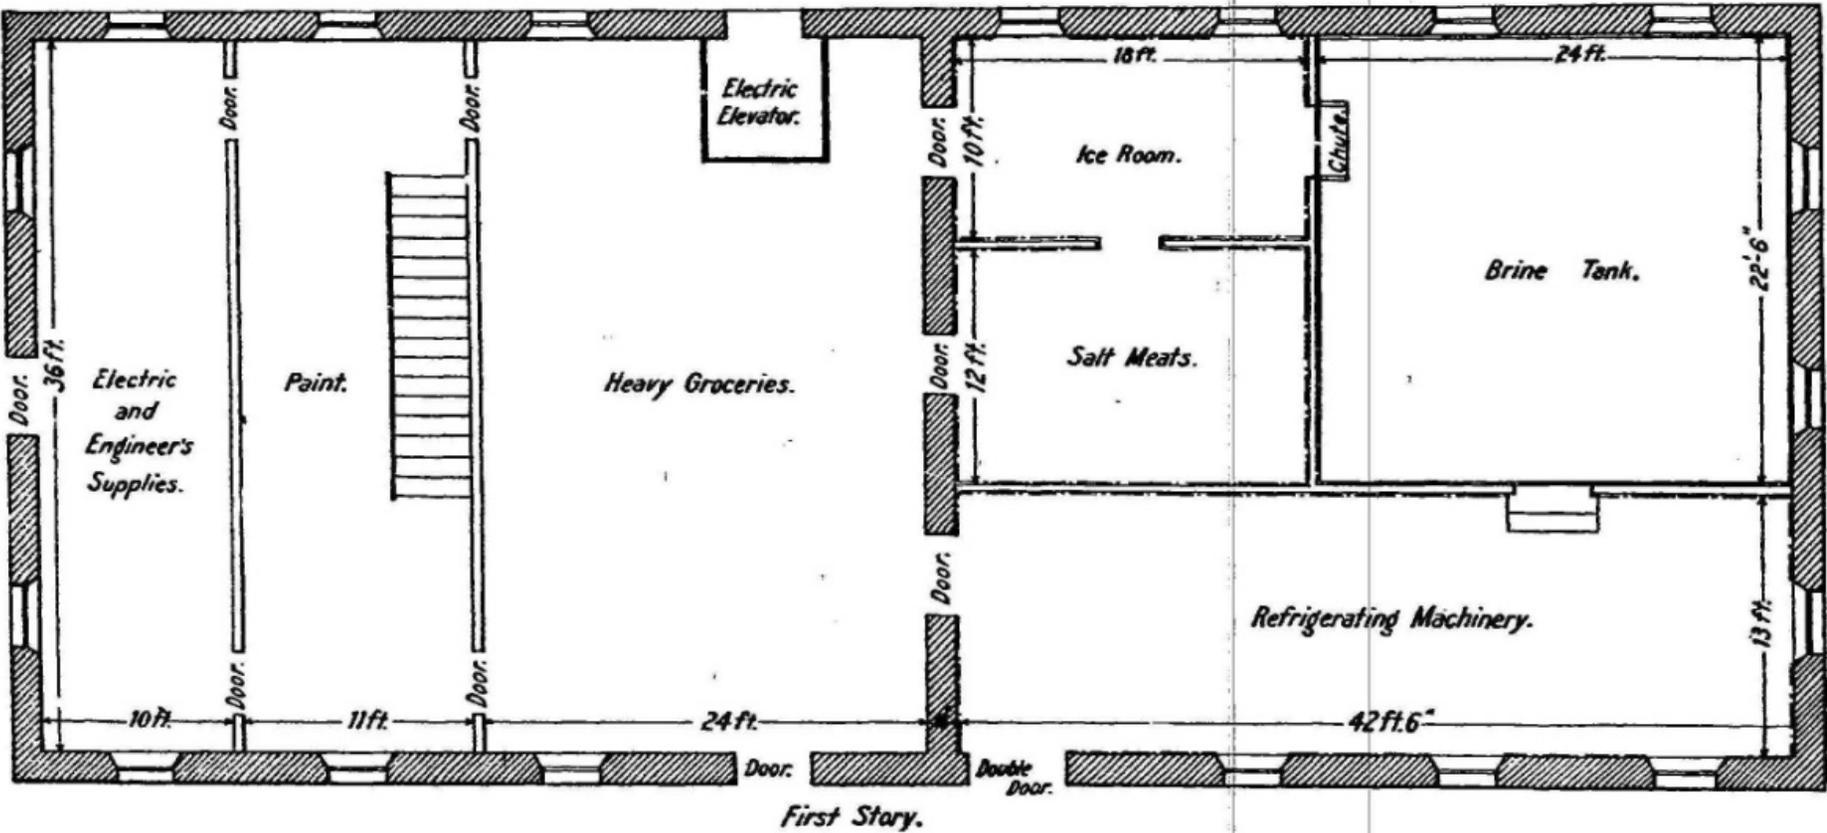
PROPOSED STOREHOUSE AND REFRIGERATING APPARATUS.

Figure 5. Original first floor plan of the Old Storeroom as it appeared in the 1899 Annual Report.

4. Builder, contractor, suppliers: Not known
5. Original plans and construction: The Old Storeroom was constructed as a three-story brick building with a rectangular plan, basement, and flat roof. It was situated adjacent to the General Kitchen and Bakery buildings. Two enclosed connecting corridors linked the Old Storeroom to the General Kitchen at the second floor level, one on the west and one on the north elevation.⁷ The connecting links had tin-covered gable roofs, double-hung windows, and paneled metal cladding.⁸ An exterior cast iron stair was located along the north elevation. It provided access from ground level to entrances on the second and third floors.⁹ The first and second floors were divided in half by brick partition walls, with each half having a distinct function relating to storage and support of the neighboring General Kitchen and Bakery buildings. The third floor was divided into thirds and provided separate workspaces for male workers, female workers, and dry goods storage.

1. Floor plans: The interior of the Old Storeroom has three floors and a basement. The first floor originally consisted of two large rooms separated by a dividing wall. The west room has been divided by a concrete masonry partition into two spaces, while the east room has been subdivided by masonry and plaster partitions into numerous smaller storage spaces and a bathroom. The second floor has two distinct areas. The east portion is divided by a double-loaded corridor running north-south that provides access to office, classroom, and restroom spaces. These spaces were apparently created by new partitions constructed in 1972. The west portion of the second

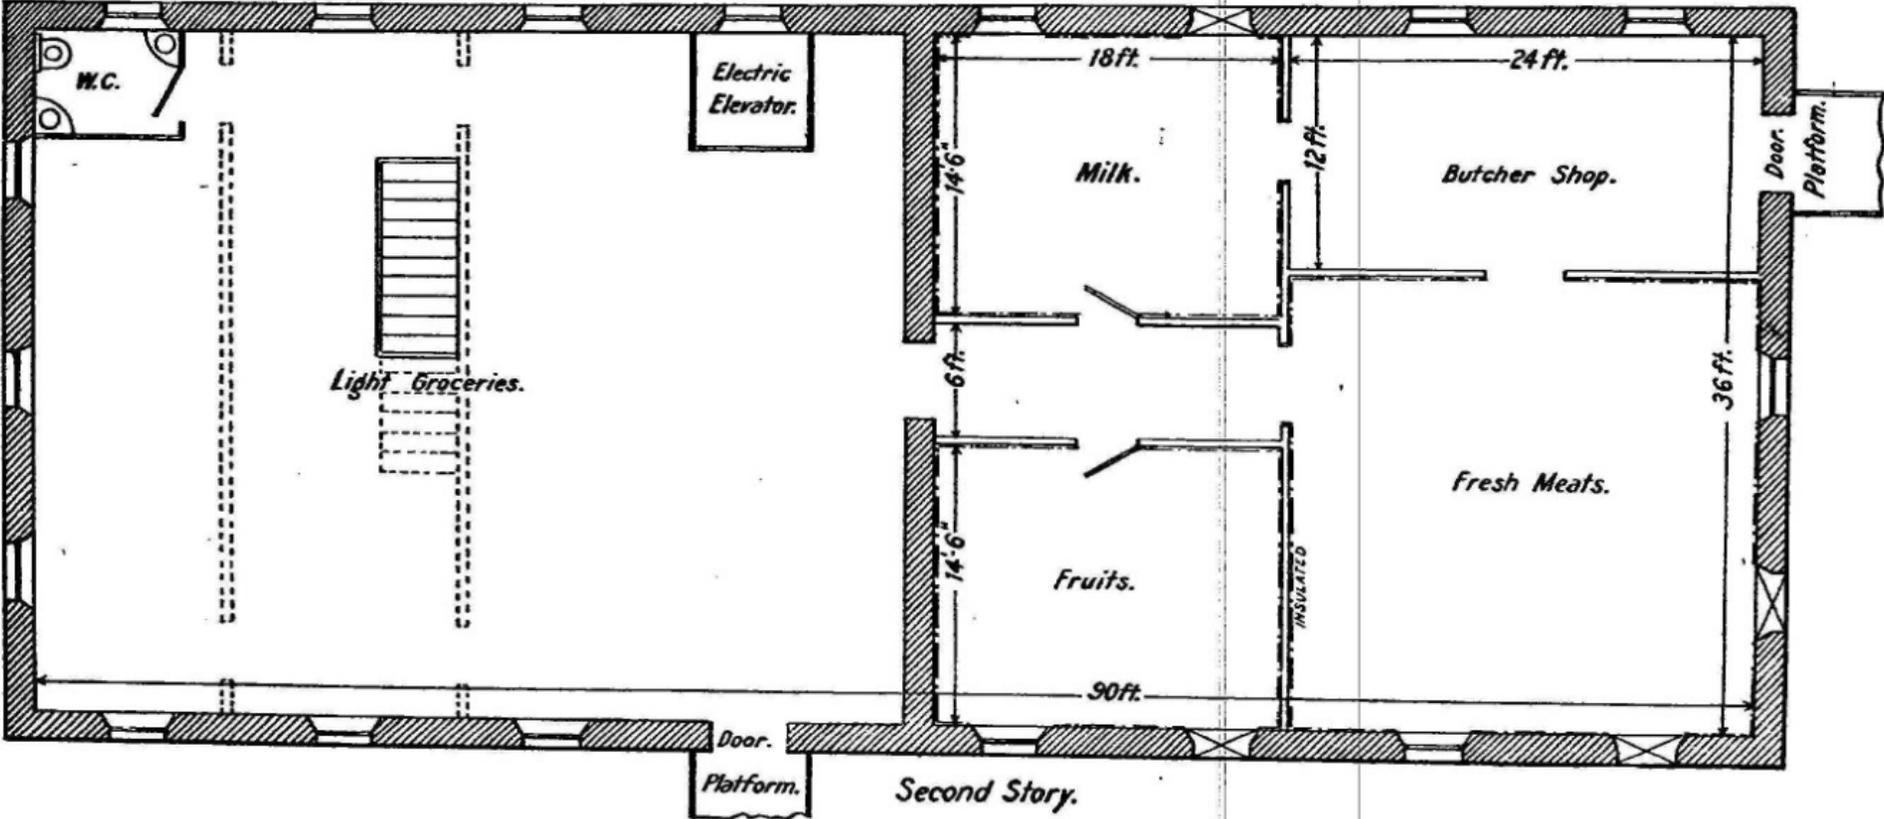
Figure 6. Original second floor plan for the Old Storeroom as it appeared in the 1899 Annual Report.

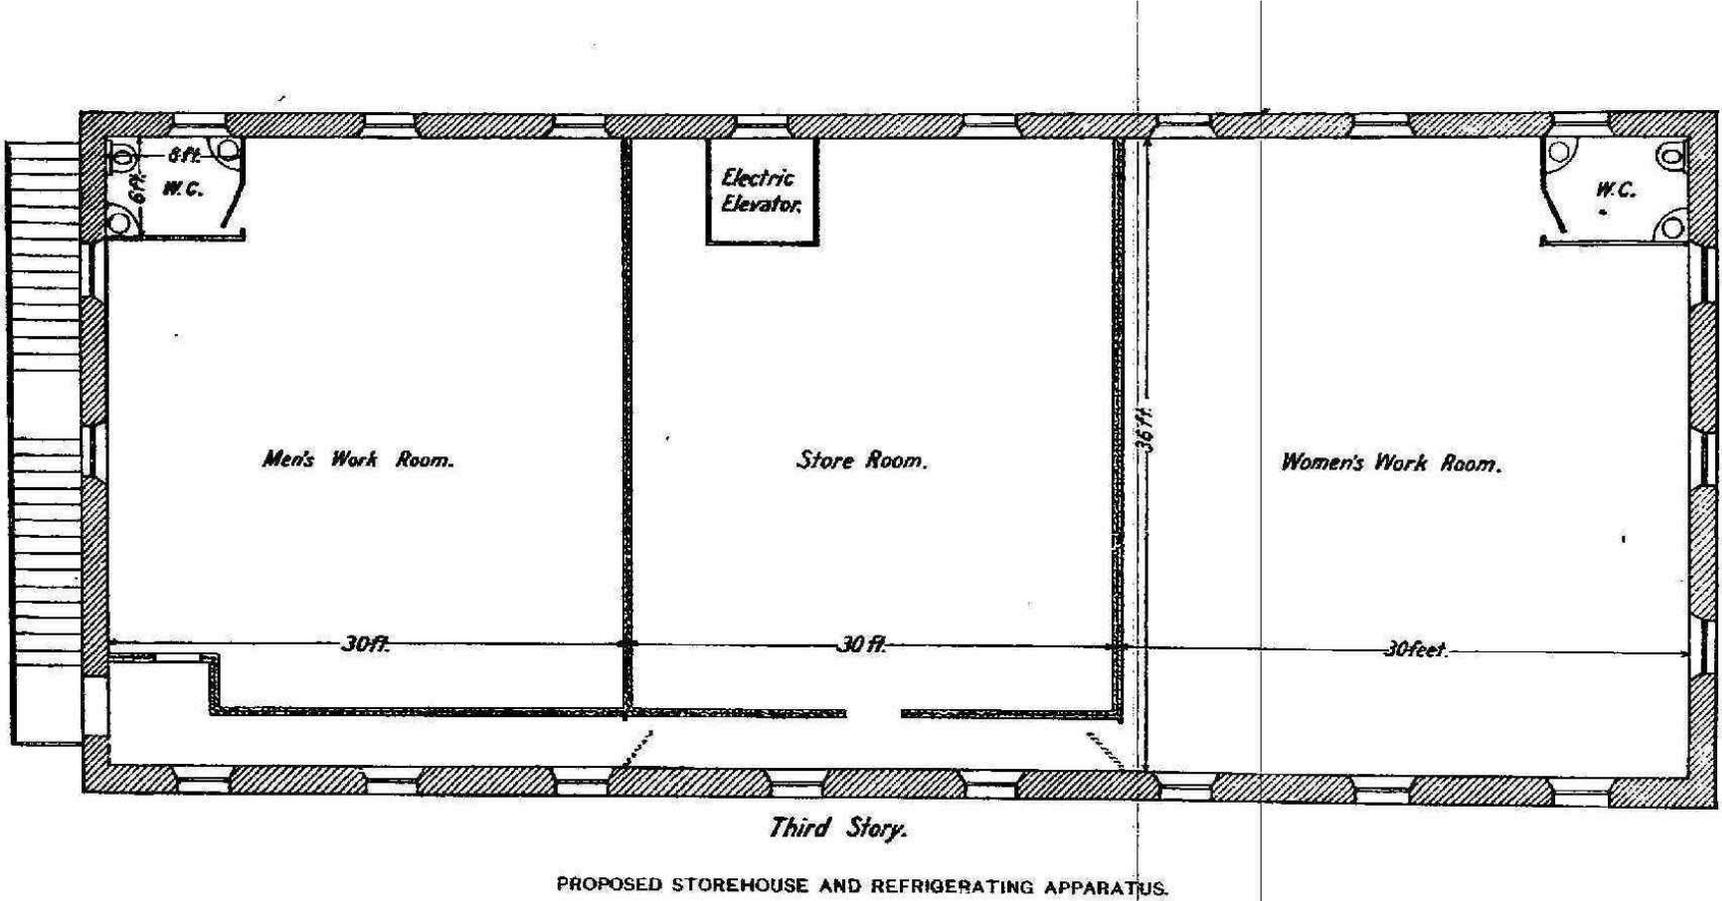
Figure 7. Original third floor plan for the Old Storeroom as it appeared in the 1899 Annual Report.

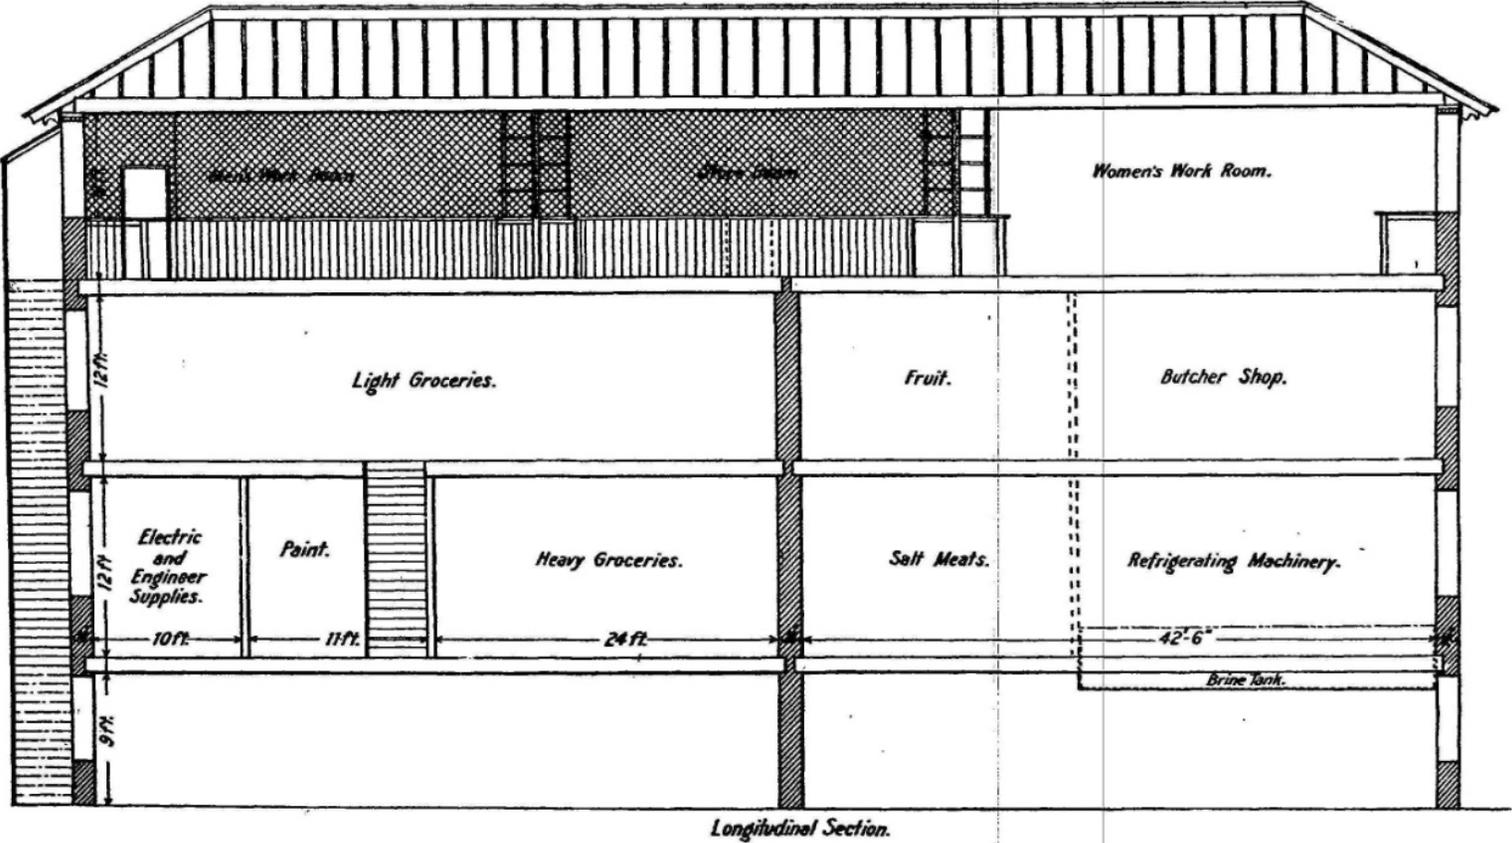
Figure 8. Longitudinal section of the Old Storeroom. Obtained from the 1899 Annual Report.

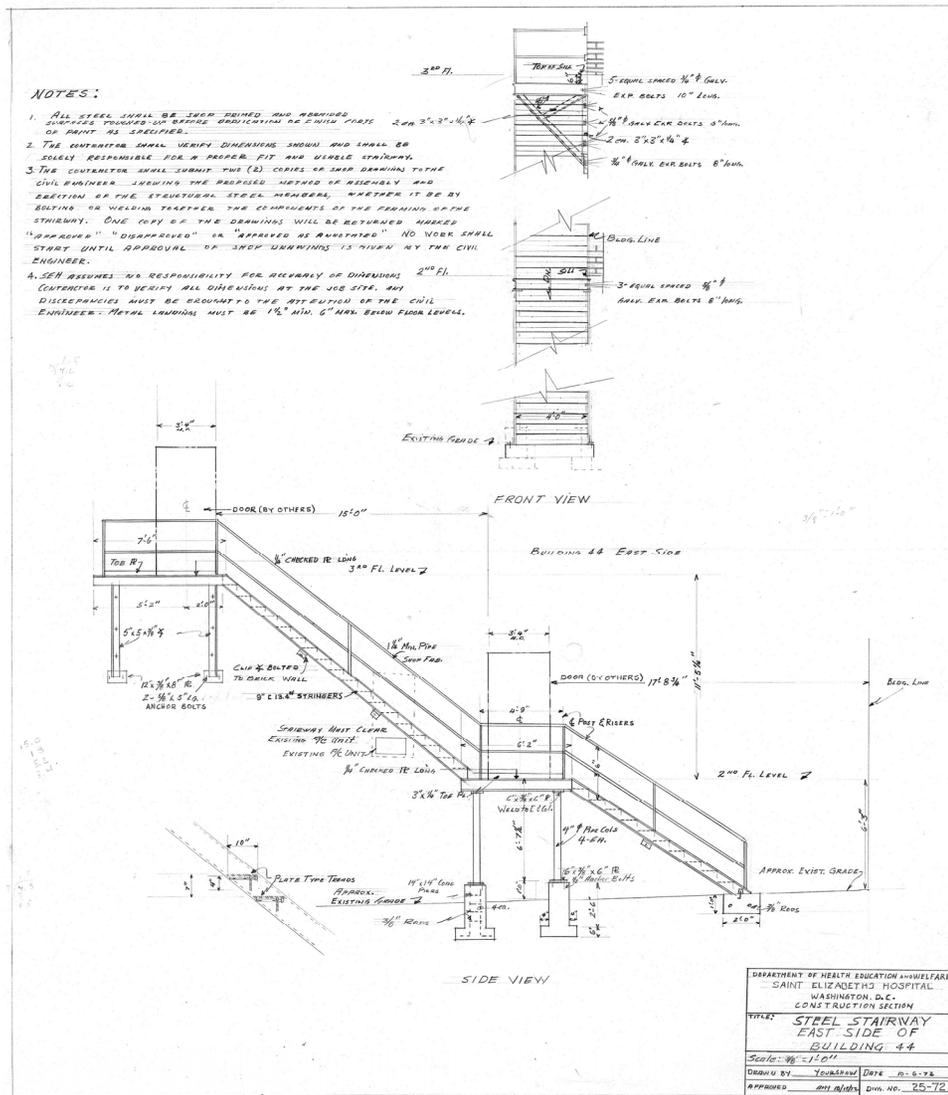
Figure 9. Construction drawings for the addition of the south facade exterior stairway, 1972. Source: GSA archives, image DC1458SE0102.

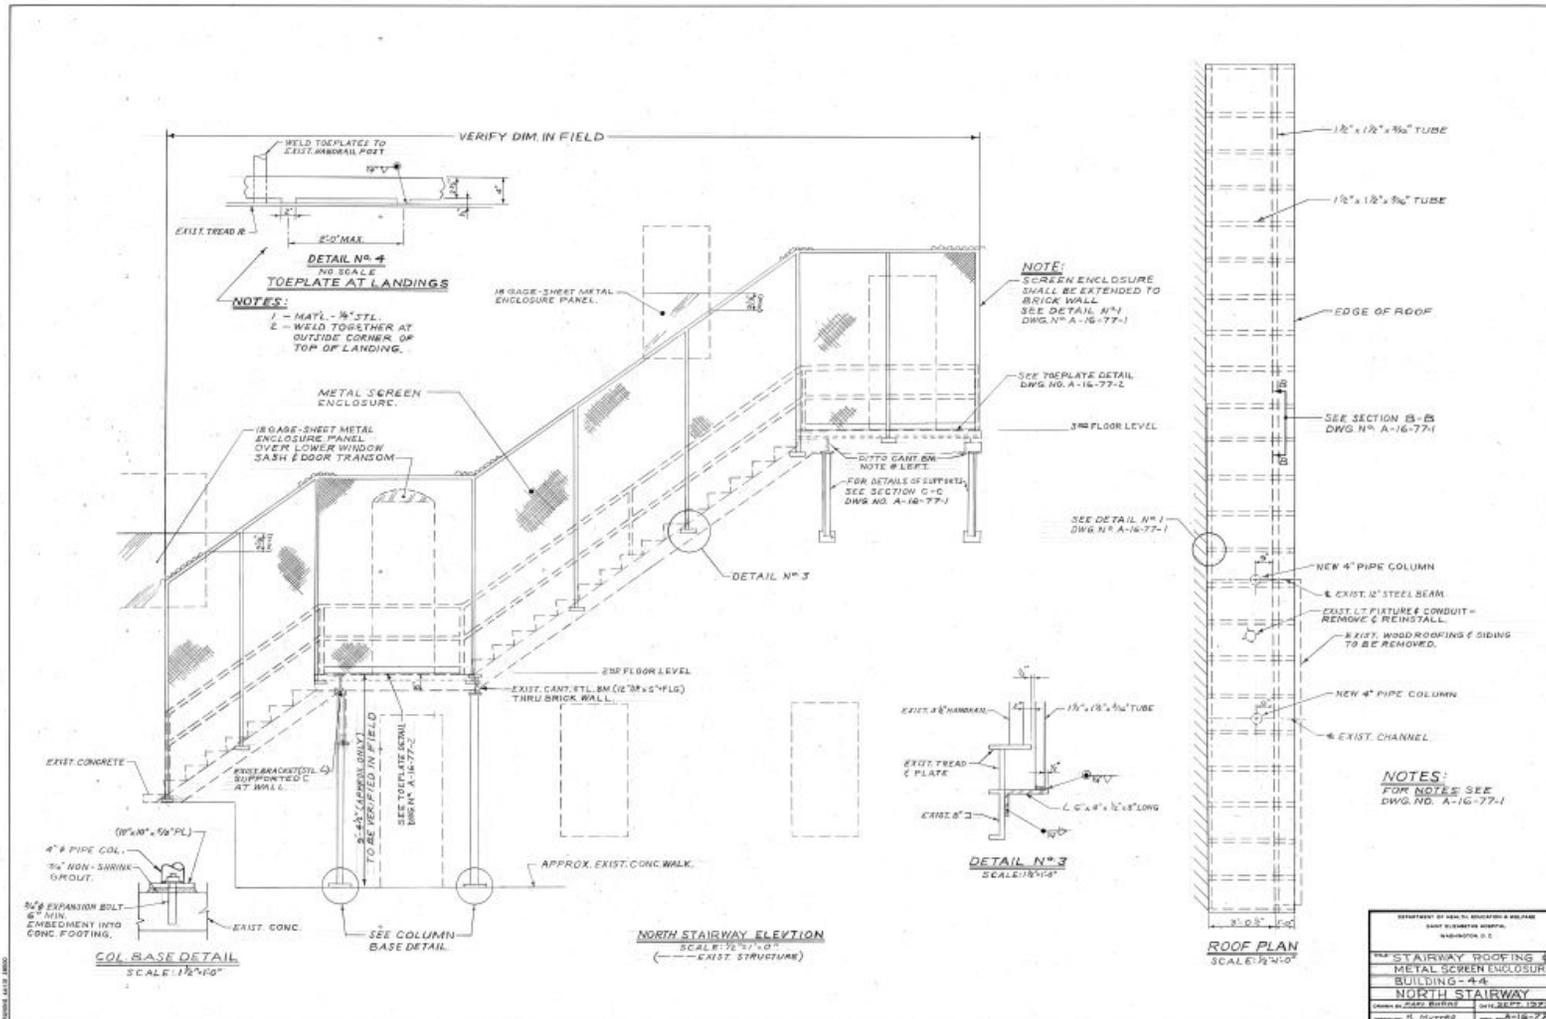
Figure 10. Construction drawings for the enclosure around the exterior stairway, 1977. A similar enclosure was added to the south stairway at the same time, as well as a ladder from the third floor stair landing to the roof. Source: GSA archives, image DC1458SE0100. See also GSA archives, image DC1458SE0101.

In 1977, alterations were made to the exterior steel fire stair, including the erection of a metal screen enclosure and sheet metal roofing.¹¹
