CAPE CANAVERAL AIR FORCE STATION, LAUNCH COMPLEX 39,  
ROTATION PROCESSING & SURGE FACILITY  
(John F. Kennedy Space Center)  
Launcher Road, north of the Vehicle Assembly Building  
Cape Canaveral vicinity  
Brevard County  
Florida

HAER FL-8-11-G  
*HAER FL-8-11-G*

CAPE CANAVERAL AIR FORCE STATION,  
LAUNCH COMPLEX 39,  
ROTATION PROCESSING & SURGE FACILITY

HAER NO. FL-8-11-G

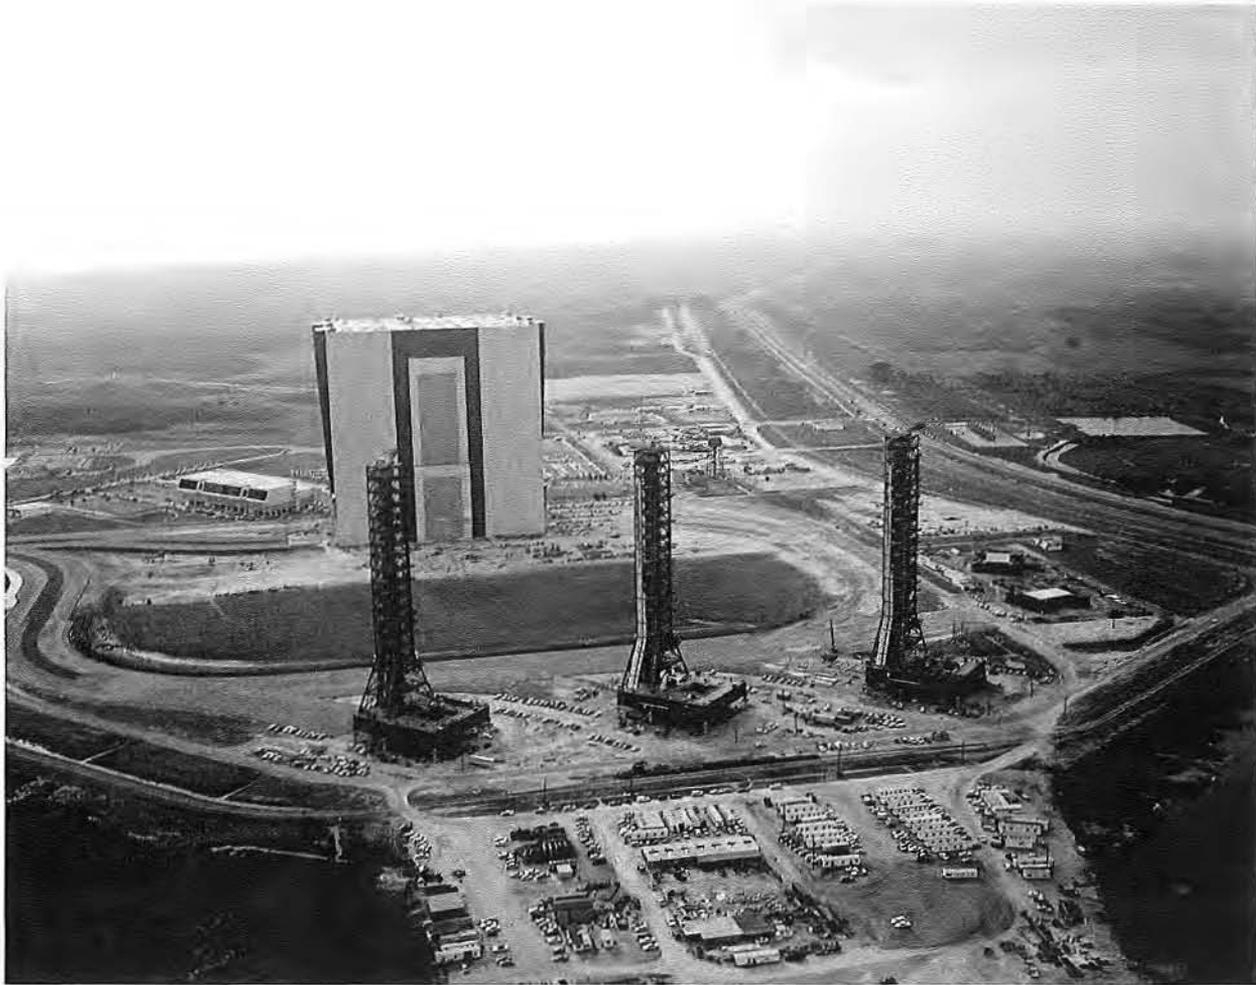
Aerial View of Proposed RPSF Area, Foreground, with VAB in Background, View to South, January 7, 1966 (Courtesy of Kennedy Space Center, Negative 100-KSC-66C-254).

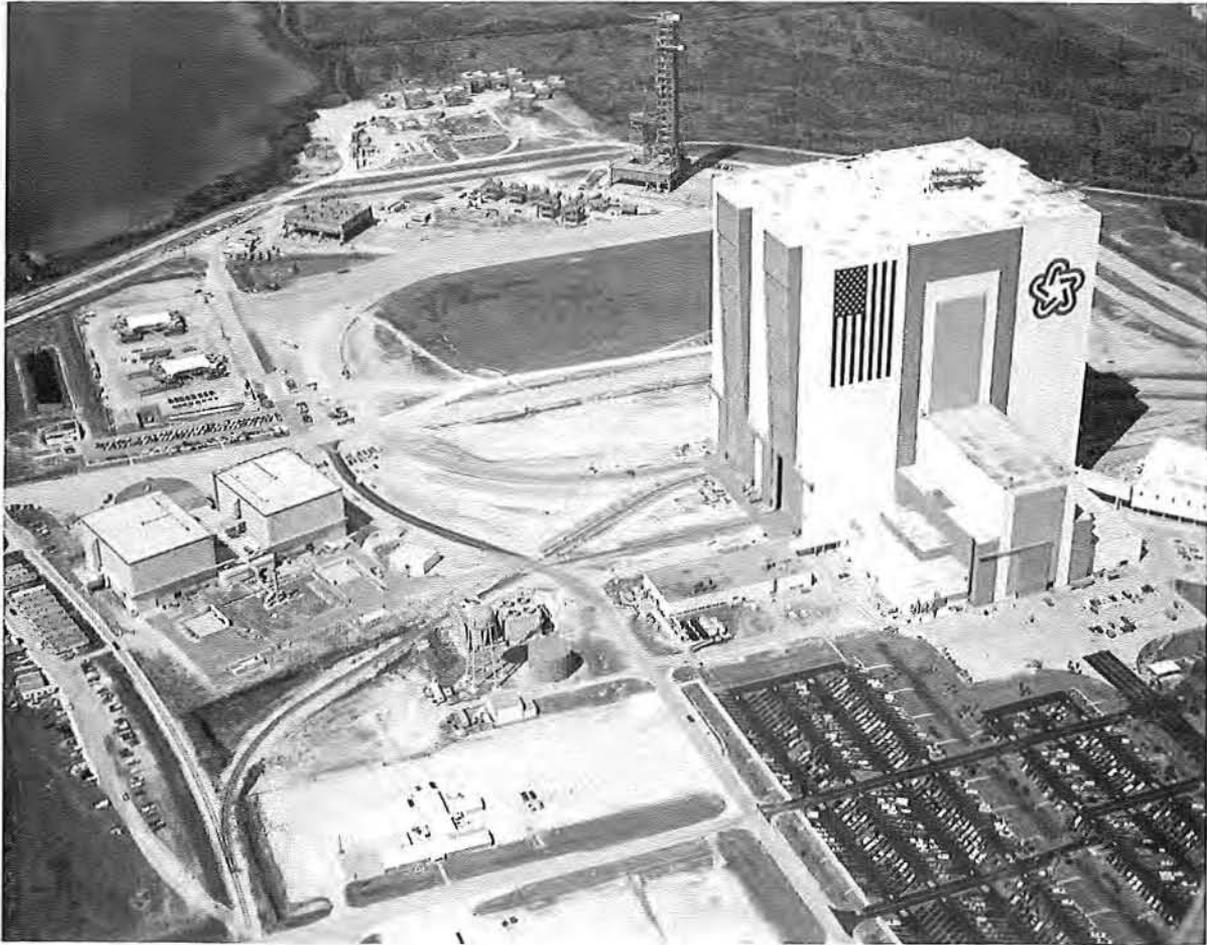
Aerial View of VAB Complex, with Proposed RPSF Area at Top of Photograph, View to North, March 21, 1979 (Courtesy of Kennedy Space Center, Negative 116-KSC-379C-267-8).

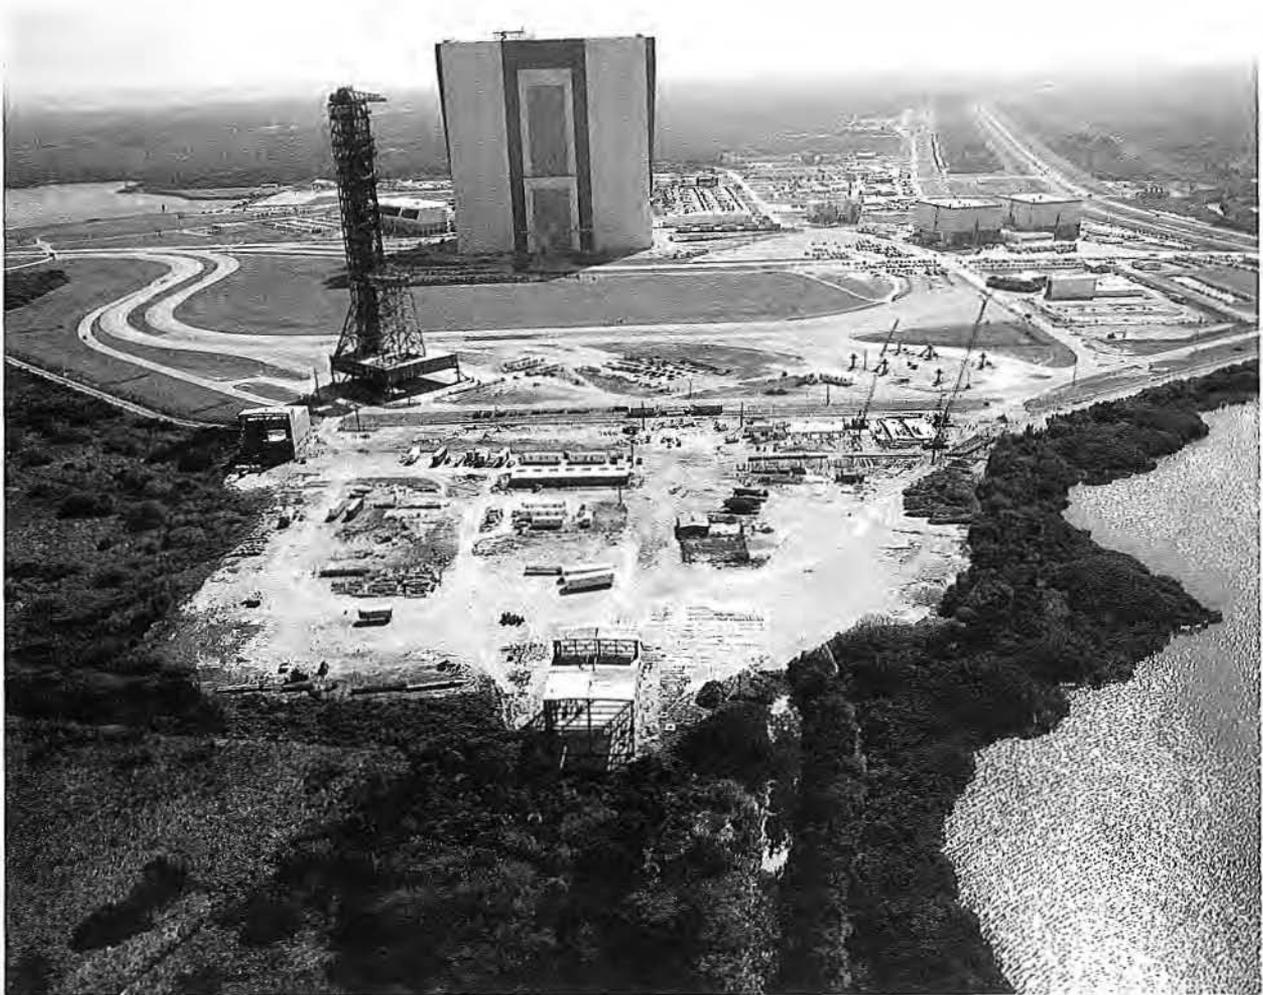
Aerial View of RPSF Complex Under Construction at Bottom of  
Photograph, View to South, February 8, 1983 (Courtesy of Kennedy  
Space Center, Negative 108-KSC-383C-267-20).

In the months that followed, the progress of the RPSF construction can be documented by a series of aerial photographs taken by NASA of the VAB area, dating from early February 1983, to June 1984. The aerial from February 8, 1983 illustrates the early progress made on the surge buildings. Their steel frames were standing and the roofs were in place, although the walls had not been installed. At the site of the main building, construction of the foundation was underway. Building K6-446, constructed prior to 1966, is standing in the middle of the site complex.<sup>39</sup>

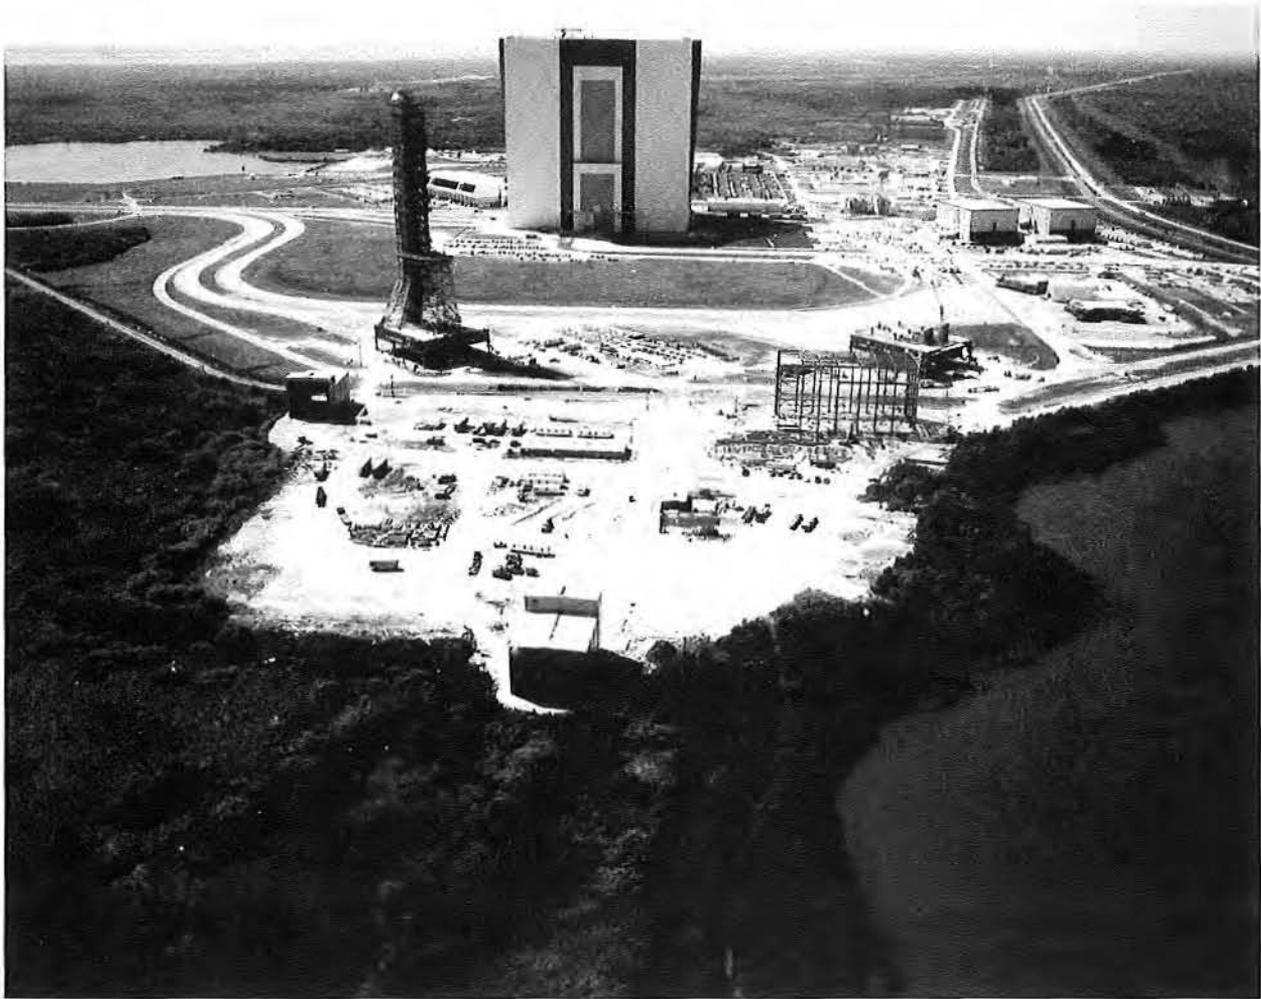
Aerial View of RPSF Complex Under Construction, Showing RPSF Steel Frame, View to South, April 21, 1983 (Courtesy of Kennedy Space Center, Negative 108-KSC-383C-1085-90).

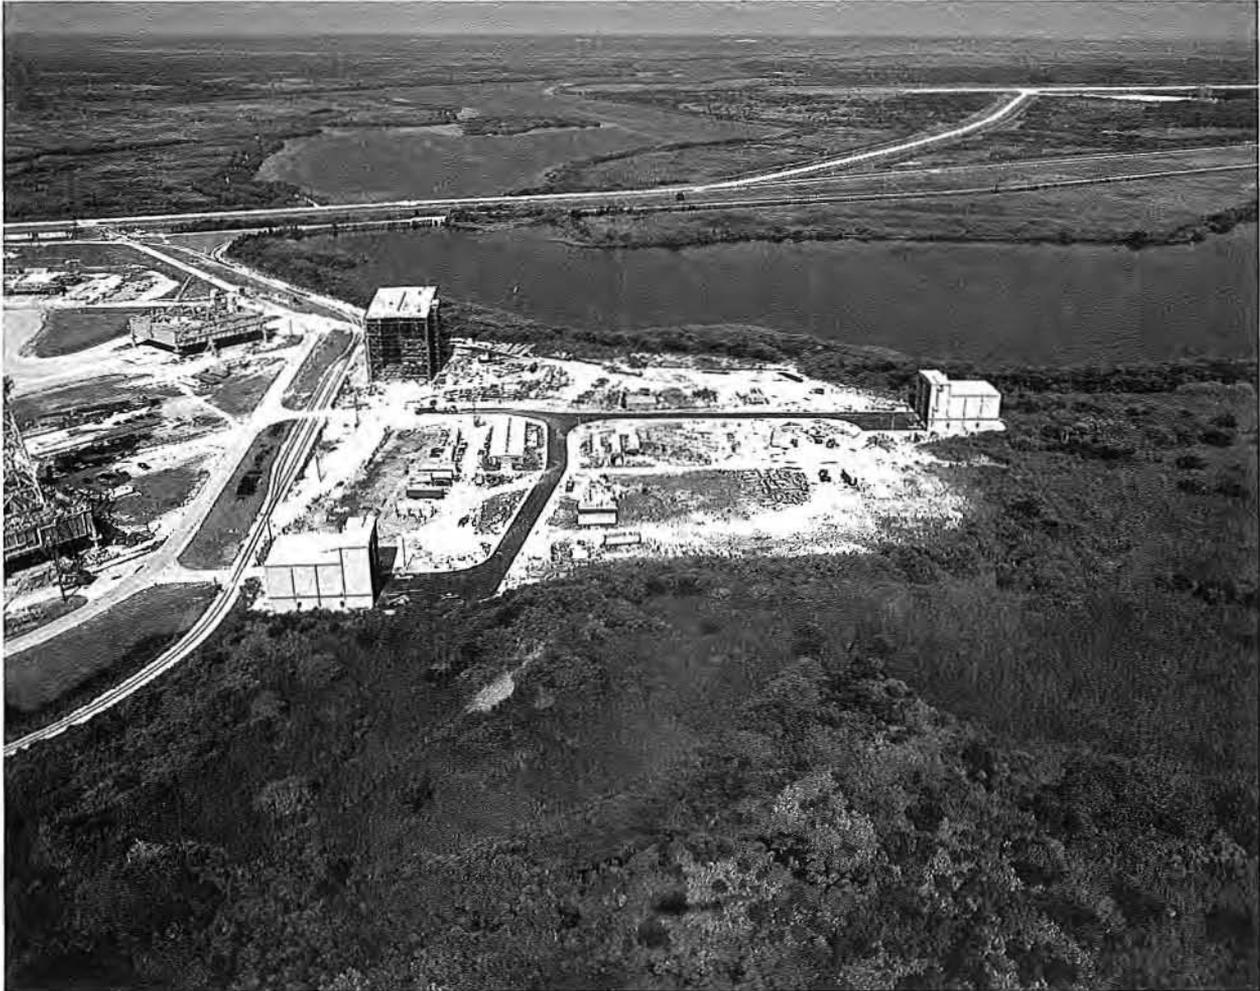
Aerial View of RPSF Complex Under Construction, View to West,  
July 5, 1983 (Courtesy of Kennedy Space Center, Negative 108-  
KSC-383C-2203-40).

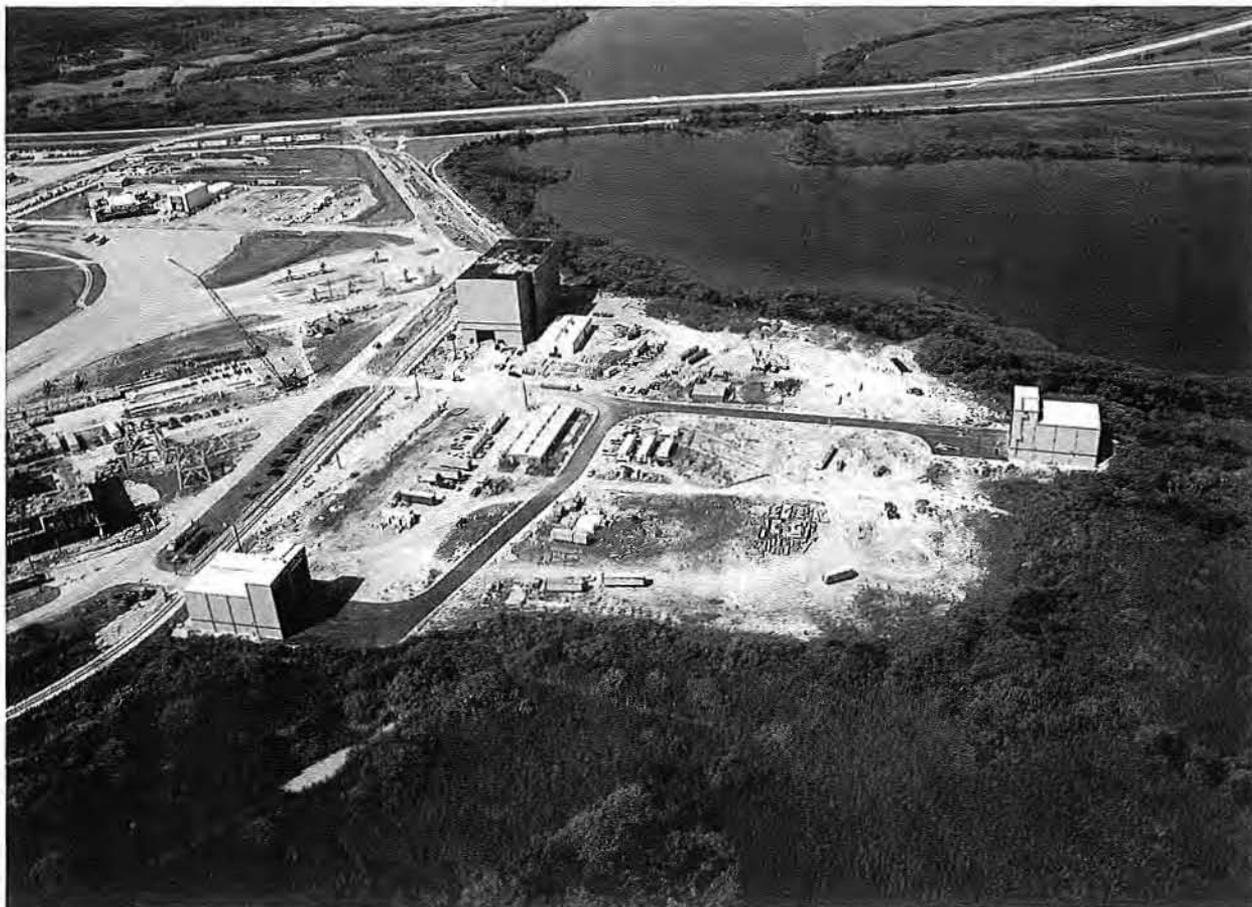
Aerial View of RPSF Complex Under Construction, View to West-Southwest, September 1, 1983 (Courtesy of Kennedy Space Center, Negative 116-KSC-383C-3090-30).

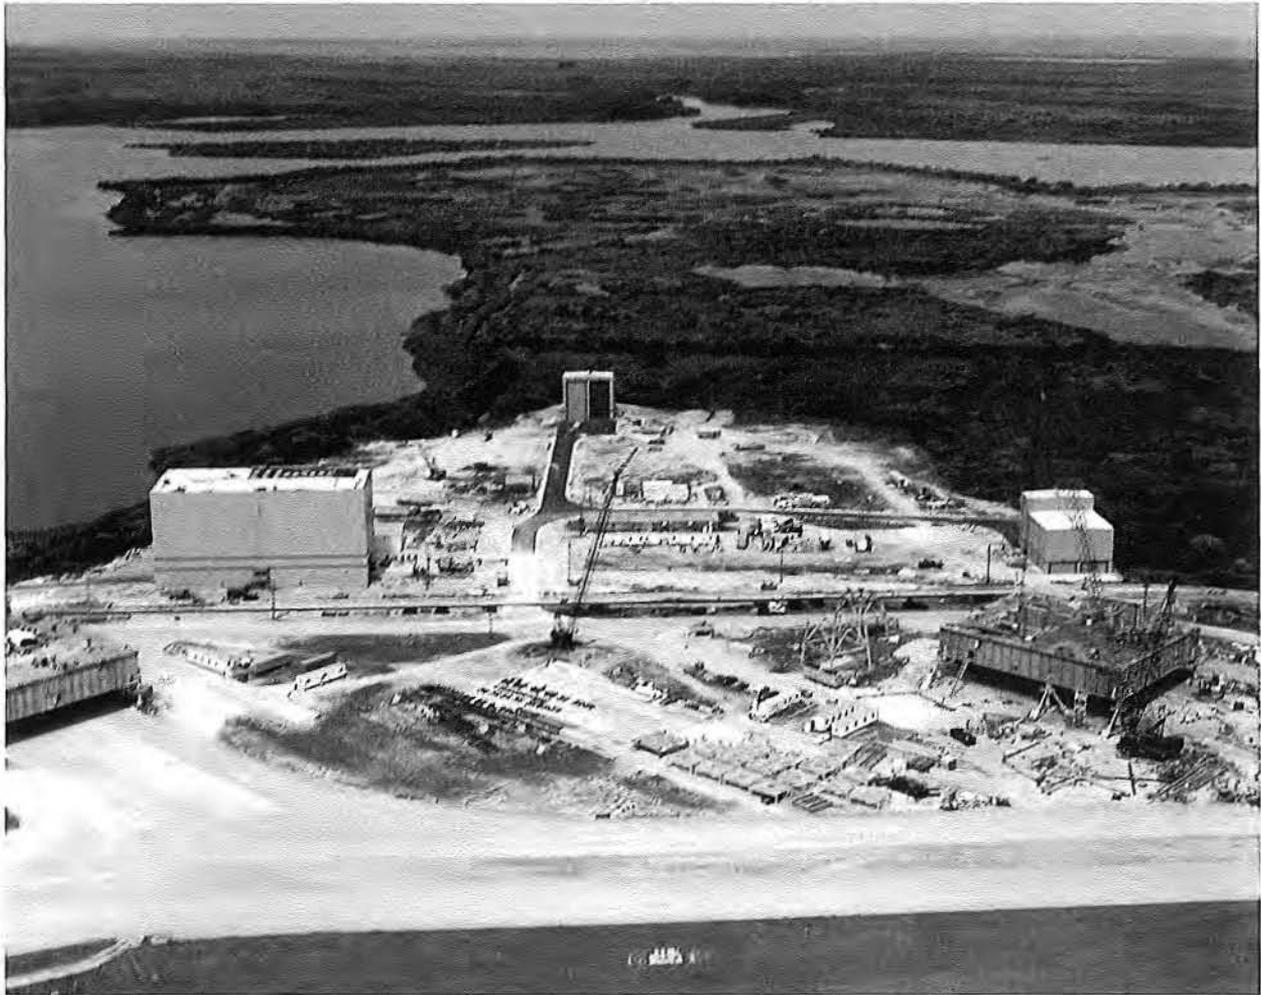
Aerial View of RPSF Complex Under Construction, View to North,  
October 3, 1983 (Courtesy of Kennedy Space Center, Negative 108-  
KSC-383C-3674-1).

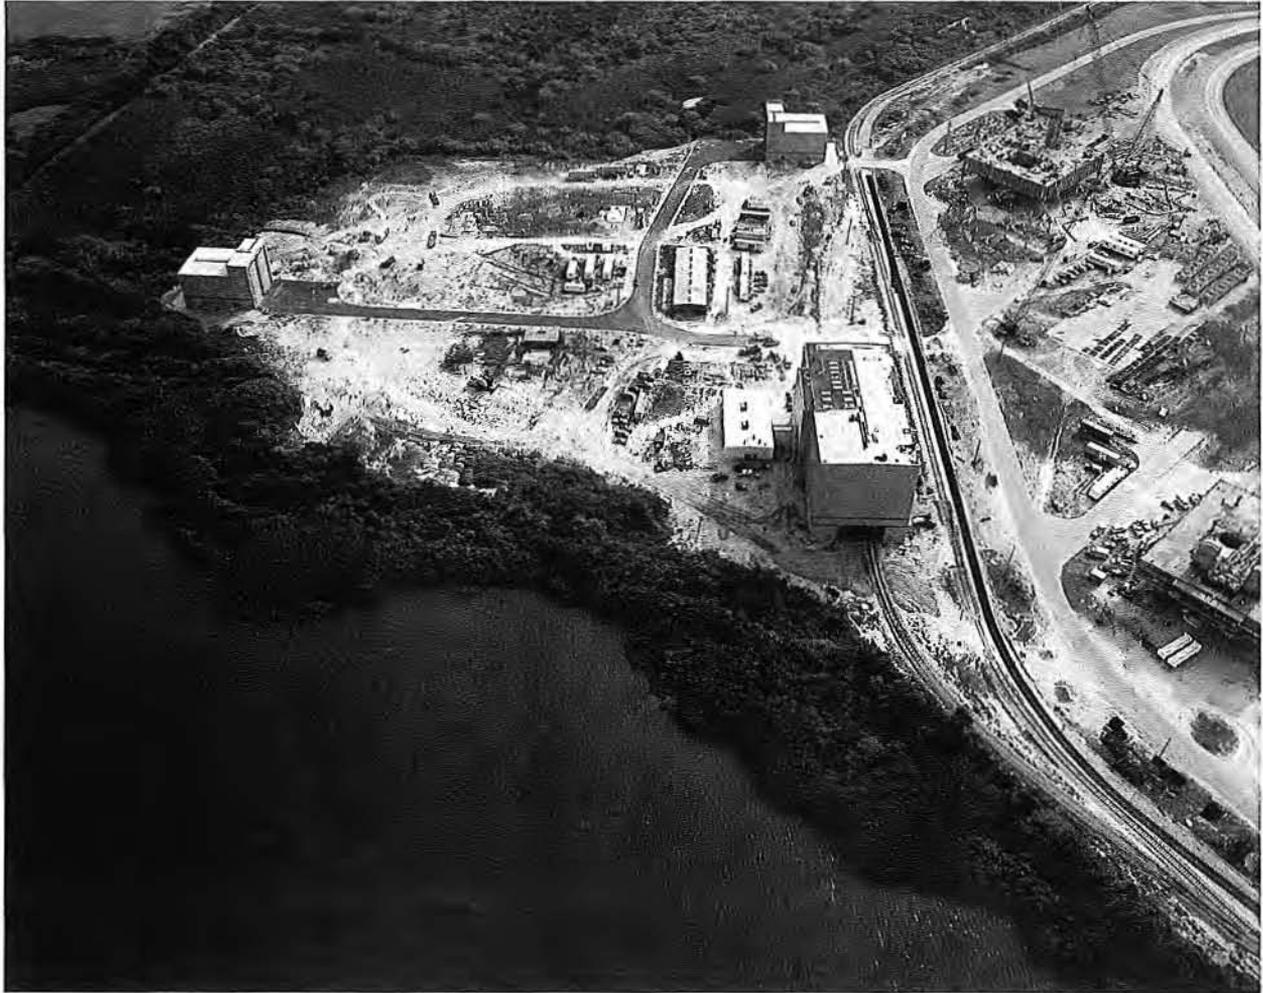
Aerial View of RPSF Complex Under Construction, View to East,  
October 4, 1983 (Courtesy of Kennedy Space Center, Negative 116-  
KSC-383C-3561-100).

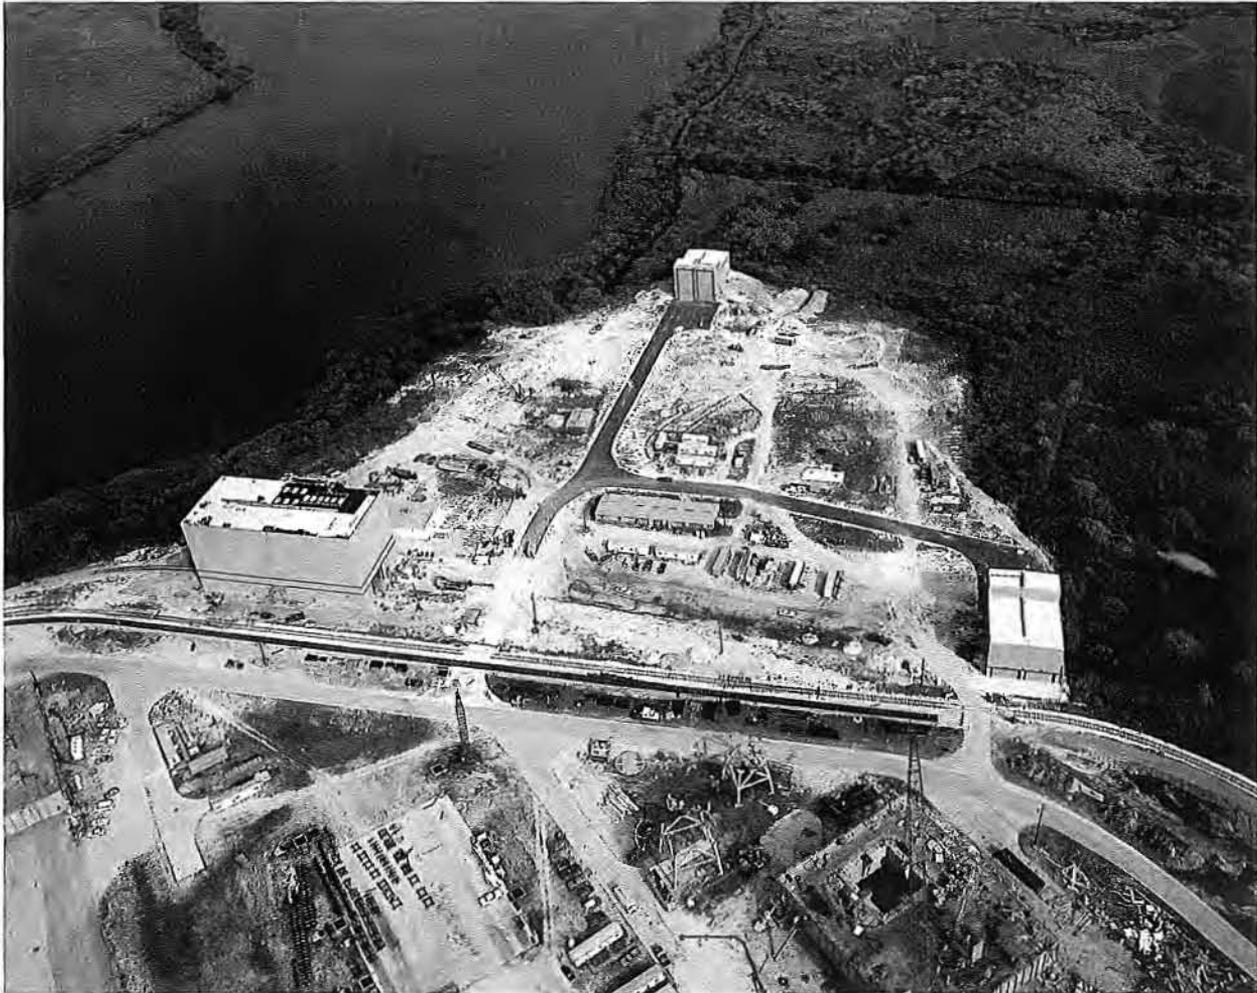
Aerial View of RPSF Complex Under Construction, View to North,  
October 4, 1983 (Courtesy of Kennedy Space Center, Negative 116-  
KSC-383C-3563-20).

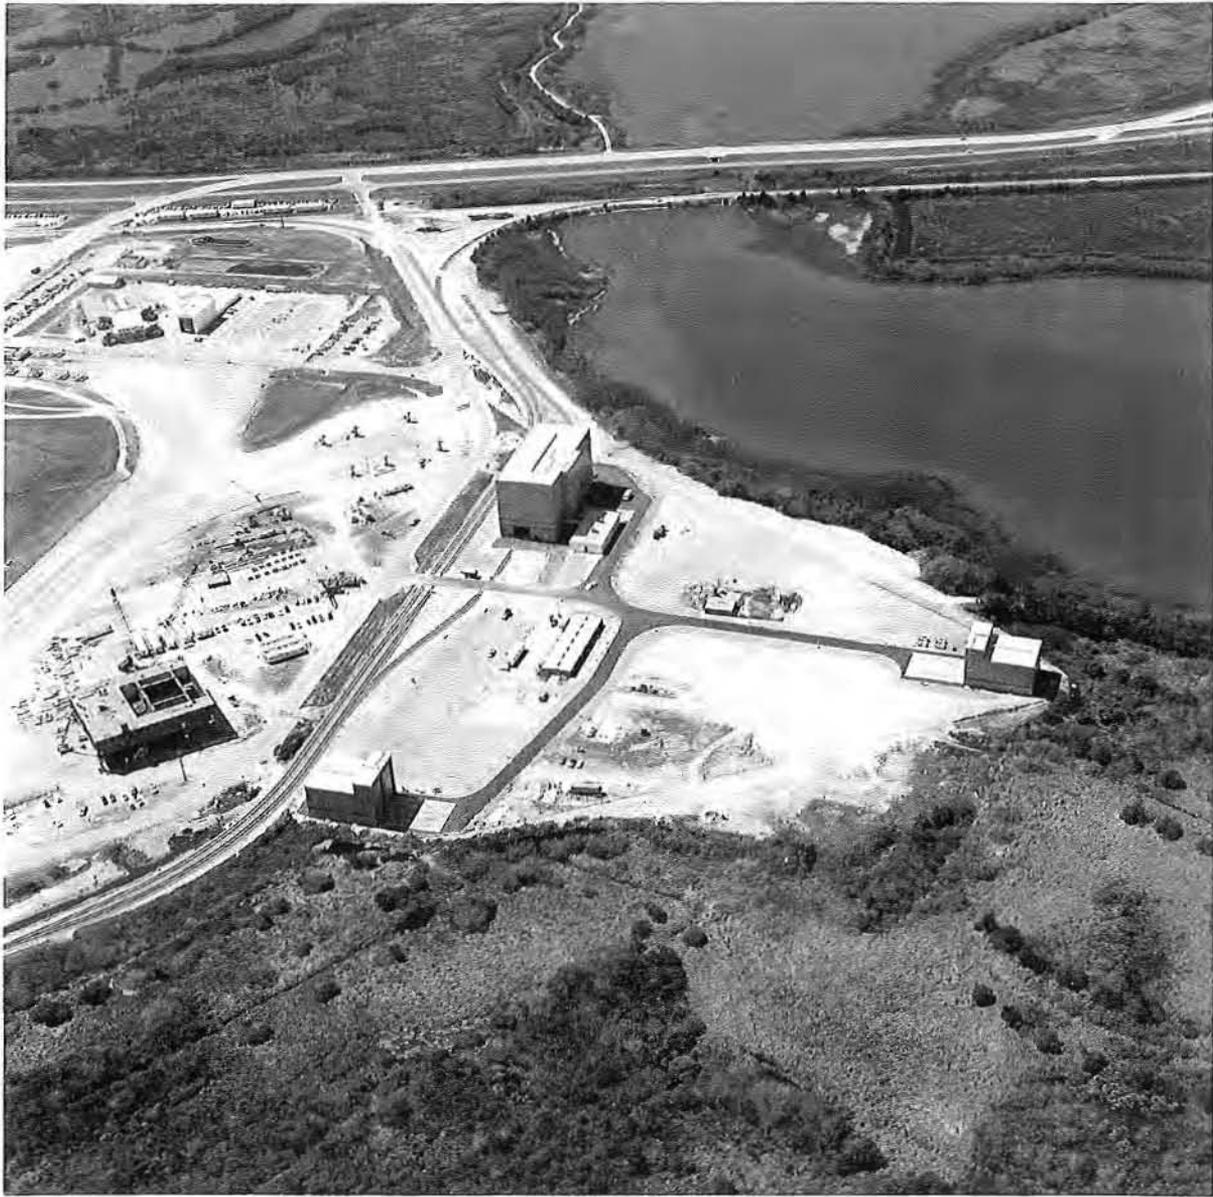
Aerial View of RPSF Complex, View to West, March 8, 1984  
(Courtesy of Kennedy Space Center, Negative 108-KSC-384C-1134-7).

By March 1984, it appeared that construction was basically completed, both inside and outside.<sup>44</sup> Photographic evidence corroborates the official completion date of the building's construction, given as 1984.<sup>45</sup>

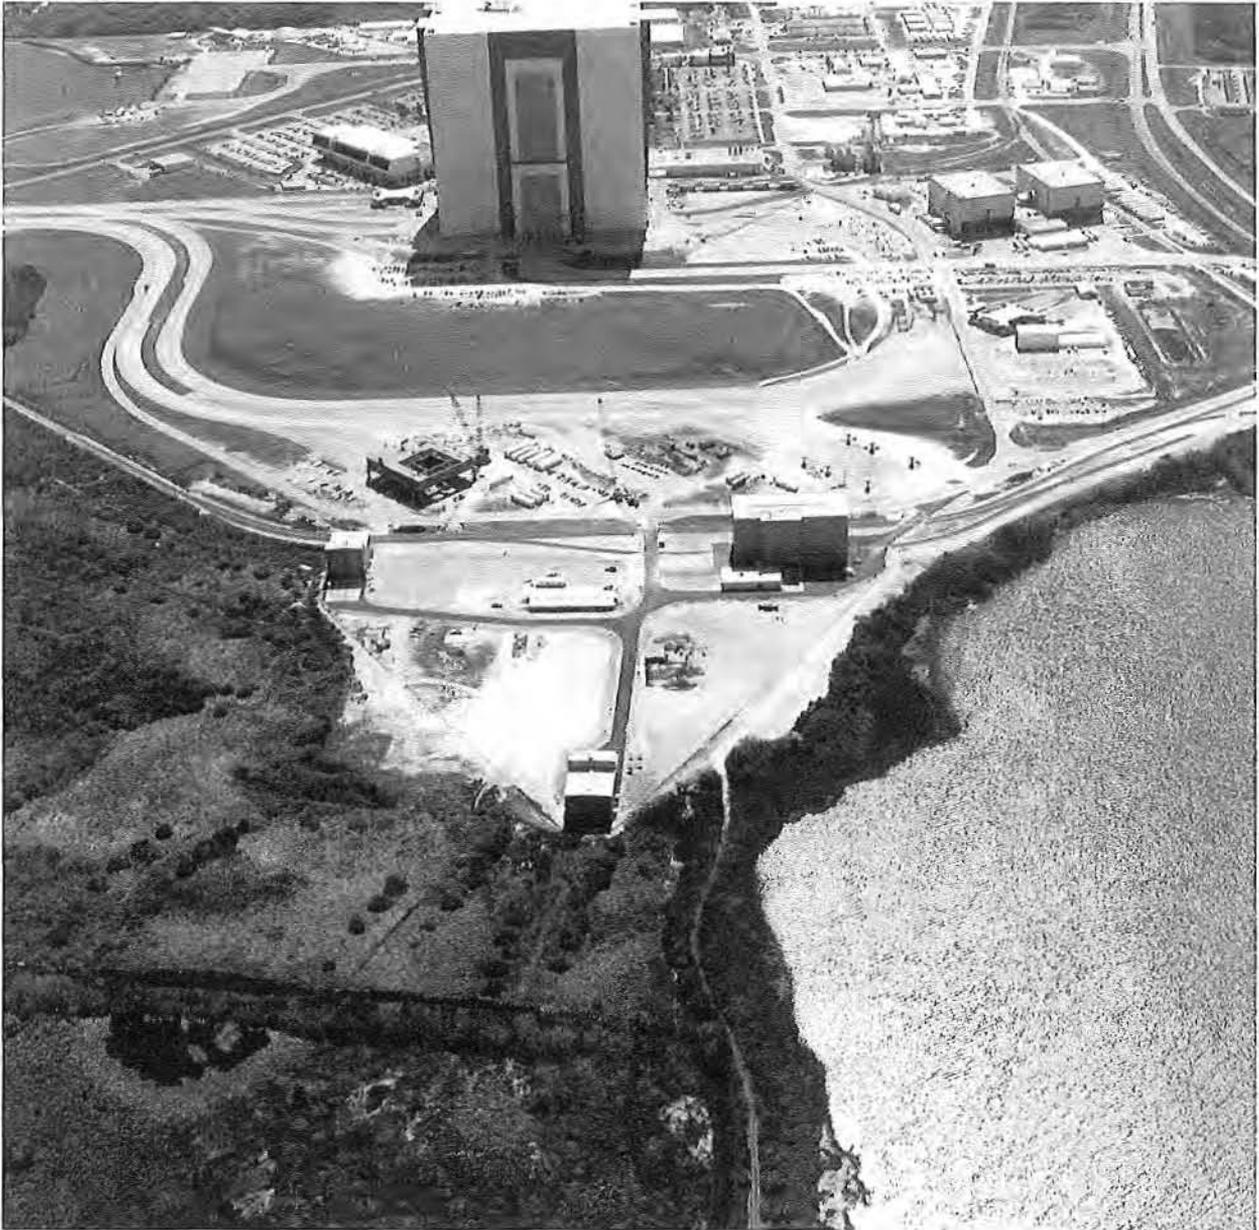
Aerial View of RPSF Complex, View to South with VAB in Background, March 9, 1984 (Courtesy of Kennedy Space Center, Negative 108-KSC-384C-1134-1).

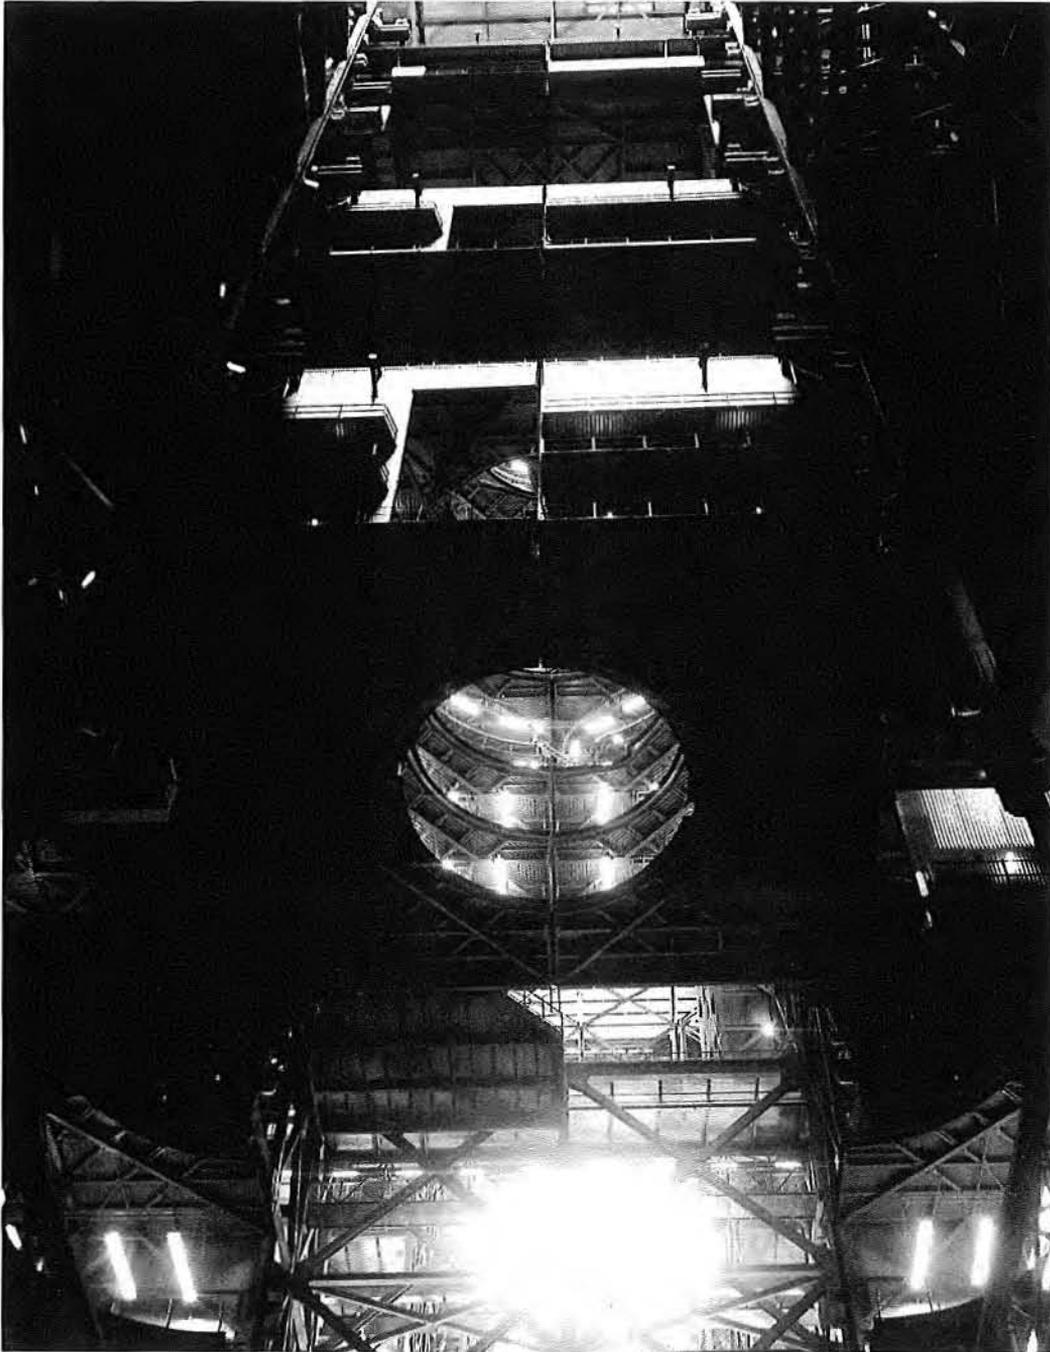
View of VAB Work Platforms in Assembly Area, July 7, 1966  
(Courtesy of Kennedy Space Center, Negative 116-KSC-66-13950).

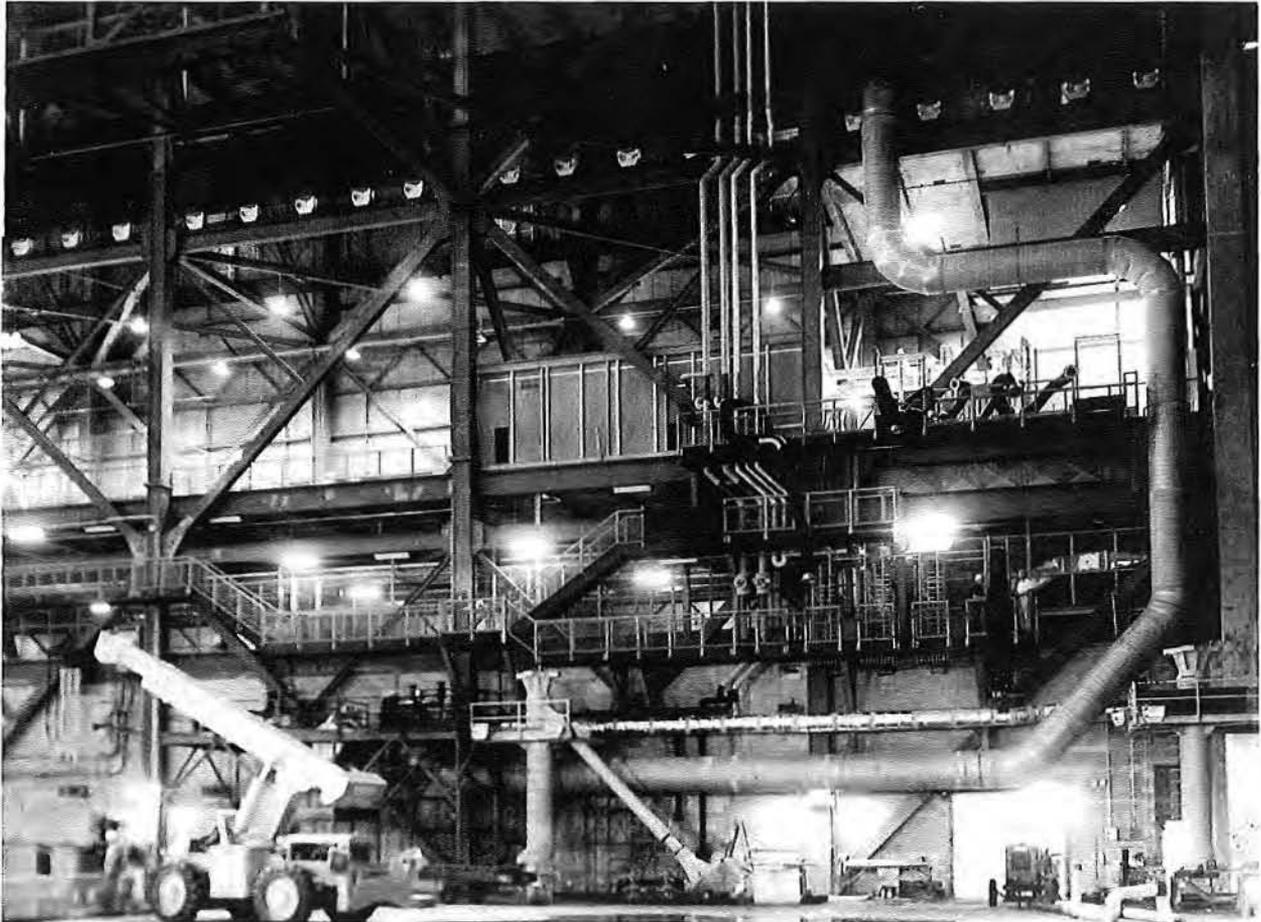
View of VAB North Wall in Assembly Area, July 6, 1966 (Courtesy of Kennedy Space Center, Negative 116-KSC-66-13947).
