FORT BENNING, VETERINARY HOSPITAL COMPLEX WARD  
(Main Post Veterinary Hospital Ward)  
(Building No. 266)  
7140 10th Division Court  
Maneuver Center of Excellence  
Fort Benning Military Reservation  
Chattahoochee County  
Georgia

HABS GA-2426-B  
*HABS GA-2426-B*

VETERINARY HOSPITAL COMPLEX, Hospital Ward  
(Building No. 266)

HABS No. GA-2426-B

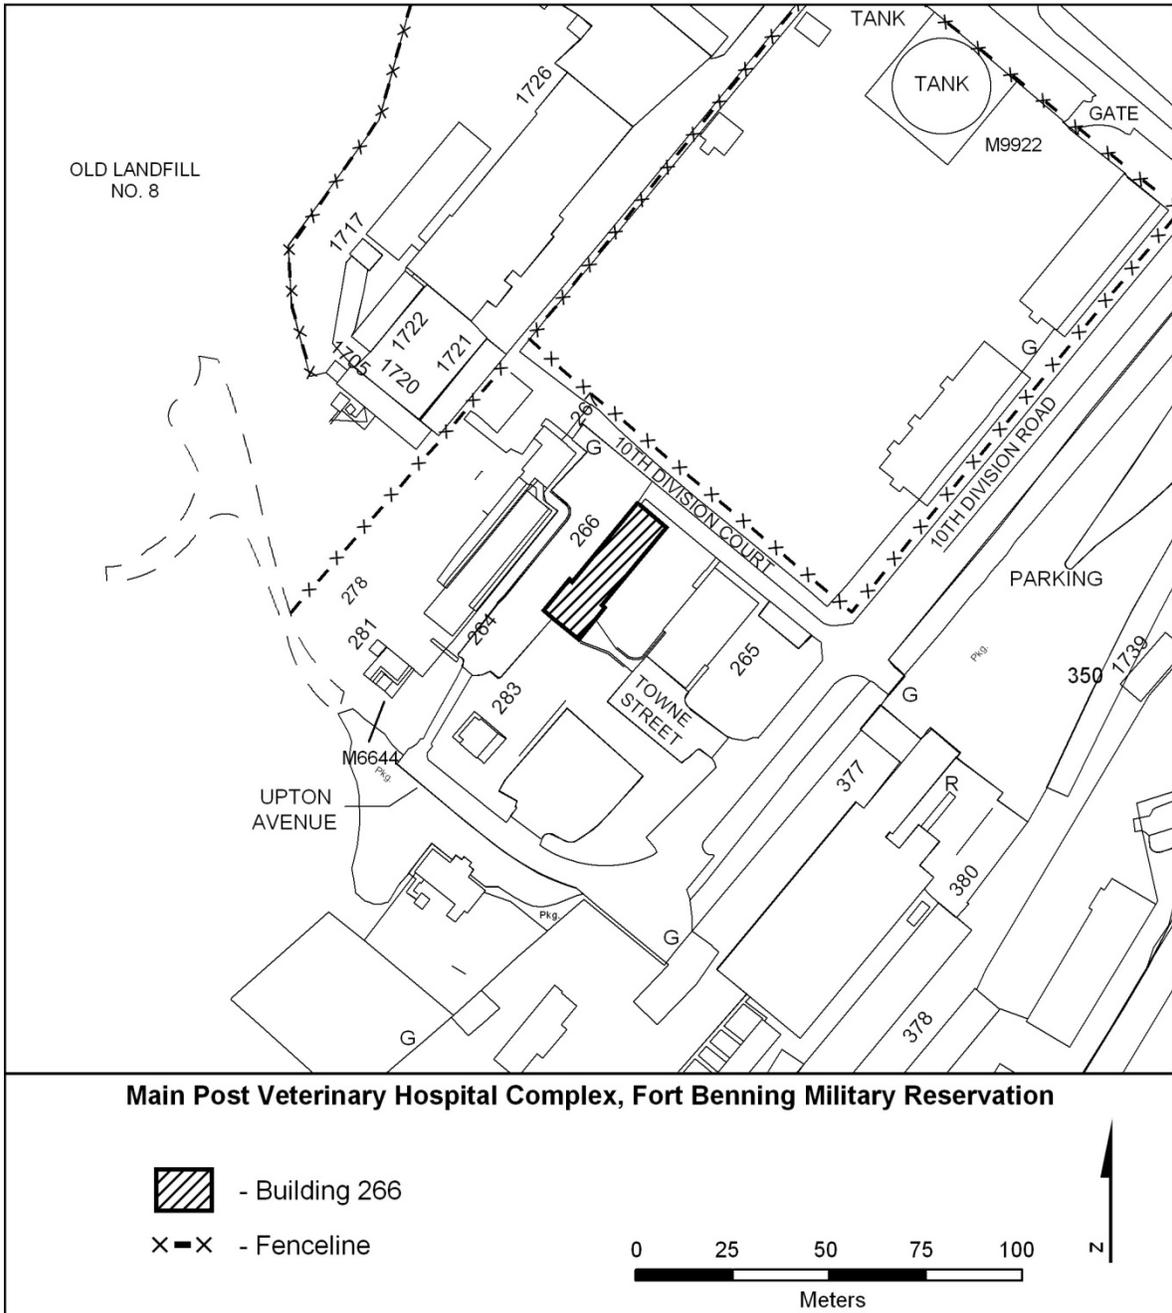
Site plan for the Veterinary Hospital Complex. Electronic database drawing available in Plans and Support, Master Planning Office, Directorate of Public Works, Building 6, Fort Benning, Georgia.

9. Original furnishings: All original furnishings were removed.
- D. Site: The building is located on the northwest side of the veterinary hospital building, Building No. 265, at the northwestern end of Towne Street. Building No. 266 is the middle building of the three primary buildings in the veterinary hospital complex. The front of the building faces southwest. Towne Street runs through the drive thru (former wagon shed) on the southwestern façade. Tenth Division Court terminates near the northeast rear of the building. A grass lawn occupies the area between Building Nos. 265 and 266.

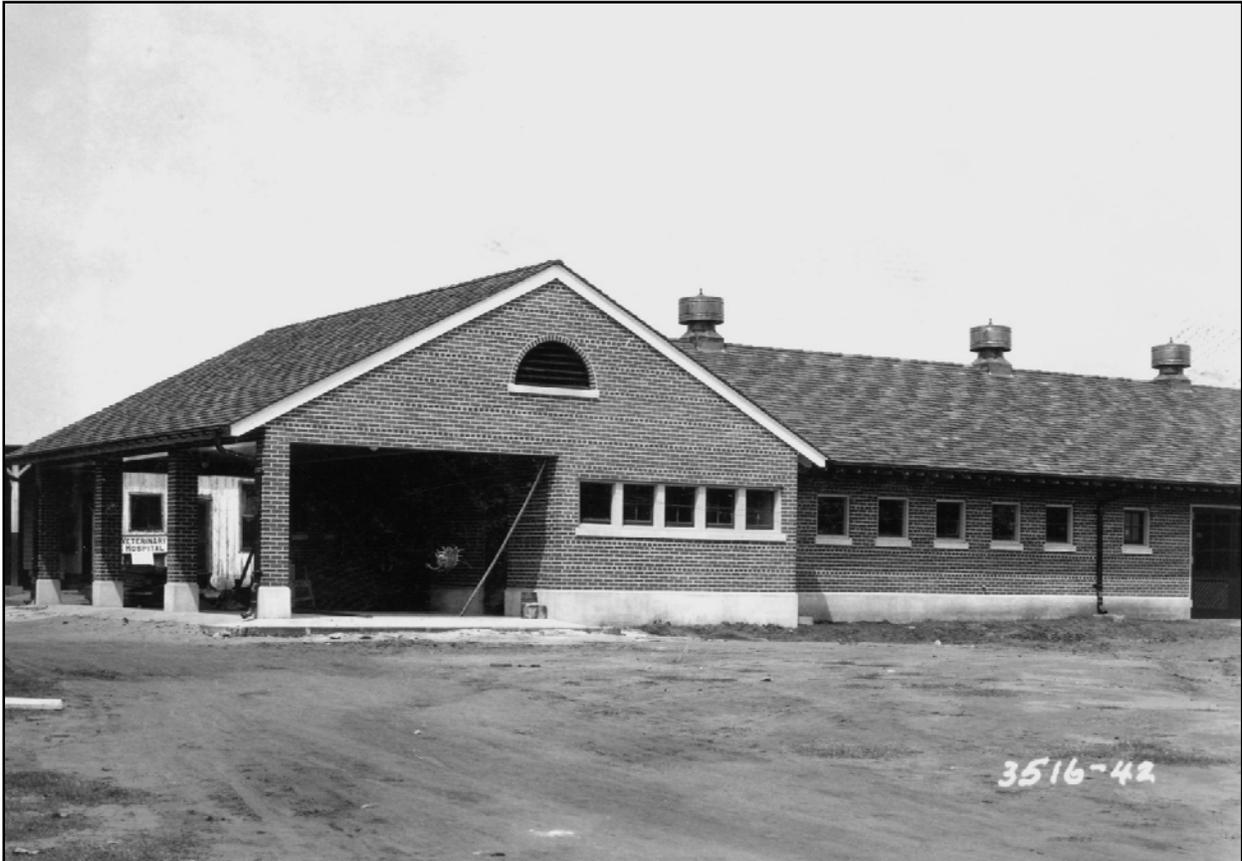
View of the southwest façade and southeast side of the Veterinary Hospital Ward, Building No. 266, facing northwest. In the left background, beyond the central bay of the wagon shed, is a wooden sign for the veterinary hospital. Original photograph on file at the National Infantry Museum, Fort Benning Military Reservation, Columbus, Georgia (Folder 1/3/39:Buildings – Industrial Buildings).

Exterior modifications include: replacement of entry bay door on southwest front with double-leaf wood doors; removal and replacement of original metal rolling door on northwest side; enclosure of entry bays on the southeast side and northeast rear with concrete; and removal of original exterior window grills. Historic photographs of Building No. 266 after its construction indicate the entry bays on the sides and rear of the building were constructed with double leaf wood doors and not the rolling doors as depicted on the 1933 drawing.

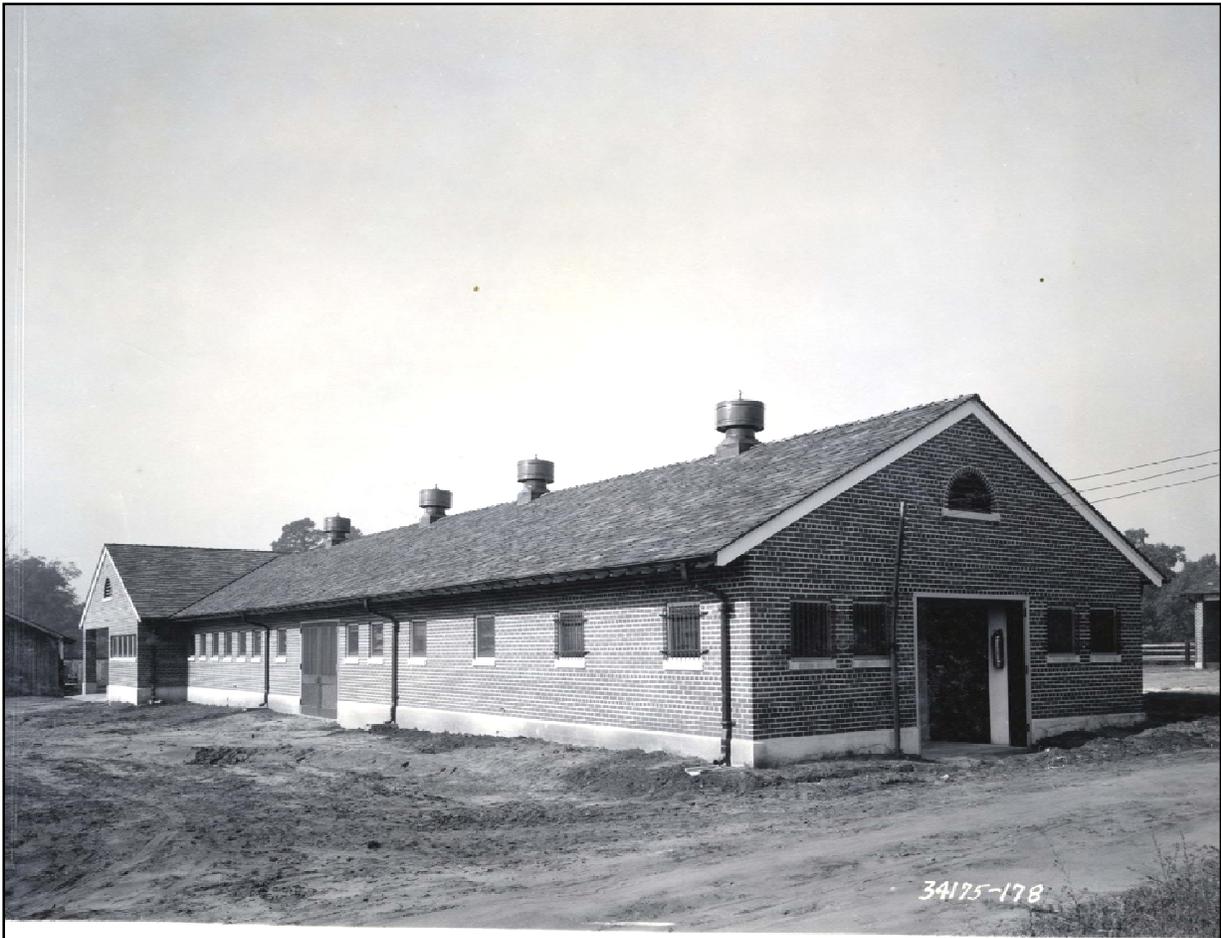
View of the southeast side and northeast rear of the Veterinary Hospital Ward, Building No. 266, facing southwest. Original photograph on file at the National Infantry Museum, Fort Benning Military Reservation, and Columbus, Georgia (Folder 1/3/39:Buildings – Industrial Buildings).

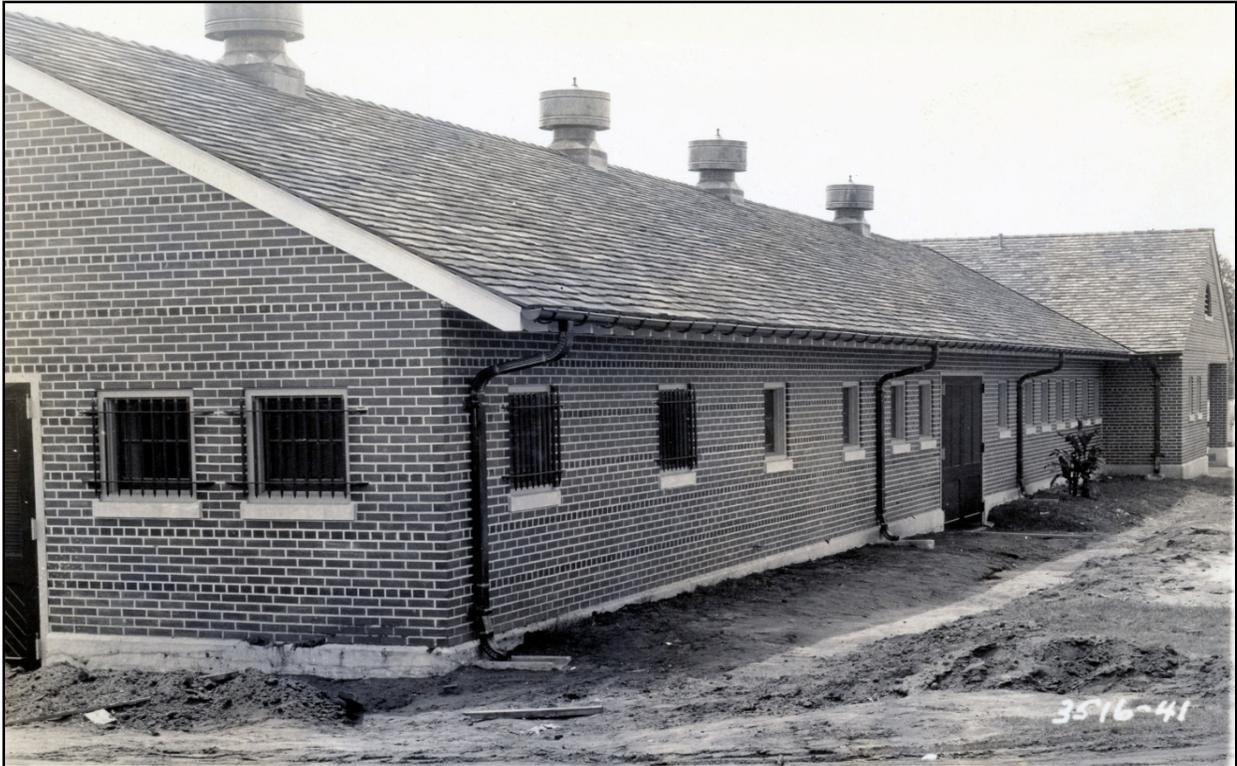
View of the northwest side of the Veterinary Hospital Ward, Building No. 266, facing south. Original photograph on file at the National Infantry Museum, Fort Benning Military Reservation, Columbus, Georgia (Folder 1/3/39:Buildings – Industrial Buildings).

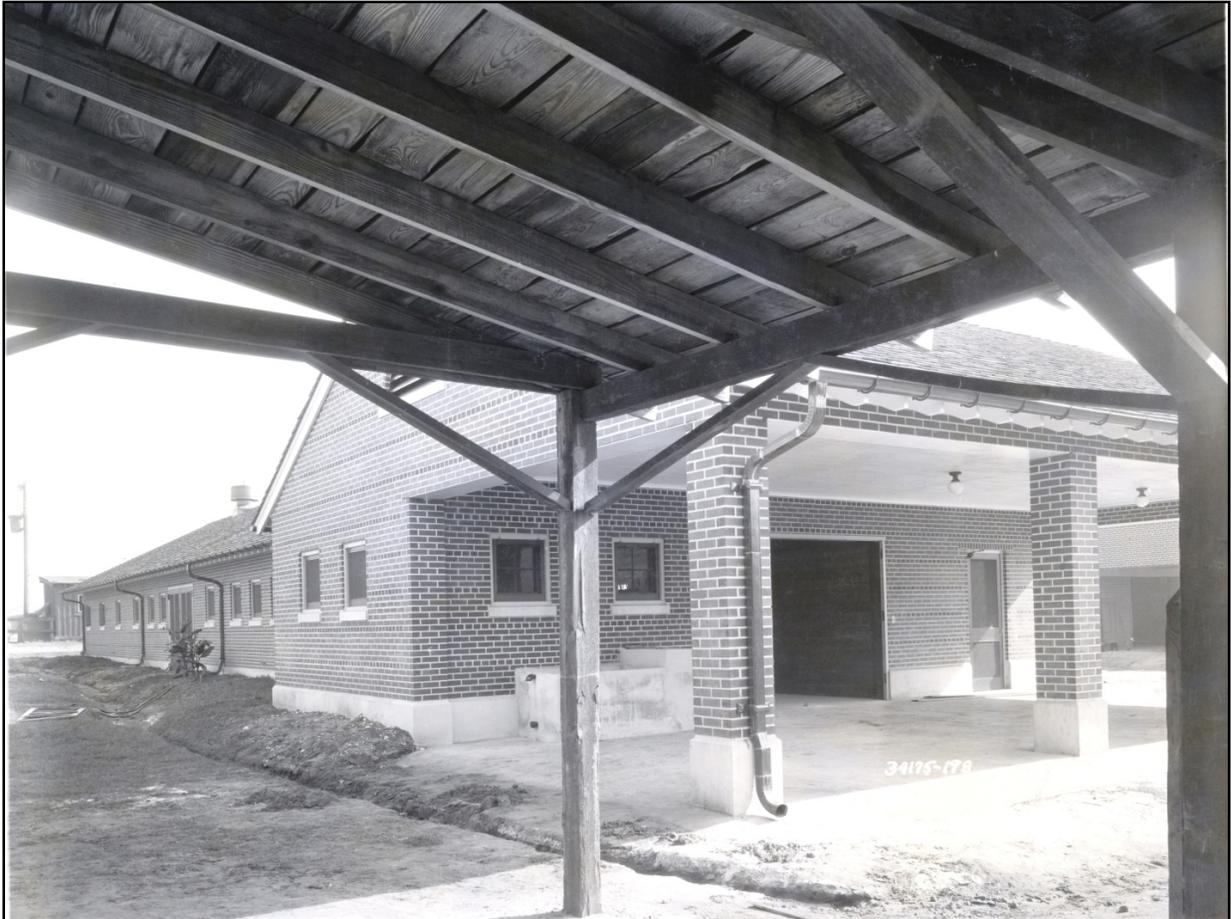
View of the northwest side and southwest façade of the Veterinary Hospital Ward, Building No. 266, facing northeast. Original photograph on file at the National Infantry Museum, Fort Benning Military Reservation, Columbus, Georgia (Folder 1/3/39:Buildings – Industrial Buildings).

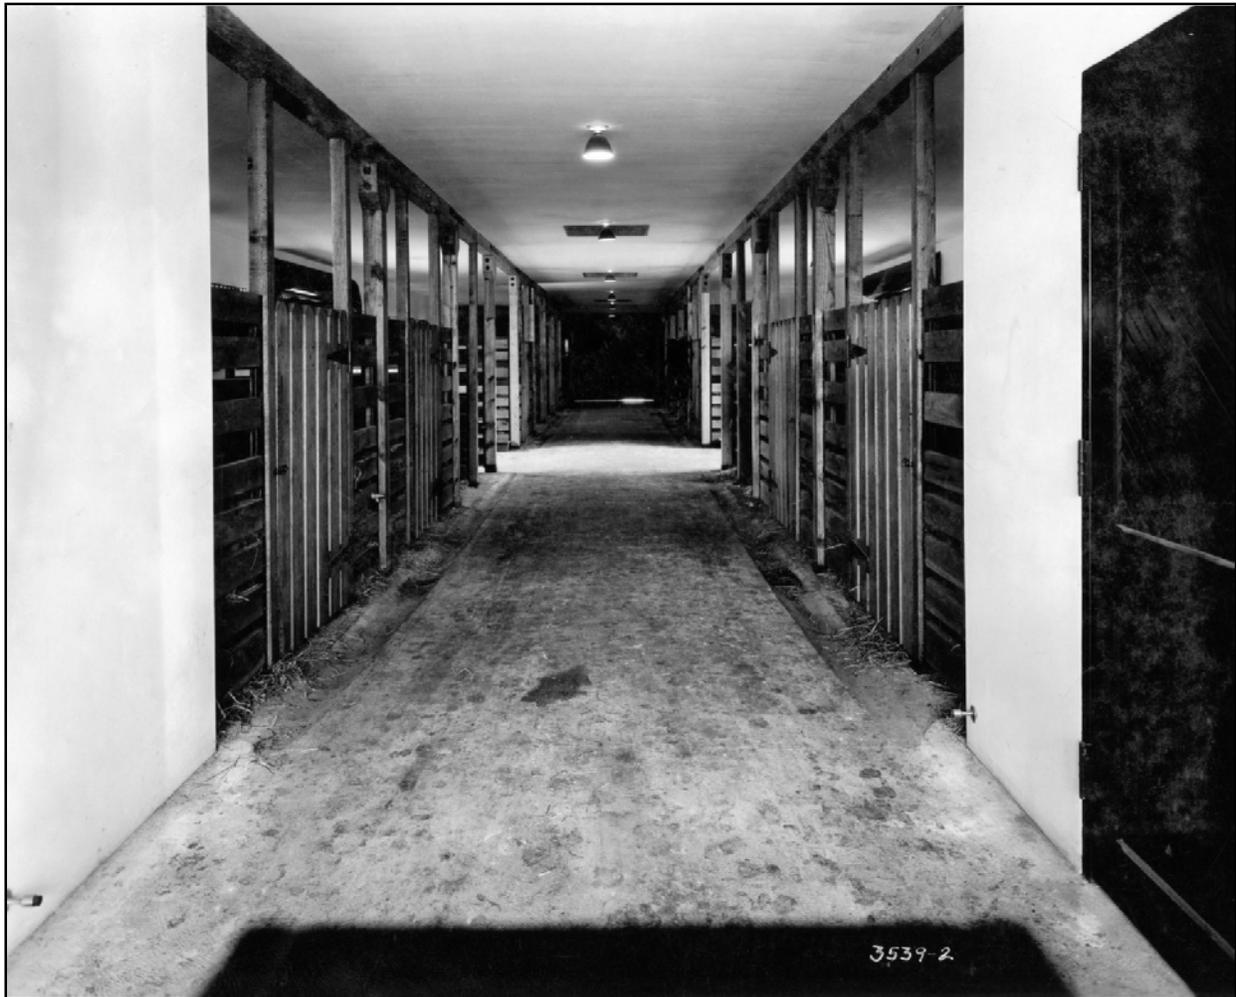
Interior corridor of the Veterinary Hospital Ward with box stalls in middle ground. Original photograph on file at the National Infantry Museum, Fort Benning Military Reservation, Columbus, Georgia (Folder 1/4/49:Buildings – Veterinary Hospital and Office).

7. Alterations and Additions: As constructed, the veterinary hospital ward, Building No. 266, contained a central corridor; eight single stalls; four double stalls; four box stalls; grain room; saddle room; hay and bedding room; colic stall; and wagon stall. Entry bays were located in the center bay of each side of the building. Windows openings had exterior and interior window grills.

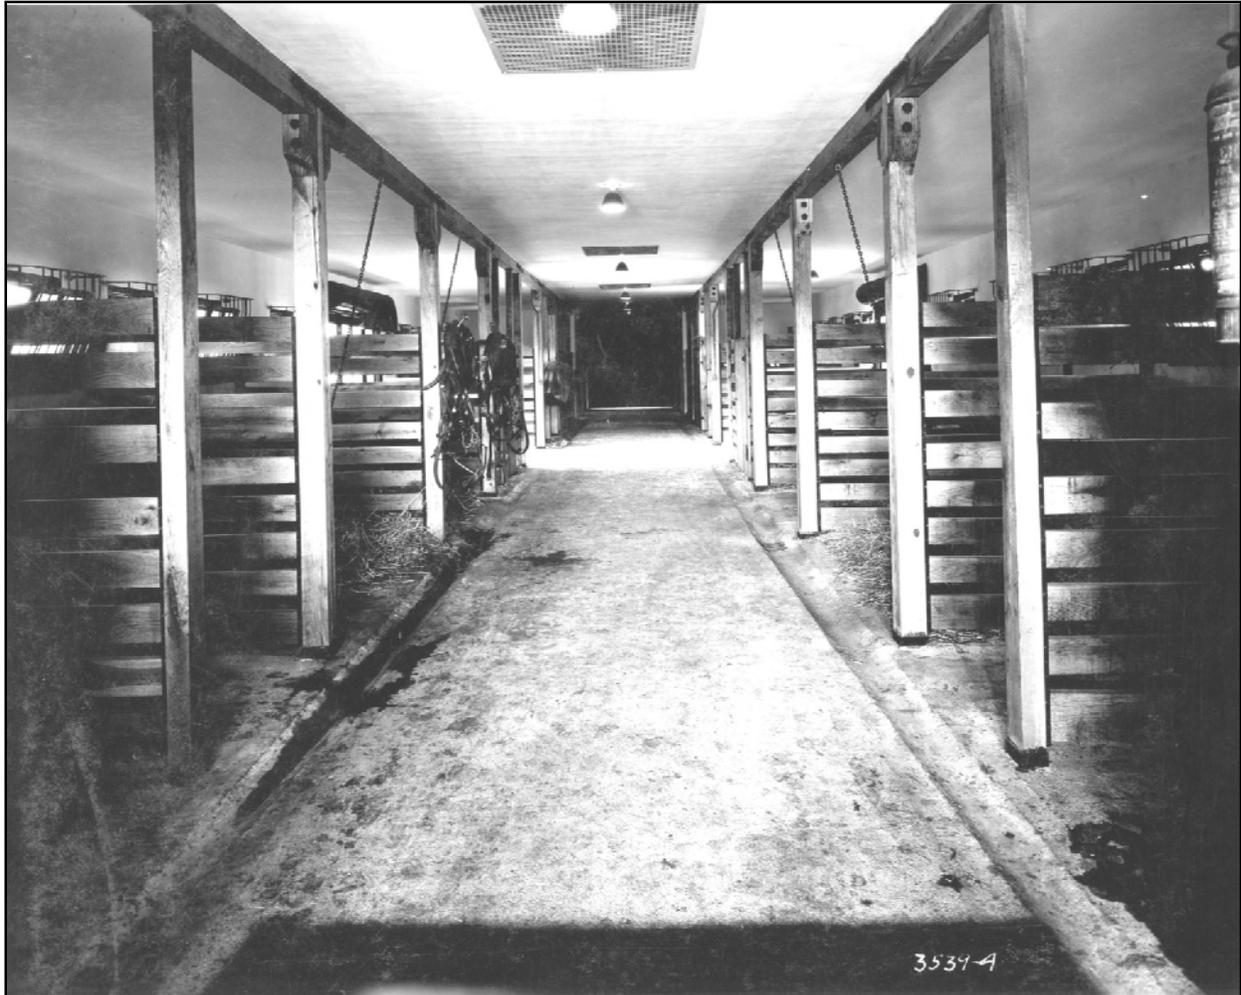
Interior corridor of Veterinary Hospital Ward with open stalls in foreground. Original photograph on file at the National Infantry Museum, Fort Benning Military Reservation, Columbus, Georgia (Folder 1/4/49:Buildings – Veterinary Hospital and Office).

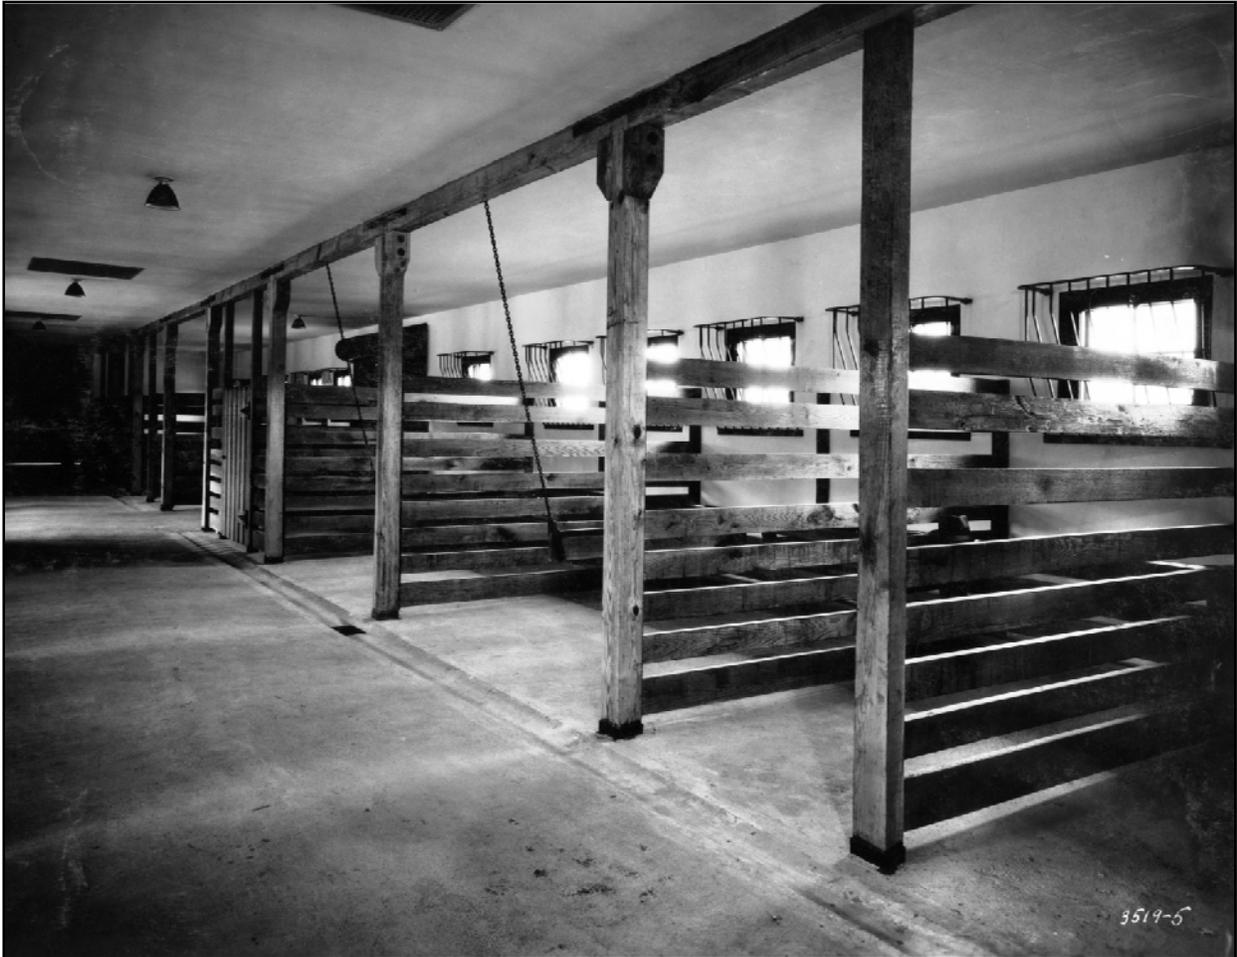
Single stall, double stalls, and box stall (from left to right) in the Veterinary Hospital Ward. Note original interior window grilles. Original photograph on file at the National Infantry Museum, Fort Benning Military Reservation, Columbus, Georgia (Folder 1/4/49:Buildings – Veterinary Hospital and Office).

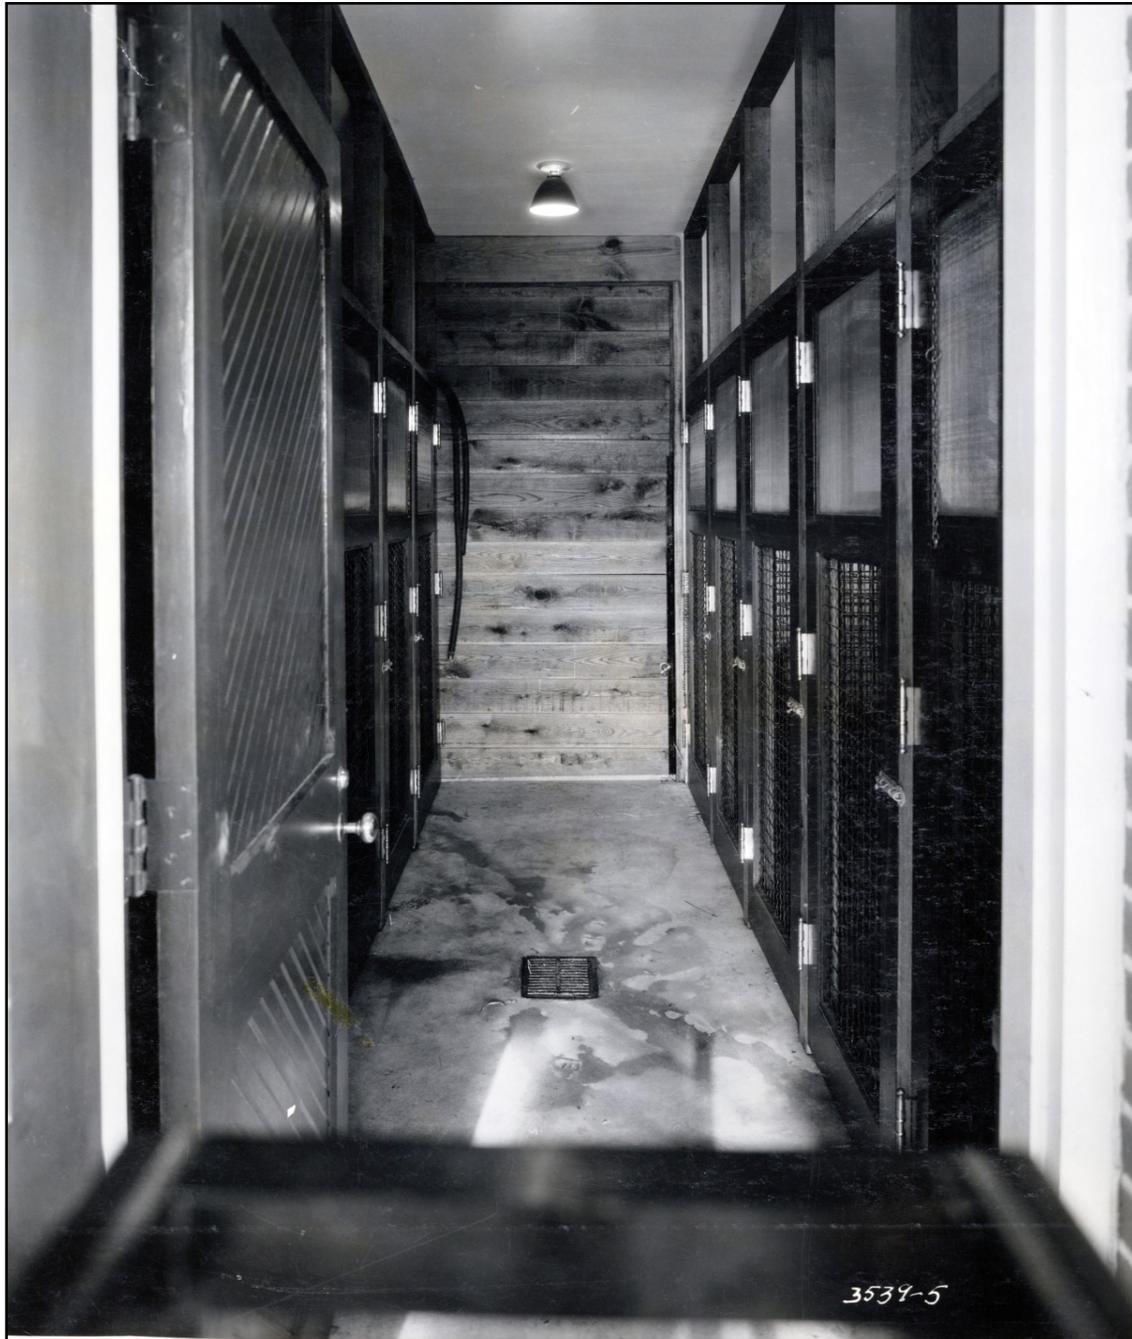
Dog Kennel, Veterinary Hospital Ward. Original photograph on file at the National Infantry Museum, Fort Benning Military Reservation, Columbus, Georgia (Folder 1/4/49: Buildings – Veterinary Hospital and Office).
