FORT BENNING, VETERINARY HOSPITAL COMPLEX
AMBULANCE GARAGE
(Main Post Veterinary Hospital Ambulance Garage)
(Building No. 267)
7110 10th Division Court
Maneuver Center of Excellence
Fort Benning Military Reservation
Chattahoochee County
Georgia

HABS GA-2426-C
HABS GA-2426-C

VETERINARY HOSPITAL COMPLEX, Ambulance Garage (Building No. 267)

HABS No. GA-2426-C

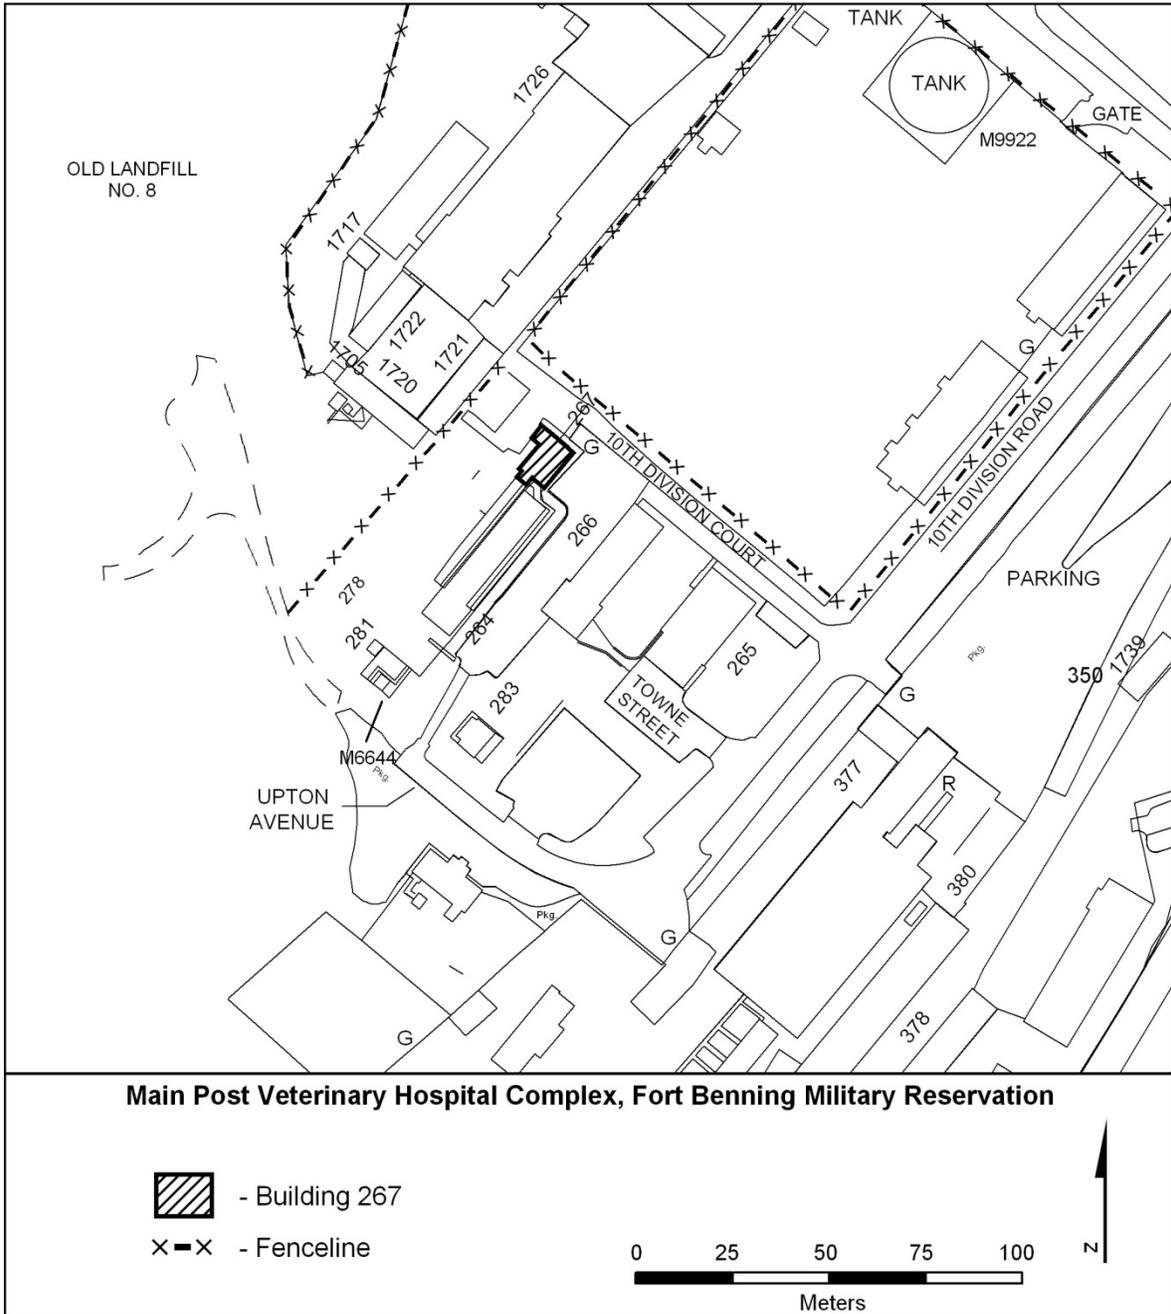
Site plan for the Veterinary Hospital Complex. Electronic database drawing available in Plans and Support, Master Planning Office, Directorate of Public Works, Building 6, Fort Benning, Georgia.

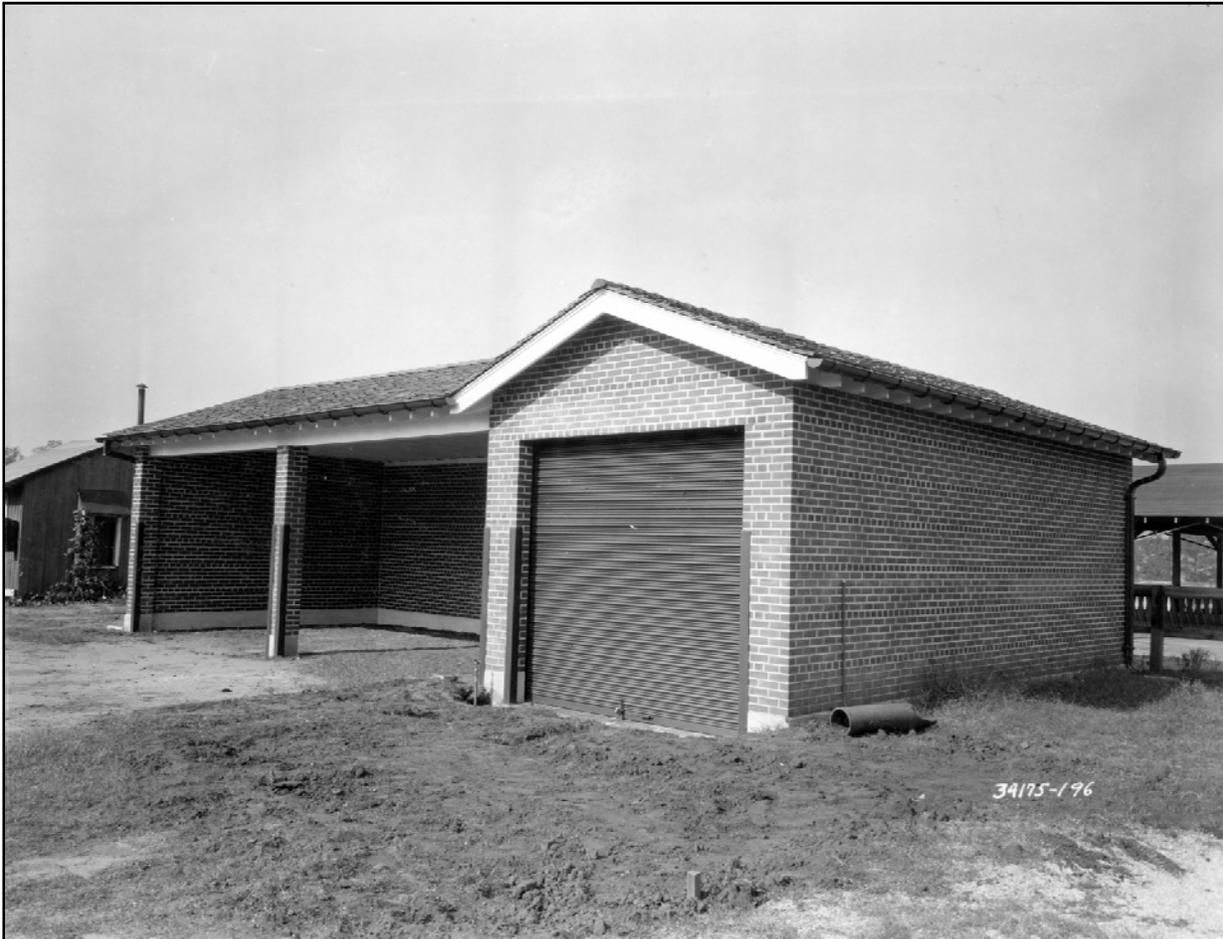
View of the Veterinary Hospital Ambulance Garage (Building No. 267) as constructed with two open bays and enclosed garage bay, facing southwest. Original photograph on file at the National Infantry Museum, Fort Benning Military Reservation, Columbus, Georgia (Folder 1/3/39:Buildings – Industrial Buildings).

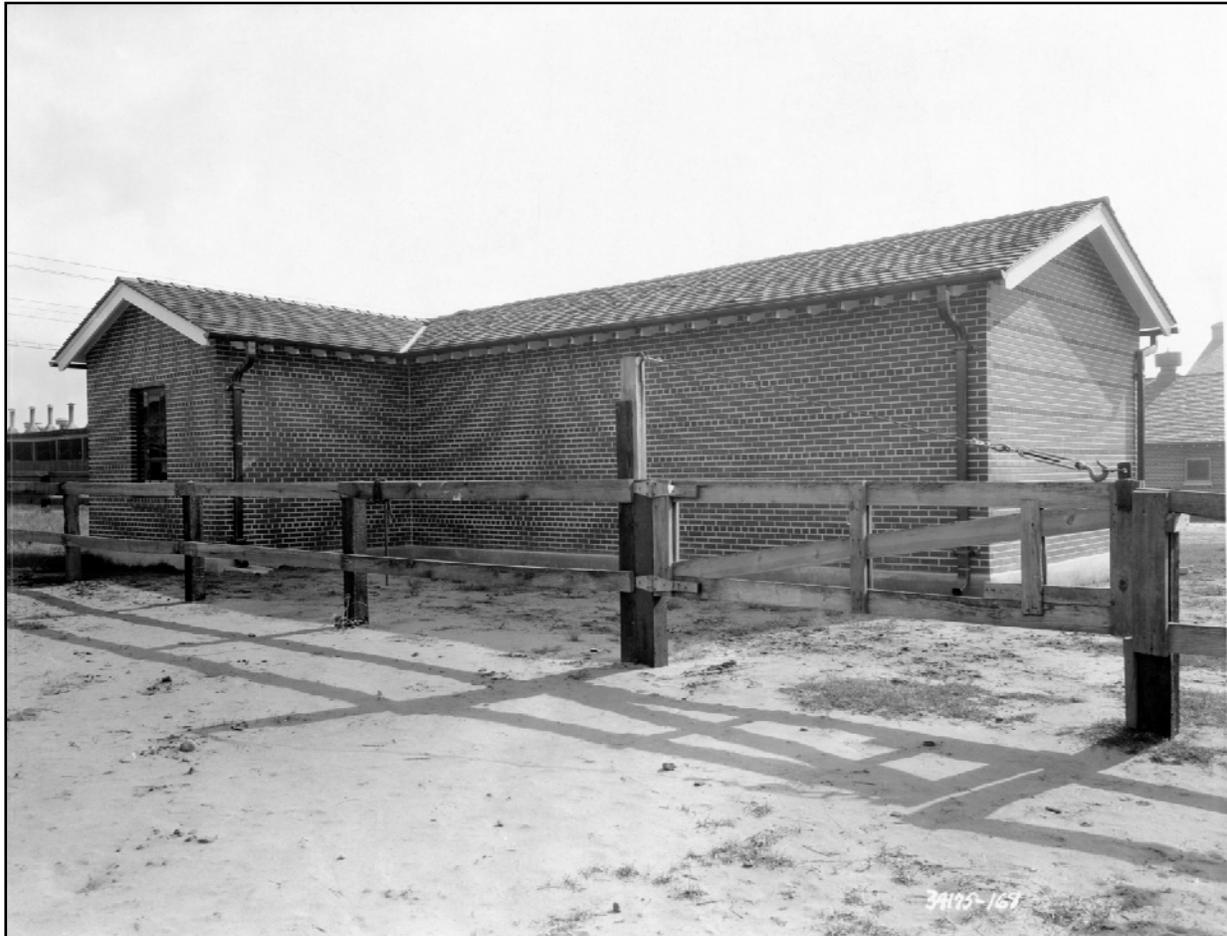
View of the rear (northwest) and southwest side of the Veterinary Hospital Ambulance Garage (Building No. 267), facing northeast. Original photograph on file at the National Infantry Museum, Fort Benning Military Reservation, Columbus, Georgia (Folder 1/3/39:Buildings – Industrial Buildings).
