BARNS OF MID-MARYLAND
Carroll County, MD
Frederick County
Maryland

HABS MD-1275
MD-1275

HISTORIC AMERICAN BUILDINGS SURVEY

BARNs OF MID-MARYLAND

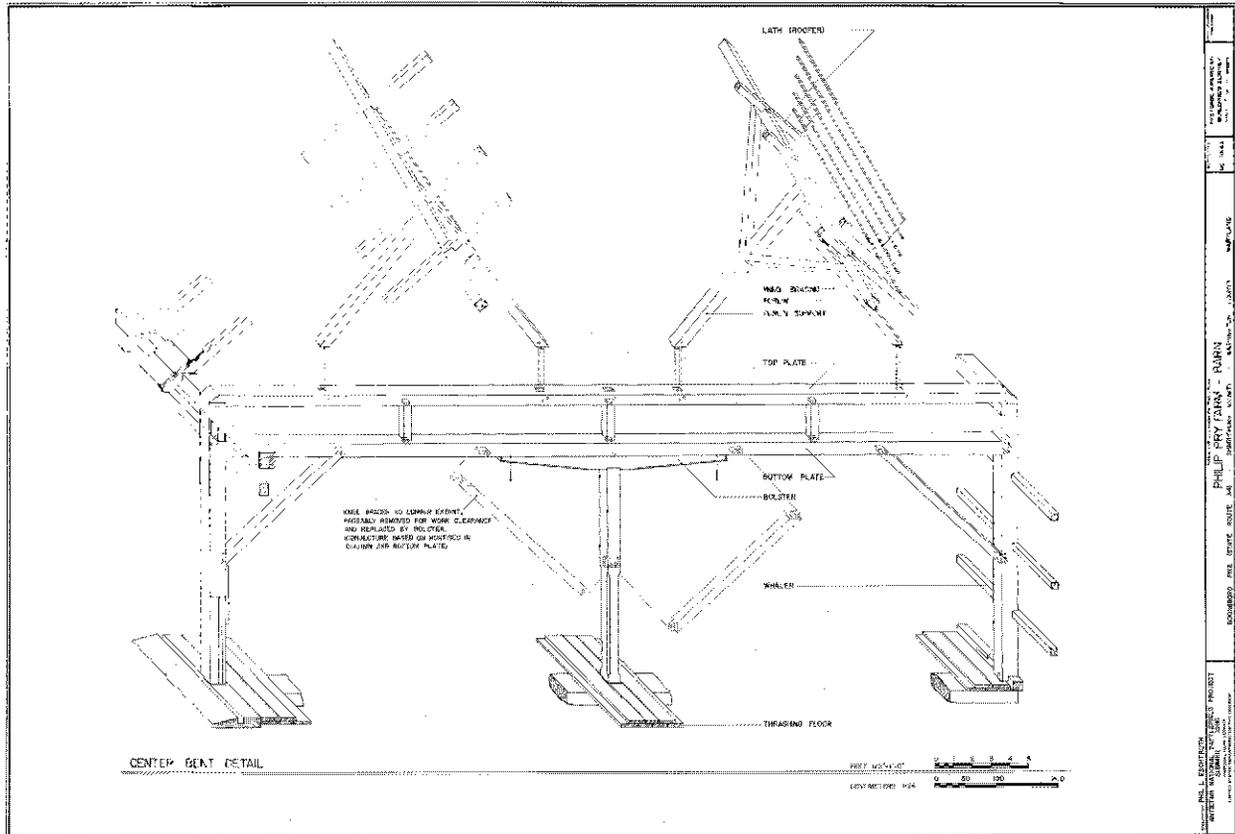
Figure 1, Philip Pry Farm Barn, typical canted queen post bent detail, Antietam National Battlefield, Washington County, built ca. 1844 (drawn by Phil L Eschtruth, National Park Service Historic American Buildings Survey, MD-864-A, 1986)

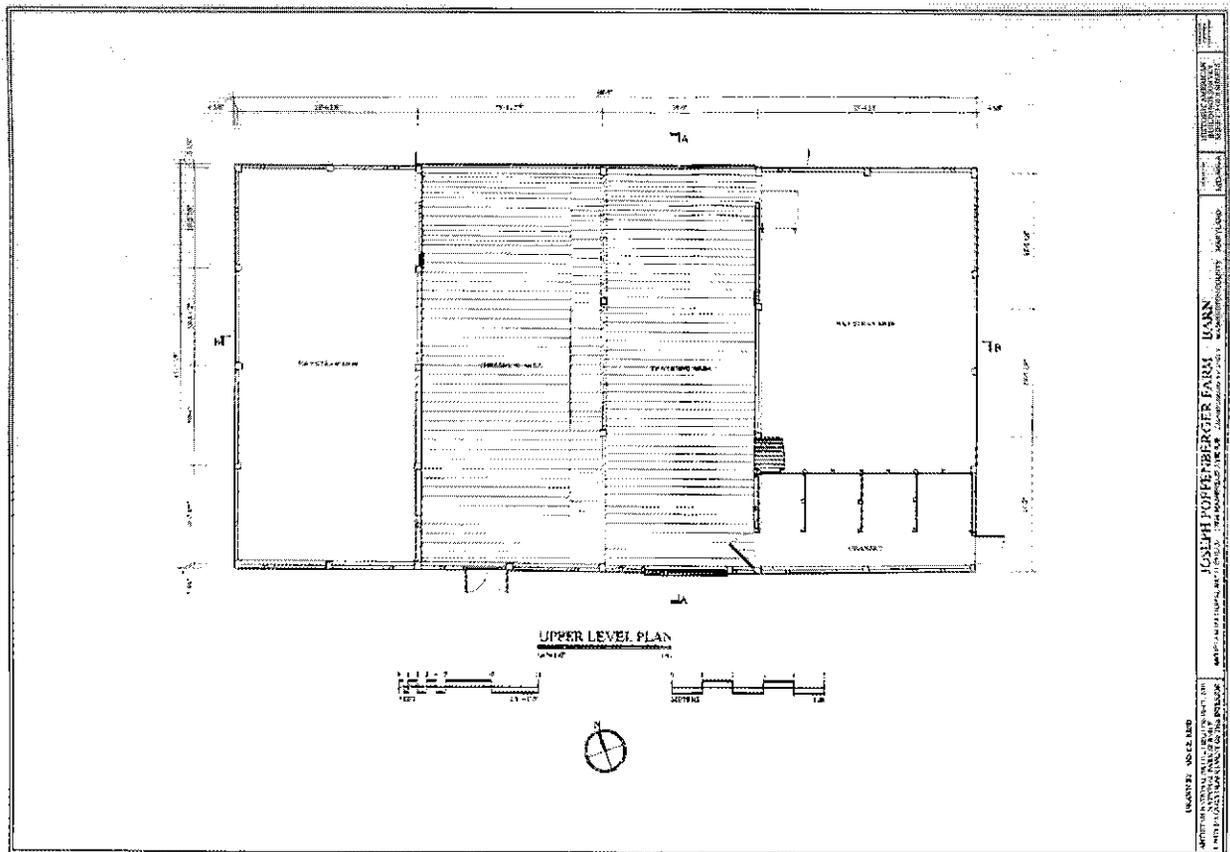
Figure 7, Joseph Poffenberger Farm Barn, Upper Level Plan, Antietam National Battlefield, Washington County (drawn by Anne E. Kidd, National Park Service Historic American Buildings Survey MD-966-A, 2005)

battened to prevent the loss of grain. Flailing or mowstead walls about four feet in height separated the threshing floor from the mows, which were spaces for storing hay and straw. The walls also helped to contain the threshed and winnowed grain in the center bays.⁵⁶ The upper floor plan of the Joseph Poffenberger Barn (Fig. 7) is representative of most interior arrangements of bank barns with the central threshing floor and flanking mows. The Poffenberger Barn also has a granary built in to the southeast corner in the forebay section.

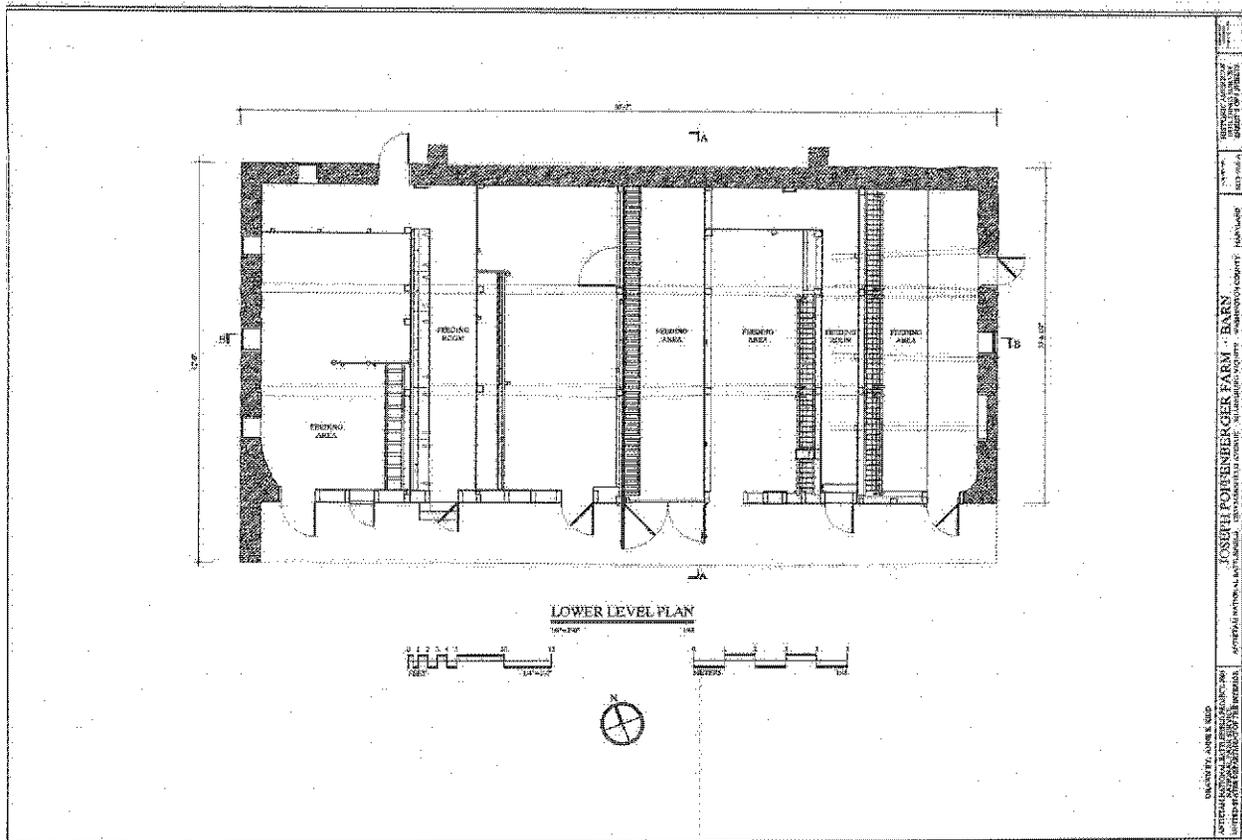
Figure 9, Joseph Poffenberger Farm Barn, Lower Level Plan, Antietam National Battlefield, Washington County (drawn by Anne E. Kidd, National Park Service Historic American Buildings Survey MD-966-A, 2005).

The first floor of a bank barn was used for sheltering and feeding livestock. It was usually arranged with stalls running perpendicular to the forebay with an aisle along the back wall, which may have been accessible from a set of stairs descending from the threshing floor and may in some cases also been accessible from a door in the foundation. Aisles ran between stalls to access feeding troughs. Two-part Dutch doors were commonly used, one for each row of stalls and one for each aisle, opening onto the barnyard so as to allow light in while still containing the animals. The overhanging forebay provided protection for these entrances. The following lower level plan of the Poffenberger Barn shows one possible arrangement of stalls and aisles (Fig. 9).

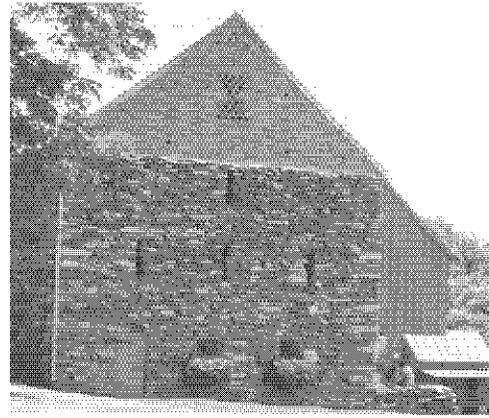
Figure 11, Browns Farm, Burkittsville, Frederick County
(photo: Virginia Price)

The Brown's Farm (Fig. 11) in Burkittsville in Frederick County was built around 1780 to 1800.⁷² It is unique in its use of three materials: stone in the gable ends and ramp wall, brick in the gable sections, and timber frame in the forebay. It is considered in this section due to the use of masonry with the asymmetrical gable/open forebay configuration. The walls are made of rubble and fieldstones with quoins

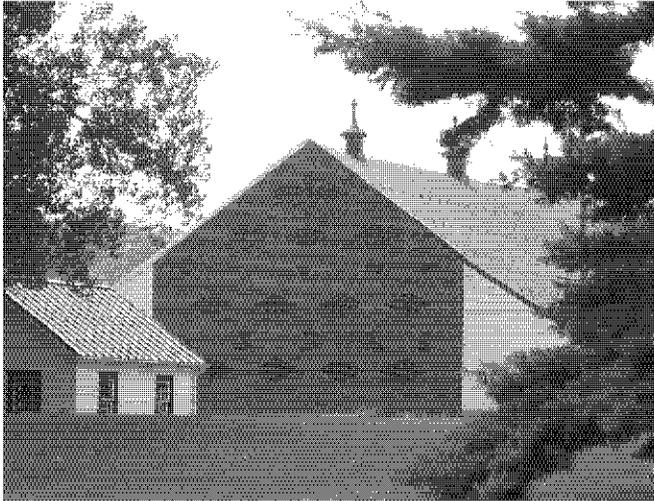
NOTES: Brick is laid in 5:1 common bond on a rubble limestone foundation with quoins except along forebay side, which is made of brick. There are three rectangular framed wood louvers in gable end foundation. Brick patterns in the gable end are three rows of diamonds (3, 2, 1 rising from foundation to gable). The lower level forebay has alternating doors and louvers (5) with a pair of doors near the center. The forebay faces west and has a dormer placed slightly to the north of center. The dormer was likely a later addition to the barn.

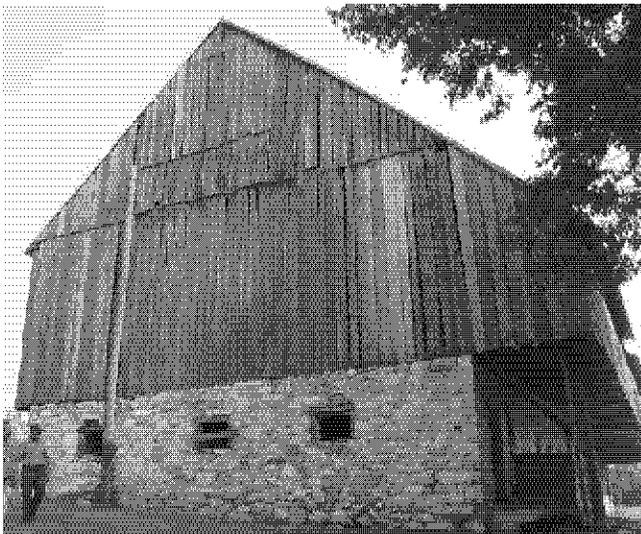
(i) NEWCOMER FARM BARN

NOTES: The late nineteenth-century dormer was added to accommodate threshing. The forebay faces east. The barn measures 50 x 95 feet, and is made from fieldstone laid in a random rubble pattern. There are five bents with rafters and purlins, vertical sheathing with an overlap on the gable end at eave height, three wood frames with louvers in foundation of gable ends, eight Dutch doors, and six wood framed louvers in the foundation under the forebay.

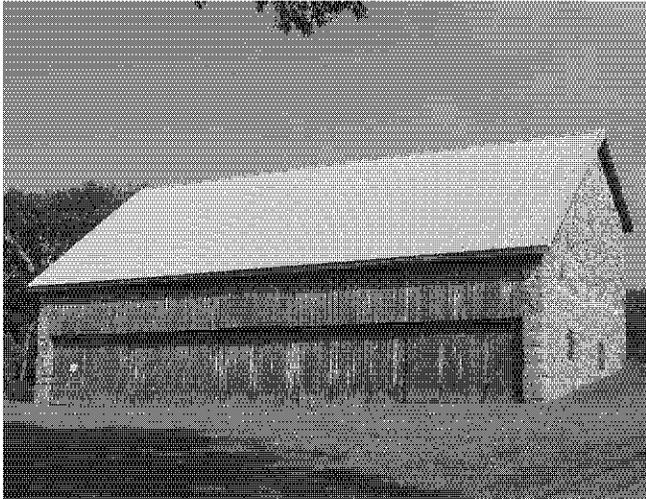
(i) FRANCIS MANTZ FARMSTEAD

NOTES: This is the only stone barn in the Urbana region of Frederick County. The east gable wall and ramp wall are constructed of rubble limestone and the west gable is stone with timber framing in the gable, which may be a later repair. The forebay faces south and is sheathed in vertical boards.

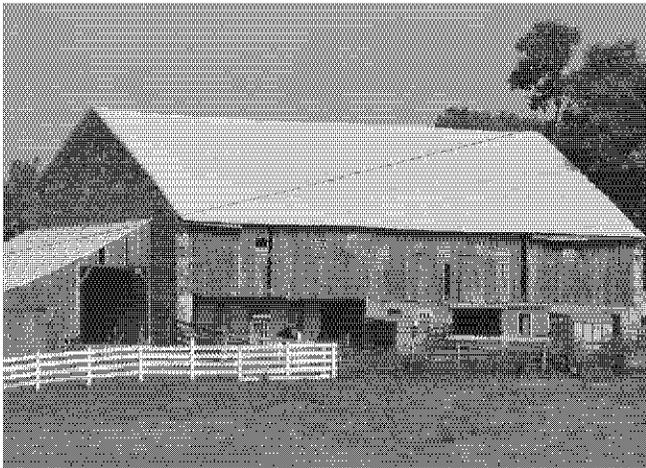
(ii) STONE BARN

NOTES: The foundation is stone while the primary construction material is brick laid in 5:1 common bond. There are three wheat sheaf ventilators evenly spaced above, between which are two triangle ventilators. Two wheat sheaf patterns and one triangle follow a similar arrangement on either side of the ramp in the gable ends. Frame construction and wood vertical boards make up the gable sections.

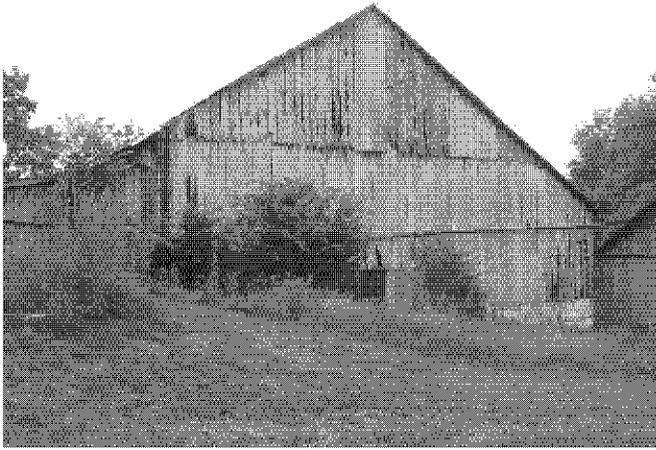
Figure 12a, Joseph Parks Barn, west elevation

There are few examples of this subtype. Shown here is the Joseph Parks Barn at the Antietam National Battlefield in Washington County built around 1820 (Fig. 12a, c). The forebay faces south and is half closed on west side (Fig. 12b). The foundation is a whitewashed rubble limestone foundation. The entire structure is sheathed in several overlapping layers of vertical wood boards. The framing is a canted queen post with tie and cross beams which divides the interior space into a central threshing floor flanked by two hay mows with a granary built into southeast corner. Its overall dimensions, not including the late nineteenth or early twentieth century wagon shed addition on the east side, are approximately 40 x 60 feet.⁷³

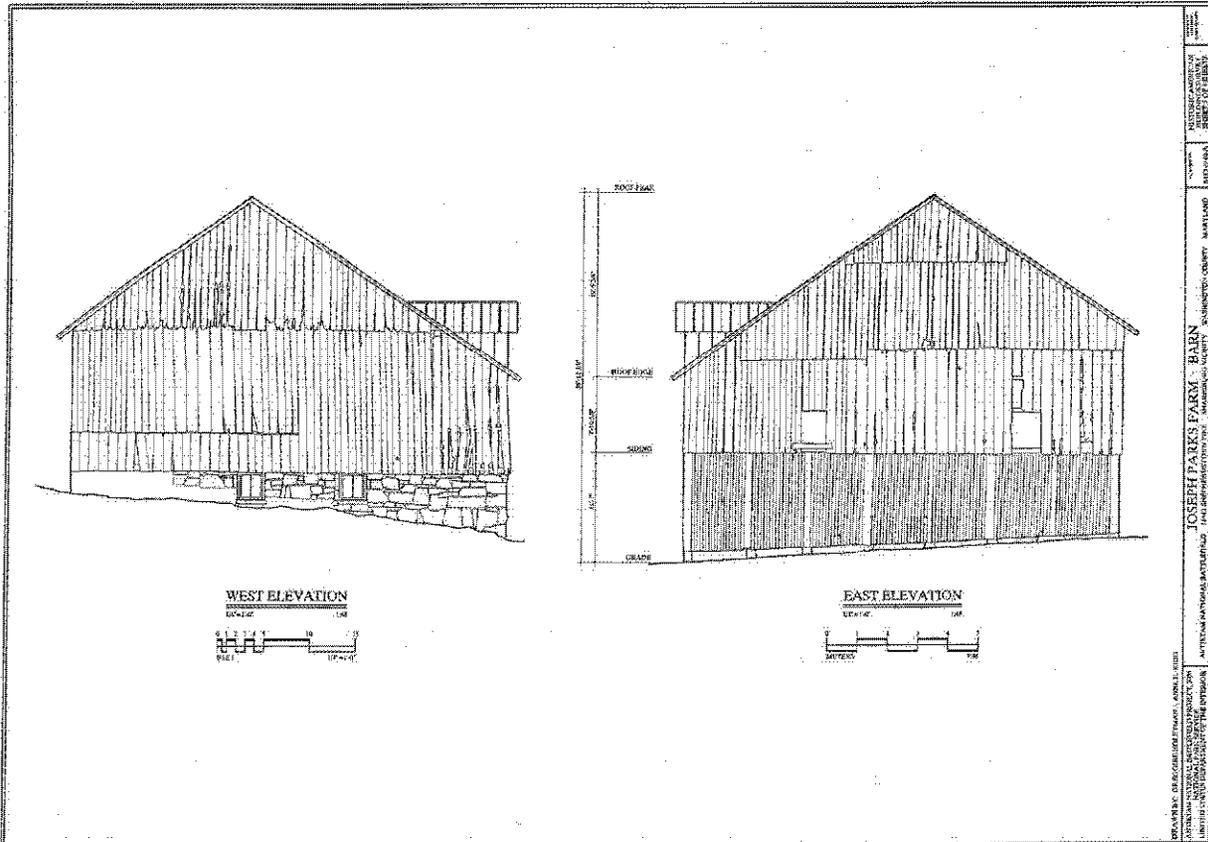
Figure 12c, Joseph Parks Farm, east and west elevations, Antietam National Battlefield, Washington County (drawn by Anne E. Kidd, National Park Service Historic American Buildings Survey MD-940-A, 2005)

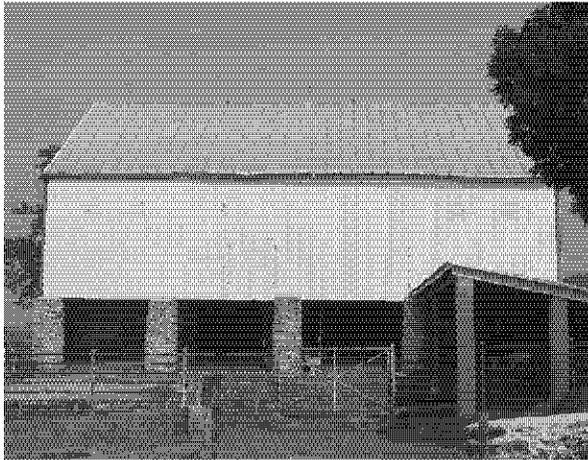
Figure 14a, Haines Barn, forebay (SE view)

The Haines Barn (Fig. 14a, b) at 110 Stem Road in Carroll County is also unusual within the study area. Its lower gable walls and ramp wall are constructed of brick laid in common bond with fifth course headers. Although a historic photograph shows that the gable sections, forebay, and granary on the along the ramp were once sheathed in vertical wood boards, they are now covered with vinyl sheets. The forebay, which faces southeast, extends almost half the depth the main brick structure of the barn and is supported on five slightly tapered stone piers. The brick gable ends have hour glass/wheat sheaf ventilation patterns. Two concrete silos stand on the northwest side of the barn, one on either side of the ramp, and a shed or granary addition extends from the main structure on the west side of the ramp.

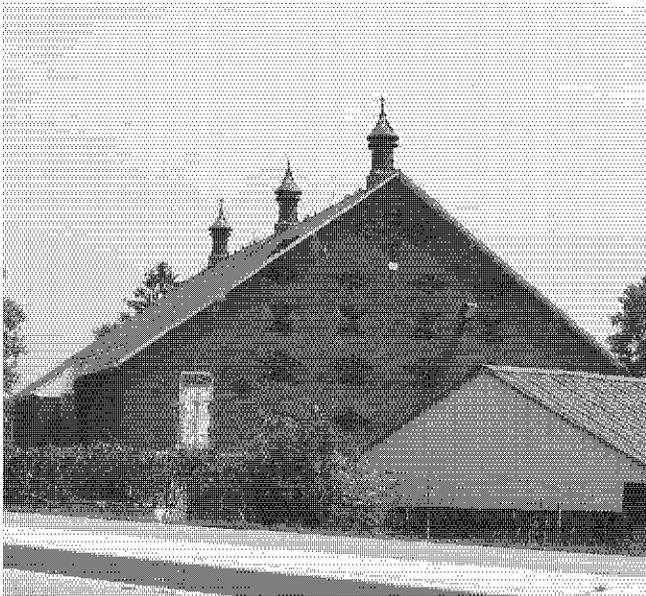
(ii) SHAFER FARM

NOTES: A raised random course limestone foundation extends to the edge of the forebay, which is cantilevered six feet and sheathed in vertical board siding. There are three decorative metal ventilators on the ridge and two projecting brick granaries on either side of the ramp. Brick ventilation patterns include the unfolding lily, a row of diamonds, a row of wheat sheaves, a row of wine glasses and followed by another row of diamonds.

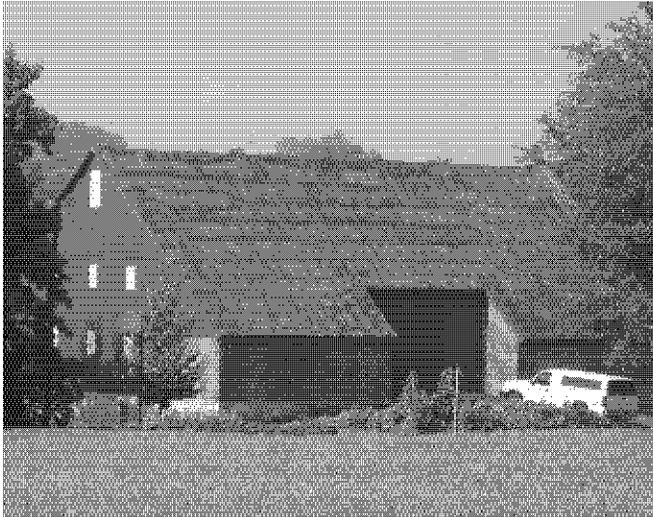
(iii) Kretsinger Farm

NOTES: The barn is constructed of rubble stone with quoins. The forebay faces east and is sheathed with German siding on the upper level. The forebay is closed on both ends with an arched doorway on the north end providing access to the barnyard. Vertical slit loopholes provide ventilation in the stone walls as well as a circular opening high in the gable section. There are two projecting stone granaries on the west elevation.

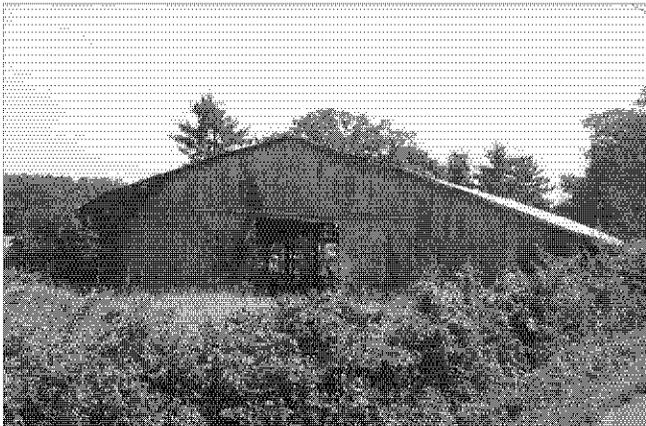
(i) PUTNAM ROAD BARN

NOTES: This is a frame structure on a stone and brick foundation sheathed in board-and-batten siding. The ridgeline runs southeast-northwest with doors centered in the gable end with a hayloft door flanked by two four-light windows. There are also two six-light windows in the northeast and southwest walls. The roof is standing seam metal.

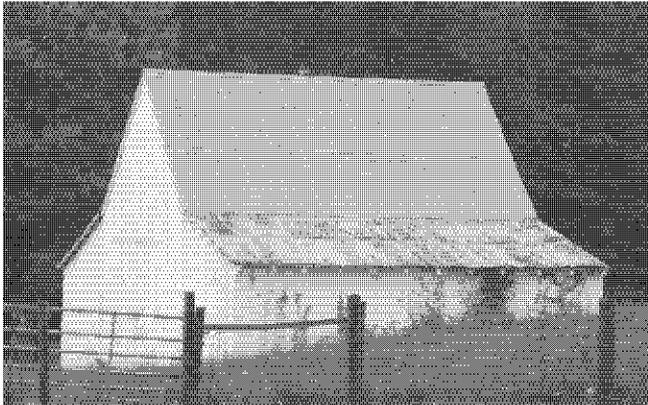
(i) THE MAPLES BARN
COUNTY: Washington
LOCATION: Mapleville Rd (MD66) at Chewsville Road

NOTES: Located northwest of a TYPE A3 barn on the same property, this small frame transverse crib barn has a steep ridge running east-west with sheds of shallow slope on either side.

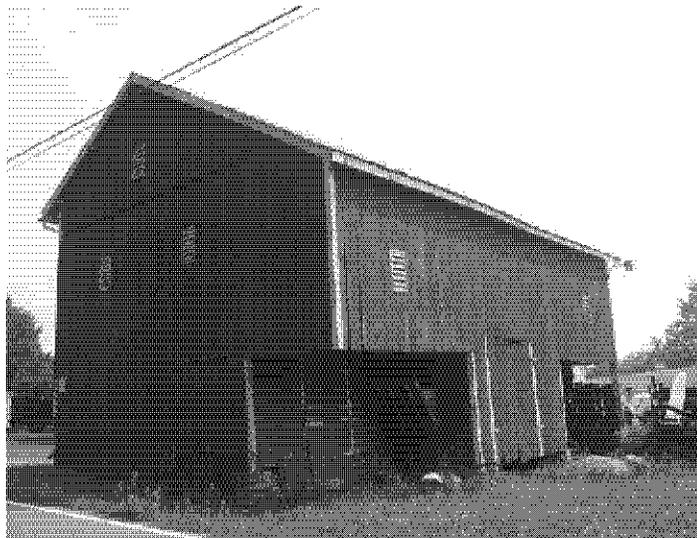
Figure 16, 3869 Watson Lane, Carroll County

There was also another barn of a similar form observed along Watson Lane in Carroll County with an asymmetrical gable and an open forebay (Fig. 16). The interior of this ground barn was not accessible. It appears to be frame construction sheathed in vertical wood boards on a stone foundation. Each crib or stable has a single Dutch door opening out under the forebay. A central aisle between the two cribs extends to the edge of the forebay and is enclosed on all sides. This extension has double-hinged doors opening out into the barnyard with a feed rack under the forebay on either side. There are rectangular, wood louvers in all of the exterior walls.

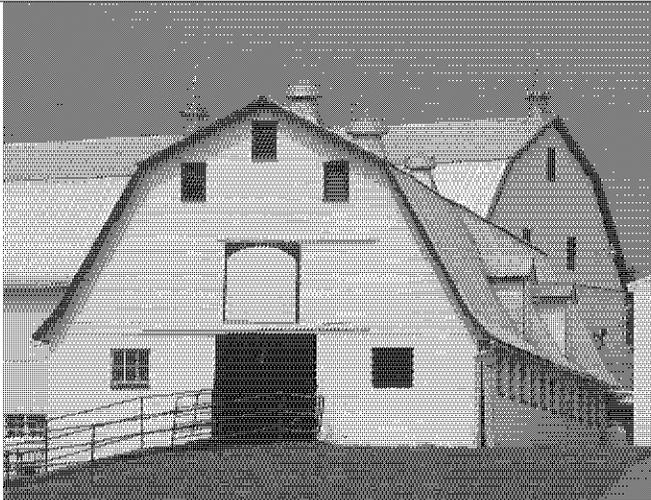
COUNTY: Washington
LOCATION: 17224 Broadfording Road

NOTES: The barn has a concrete block raised foundation and German siding in the gable section. The ridge runs southeast-northwest and has three metal ventilators. There are eleven six-light windows along the length the barn with two dormers in the lower slope of the gambrel roof. The gable end has two windows on either side of the main door, above which is a sliding hayloft door and three framed rectangular louvers providing ventilation. Behind this barn is a large banked barn, also with a gambrel roof.

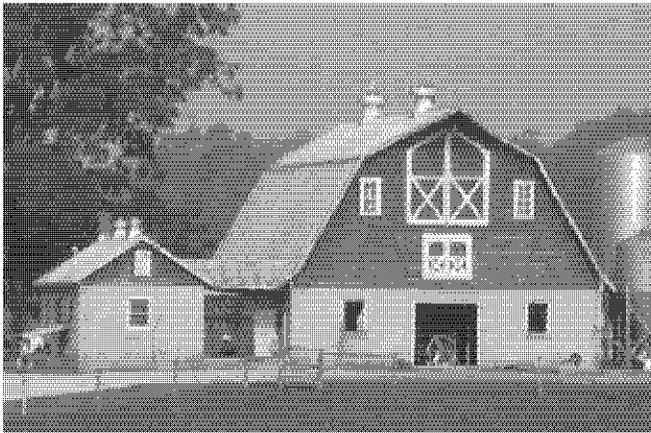
(iii) STONER-SAUM FARM
COUNTY: Carroll
LOCATION: McKinstry's Mill Road

NOTES: The barn is made of a concrete block raised foundation and has horizontal wood siding in the gable section. The ridge runs east-west and has two metal ventilators. Above the main barn door are a pair of small double doors, a pair of large hayloft doors angled to the slope of the roof with a four-over-four light sash window on either side, and a rain hood. There is also an attached dairy on the south side of this barn.

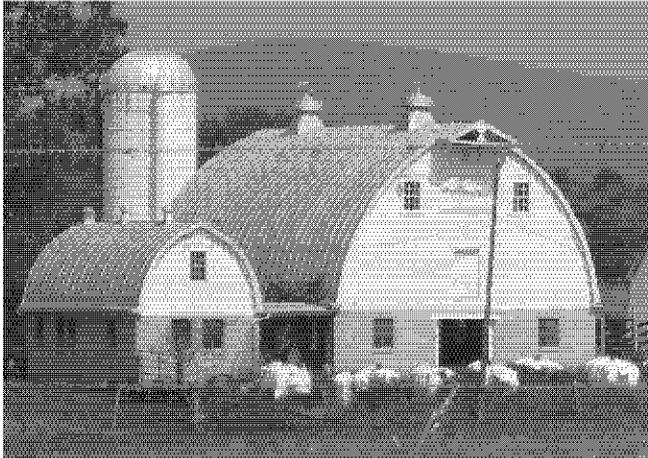
Figure 20, Pointed-arch roof dairy barn, Emmitsburg, Frederick County

Type J3 is generally identical to J4, differentiated by the concave roof planes coming to a point at the ridge to form a pointed arch or Gothic arch shape. The example shown below is located at the intersection of Four Point Road and Motters Station Road in the vicinity of Emmitsburg in Frederick County (Fig. 20). There are several other barns of this type within the region including that at the Miller-Warner Farm near Lineboro built in 1941, the Close Farm near Westminster built in the early twentieth century, and the barn at the Biggs Farm in Detour built around 1920.⁹⁷ All three of these barns are located in Carroll County. Another of this type formerly stood on the Forney-Mikesell Farm near Thurmont in Frederick

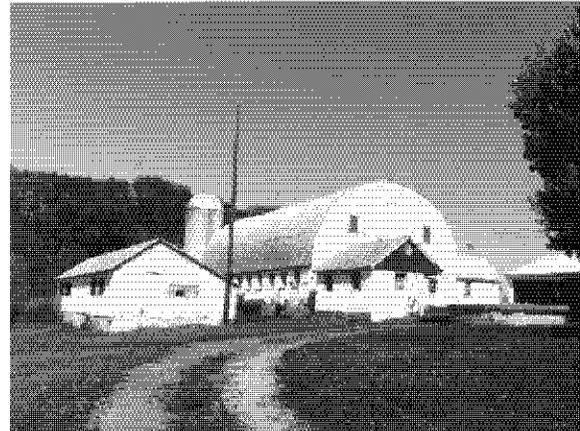
Figure 21, Martin Farm, 10427 Welty Road, Emmitsburg, Frederick County (photo: Mary Kendall Shipe)

The Martin Farm in the vicinity of Emmitsburg in northern Frederick County was the only example of this type to be encountered during this study (Fig.21). Like the other dairy barns, it is constructed of concrete block with vertical board siding but has a barrel roof covered in standing seam tin.¹⁰⁰

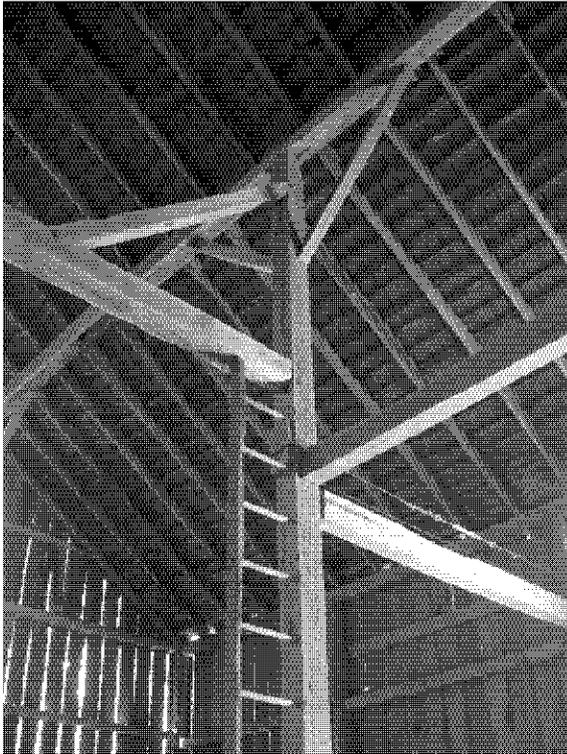
A1. Baker Farm

Braced post-to-purlin framing system. The bents have three interior posts with only the end posts running full to the height of the purlin. The central post rises to the height of the tie beam, which is much lower than the height of the purlin. Secondary girts span the space between end posts and the framing on the exterior wall.

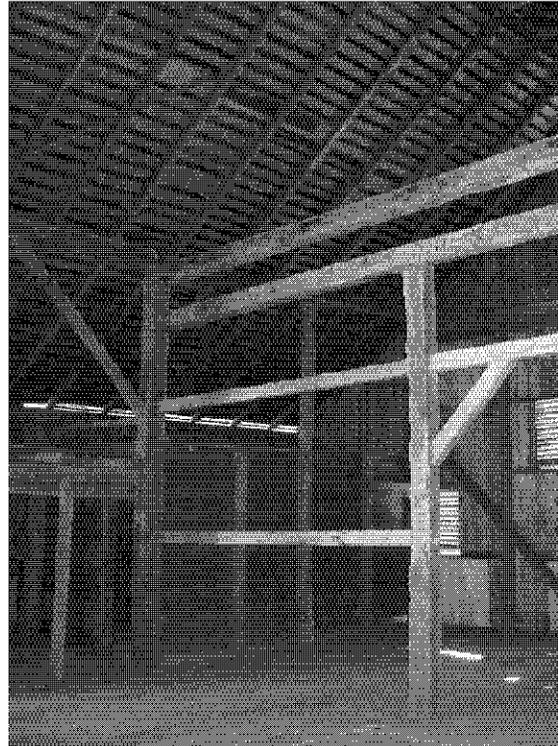
A2. Snook Farm

Braced purlin post framing with six interior bents. The central bent and those two flanking the threshing floor have three interior posts that rise full to the tie beam at the height of the purlin. The outer bent on the northwest side has three interior posts but only the end posts rise to the tie beam. A bent with two interior posts divides both mows.

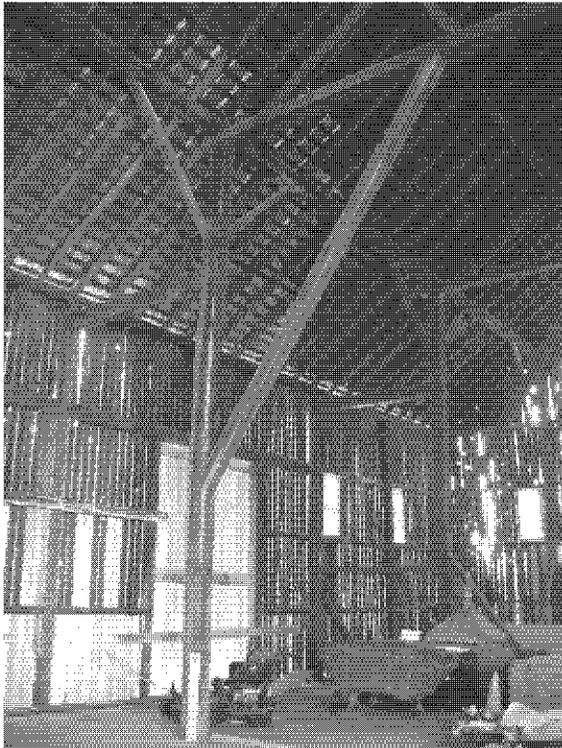
A3. Thomas Farm

Braced post-to-purlin framing system. The tie beam runs from post to post at the height of the primary purlin and supports two canted and braced queen posts with diagonal struts. Girts connect the purlin posts to the exterior wall framing at the height of the eave. Each bent has only two interior posts but especially long braces supporting the tie beam.

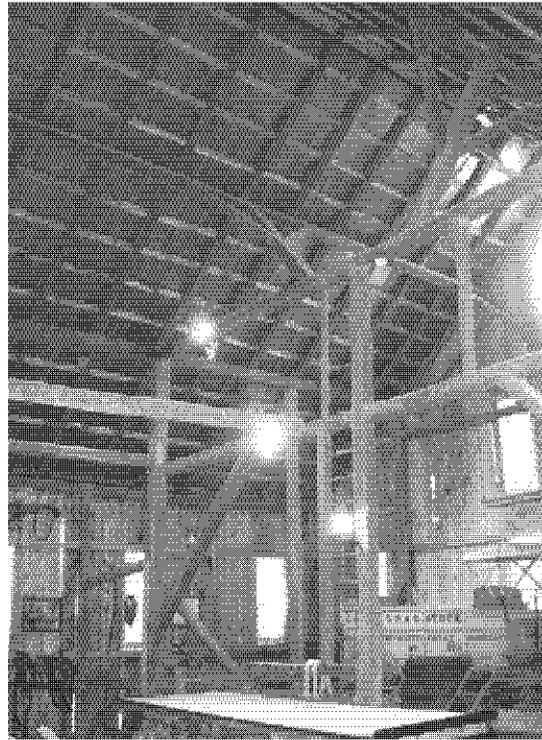
A4. Alms Barn

Braced post-to-purlin framing system. The bents have three interior posts that all run full to the tie beam at the height of the primary purlin. The tie beam supports two canted and braced queen posts. Secondary braced girts run between the posts and connect the bents at the height of the eave. They also connect the ends posts to the exterior framing.

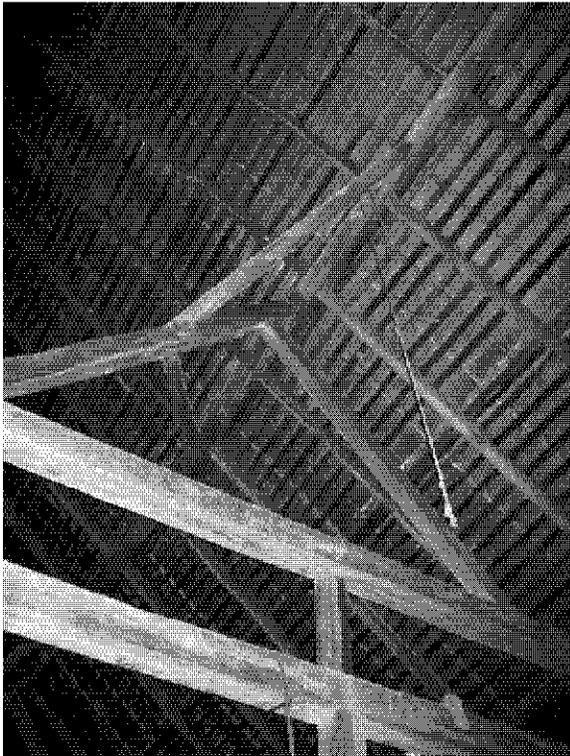
A5. Pry Farm Barn
County: Washington
Location: Antietam National Battlefield
Date: 1844

Canted and braced queen post with wind bracing framing system with three interior bents. The central bent has three posts and divides the threshing floor. This aisle post on the central bent has a bolster while all other posts have braces. All other bents have four posts. The end post, on all bents, is the only one that rises to the tie beam at the height of the eave. A girt runs between the end posts.

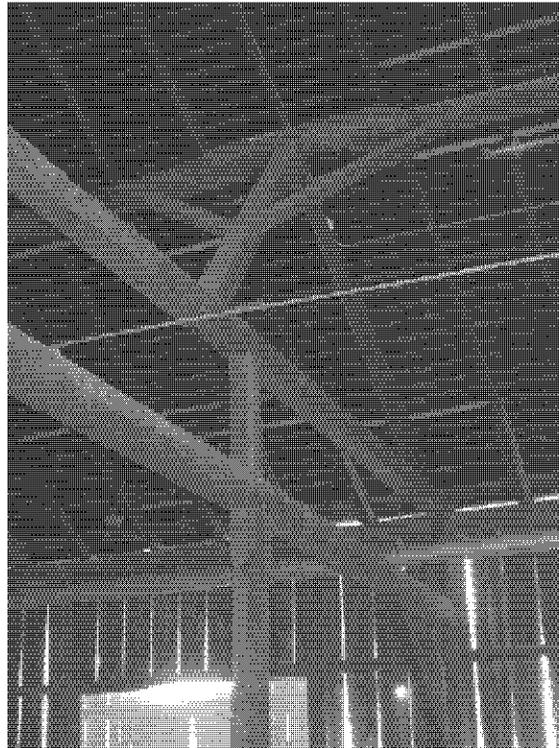
A6. Mumma Farm Barn
County: Washington
Location: Antietam National Battlefield
Date: ca. 1870

Diagonal queen post framing system similar to Pry Farm Barn (A5), although all three interior bents have four posts.

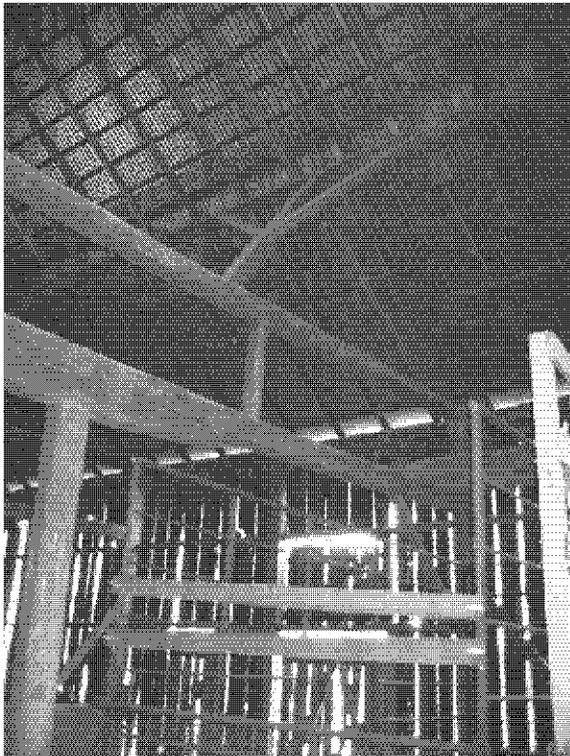
A7. Roulette Farm Barn

Four post bents with canted queen posts, except the central bent that divides the threshing floor has only three posts. The aisle post on the central bent has a bolster while end posts have braces. Only the end posts run continuously to the tie beam at the height of the eave and are supported by down braces.

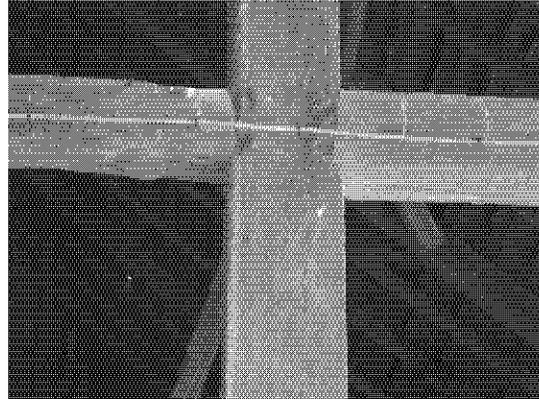
A9(ii) Smith-Reensburg Barn detail

Double pegged and shouldered mortise and tenon connection of girts to post with marriage marks. (Photo: Virginia Price)

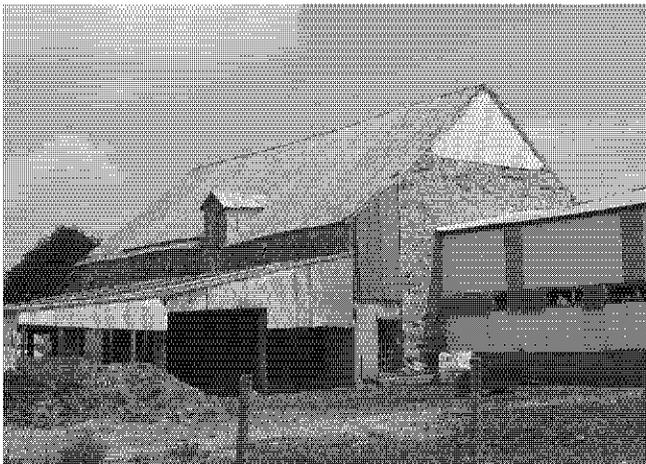
Thomas Link Barn, Stauffer Road

A2. Asymmetrical gable/open forebay (stone)

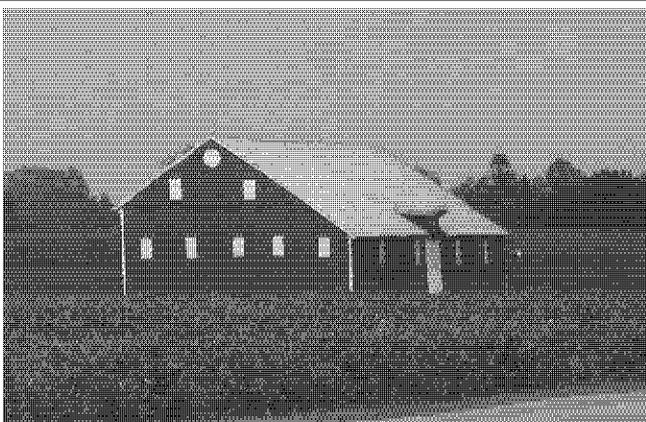
West side of Old Frederick Road north of
Eaton Road

A4. Asymmetrical gable/open forebay (timber)

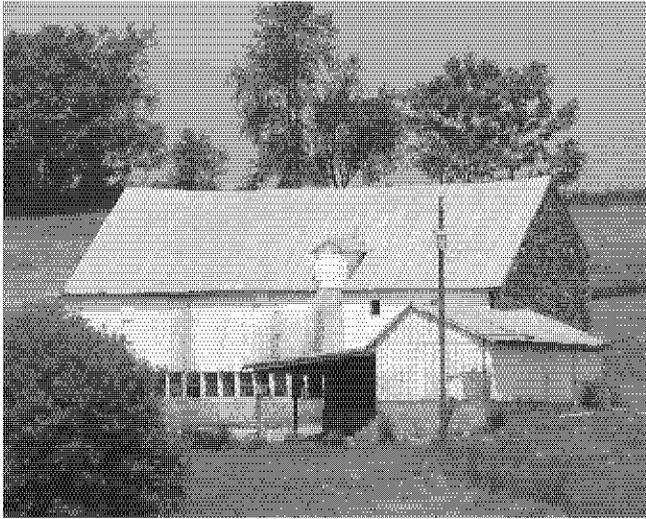
West side of Green Valley Road north of
New London Road

B1: Asymmetrical gable/closed forebay (stone)

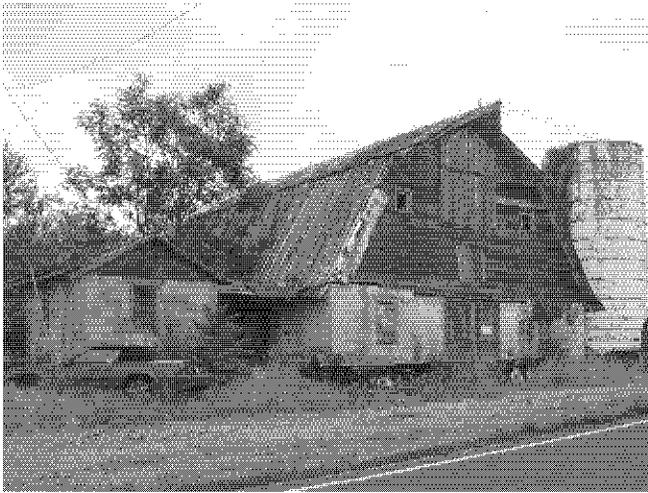
10069 McKinstry's Mill Road

L1: Gambrel roof dairy barn

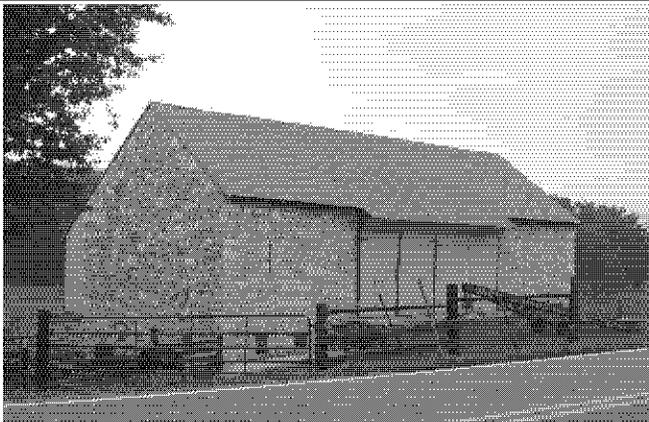
Leiters Mill Road

Note: Rear extension appears to be an addition

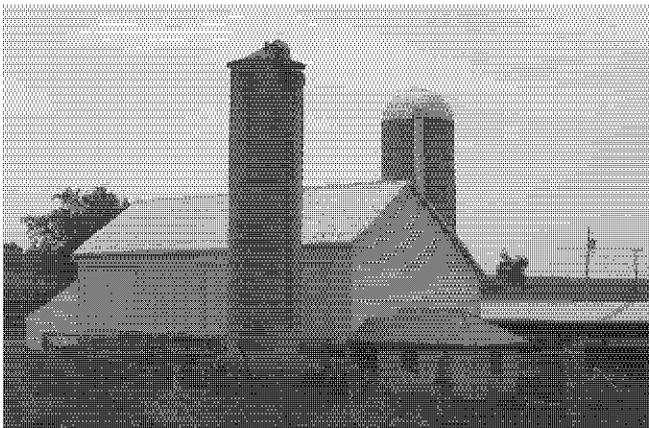
The Maples, west side Mapleville Road
(MD 66) north of Chewsville Road

Asymmetrical gable (forebay closure undetermined)

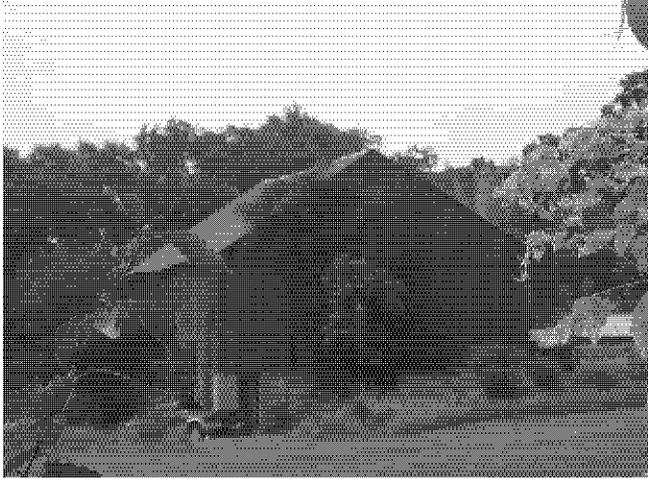
20822 Millers Church Road

Symmetrical gable/forebay closure undetermined

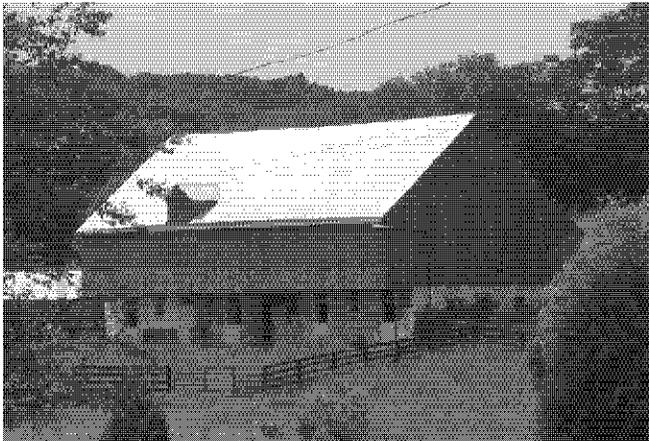
MD 144 at Gilardi Road

G: Rear extension

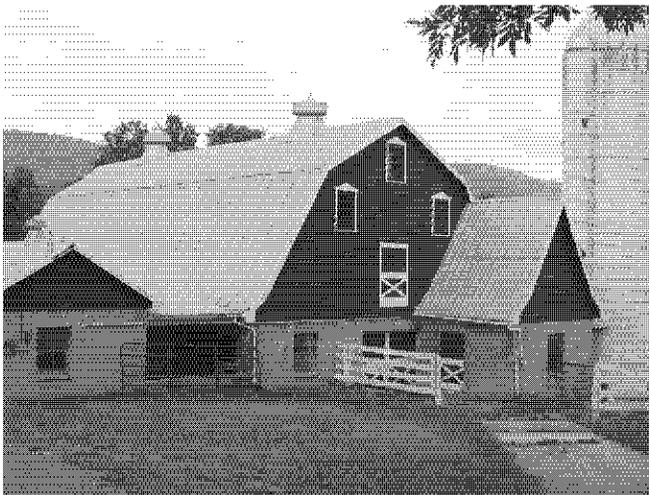
Yarrowsburg Road and MD 67

L1: Gambrel roof dairy barn (concrete block)

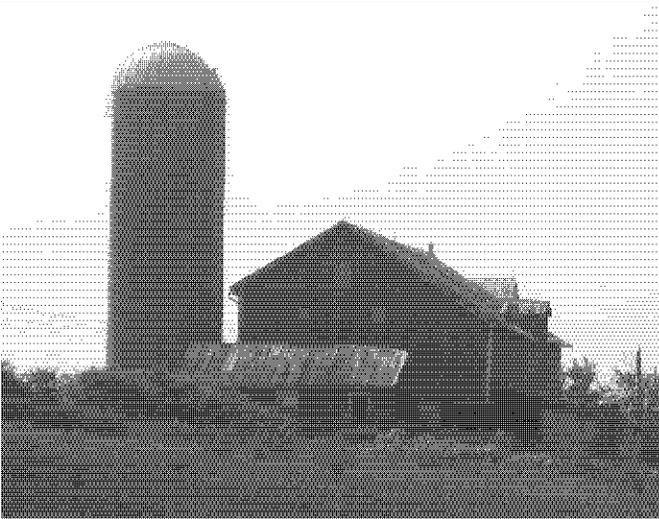
A4: Asymmetrical gable/open forebay (timber)

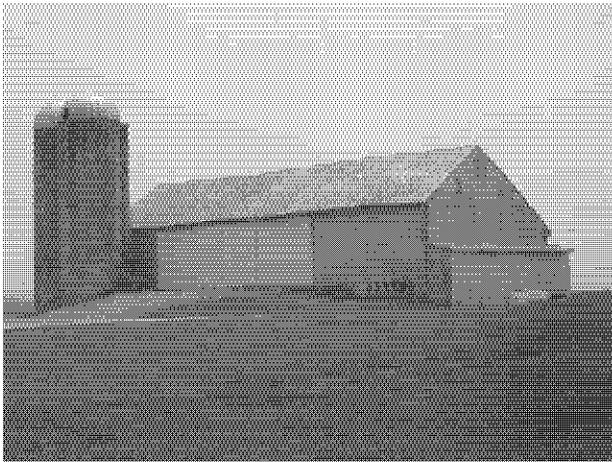
South side of Uniontown Road

C1. Symmetrical gable/closed forebay (timber)

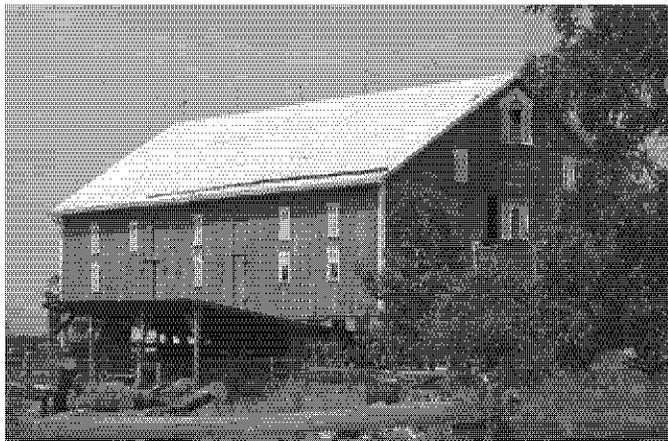
Mountview Farm, 3850 Bullfrog Road

F: Symmetrical gable/open forebay

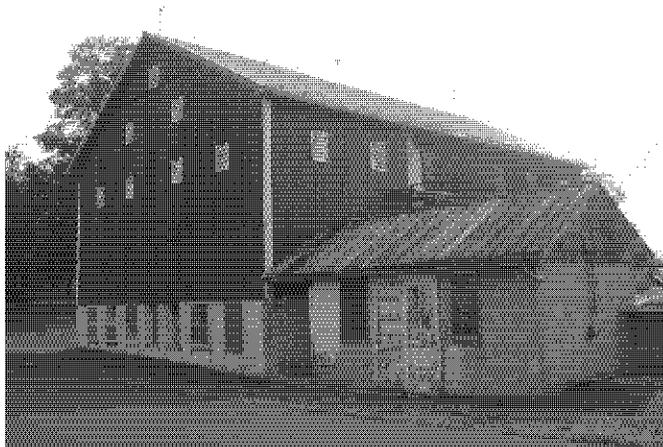
1470 McKinstry's Mill Road

Symmetrical gable/forebay closure undetermined

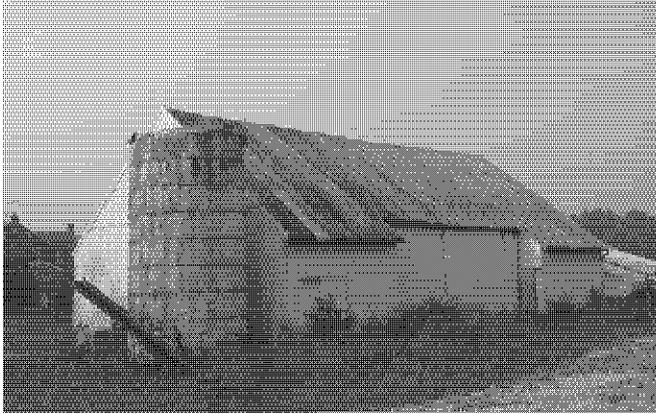
Just south of 4209 Sams Creek Road

G: Rear extension

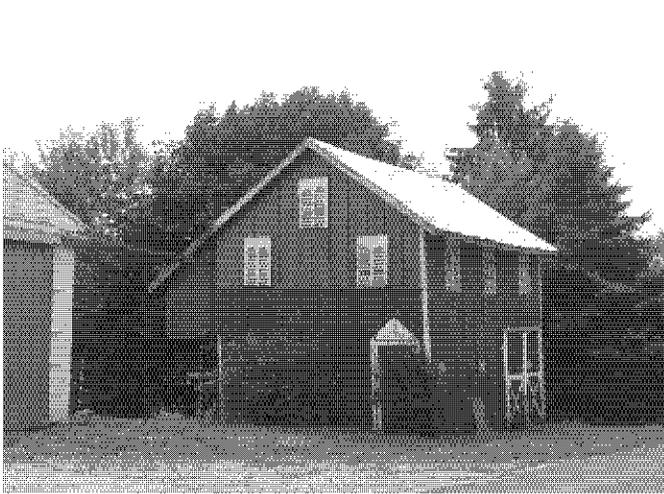
Arter's Mill Road at Flickinger Road

H2: Single unit barn with forebay (asymmetrical)

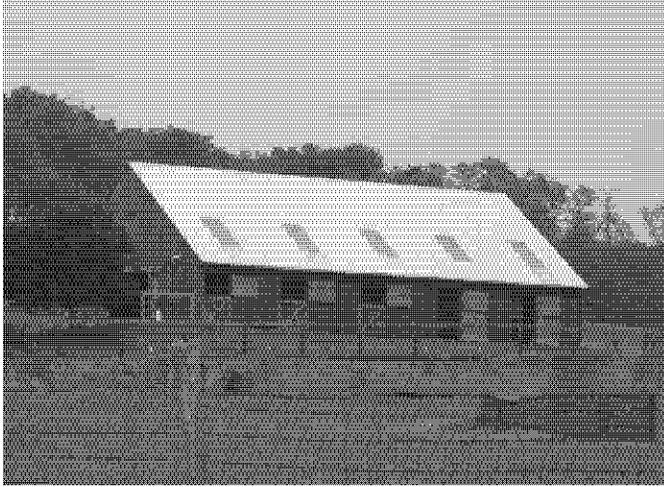
1126 Silver Valley Run Road

I1. Transverse crib barn (single slope)

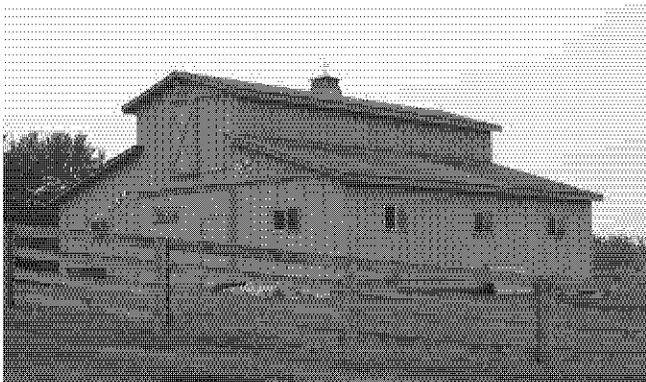
Turkeyfoot Road at Leppo Road

I2. Transverse crib barn (two slopes)

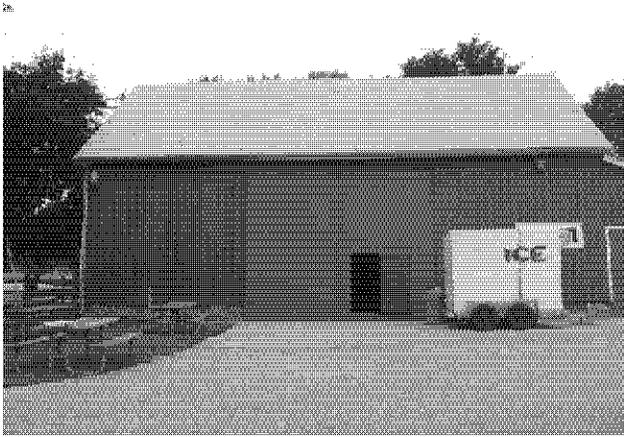
Hay barracks barn, Carroll County Farm
Museum, ca. 1850

J2: Gable three-bay barn

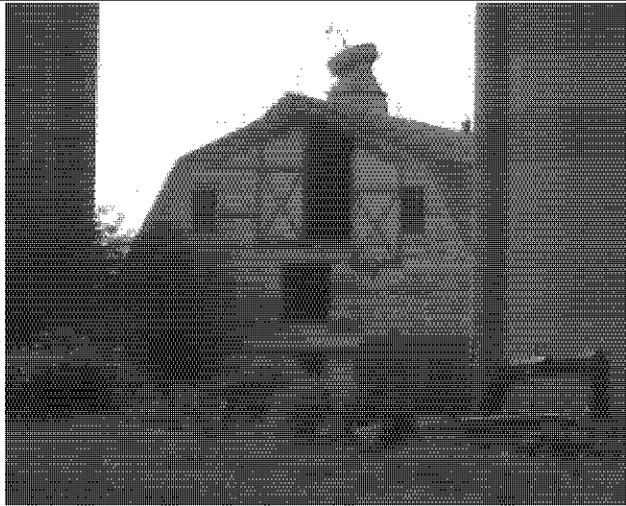
Pipe Creek Road

L1: Gambrel roof dairy barn (concrete block)

The gambrel roof of this subtype is set directly on the concrete block foundation in all but one known example, in which a couple feet of framing placed on top of the foundation elevates the roof. The eaves of the roof are flared in the Dutch gambrel style. Gambrel roof dairy barns may or may not have a rain hood. Those with a rain hood always have a set of hayloft doors directly underneath. This is the most common roof form observed for dairy barns within the region.

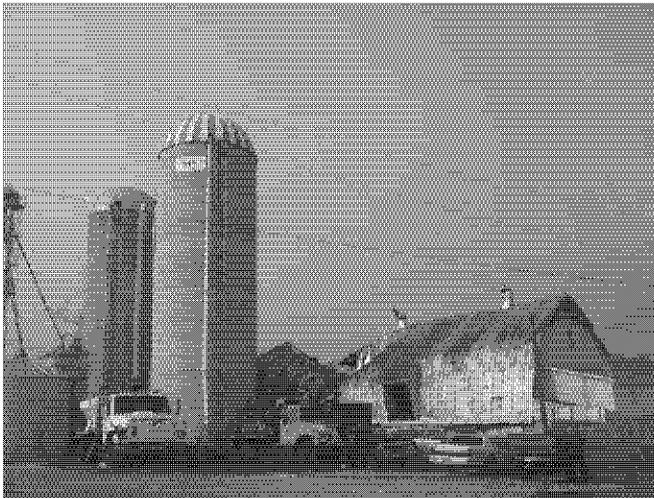
3803 Sams Creek Road

L2: Pointed-arch roof dairy barn
