CALUMET & HECLA ROUNDHOUSE
Northeast corner of Mine & Depot Streets
Calumet
Houghton County
Michigan

HABS No. MI-428

WRITTEN HISTORICAL AND DESCRIPTIVE DATA

HISTORIC AMERICAN BUILDINGS SURVEY
National Park Service
U.S. Department of the Interior
1849 C St. NW
Washington, DC 20240

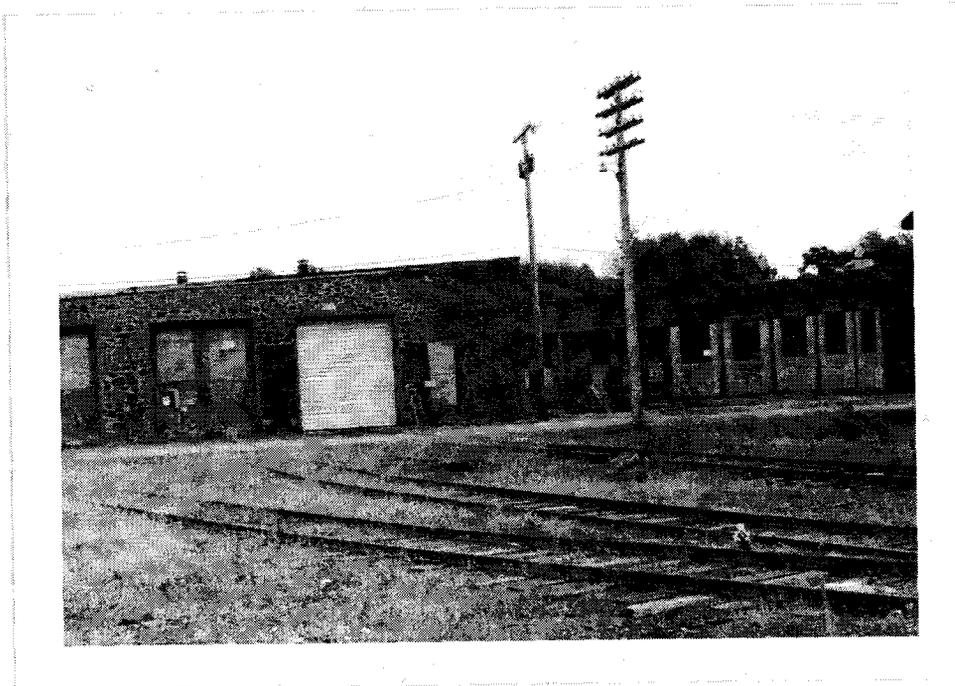
Fig. 1 View looking west to east generally at the roundhouse's Mine Street (west) elevation.
Note section in foreground dates to 1902. Photograph by author, 1975.

- Significance: The Calumet and Hecla Roundhouse, built in four stages between 1886 and 1928, is a handsome train maintenance building constructed in the particularly distinguished broken ashlar patterns imported to the region by Cornish miners (fig. 1). The shed serviced the locomotives and cars of the Calumet and Hecla Mining Company. This copper mining firm operated its own railroad and maintained its own stock to insure the efficient operation of all its interests.

3. Walls: The roundhouse walls consist of hammer-dressed, random ashlar masonry, pointed, of the predominantly gray, local poor rock.

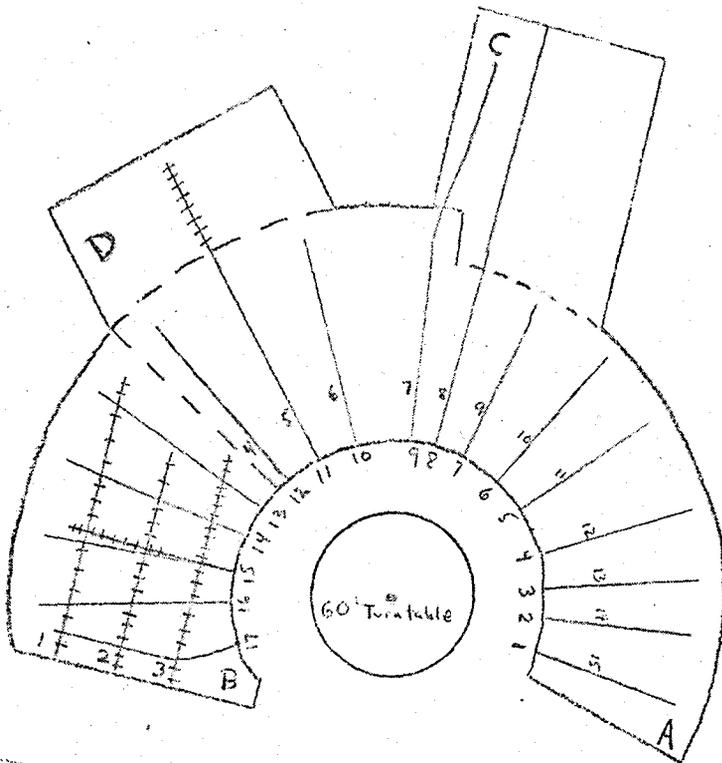
Fig. 2 Sketch plan of the roundhouse.

C+H Round House - Sketch plan

- A 1886-8 structure:
- B 1902 addition
- C 1907 addition
- D 1928 addition
- Train bays before 1928
- + Train bays added 1928

Track numbers after 1928 are numbered clockwise

Train bays are numbered counter-clockwise

1. Overall dimensions: The roundhouse is a one-story structure that is semi-circular in shape with two rectangular projections. Facing the turntable, the 1886-88 façade extends for twelve bays, plus another five bays on the 1902 addition. Facing Mine Street, there are three bays; these were constructed in 1928 although the building dates to 1902. The 1907 addition has two bays in the east wall, while the northeast wall of the 1928 addition contains one bay.

1. Floor plan: The roundhouse is a one-story structure encompassing 225 degrees of train roundhouse with three rectangular additions alongside the outside of the ring (fig. 2). One addition, recently (ca. 1965) built of concrete block, is merely a corridor connecting the roundhouse with the paint shop to the north. Since the roundhouse was originally designed to service locomotives and other railroad cars, the interior spaces were fitted to that purpose. The additions were designed to enhance and support that activity. Of the maximum of nineteen train bays, only about eight could still be used for that purpose since other doors have been closed up in or tracks removed, or both. The additions are now used as work, storage, and office space by a two-person crew of Universal Oil Products' employees and as a warehouse by Coppertown, USA.
