MONTANA-DAKOTA UTILITIES BUILDING
(BILLINGS GAS COMPANY BUILDING)
2603 2nd AVENUE NORTH
BILLINGS, MONTANA
YELLOWSTONE COUNTY

HABS No. MT-120

WRITTEN HISTORICAL AND DESCRIPTIVE DATA
DRAWINGS
FIELD RECORDS

MONTANA-DAKOTA UTILITIES BUILDING (Billings Gas Company Building)

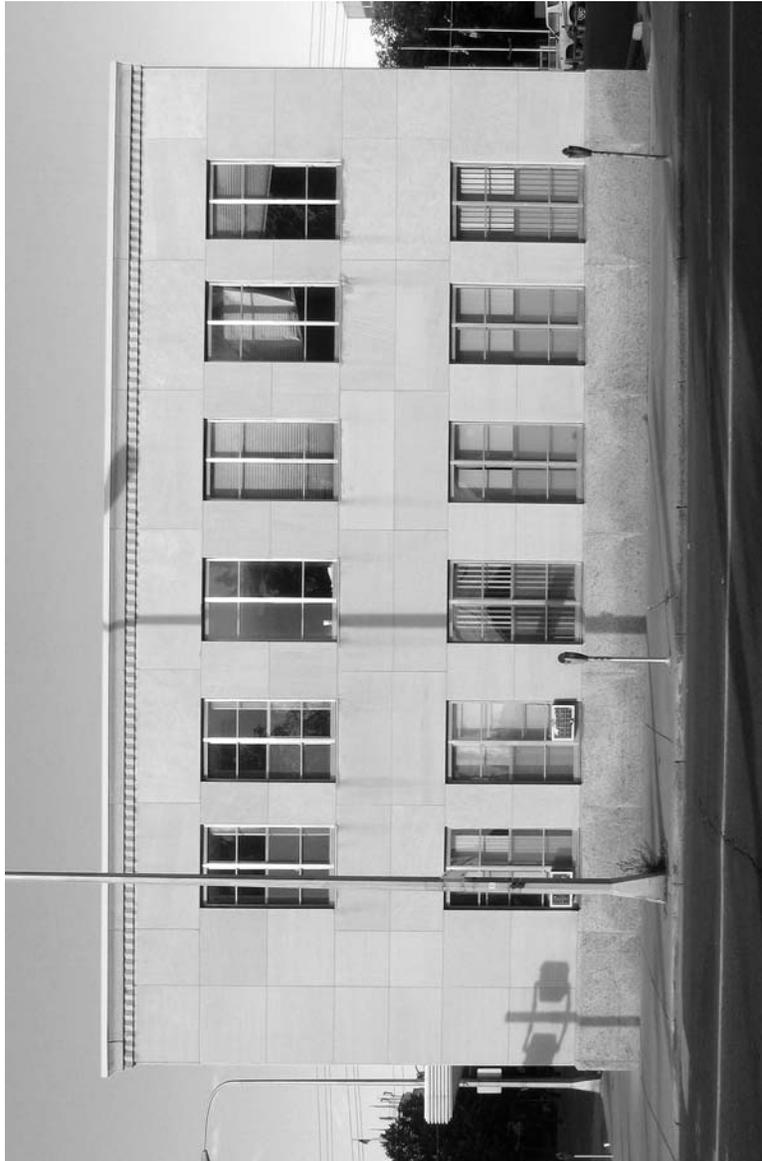
PHOTOGRAPH NO. MT-120.3

MT-120.1	Exterior elevation, from southeast
MT-120.2	South elevation
MT-120.3	East elevation
MT-120.4	South elevation – close-up of entry
MT-120.5	South elevation – close-up of entry from southeast
MT-120.6	Southeast elevation – close-up of cornice
MT-120.7	South elevation – close-up of public stairway entry, from southeast
MT-120.8	West elevation
MT-120.9	Drive-up payment booth, from northwest
MT-120.10	North elevation
MT-120.11	Exterior elevation, from northwest
MT-120.12	Entry lobby, looking east
MT-120.13	Original teller area, looking northeast
MT-120.14	Interior public stairway, looking southwest from first floor
MT-120.15	Second floor hallway, looking east
MT-120.16	Second floor hallway – close-up of door transom
MT-120.17	Second floor northwest office, looking northwest
MT-120.18	Interior public stairway, looking south from second floor
MT-120.19	Demonstration kitchen at west end of employee meeting room in basement
