PISGAH NATIONAL FOREST INN, KALMIA CABIN  
Blue Ridge Parkway Milepost 408.6  
Ashville  
Buncombe County  
North Carolina

HABS No. NC-356-F

ARCHITECTURAL DATA FORM

RENTAL CABIN  
" KALMIA " CABIN

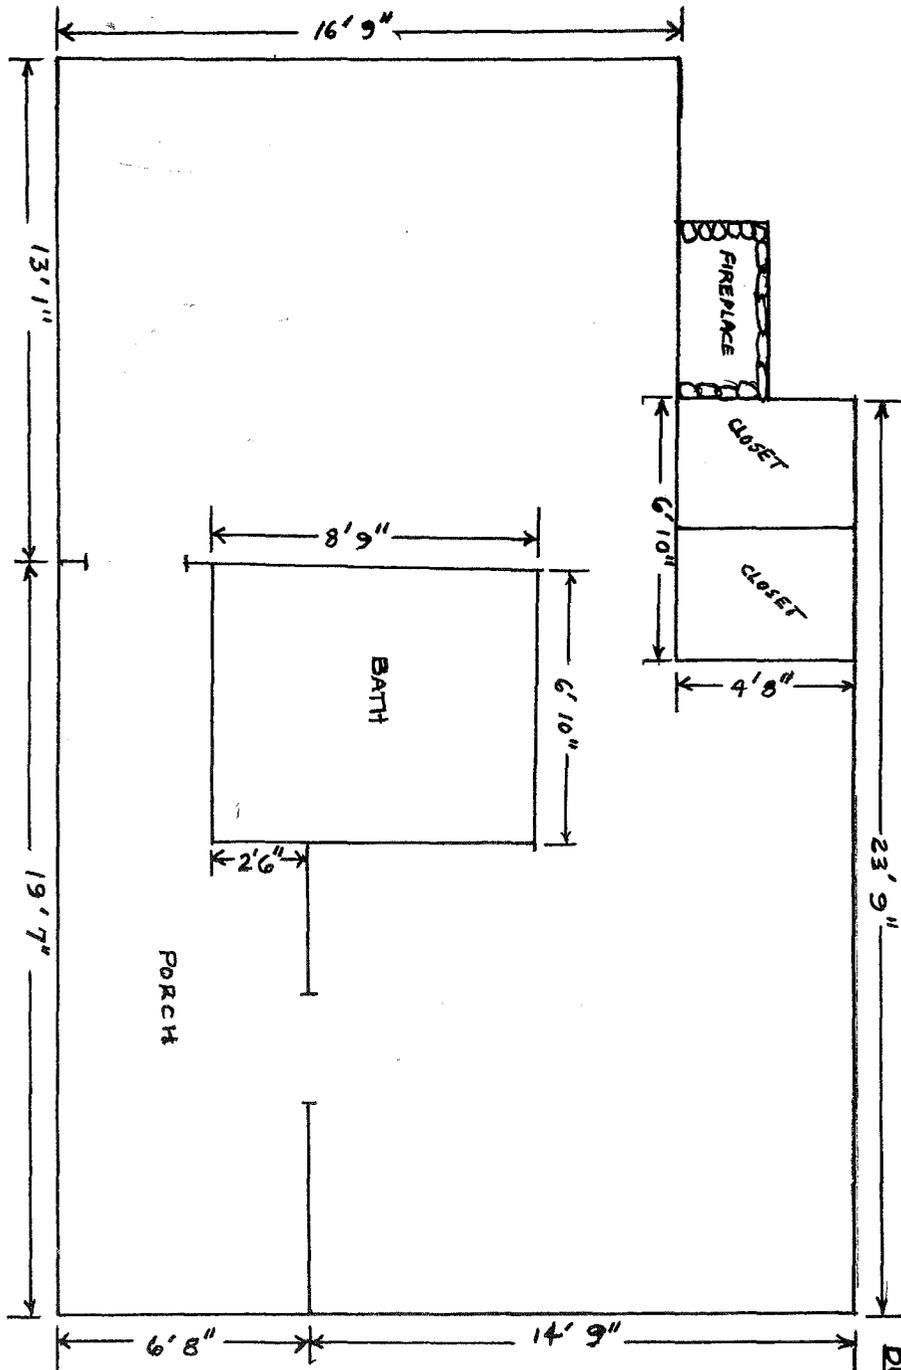
HABS SKETCH DRAWING  
NOVEMBER 25, 1987

1" = 5 FT

543 sq. Ft.

S. PE AND DIMENSIONS OF STRUCTURE (SKETCHED FLOOR PLANS ON SEPARATE PAGES ARE ACCEPTABLE) Kalmia Cabin is a one-story rectangular structure with a shed porch and gabled roof.		
EXTERIOR FEATURES OF NOTE Kalmia Cabin has an exterior chimney for the fireplace in the northwest corner.		
INTERIOR FEATURES OF NOTE (DESCRIBE FLOOR PLANS, IF NOT SKETCHED) The cabin consists of two bedrooms, each with a separate entrance from the porch; a bath connects the two rooms.		
MAJOR ALTERATIONS AND ADDITIONS WITH DATES There have been changes to meet life safety codes including walls, doors, bathroom fixtures, smoke alarms, and these have had some impact on structural integrity.		
PRESENT CONDITION AND USE Kalmia Cabin is a badly deteriorated structure. It has been used since the late 1960's for concessioner seasonal employee housing.		
OTHER INFORMATION AS APPROPRIATE None		
SOURCES OF INFORMATION (INCLUDING LISTING ON NATIONAL REGISTER, STATE REGISTERS, ETC.) tional Register of Historic Places Inventory, Nomination Form, 10/14/82 completed by a consultant to the North Carolina Division of Archives and History, updated and amplified 3/26/86 by National Park Service, Southeast Region.
