OVERHILLS, HAY SHED
(Building No. 137)
Overhills Historic District
East of Nursery Road
Fort Bragg
Harnett County
North Carolina

HABS
NC-407-D

OVERHILLS, HAY SHED

(Building No. 137)

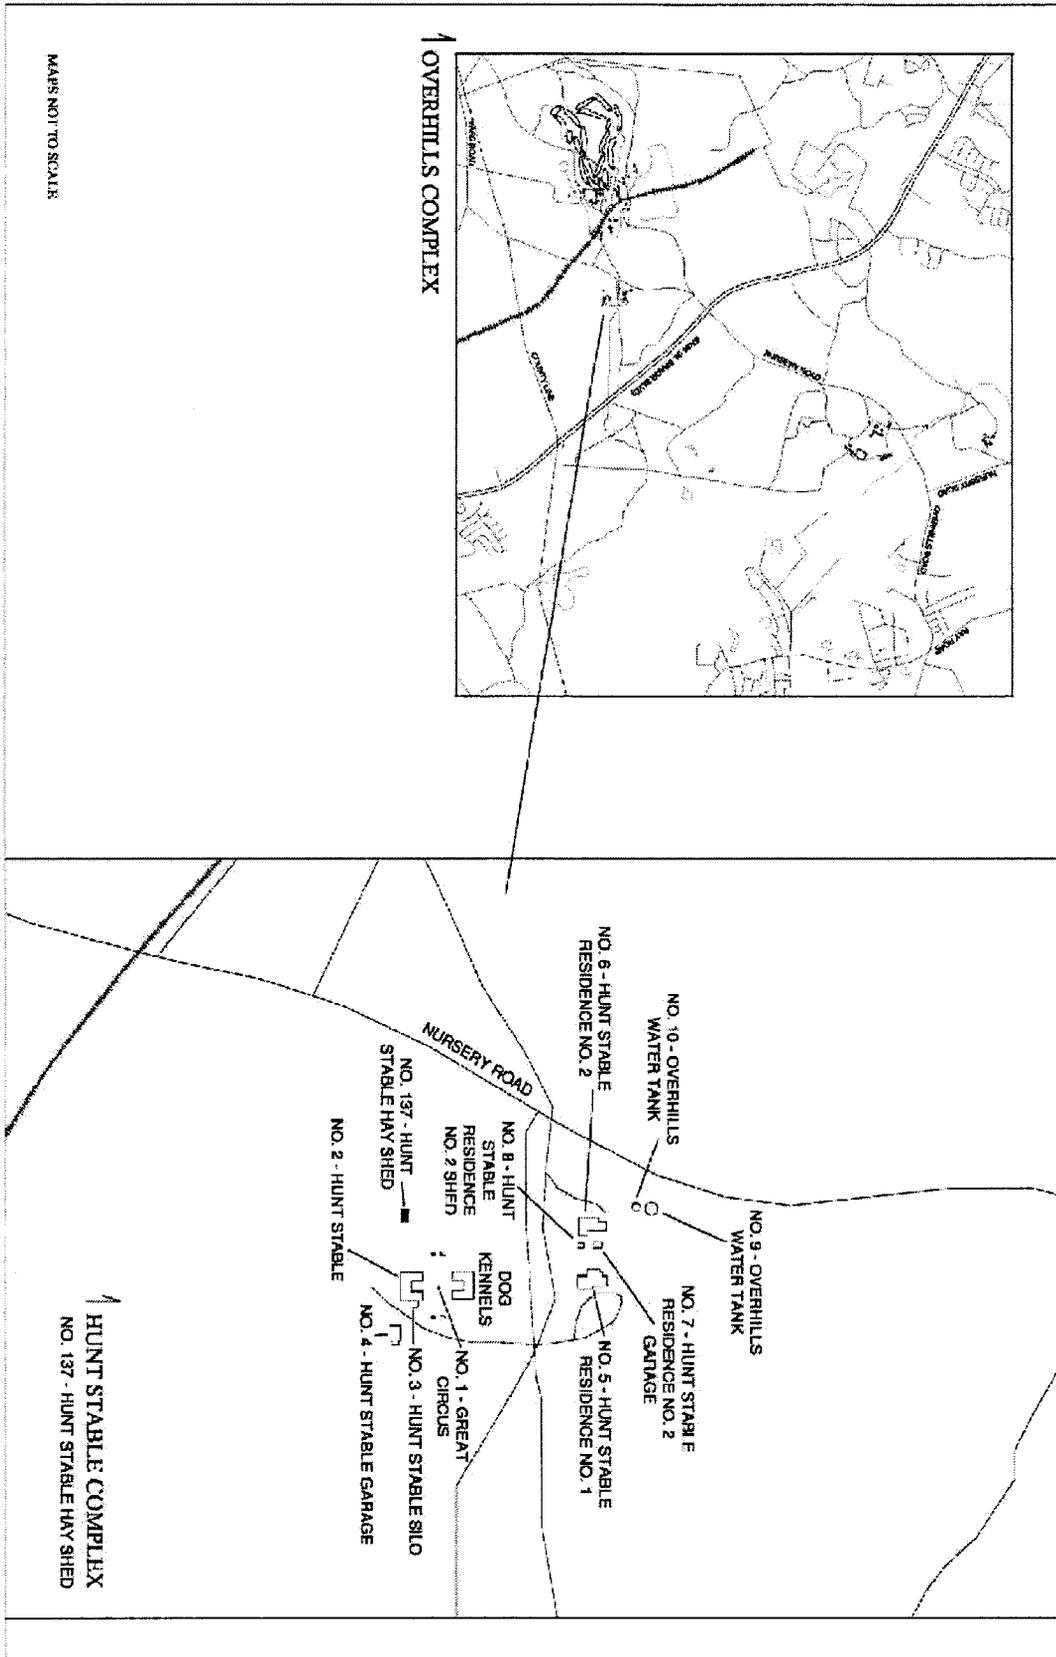
OVERHILLS, HAY SHED
(Building No. 137)
HABS No. NC-407-D (page 6)

The east elevation (Photo NC-407-D-1) is blind with plank boards abutted to the planks of the north facade.

The south elevation (Photo NC-407-D-1) is also sided with plank boards and contains the only entrance to the shed. A metal feed bin is attached to the siding to the left of the entrance.
