OVERHILLS, RIDING STABLE
(Building No. 15)
Overhills Historic District
West of Nursery Road & North of Thurman Road
Fort Bragg
Harnett County
North Carolina

HABS NC-407-H
NC-407-H

HISTORIC AMERICAN BUILDINGS SURVEY

HABS No. NC-407-H

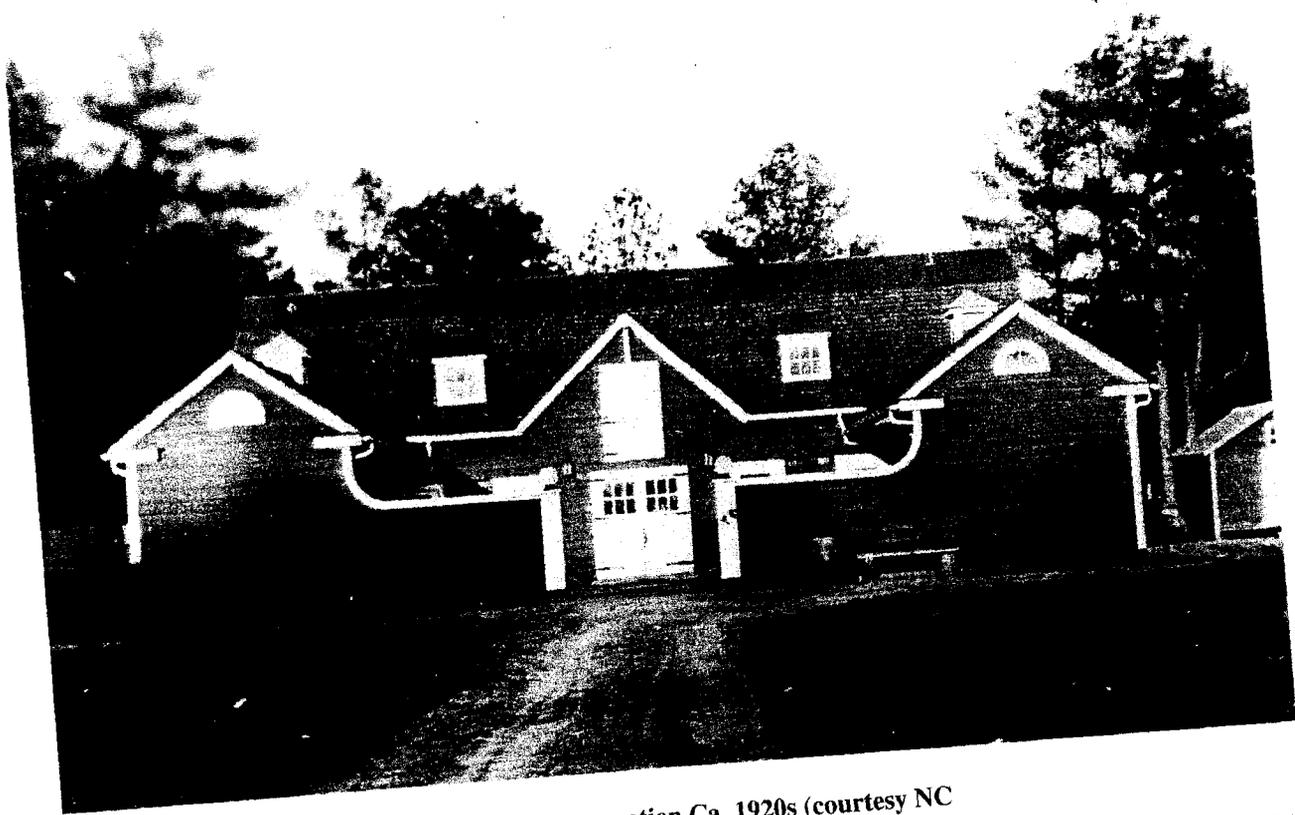
Figure 1: Overhills Riding Stable after first renovation Ca. 1920s (courtesy NC SHPO)

blocks (See figure 1). A small addition was also built next to stable block on northwest.

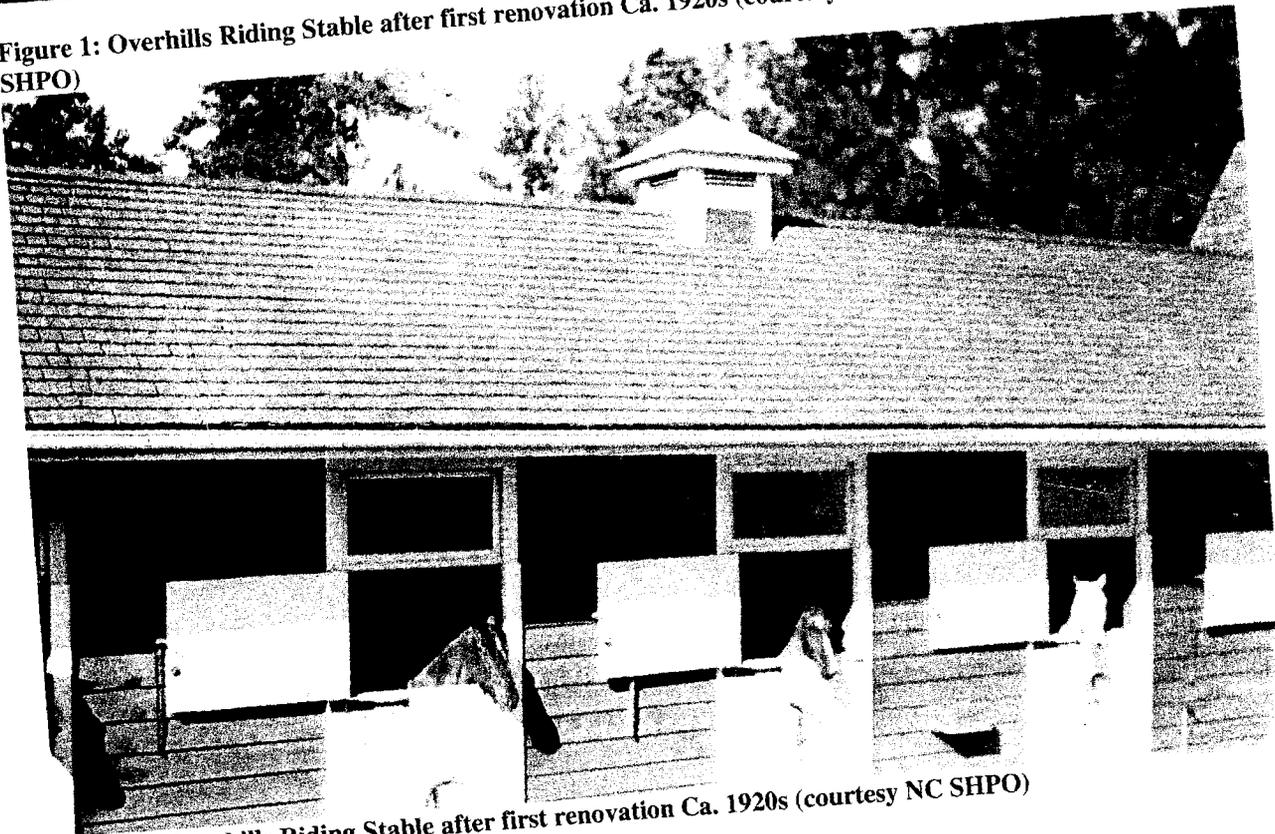
Figure 2: Overhills Riding Stable after first renovation Ca. 1920s (courtesy NC SHPO)

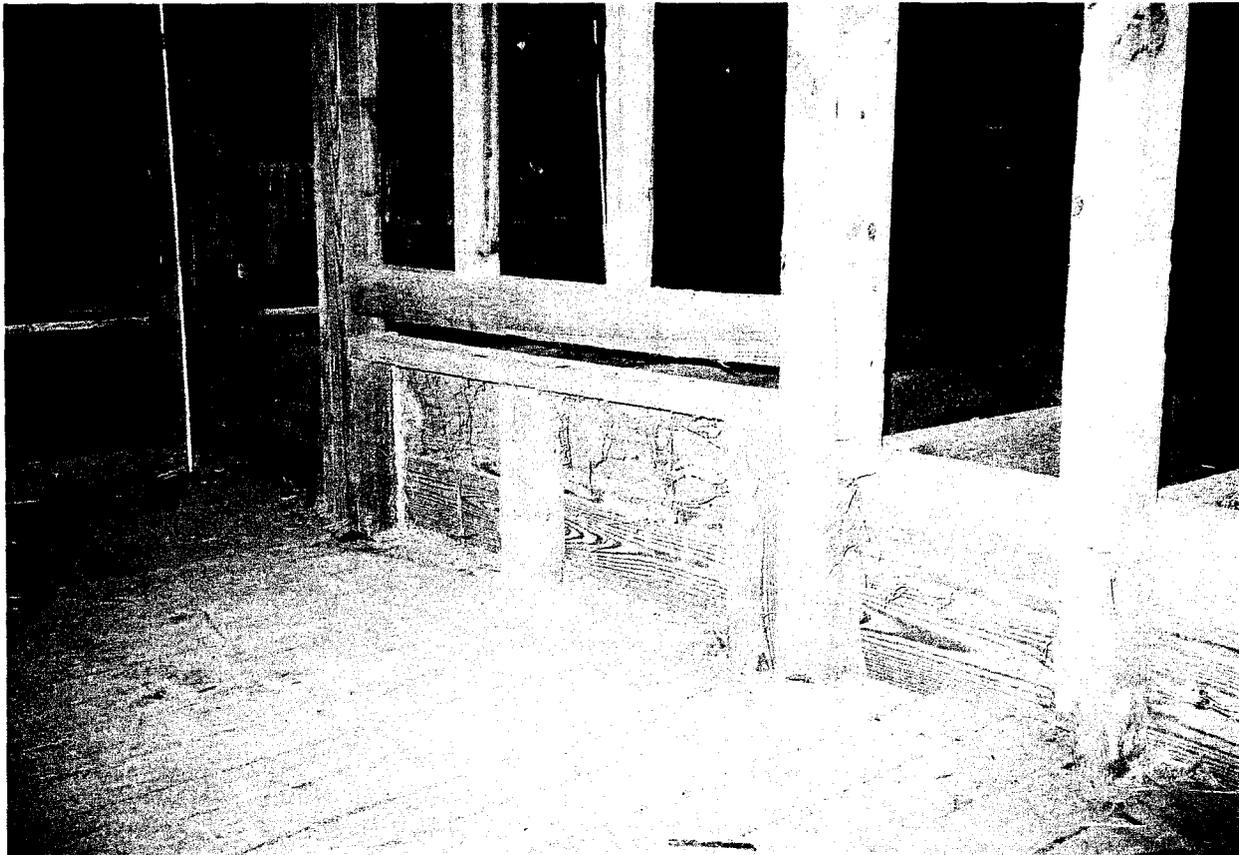
Figure 3: Overhills Riding Stable hayloft detailing old transoms shown in figure 2 (ERDC-CERL).
