OVERHILLS, HARRIMAN COTTAGE  
(Building No. 46)  
Overhills Historic District  
West of Thurman Road & East of Overhills golf course  
Fort Bragg  
Harnett County  
North Carolina

# HISTORIC AMERICAN BUILDINGS SURVEY

## OVERHILLS, HARRIMAN COTTAGE

HABS No. NC-407-AA

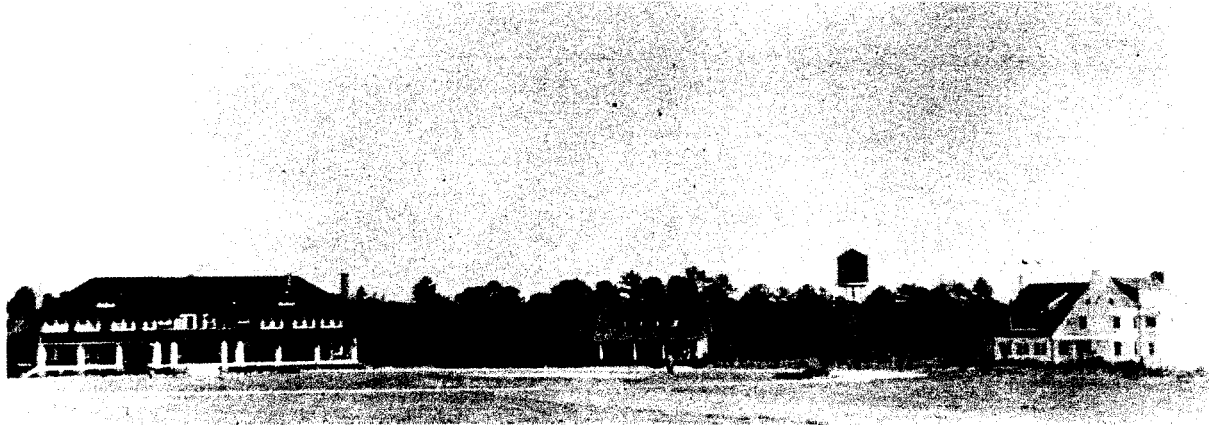
**Figure 1: L-R Overhills Country Club, Harriman Cottage, Covert Cottage, view to the east Ca. 1920s (courtesy PWBC, Fort Bragg).**

(1) View of Overhills Country Club, Harriman, and Covert Ca. 1920s.

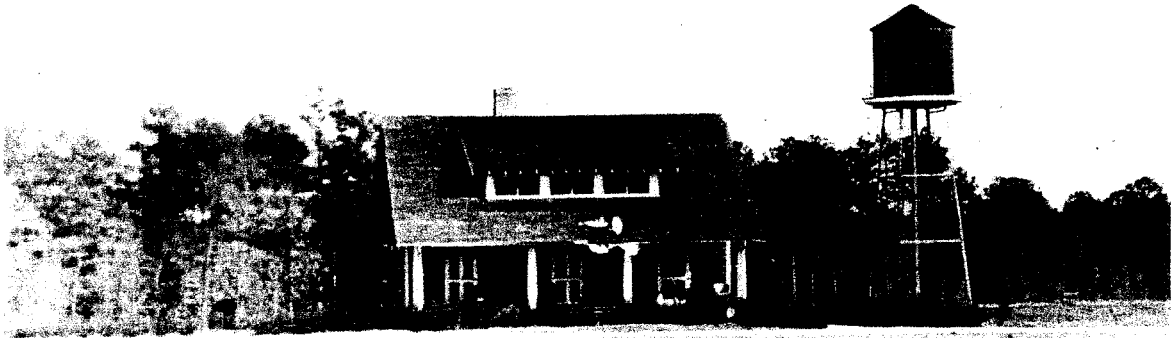
**Figure 2: Harriman Cottage, view to the east Ca. 1920s (courtesy PWBC, Fort Bragg).**

(2) View of Harriman Ca. 1920s.
