RARITAN ARSENAL, WAREHOUSE M-4  
2890 Woodbridge Avenue  
Bonhamton Vicinity  
Middlesex County  
New Jersey

HABS No. NJ-1061-B

HISTORIC AMERICAN BUILDINGS SURVEY  
RARITAN ARSENAL, WAREHOUSE M-4 HABS No. NJ-1061-B

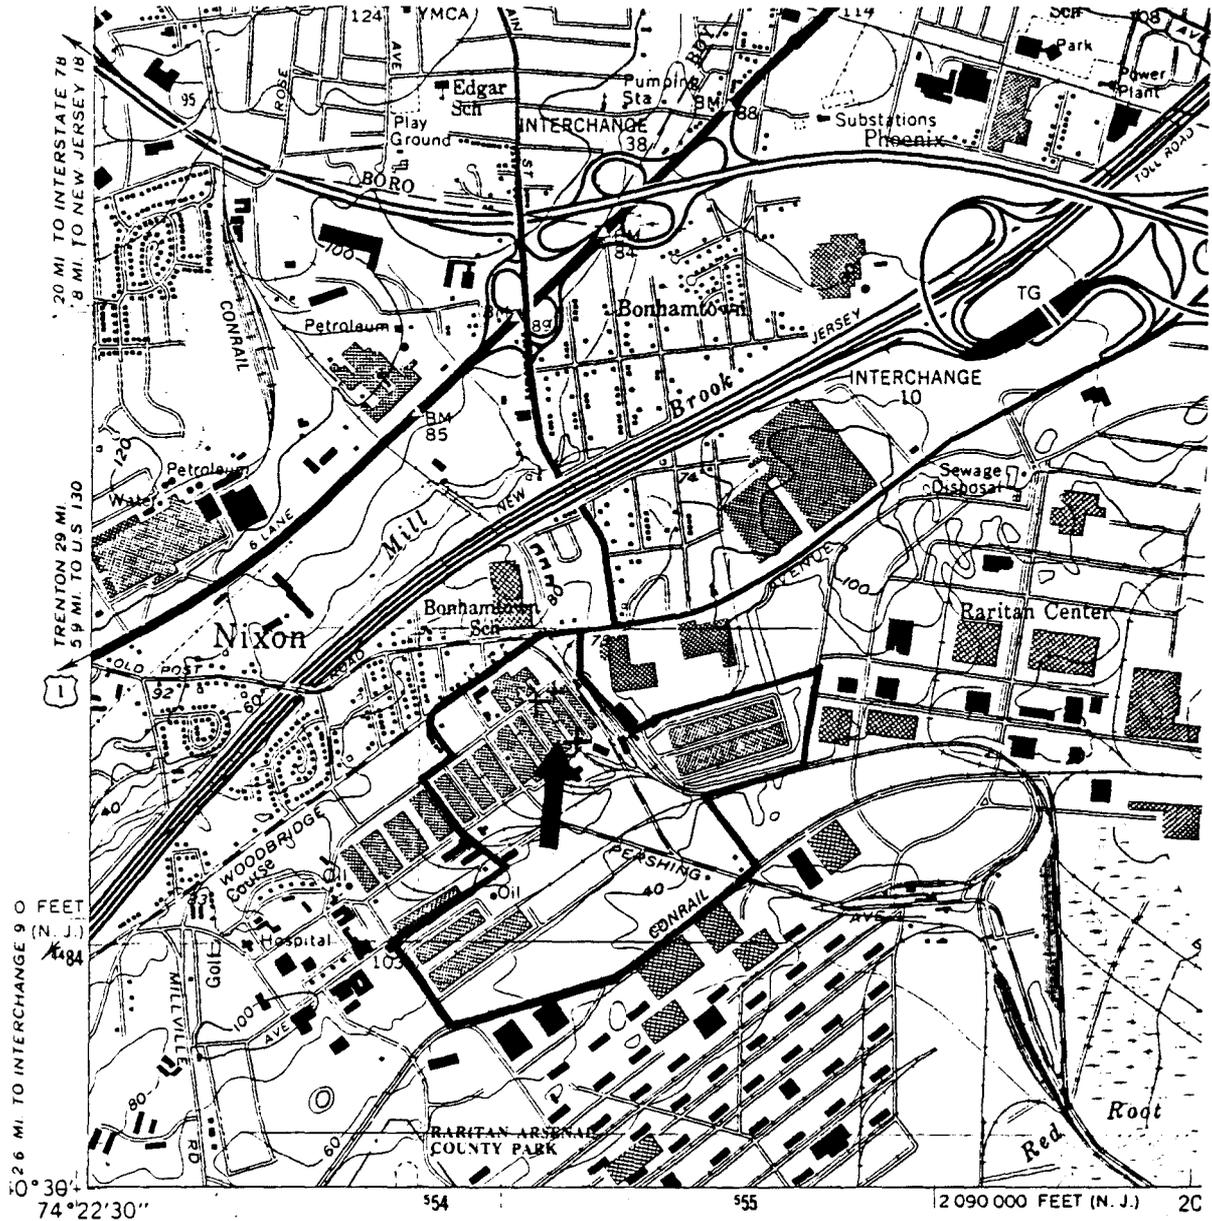
PROPERTY SITE PLAN

Map showing the extent of the Raritan Arsenal now owned by U.S. E.P.A. Arrow points to subject building.

Base map is USGS Perth Amboy Quad (1956, photorevised 1981), 7.5 minute series.

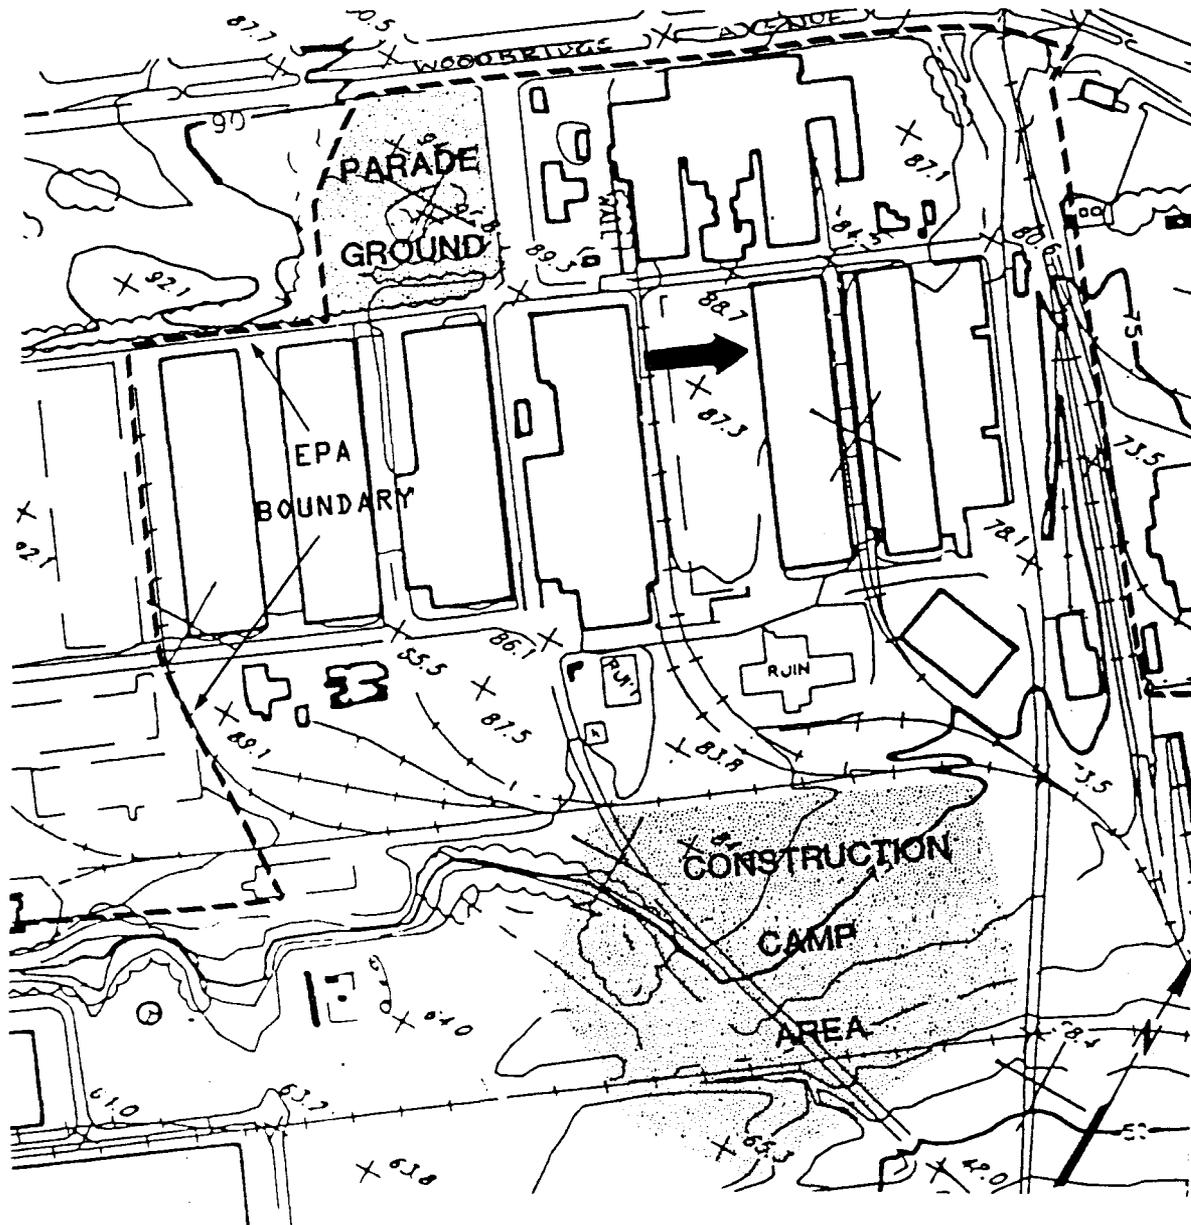
PROPERTY PLOT PLAN

Map of the E.P.A.-owned property which includes part of the former Raritan Arsenal. Arrow points to subject building. Base map is from Figure 17 of the Stage I Cultural Resources Survey, U.S. Environmental Protection Agency Edison Facility, 1990.

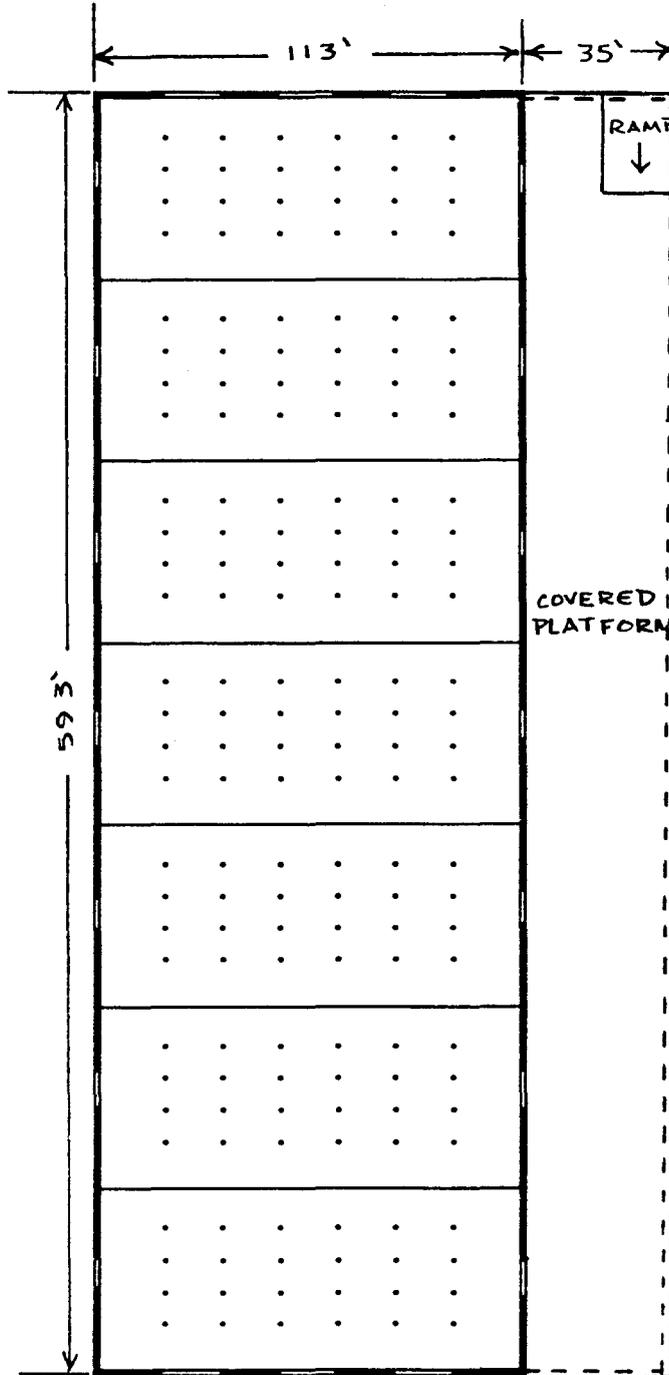
SKETCH FLOORPLAN  
Not to scale

1. Floor plans: The single-story building is arranged on a grid system. The building has six wooden piers, each sixteen feet

apart and sixteen feet from the side walls, across its width (east-west axis). Four wooden piers, each sixteen feet apart, occupy the length (north-south axis) of all seven bays; the end piers of each bay are sixteen feet from an internal fire wall. Thus, one 80-foot section forms one bay, with a door centered in each of the exterior walls of the bay. The fire walls originally had three evenly-spaced openings; variations in this pattern on some spaces are due to later alterations. The building is thus composed of a series of large rooms, lighted on two sides and from the skylight above, with direct exterior access as well as access from identical rooms through internal fire doors.

1. Architectural character: The warehouse is a single-story rectangular building, with regularly spaced brick piers on the exterior and wooden piers on the interior in a grid of sixteen feet on center. Interior fire walls of hollow tile divide the building into bays. (See attached floorplan). The regular grid gives the building its form, and dictates the spacing of openings within the bays. It is a building whose form is a direct expression of function, not style.
