NEW YORK STATE BARGE CANAL, GUARD GATE 15 (MEDINA)
(Erie Canal, Guard Gate 15 (Medina))
West of Bates Road bridge
Medina
Orleans County
New York

HAER NY-496
HAER NY-496

WRITTEN HISTORICAL AND DESCRIPTIVE DATA

NEW YORK STATE BARGE CANAL, GUARD GATE 15 (MEDINA) Erie Canal, Guard Gate 15 (Medina)

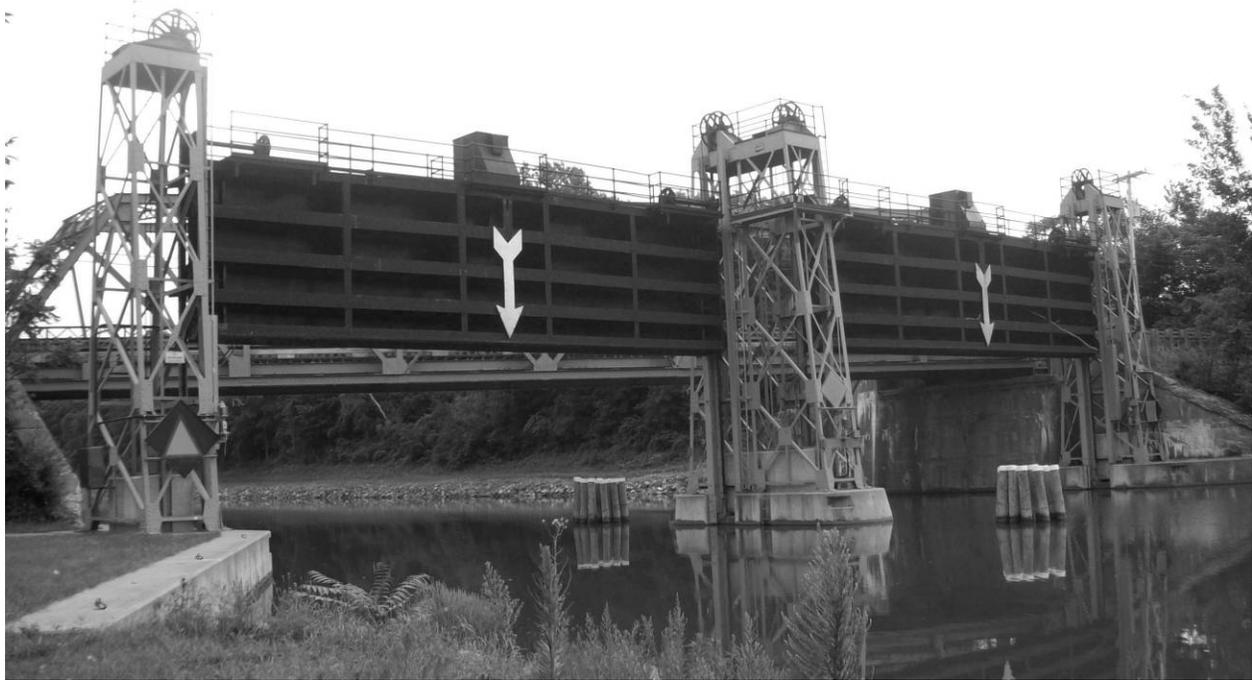
Image: Guard Gate 15. Field photograph taken by HAER recording team, summer 2009.

Description: Guard Gate 15 spans the Erie Canal and is typical of the guard gates on the Barge Canal.¹ The guard gate consists of a two-span, riveted-steel superstructure on concrete center piers and abutments. The 55'-wide steel gates are offset and are frame with steel skin plates on the upstream side. The guard gate operates with cables and steel and reinforced-concrete counterweights running over sheaves on steel lattice towers. A modern steel mechanical cabinet sits on top of each gate. Guard Gate 15 is in good condition.
