NEW YORK STATE BARGE CANAL, LOCK CS4
(Cayuga-Seneca Canal, Lock CS4)
Intersection of Locust and Washington streets
Waterloo
Seneca County
New York

HAER NY-524
HAER NY-524

WRITTEN HISTORICAL AND DESCRIPTIVE DATA

NEW YORK STATE BARGE CANAL, LOCK CS4 (Cayuga-Seneca Canal, Lock CS4)

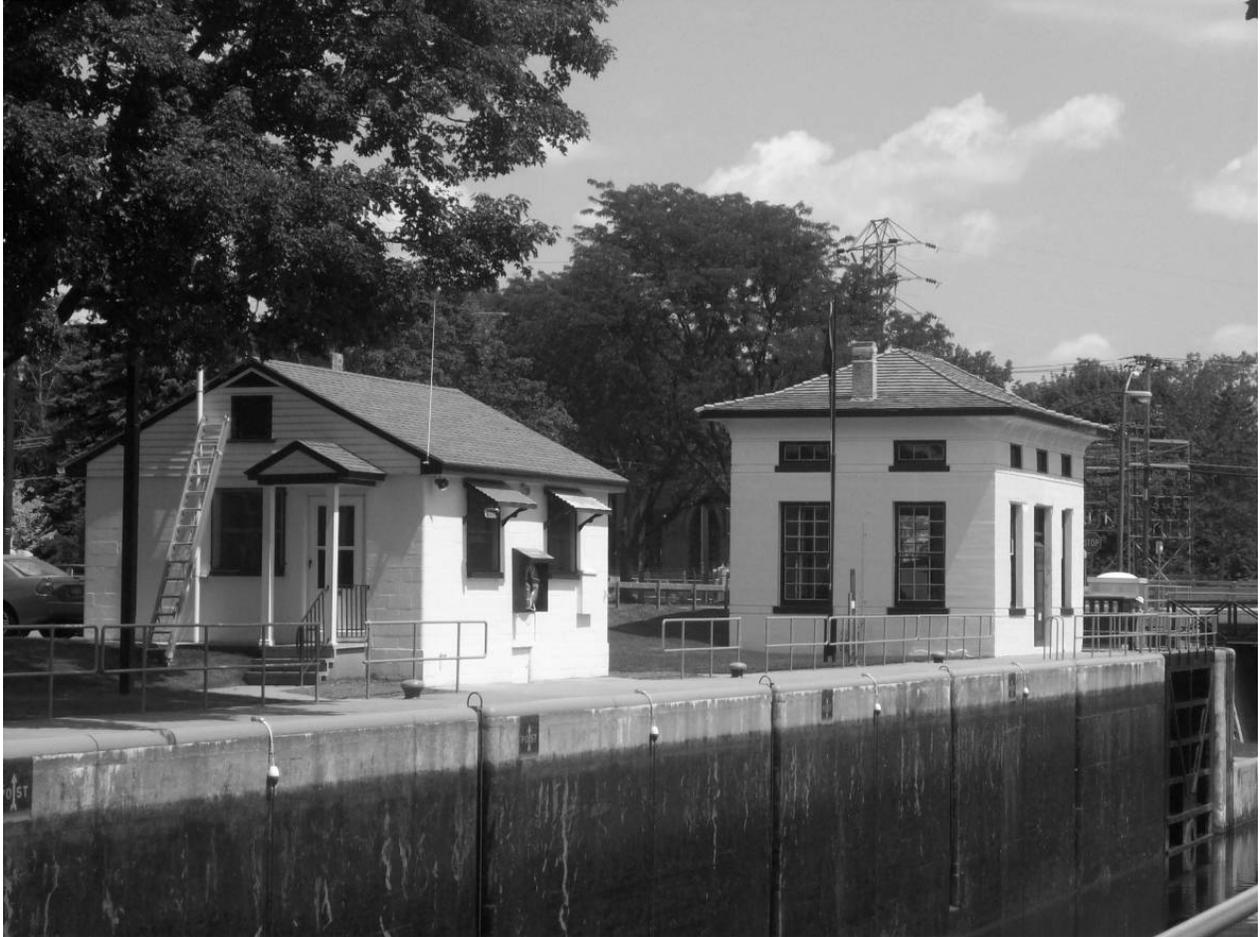
Image 1: Lockhouse on left with powerhouse on right. Field photograph taken by HAER recording team, summer 2009.

The powerhouse sits on the north chamber wall at the west end of the lock. It is a single-story, concrete building on a concrete foundation. The hipped roof still has the original green glazed

tiles, and there is a brick chimney. The building has nine-over-nine light wood windows and three-light windows under the eaves. The wood entry doors have been modified by the addition of modern screen doors. Water flowing under the powerhouse operated the extant vertical-shaft Francis turbines connected to 50-kw, 150-volt DC generators. The building is in fair condition but is highly significant as one of the few powerhouses with its operating machinery still intact.²

The lockhouse, which is centered on the north chamber wall, dates to a 1959 effort by the State of New York's Department of Public Works to build new lockhouses along the Barge Canal.³ The single-story concrete block structure sits on a concrete foundation. There is horizontal wood siding in the gable ends, and the gable roof is covered with asphalt shingles. The lockhouse has a brick chimney. Fenestration consists of sliding aluminum windows with steel mesh coverings, some of which are shaded by awnings. Pane-and-panel doors with gable overhangs are located on the gable ends of the building. The lockhouse is in good condition.

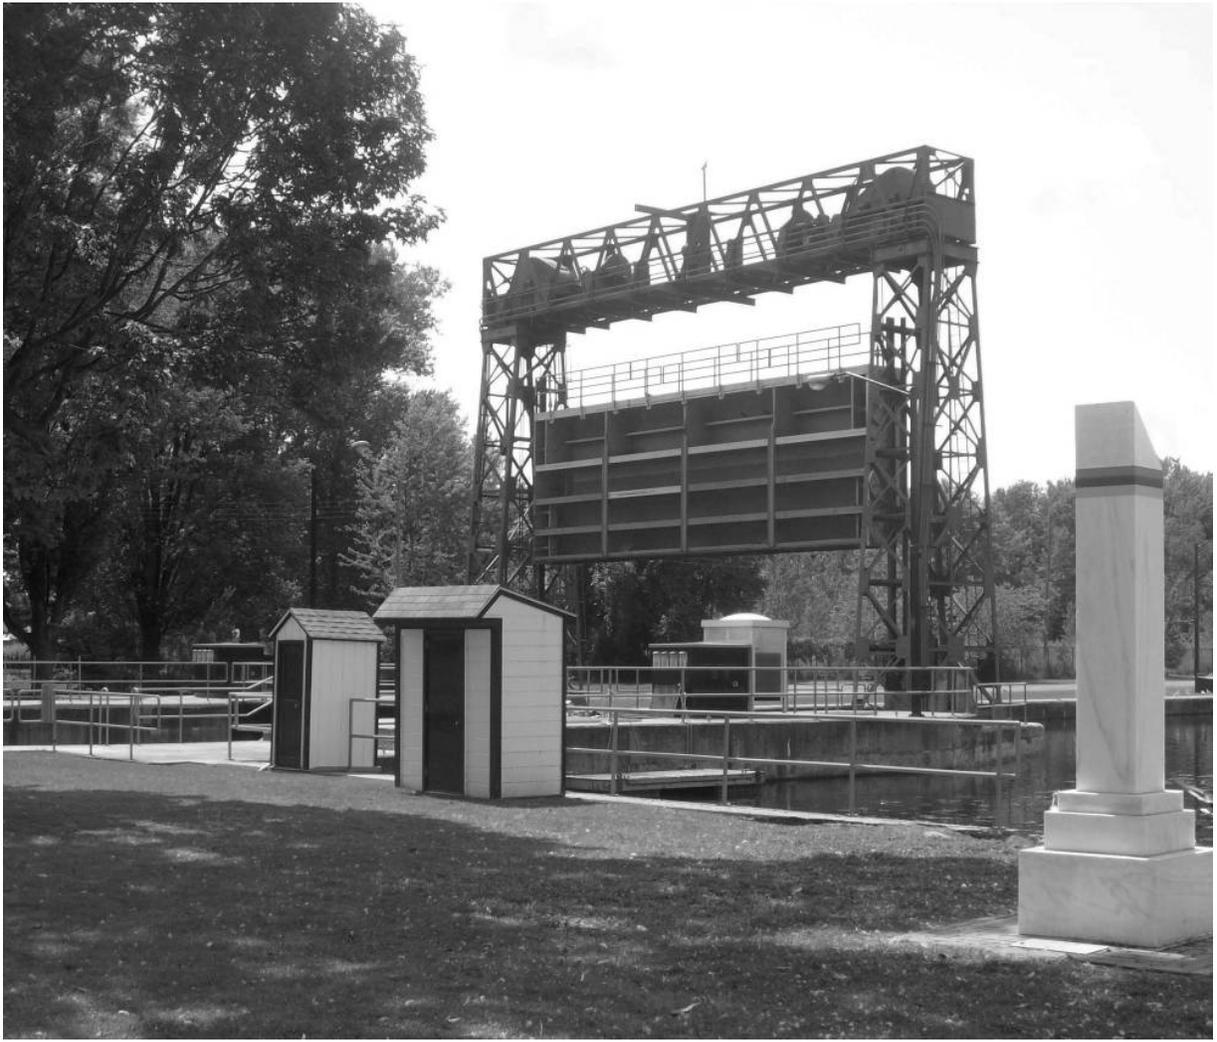
Image 2: Guard gate. Field photograph taken by HAER recording team, summer 2009.

A 45'-wide guard gate is located at the west (upstream) end of the lock chamber. It has a riveted steel truss superstructure. The north tower sits on a concrete abutment, while the south tower sits on the concrete approach wall. The vertical-lift steel gate operates by a cable pulley system and steel counterweights. It appears to be in good to fair condition.
