NEW YORK STATE BARGE CANAL, LOCK O1
(Oswego Canal, Lock O1)
87 State Street off County Route 57
Phoenix
Oswego County
New York

WRITTEN HISTORICAL AND DESCRIPTIVE DATA

HAER No. NY-529

Appendix: Images of Current Conditions

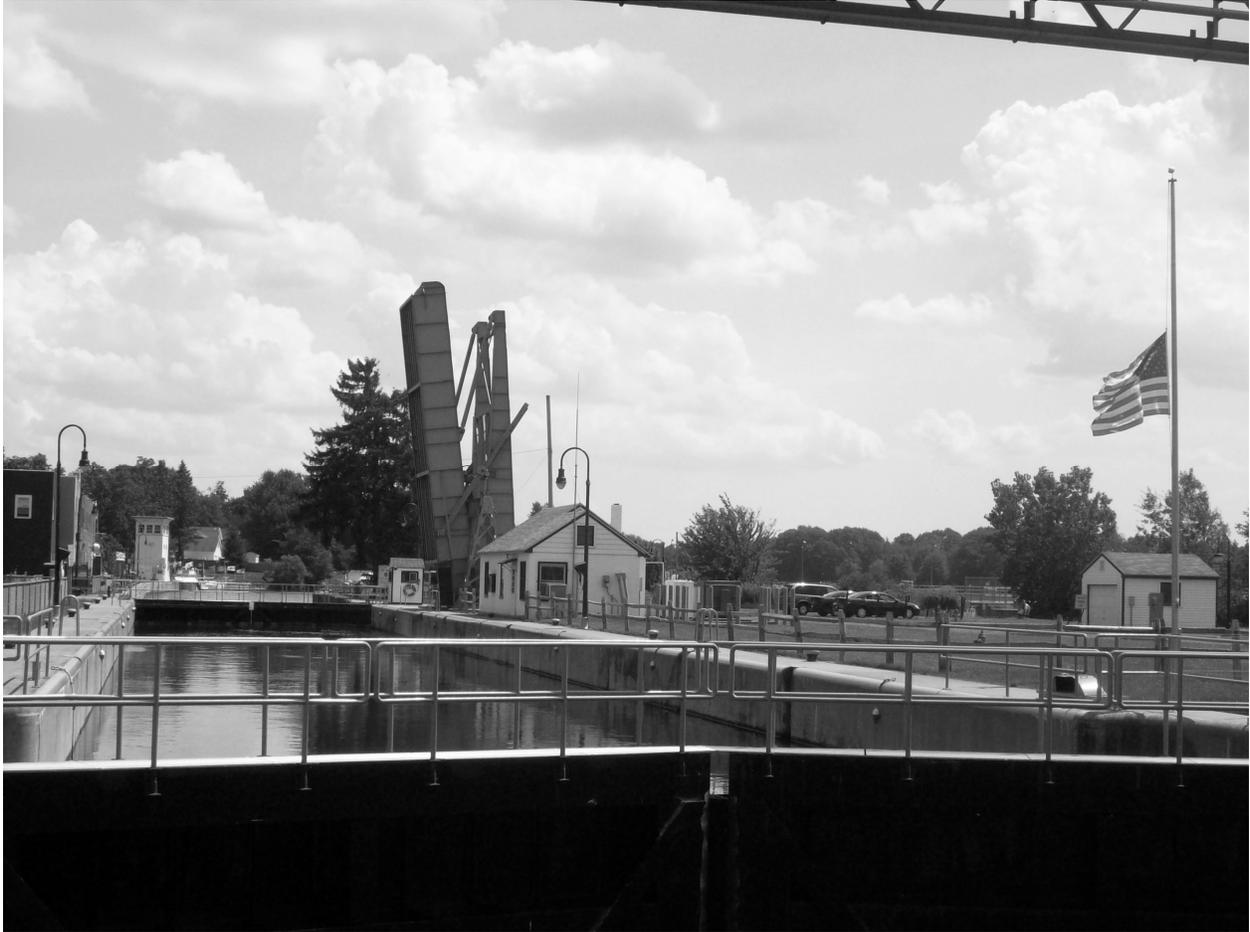
Image 1: Overview of lock chamber and related structures. The lockhouse is to the right of the chamber with the garage behind at the far right of the image. Bridge Street lift bridge is behind the lockhouse. Field photograph taken by HAER recording team, summer 2009.

The 1958 lockhouse is located at the downstream end of the lock on the southern chamber wall. The single-story concrete block structure sits on a concrete foundation and has a rear extension used as a generator room. The gable-front roof is covered with asphalt shingles. The wood-sided dormer has a one-over-one-light vinyl window and a roof covered with asphalt shingles. The entrance is a wooden pane-and-panel door. The building is in good condition. A garage is situated on the access road, adjacent to the parking area. It is a single-story, gable-front, frame structure on a poured concrete foundation. The gable roof has asphalt shingles. The building is clad in wood siding and has a modern vinyl garage door. The fenestration consists of wood windows with steel mesh on the interior. The garage appears to be in good condition.

The lock has a 10.2' lift to the south with normal pool elevations 352.8' below and 363' above. The concrete chamber walls have been lined with steel plates and coping. There are double-leaf, steel miter lock gates at each end of the lock chamber operated by spars and gear trains powered by the original electric motors in cast-iron housings located in pits below the deck. The chamber is watered by culverts equipped with valves. While original, the gate and valve operating machinery differs from that used elsewhere on the system, which may be due to its early installation under a different contract. There are riveted-steel electrical cabinets at each corner of the lock. The capstans are located on a raised concrete platform that is surrounded by steel railing and open grates. Concrete-filled cast-iron bollards on concrete pads line either side of the

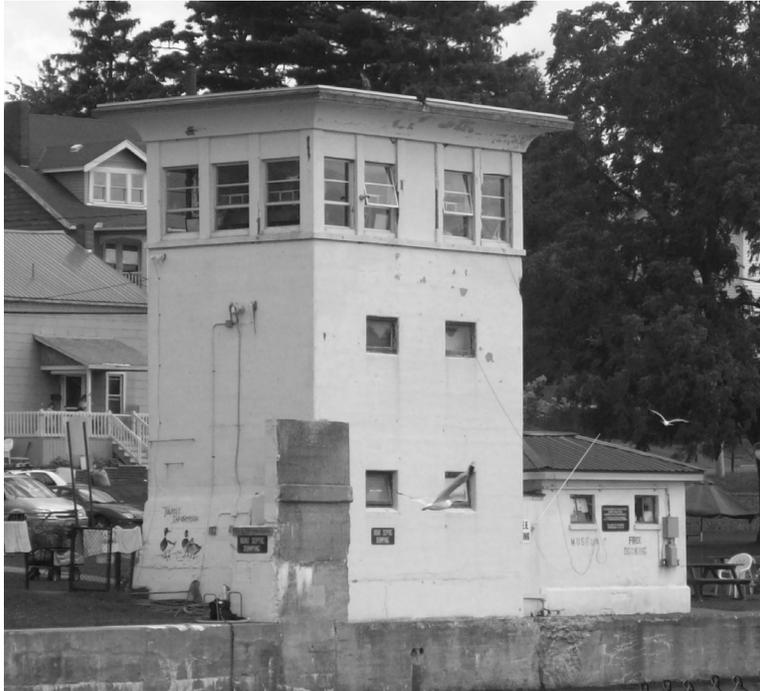
Image 2: Bridge house. Field photograph taken by HAER recording team, summer 2009.

The bridge house is located at the northeast end of the lock. The three-story concrete structure may have a flat or shallow hipped roof, but this could not be verified by visual inspection from the ground. The walls are punctuated by metal awning windows and a wood door. A single-story concrete addition is attached to the building. The addition has a hipped, standing-seam metal roof and two-light windows. The building is in good to fair condition.

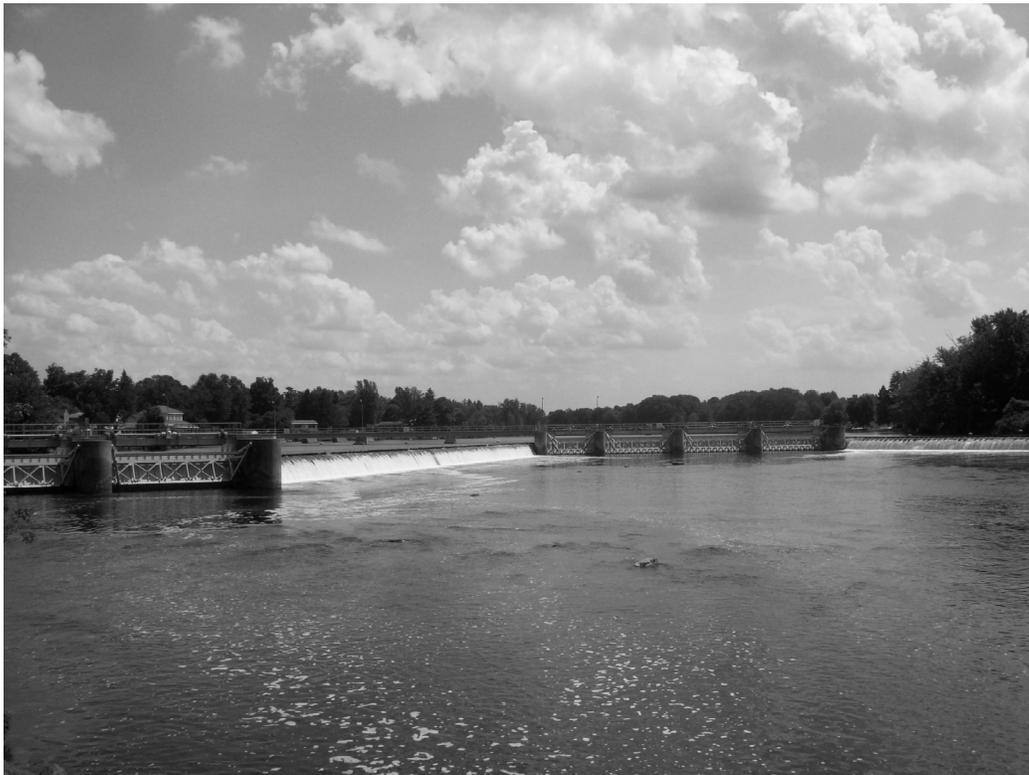
Image 3: Overview of Phoenix Dam with Tainter gates flanking the spillway. Field photograph taken by HAER recording team, summer 2009.

Stretching across the Oswego River to the south of the lock is the Phoenix Dam, consisting of movable crest and fixed crest spillways. The east end of the dam has two Tainter gates, which may date to 1980. The riveted-steel Tainter gates are located between concrete piers and abutments. The 383' spillway has a concrete apron. Next is another movable-crest section with four Tainter gates between concrete piers and a welded steel superstructure. The gates operate by a cable system and are accessible by an open-grate catwalk set on the concrete piers. On the other side of this section of the dam is a fixed-crest dam that could not be seen during the field work due to its location. This spillway is about 166' long and ends at a hydroelectric power plant. All the components of the Phoenix Dam appear to be in good condition.
