NEW YORK STATE BARGE CANAL, LOCK O5
(Oswego Canal, Lock O5)
Adjacent to Brookfield Power Plant
Minetto
Oswego County
New York

HAER NY-534
HAER NY-534

WRITTEN HISTORICAL AND DESCRIPTIVE DATA

Appendix: Images of Current Conditions

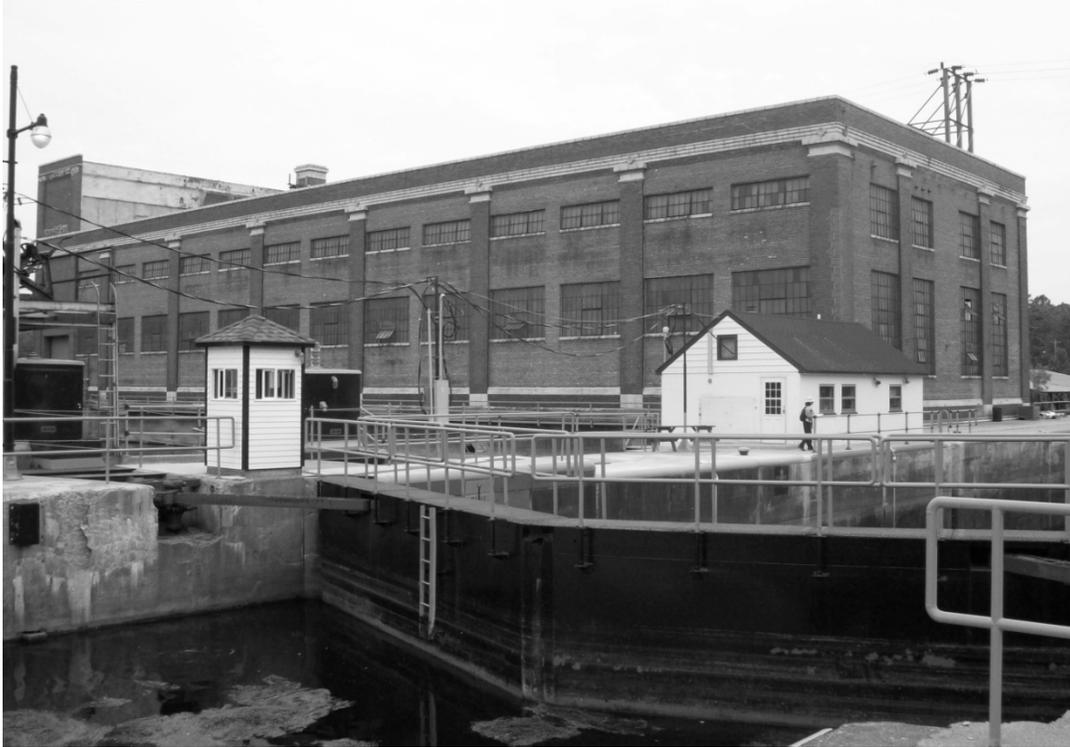
Image 1: Perspective view of the end of the lock chamber with a control stand shelter in the foreground, lockhouse behind, and Brookfield Power Plant. Field photograph taken by HAER recording team, summer 2009.

The lockhouse, which is in good condition, is located adjacent to the Brookfield Power Plant on an extended concrete wall to the west of the lock chamber. The single-story concrete building has a concrete chimney and sits on a concrete foundation. The gable-front roof is covered with asphalt shingles, and the gable ends have horizontal board infill. There are one-over-one light aluminum windows with aluminum storm windows. The entrance is a wooden pane-and-panel door.

Control stand shelters are located on the west side of the chamber at the upstream and downstream ends. Each is a single-story frame structure with horizontal fiber-cement siding and a pyramidal asphalt roof with vinyl siding windows and a single-pane door. The structures sit on concrete foundations and are in good condition.

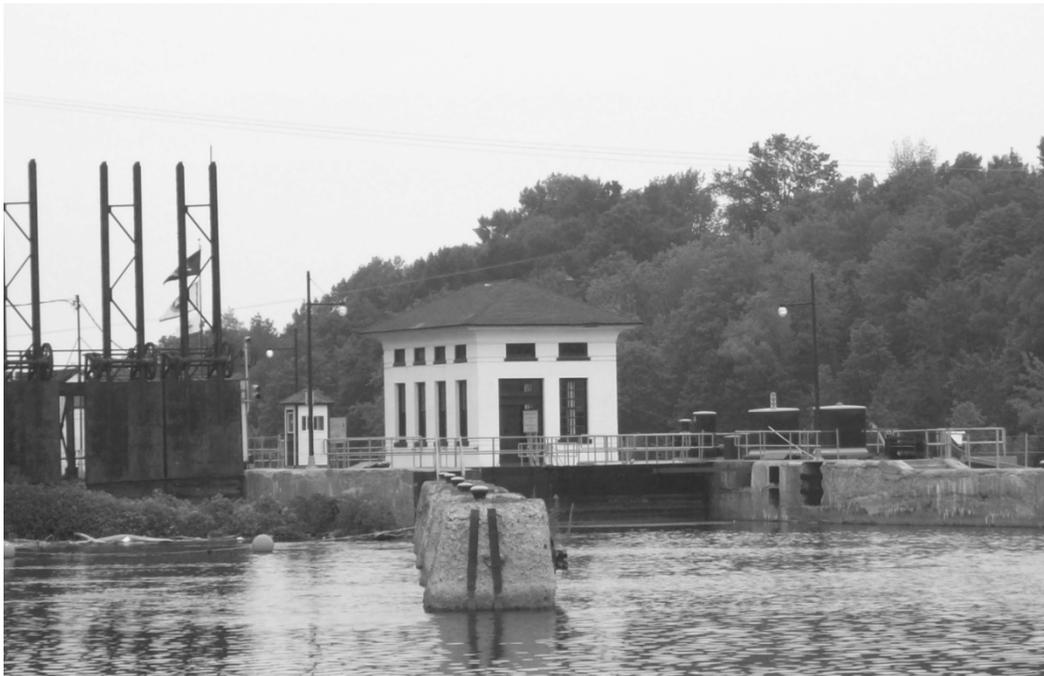
Image 2: Powerhouse at center of image. Field photograph taken by HAER recording team, summer 2009.

The powerhouse, located on the east side of the lock, is a single-story concrete building on an exposed concrete foundation. The hipped roof is covered with asphalt shingles. The fenestration consists of nine-over-nine-light wood windows and three-light windows in the eaves. The entrance is pane-and-panel wood double doors with a four-light transom. The original vertical-shaft hydroelectric generators and governors are intact. The powerhouse is in good condition.

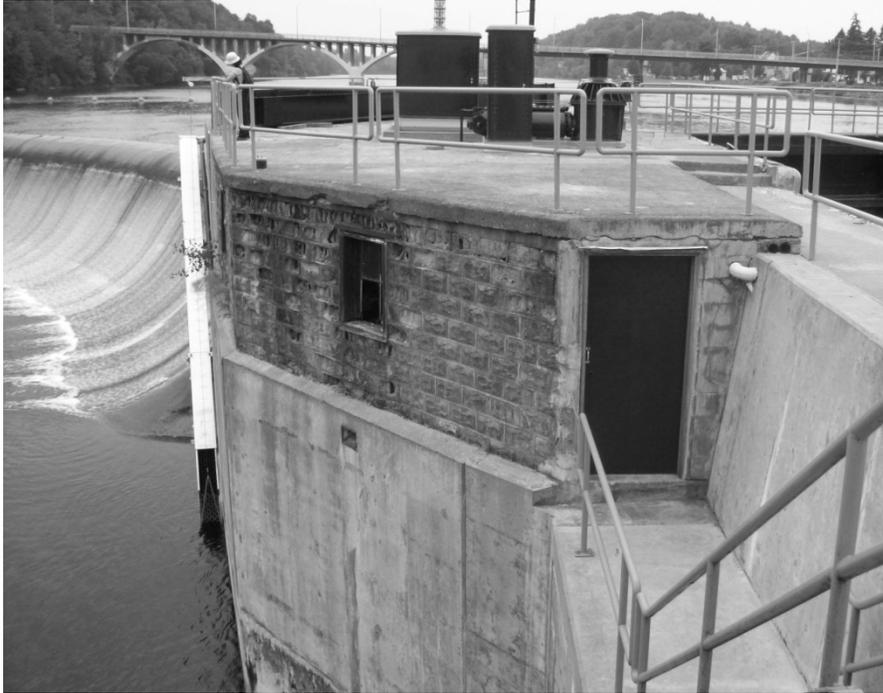
Image 3: Dam is to the left and the former lockhouse foundation is to the right. Field photograph taken by HAER recording team, summer 2009.

An open-grated stairway near the powerhouse provides access to a rusticated concrete block structure roofed with a concrete slab. There are multi-light windows and a plywood door. This may be the foundation of a pre-1950s wood-frame lockhouse at this location.

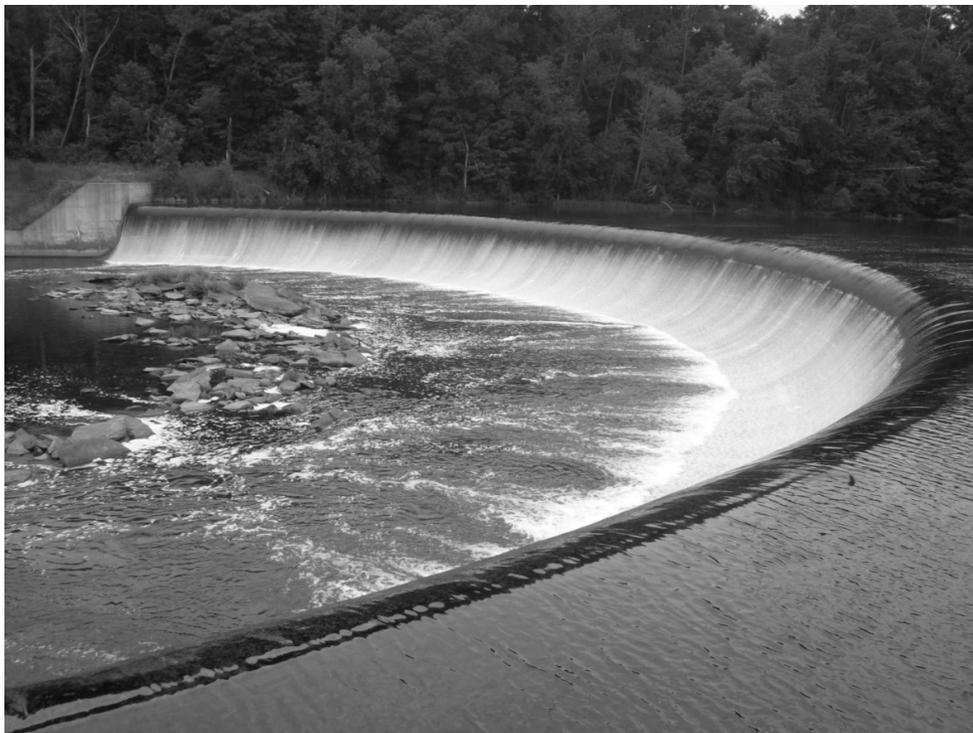
Image 4: View of curved crest of Minetto Dam. Field photograph taken by HAER recording team, summer 2009.

Extending across the Oswego River is Minetto Dam, a concrete, semi-circular, fixed crest dam with an ogee spillway. The dam appears to be in good condition.

The dam was first altered in 1939 when the crest had to be rebuilt of reinforced concrete because of disintegration. Fifty years later, it was again rehabilitated under Contract D252328.⁶
