NEW YORK STATE BARGE CANAL, LOCK O8
(Oswego Canal, Lock O8)
Canal View Drive
Oswego
Oswego County
New York

WRITTEN HISTORICAL AND DESCRIPTIVE DATA

HAER No. NY-538

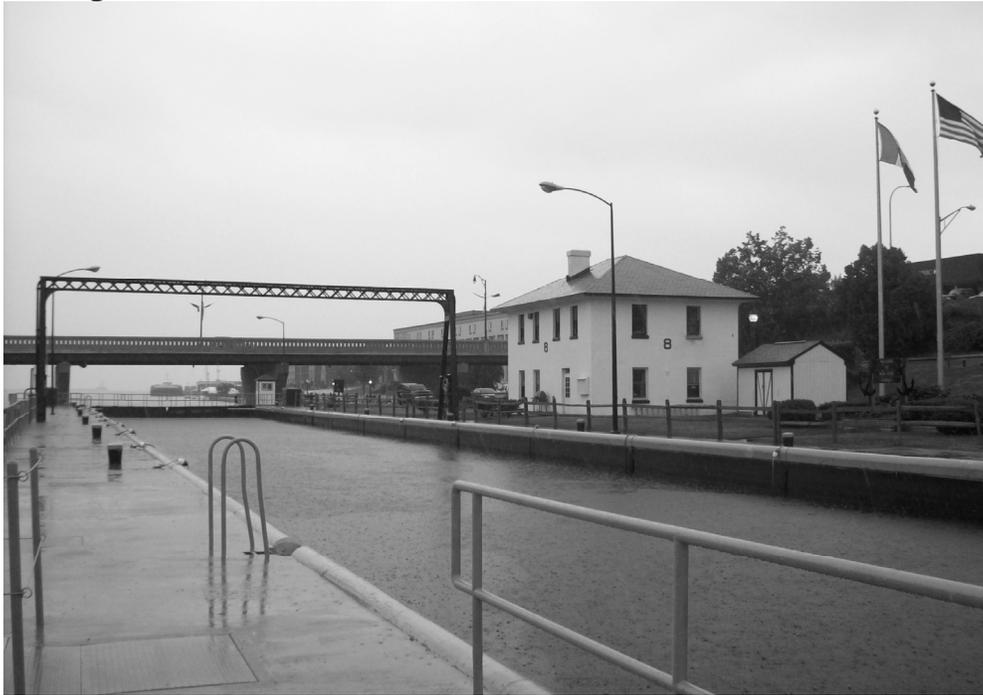
Image 1: Overview of lock with the lockhouse and storage building to the right of the chamber. Field photograph taken by HAER recording team, summer 2009.

Description: Lock O8 is located on the east side of the Oswego River near Lake Ontario and about ½ mile north of Lock O7.¹ The lock is accessed by an asphalt-covered driveway extending from Canal View Drive that leads to an asphalt parking area near the lockhouse. The lock site consists of the lock and associated structures, lockhouse, storage shed, and other auxiliary structures.

The lockhouse is a two-story concrete building with a concrete chimney that is centered on the east side of the lock chamber. The building sits on a concrete foundation. The hipped roof is covered with slate shingles. Two-over-two wood windows punctuate the building's walls. The entrance is a wood pane-and-panel door with transom. The living quarters for the operating crew were located on the second floor. The structure is in good condition.

A storage shed is near the lockhouse. The single-story frame building is on a concrete foundation. The side-gable roof is covered with asphalt shingles and has vertical-board paneled siding. The entrance is a wooden door. The building is in good condition.

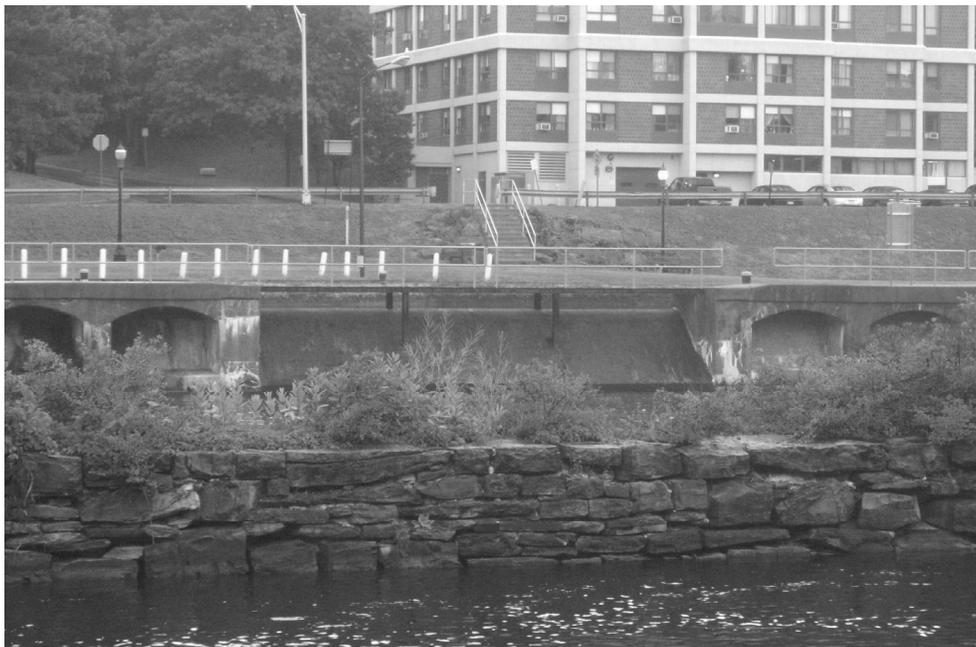
Image 2: View of spillway in the southwest guide wall. Field photograph taken by HAER recording team, summer 2009.

The exposed west (river) lock wall consists of twenty-one arches and extends to the southwest guide wall, which is interrupted by a concrete spillway that appears to be in good condition although the guide wall itself shows signs of spalling and breaking. The southwest guide wall is lined with concrete-filled cast-iron bollards, pipe railing, and modern “street light” fixtures. The southeast guide wall is concrete and exhibits areas of major spalling and breaking. There are concrete-filled cast-iron bollards set away from the wall, as well as modern light fixtures.
