ELLIS ISLAND
(U.S. Immigration Station)
Statue of Liberty National Monument
New York Harbor

HALS NY-9
HALS NY-9

HISTORIC AMERICAN LANDSCAPES SURVEY

ELLIS ISLAND (U.S. Immigration Station)

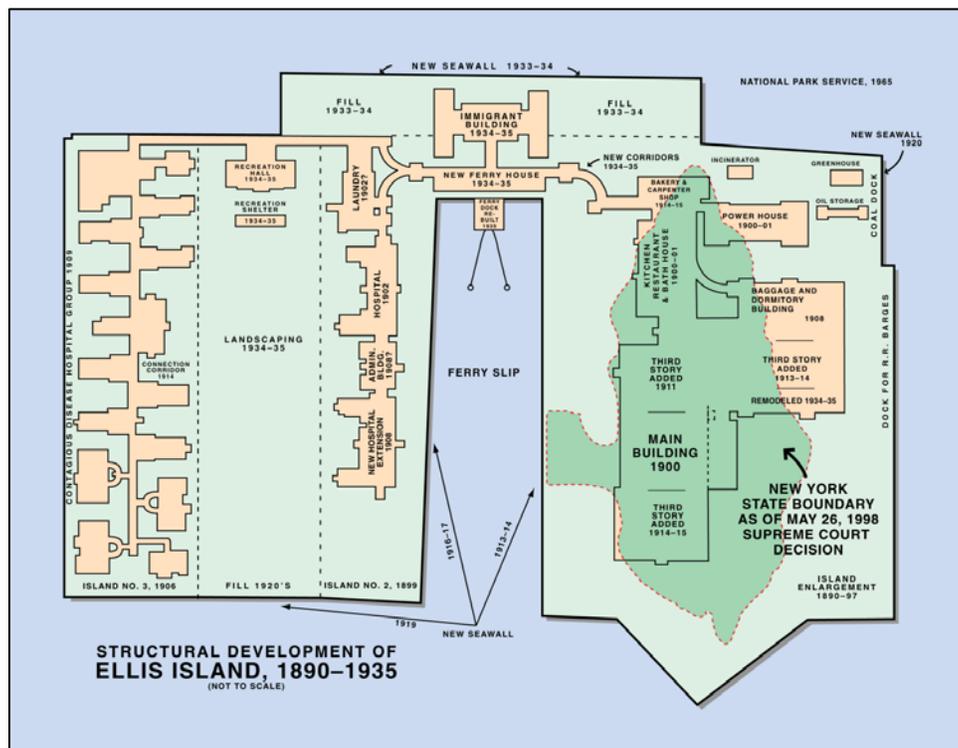
Figure 1: Structural Development of Ellis Island, 1890-1935.

This schematic plan shows the evolution of Ellis Island as it still exists today.
Source: eTechnical Information Center (eTIC), Denver Service Center, National Park Service, Department of the Interior.

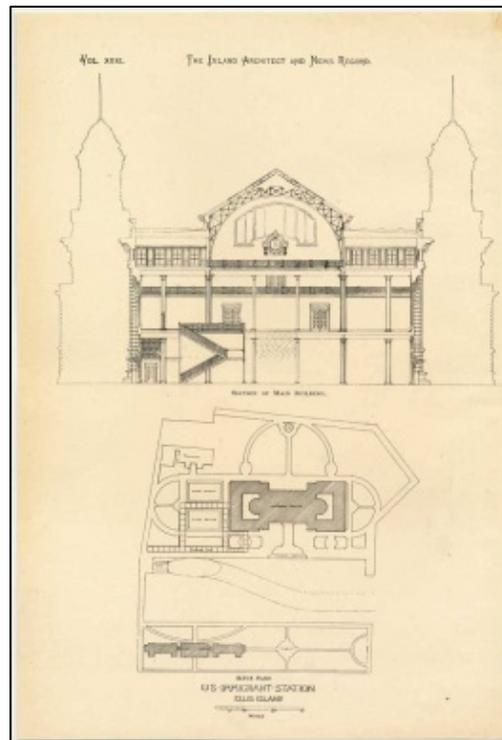
Figure 2: This image shows the original site plans proposed by Boring & Tilton in 1898.
Source: The Inland Architect (1898), Ryerson & Burnham Archives Archival Image Collection, The Art Institute of Chicago.

architectural firm of Boring and Tilton. The original 1898 Boring and Tilton plans called for symmetrical walking paths lined by rows of trees and also envisioned a hospital complex on a second island. Though the recommendations of Boring and Tilton would come to shape the Island's later landscape patterns, they were not undertaken at the time of construction of the Main Immigration Building. Instead, the Island sat mostly bare, with visible debris from construction until 1902.

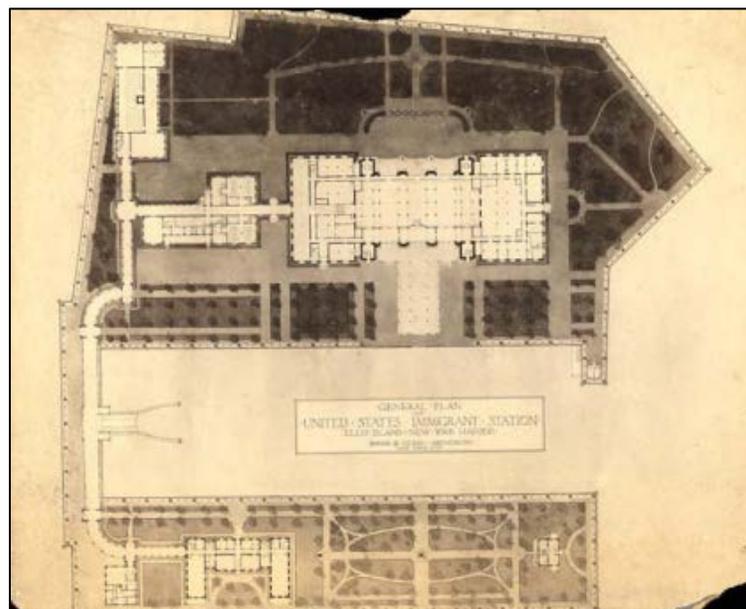
Figure 3: This image shows the revised hospital design and site plan proposed by Boring & Tilton c. 1899.
Source: Powderly Photographs, Catholic University of America Archives, Washington, DC.

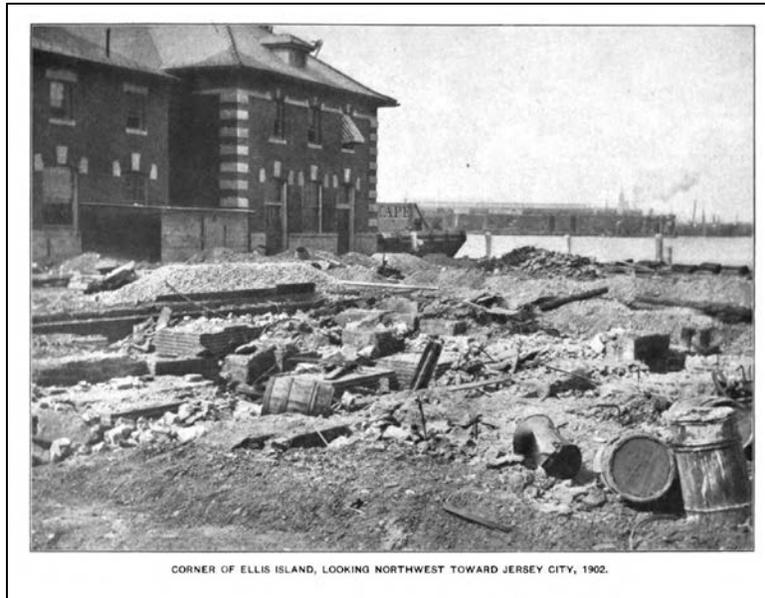
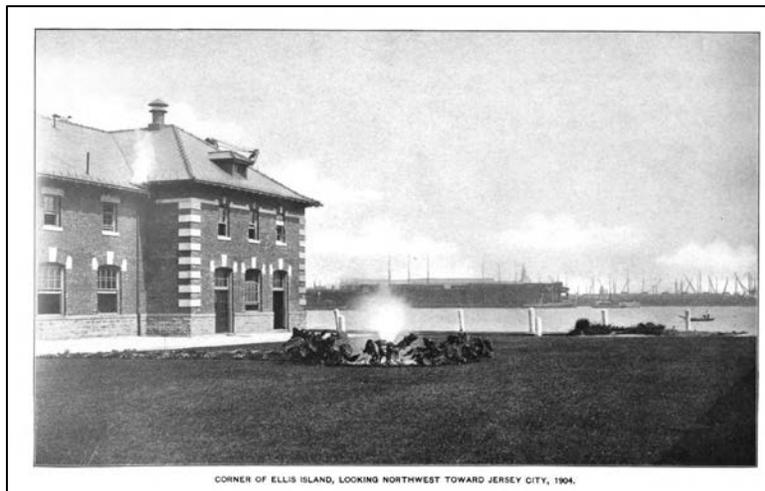
Figure 4: Before (1902) and after (1904) of Island 1 near Powerhouse. These images show the state of the landscape and the work performed under the supervision of Commissioner Williams.
Source: U.S. Department of Commerce and Labor. *Annual Report of the Commissioner General of Immigration to the Secretary of Commerce and Labor for the Fiscal Year ending June 30, 1904.* (Washington, D.C.: GPO, 1904), 117-118.

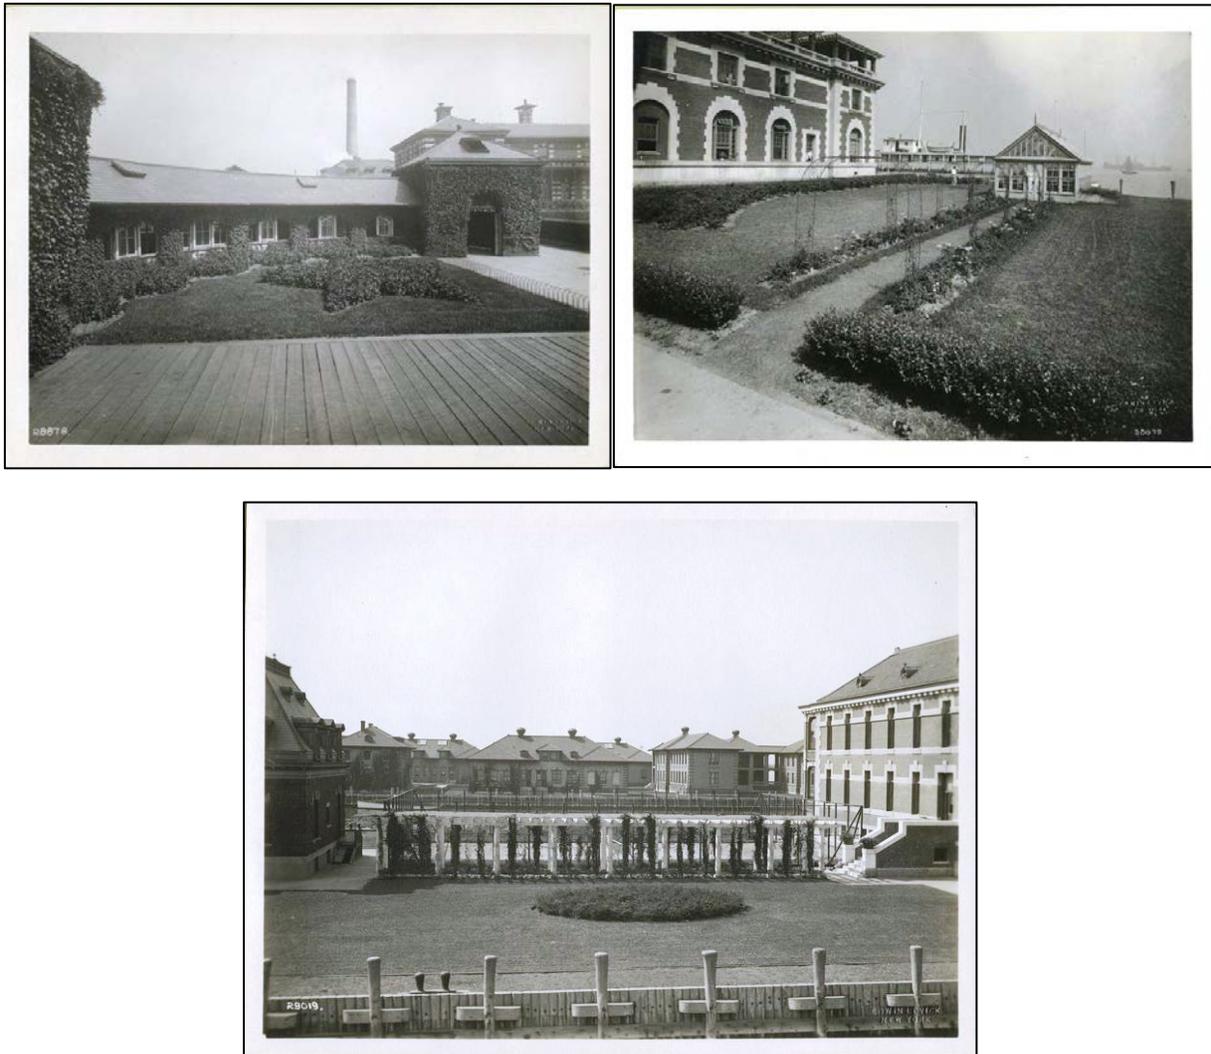
Figure 5: These images, all taken ca. 1910, show the various ornamental landscapes maintained across Island 1 and Island 2.

Top Left: “Ivy Covered Exterior of Ellis Island Building,” (Island 1)

Bottom: “View of Ellis Island Buildings, with garden and trellises in foreground,” (Island 2).

landscape (**Figure 5**). Privet hedges along new central walking paths “divided [the Island] into neat squares.”⁷ These hedges and paths were both aesthetically pleasing while also directing and controlling the movement of large numbers of immigrants. Blue grass lawns, “geraniums, nasturtiums, palms, pansies, and ferns” were also planted, which came together to make “what may be appropriately termed a well regulated and unusually prettily decorated park.”⁸ In this way Williams’ reforms served practical, social, and aesthetic functions.

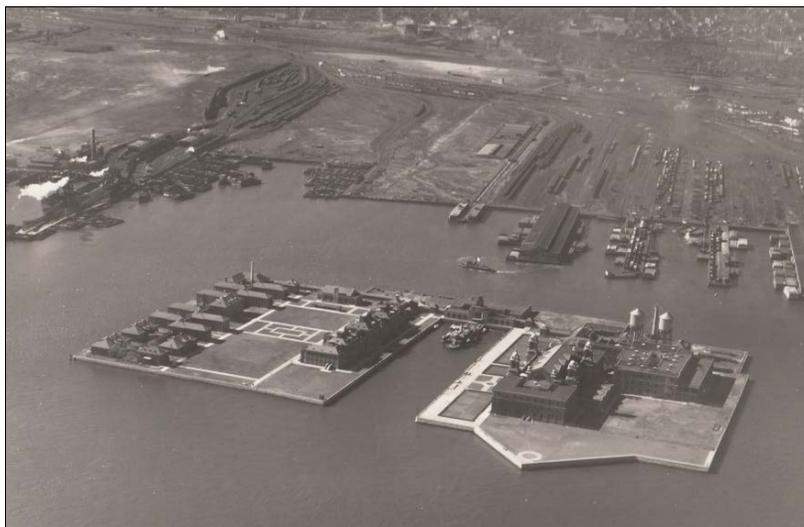
Figure 8: This image shows the completed fill, landscaping, recreational areas, and circulation paths on Ellis Island on March 11, 1940.
Source: Image 18-AA-93-58, Still Pictures Branch, National Archives and Records Administration II, College Park, MD

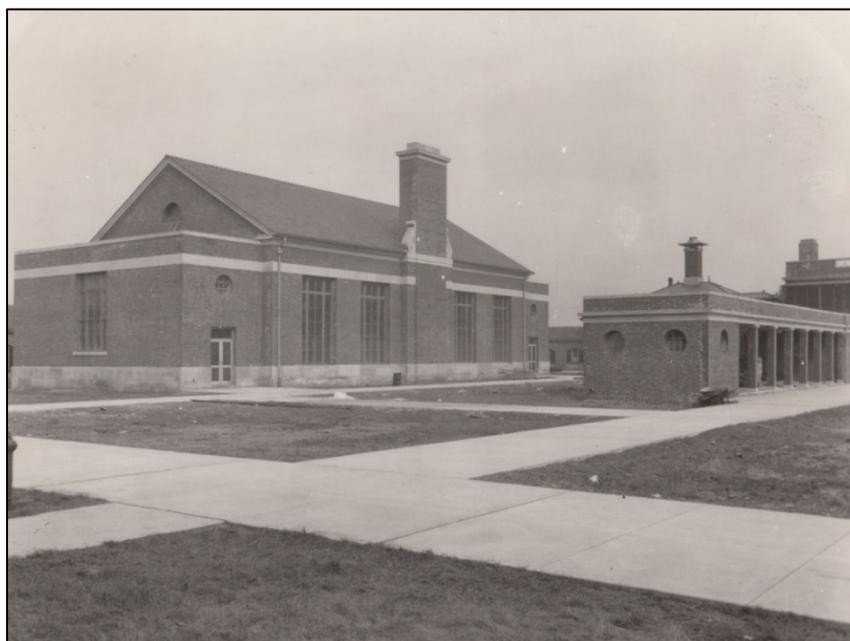
Figure 9: This image shows the newly completed Recreation Building (rear) and Recreation Shelter (front) on the fill between Islands 2 and 3 on February 26, 1937.
Source: Image 121-BCP-38B-3, Still Picture Branch, NARA II, College Park, MD.

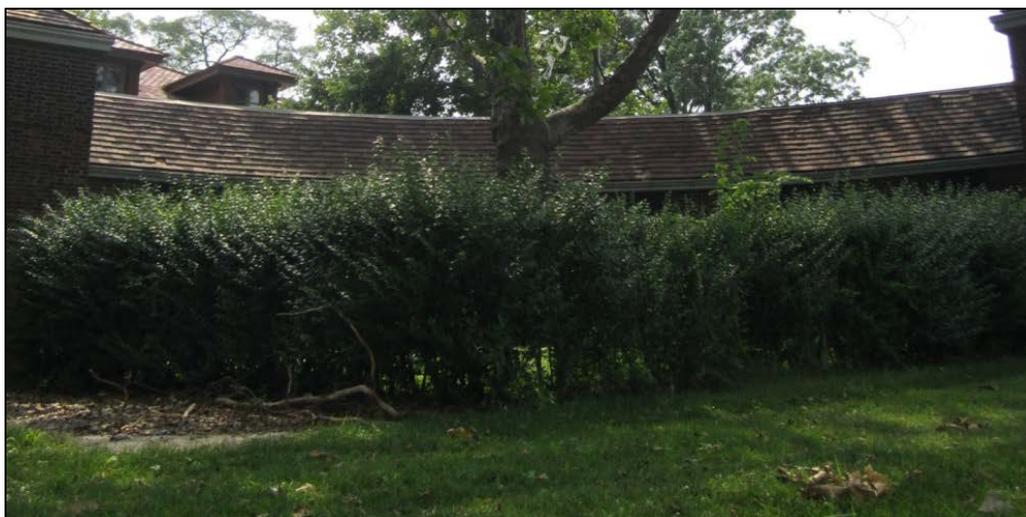
Figure 12: This privet hedge on Island 2 is the only historic hedge still present on Ellis Island.
Source: Photo by Author, July 2014.

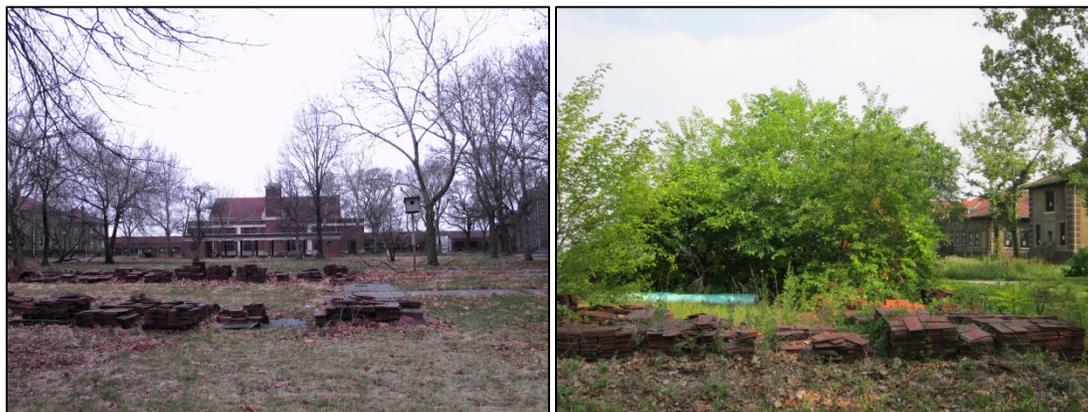
Figure 13: These images show the same rectilinear walking path at the center of the fill between Islands 2 and 3. The image on the left shows the materials being stored in the area, while the image on the right shows how these materials are being consumed by vegetation, no longer even visible from a short distance.

Though Island 1 was ready for visitors by 1990, conditions on Islands 2 and 3 remained largely unchanged. From 1999 to 2001 a Cultural Landscape Inventory was undertaken by NPS and the Olmsted Center for Landscape Preservation. This report identified historic vegetation and was used during three clearing projects from 2000 to 2002 to determine which vegetation should be preserved and which should be removed. On Island 2 a *Ligustrum species* (privet) hedge lines the walking path outside of the covered walkway between the New Ferry Building and Hospital Building. This is the only historic hedge to survive (**Figure 12**). Historic *Platanus acerifolia* (London planetrees) also remain lining the walking paths on Islands 2 and 3. On Island 3 a few non-historic trees remained after these clearing projects – *Ulmus parvifolia* (Chinese elm) between Wards 27-28 and 23-24, a *Betula species* (birch) in the Kitchen yard, and two *Betula species* (birch) between Wards 17-18 and 13-14. Despite these massive clearing projects, minimal maintenance work has been done to Islands 2 and 3 since. Thus errant, unmaintained vegetation continues to be a problem. All lawn and courtyard spaces on Islands 2 and 3 have overgrown grass and invasive plants. A new *Morus* (Mulberry tree) is currently growing on the central walking path of the recreation courtyard (**Figure 13**).

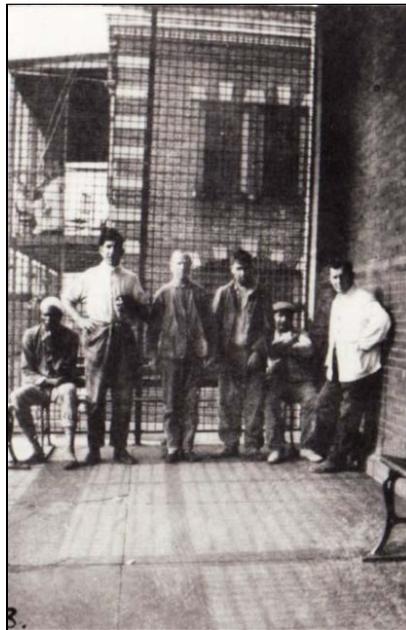
Figure 16: This image shows immigrants in the fenced-in porch of the Island 2 Hospital. Several buildings on Islands 2 and 3 had porches like this to allow sick immigrants and detainees to spend time outdoors in a controlled environment.

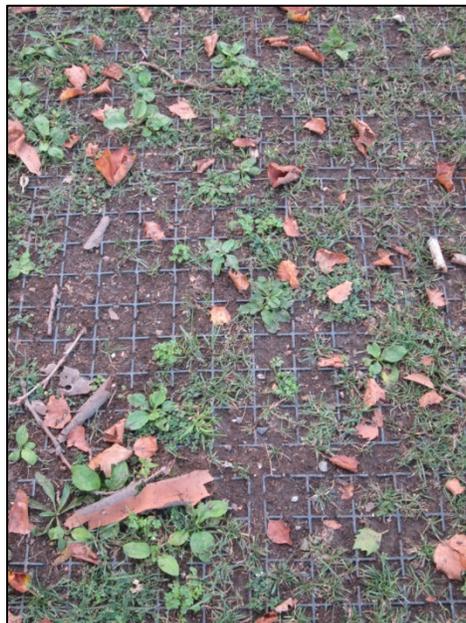
Figure 17: This image shows the paths on Island 2 which have been altered for use of NPS vehicles.
