Martin Steinhilber House  
402 South High Street  
Covington  
Miami County  
Ohio

HABS No. OH-2277

HISTORIC AMERICAN BUILDINGS SURVEY

MARTIN STEINHILBER HOUSE

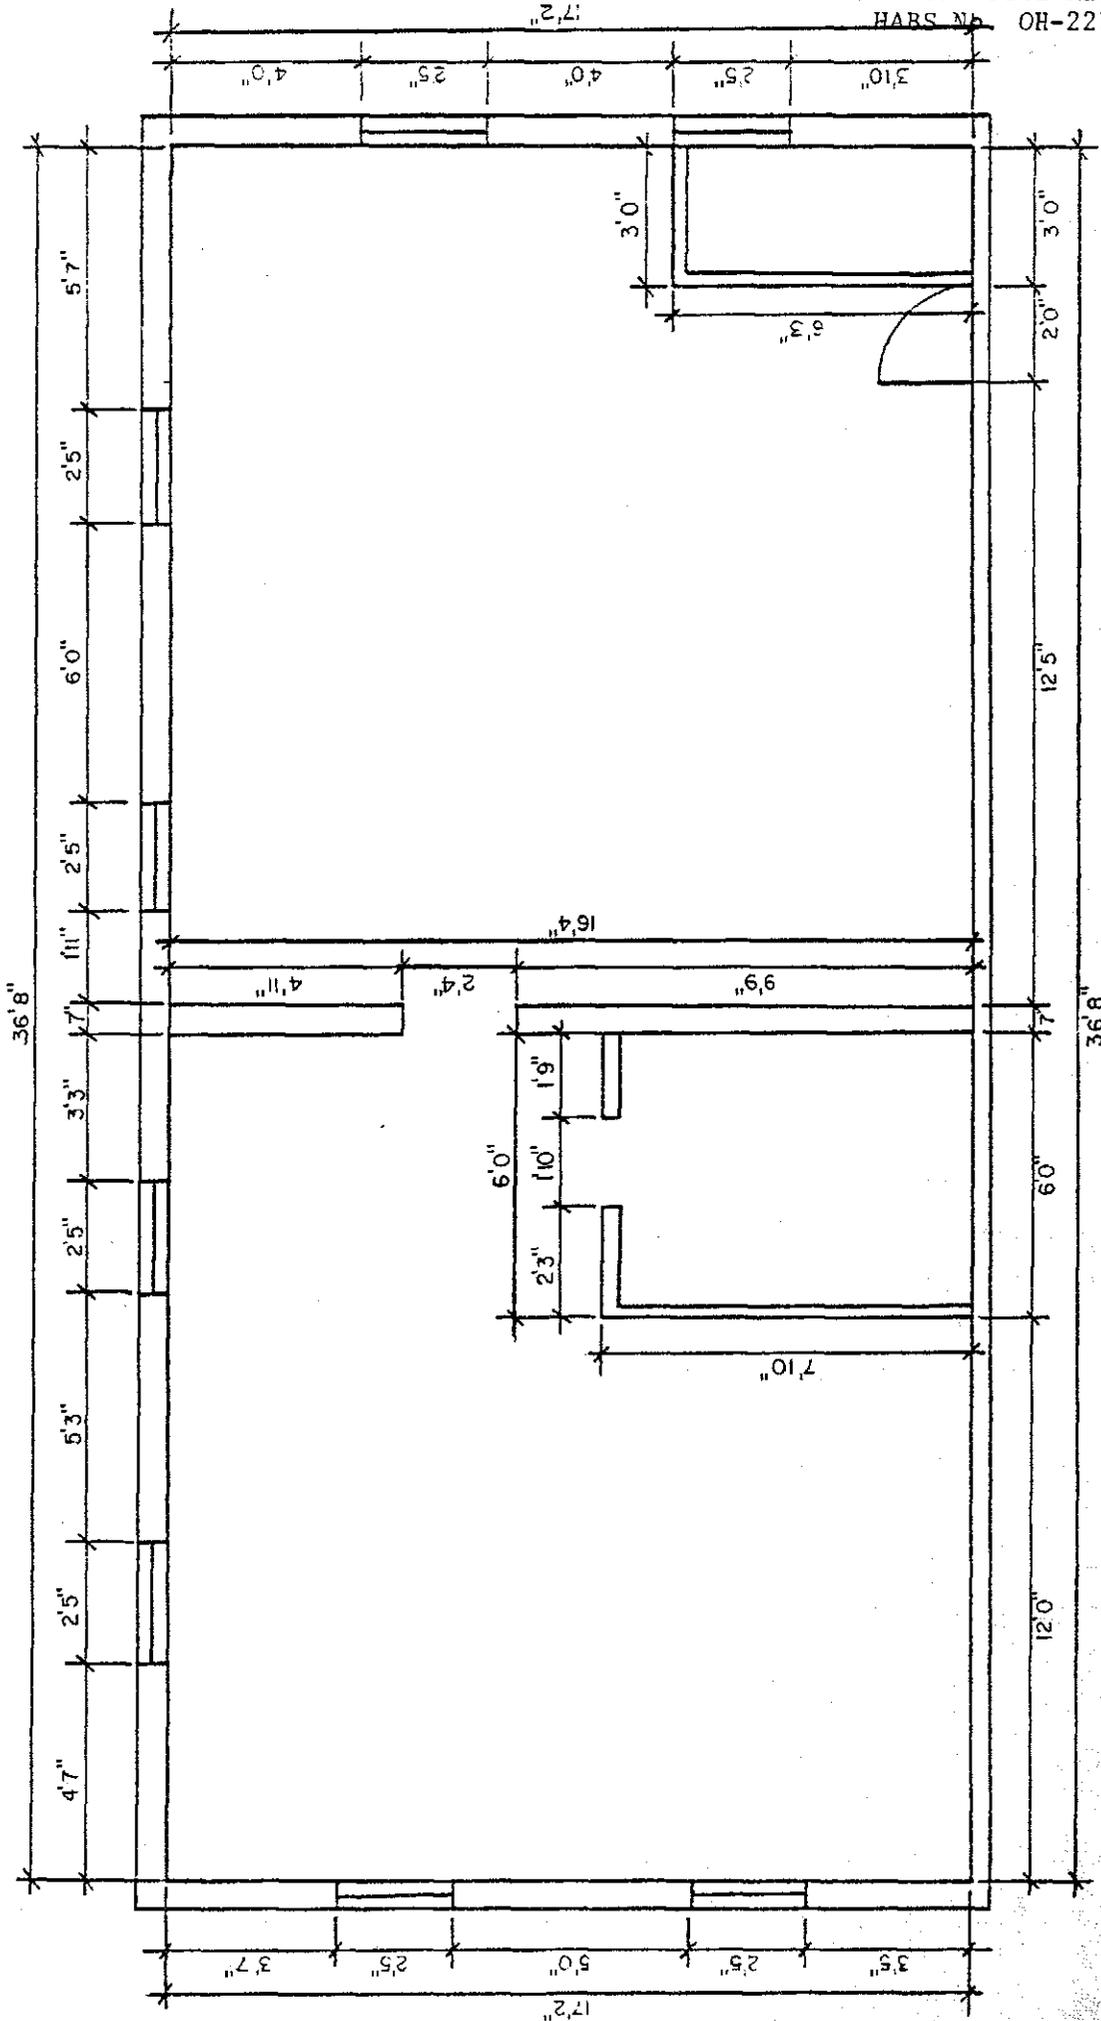
MARTIN STEINHILBER HOUSE  
HABS NO. OH-2277

1. Floor plans: The house has seven rooms on the first floor and two rooms on the second floor. The current owner believes that the original floor plan may have been different, however this is not verifiable. A sketch plan is included.

5. Openings: The locations of windows and doorways are shown on the sketch plan.
  - a. Doorways and doors: The interior doorways are plain rectangular openings with unadorned wooden framing. The doors are morticed, unpainted wood with four panels (two-over-two). On some doors there is ornate, Victorian style brass hardware. Some of the hardware is imprinted with a patent date of 1860. The knobs on some of the doors are marbled porcelain.
