HUNT COUNTRY STORE
Albemarle County Country Stores Survey
Intersection of Free Union Road & Garth Road
Charlottesville vicinity
Albemarle County
Virginia

HABS No. VA-1380

WRITTEN HISTORICAL AND DESCRIPTIVE DATA

HUNT COUNTRY STORE

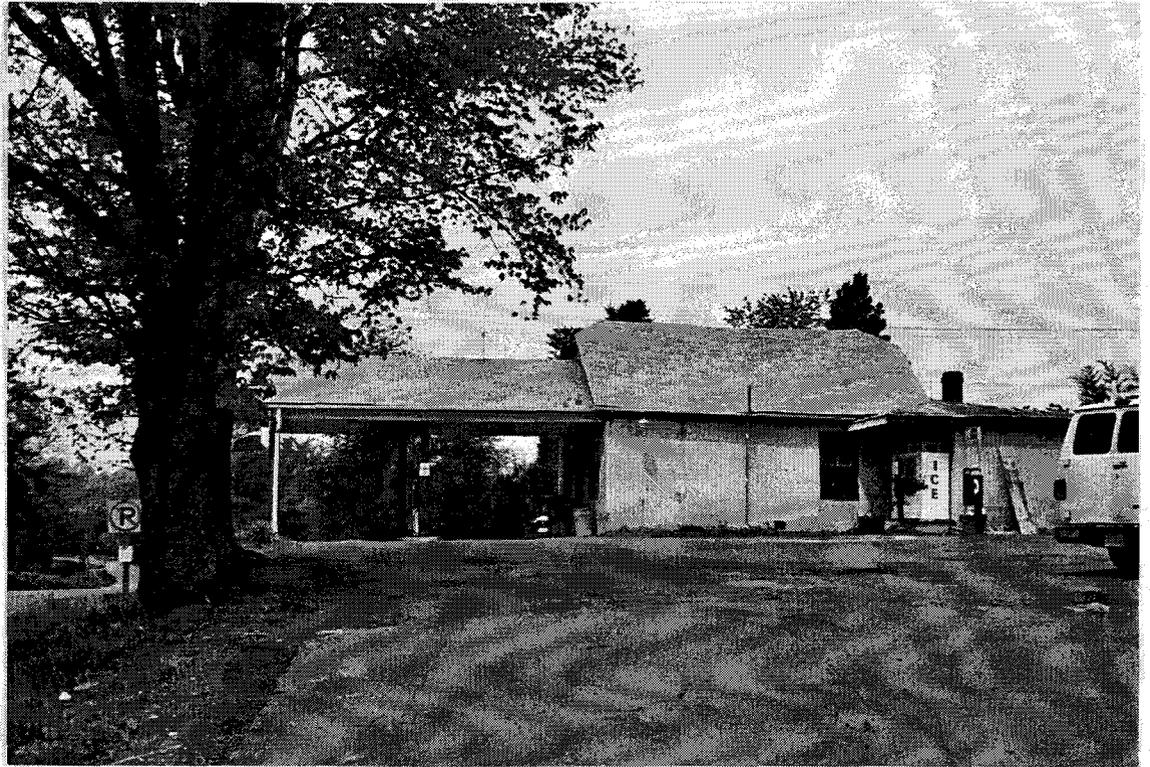
Fig. 1 East Elevation

Besides the two windows on the southern facade there is only one other visible window. It is on the east side toward the back of the main building. The dimensions of this window are equal to those of the front window. Extending underneath the window is a long patch of Portland cement instead of the yellow-painted stucco seen elsewhere. This suggests that the window may have originally been a door and served as a second entrance to the main building.

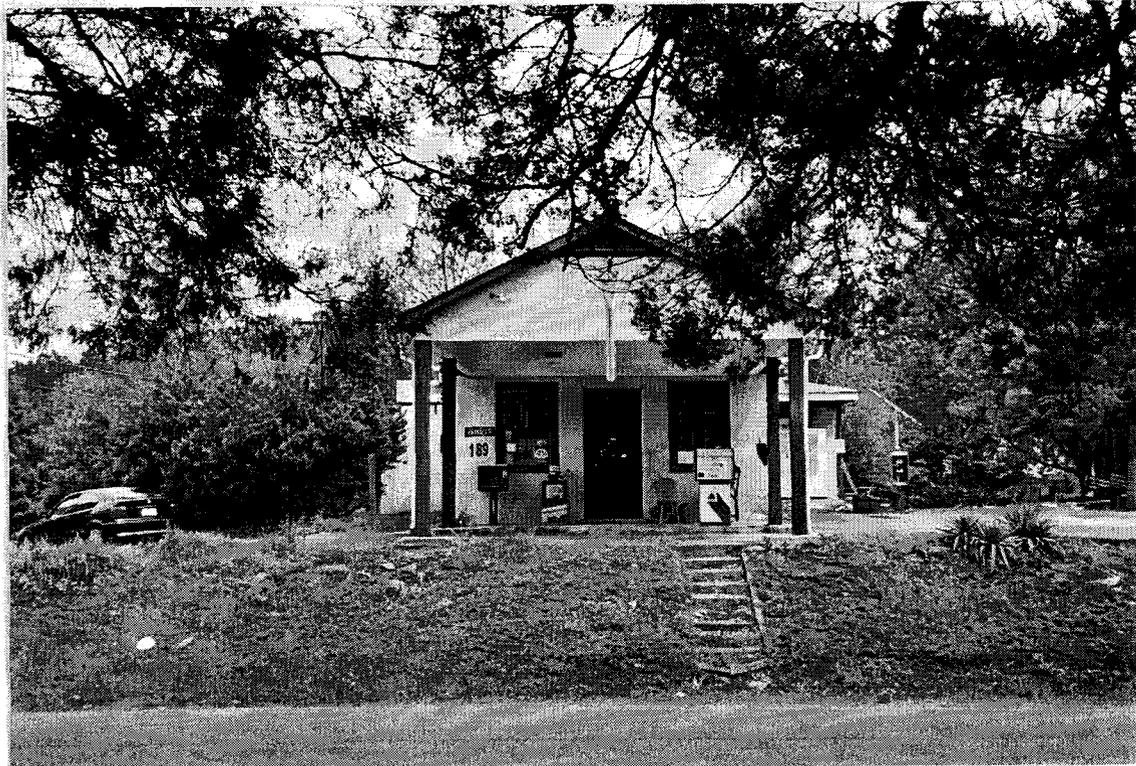
Fig. 2 South Elevation, showing overhang (photo by Talia Lanyi)

The overhang is the most visible part of the store. It extends almost 30' from the main building and fronts on Garth Road. The overhang has beams that run around the underneath perimeter and these beams connect to four wood posts that support the front portion of the overhang. The wall of the main building supports the northernmost portion of the overhang. The gas tanks are located underneath this overhang structure; two rows of cars can fit between the posts. The overhang has a single pitched roof with no ornamentation.

On the southern facade of the overhang there is a grill, placed toward the top, to allow for ventilation in the interstitial space under the gable roof. Below the grill hangs the Hunt Country Store sign that extends out from the facade. The materials used on the overhang include wood for the posts, beams, eaves, and deck, and asphalt shingles for the roof and stucco for the front facade. The paint colors are yellow for the stucco and green for the wood.

building's footprint is a long rectangle with the short end attaching to the overhang on the southern side. The southern facade is only 21' wide with a central door flanked by two large sash windows. The facade is stuccoed and painted yellow and the trim around the windows and door is made of wood and painted green. The door is 7' tall and 3' wide with a small window above and a 4" step leading into the building.

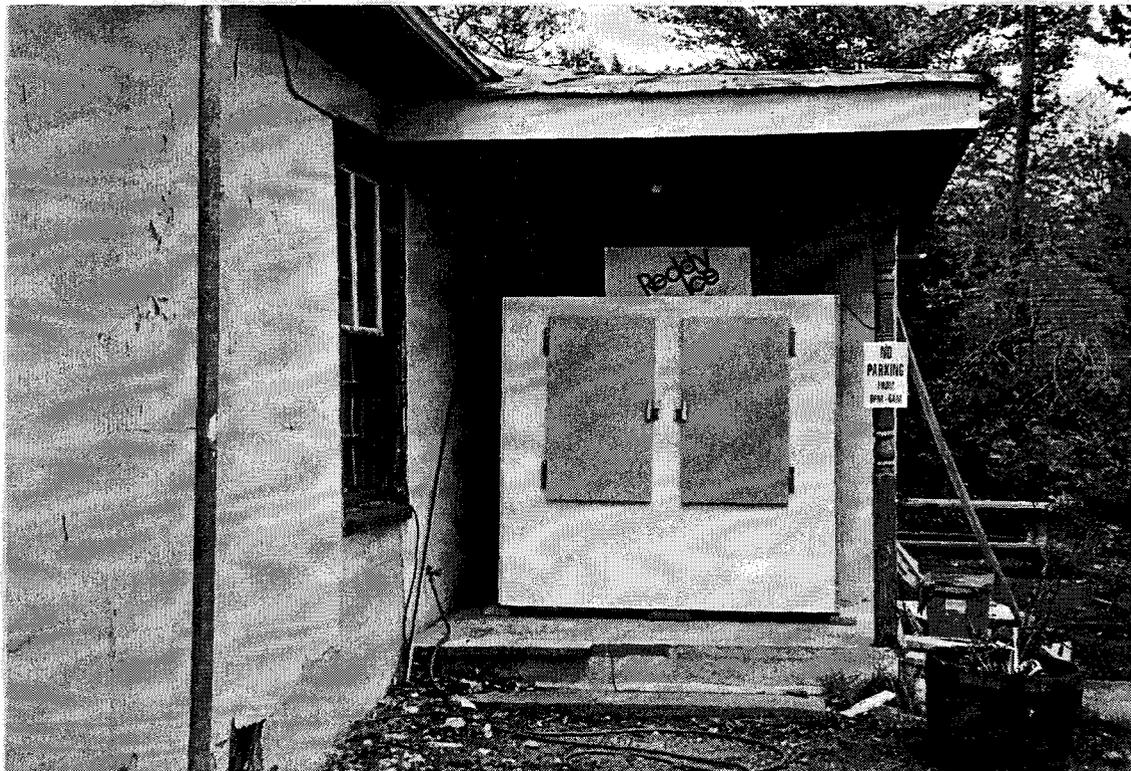
Fig. 4 View of porch to office wing (photo by Talia Lanyi)

The office wing connects awkwardly to the main building, three steps up from the original portion of the structure. The roof is separate from the main building as well. The overhang over the porch does not line up with the office fenestration, hitting the center of the window rather than the edge. Inside, the office walls are sheathed with wood paneling. A chimneystack rises above the office roof, but no fireplace is visible inside.

The porch of the office wing is not accessible from the interior of the building. On the north and east sides of the porch, there are indentations on the stucco of the two windows now covered up. These windows are not visible from the inside. The dimensions of the window openings match those in the rest of the building.

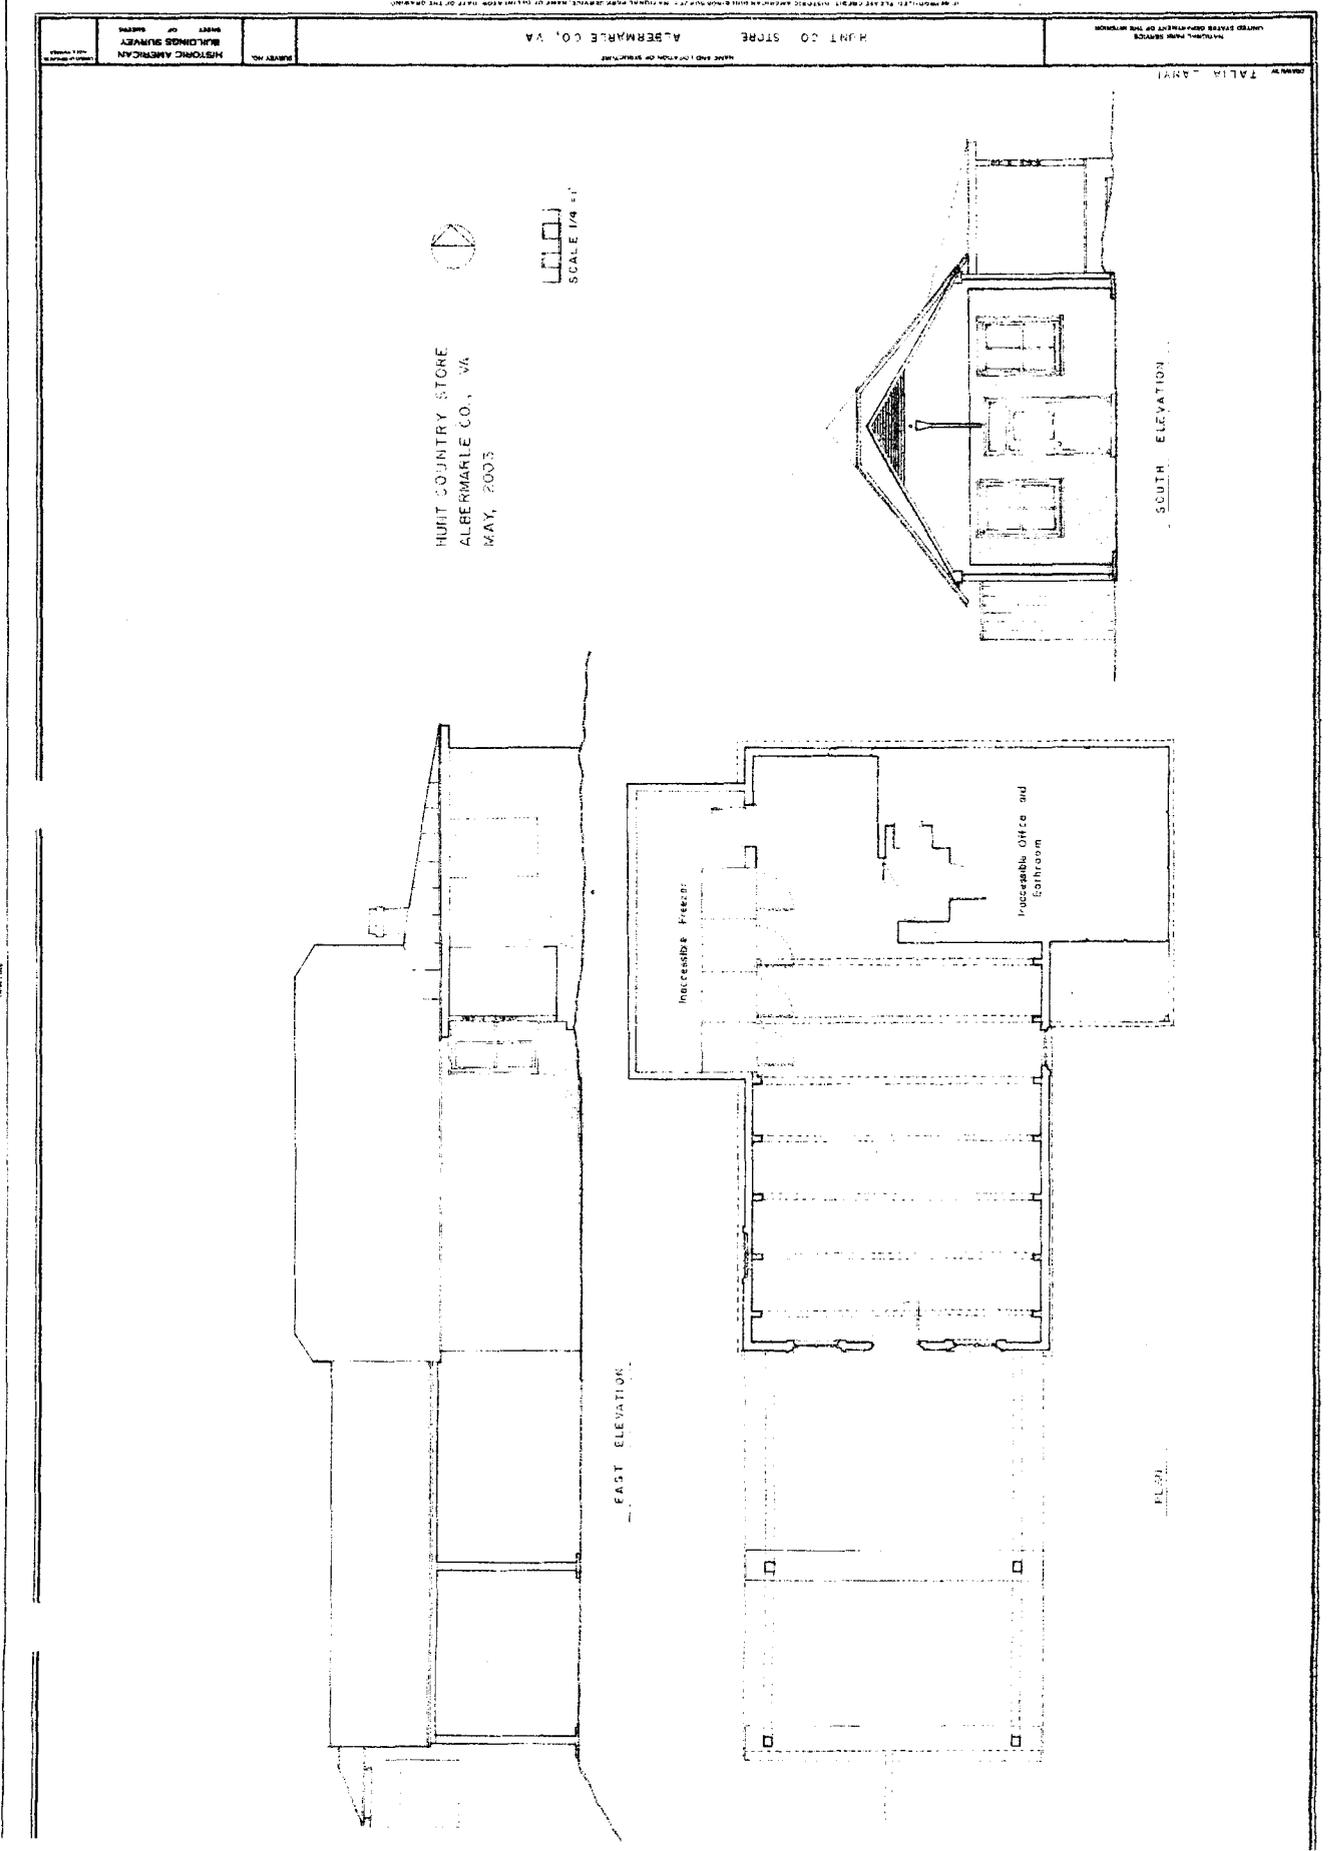
Fig. 5 Field drawings of Store – in plan as well as east & south elevations. (Drawings by Talia Lanyi)

The overall part of the building can be described as having four distinct parts. These parts include the overhang, the main building, the office wing and the freezer room. All of these parts are connected to the main store building. Based on its similarities to other datable structures, the store was likely constructed in the 1930s or 1940s.
