CRAIGS STORE
Albemarle County Country Stores Survey
2732 Craigs Store Road (Route 635)
Afton
Albemarle County
Virginia

HABS No. VA-1382

CRAIGS STORE

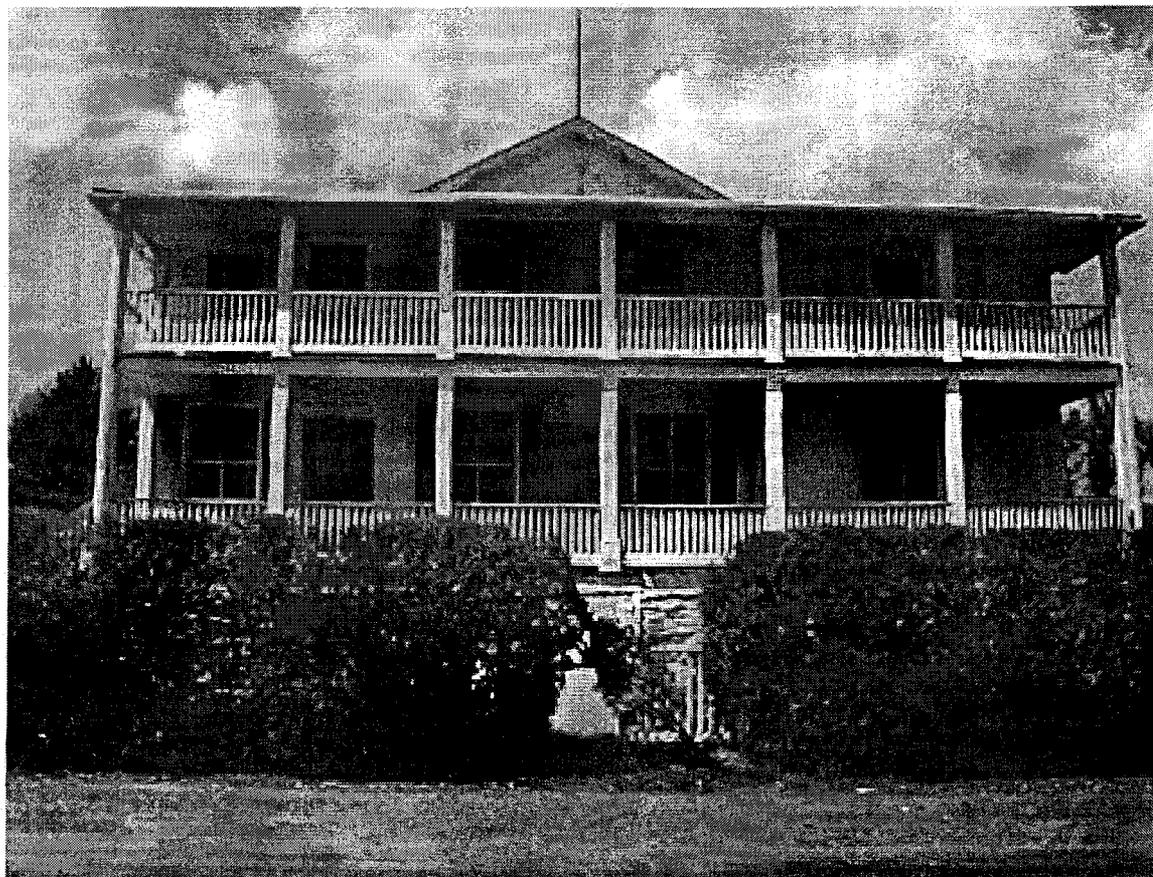
Figure 2. East (front) elevation of Craigs Store.

The front elevation of Craigs Store has a full basement story built of stone rubble; the basement is used for storage purposes (fig. 2). The basement story and foundation, both of stone rubble, is punctuated on the east facade by a white wood gate door leading under the porch to another wood door which accesses the cellar. A two-story wood porch spans the entire east elevation. The porch has square wood piers, wood railings, and beaded ceiling boards. Two doors and four single sash windows punctuate the six-bay first floor

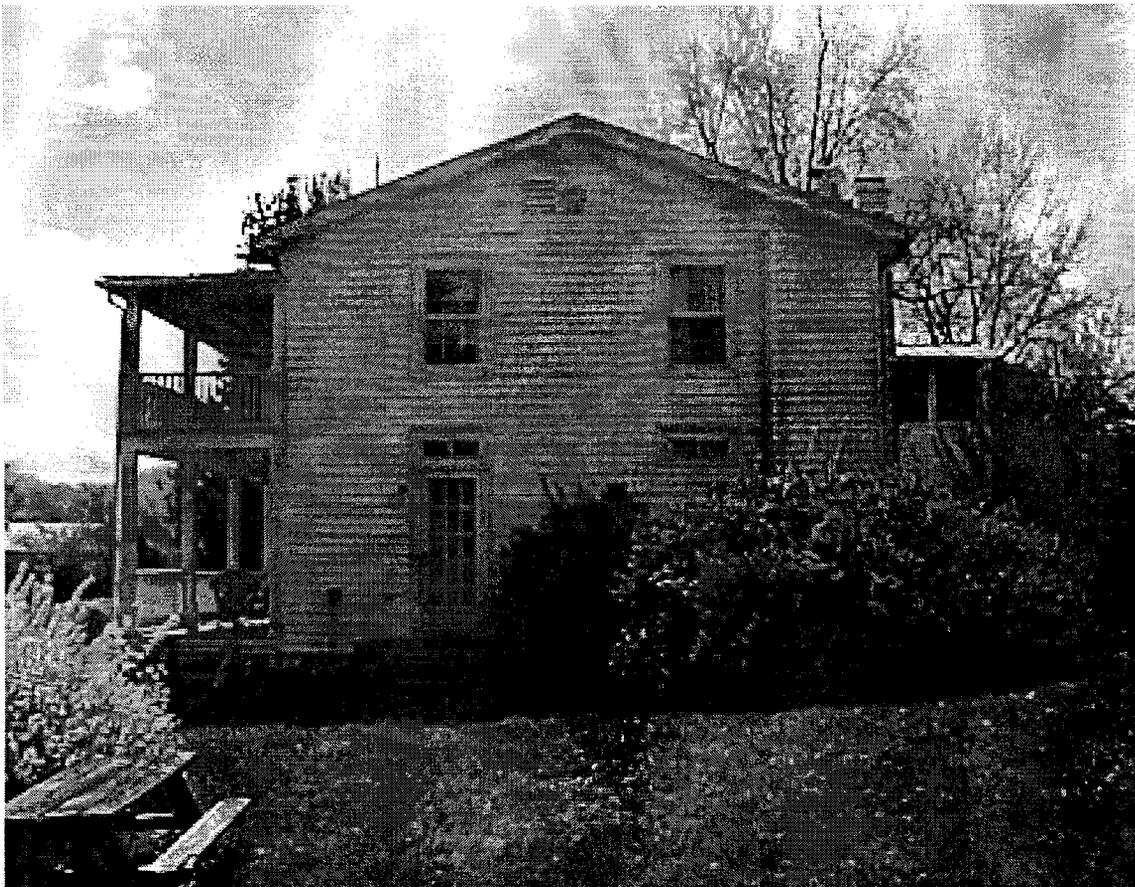
Figure 3. North elevation.

The south, west, and north elevations are clad with vinyl siding and modern, double-sash windows. The south elevation illustrates Period Two construction and has four double-sash windows. The north elevation illustrates Period Three construction and has three windows and a door (fig. 3). The west elevation has a door, two windows, and a painted stone rubble chimney in the Period One central block, one second-story window in the Period Two construction, and two windows and a brick chimney flue in the Period Three construction. The west elevation begins to illustrate the three periods of the building through its roof (fig. 4) as well as reveals the modern addition of a second-floor room supported by wood piers.

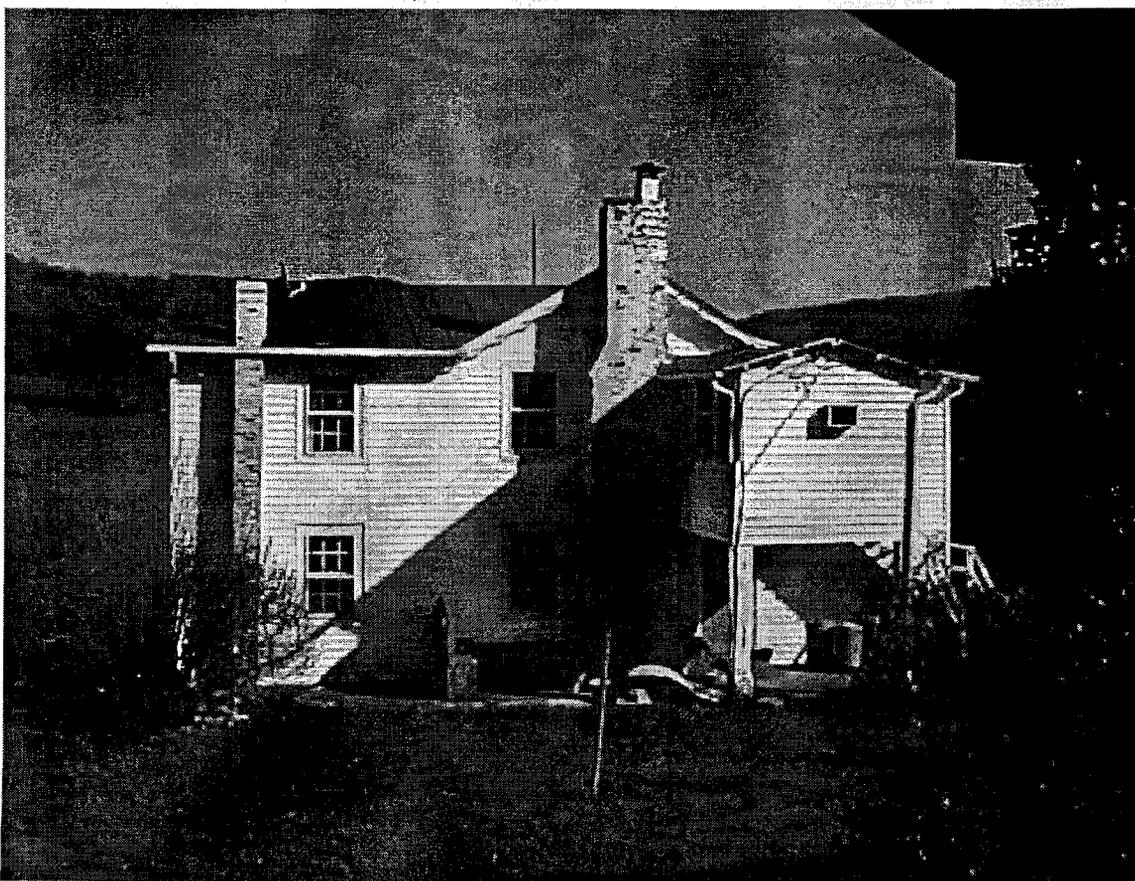
Figure 4. West (rear) elevation with the visible differences between the three different roof-framing systems.

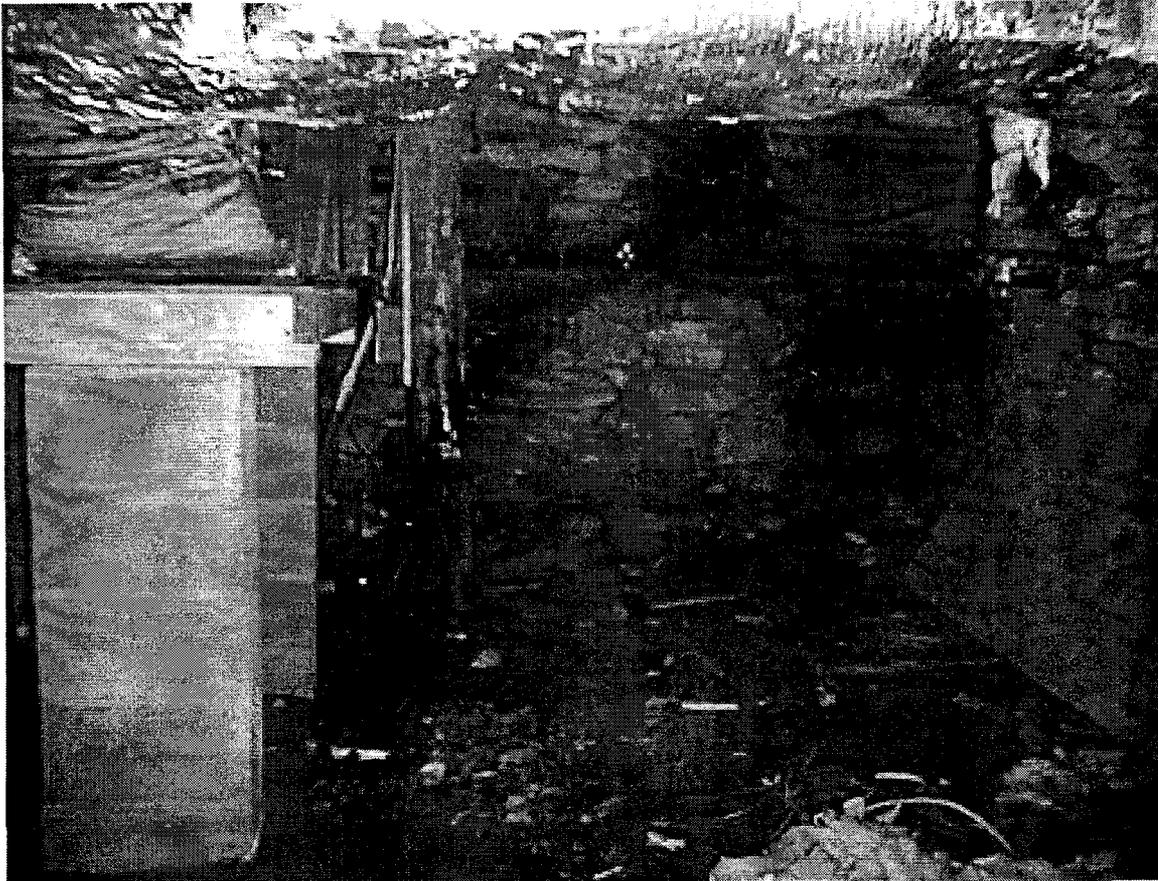
Figure 5. Stone rubble foundation of Period One.

Interior: The interior of the cellar has a red-dirt floor. The only accessible space of the cellar is that of Period One as this period's foundations create the cellar walls (fig. 5). The first floor interior consists of a large room dominating two-thirds of the space in the north portion of the house. This chamber contains the living, dining and kitchen space, and spans the footprint of Periods One and Three. Thus, all of the walls in this room are load bearing, as are the irregularly spaced wood piers connecting the Period Three addition to the Period One central block (fig. 6). The flooring consists of large, wood planks running east to west. The northwest corner of the great room leads to a modern bathroom. Interior ornamentation and detail within the house is minimal as the moldings and trim are simple wood pieces. Paneling on the south wall of the great room has large weatherboarding below the chair rail and cut nails in a few places. On the west wall of the great room is a brick mantel and hearth. The exterior of the chimney is entirely of stone rubble while the interior hearth is covered in brick. The latter represents a material alteration during Period Three because the brick is similar to the brick of the flue on the exterior of the third period construction. A door immediately south of the hearth leads to the backyard. Along the south wall of the great room, at the rear, is an enclosed staircase leading to the second story. Upon entering the house through the front door, along the south wall of the large, multipurpose chamber, there is a wood door with an original metal lock connecting to the southeast chamber. This chamber is currently used as a study. Inside this chamber are a door and a window leading to the porch on the east elevation and a window on the south elevation. The west wall of this room has a swinging door that connects to the southwest chamber, an unpainted room with one window in its south elevation. It is used for storage and laundry.

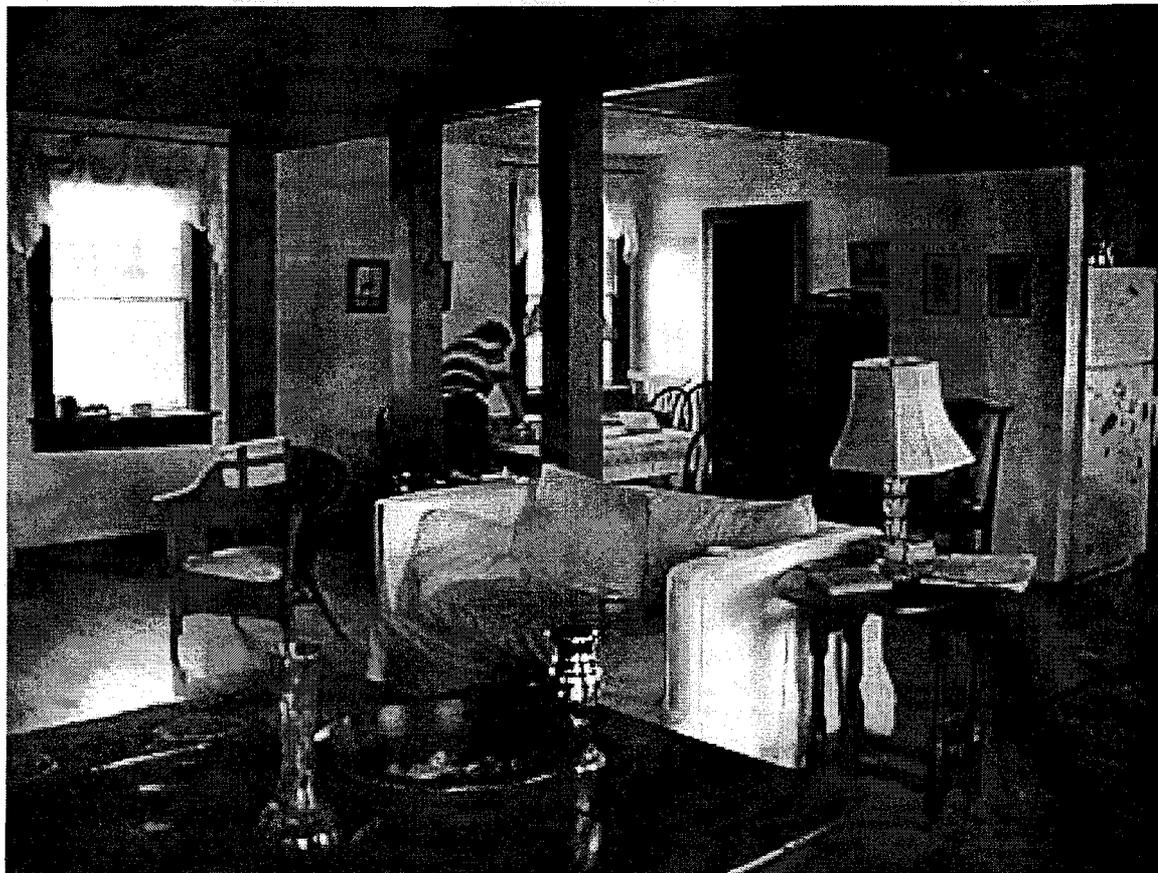
Figure 6. First floor great room interior with load-bearing piers, viewing from Period One central block north to the Period Two addition.

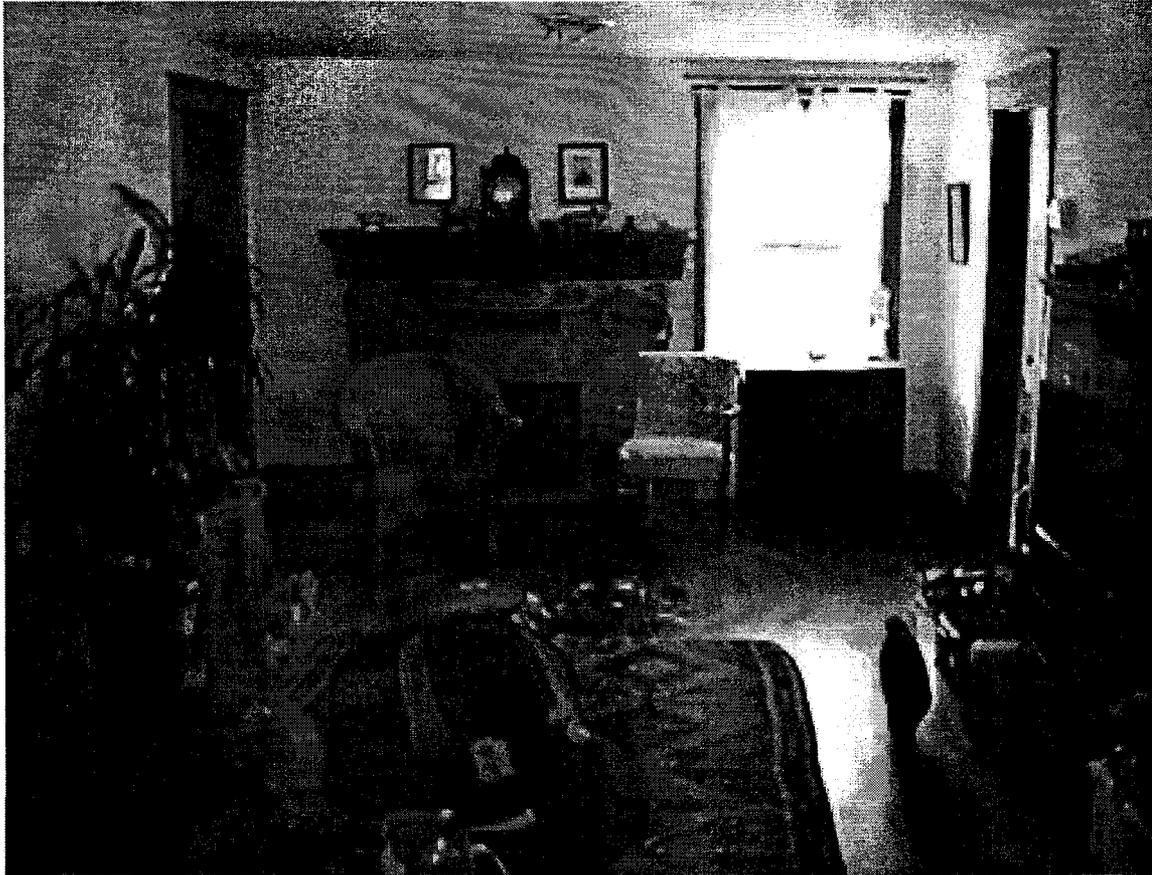
Figure 7. Second floor central hall with stone mantel, looking west.

The staircase leads to the second floor of Craigs Store and opens into a large hall with wide wood floorboards, located in the Period One section (fig. 7). The west wall of the second story has a large stone hearth, directly above the one on the first floor. The south wall of this floor has one door leading to a bedroom and bathroom, in the Period Two space. The north wall has two doors leading to two bedrooms connected by a bathroom in the Period Three section.

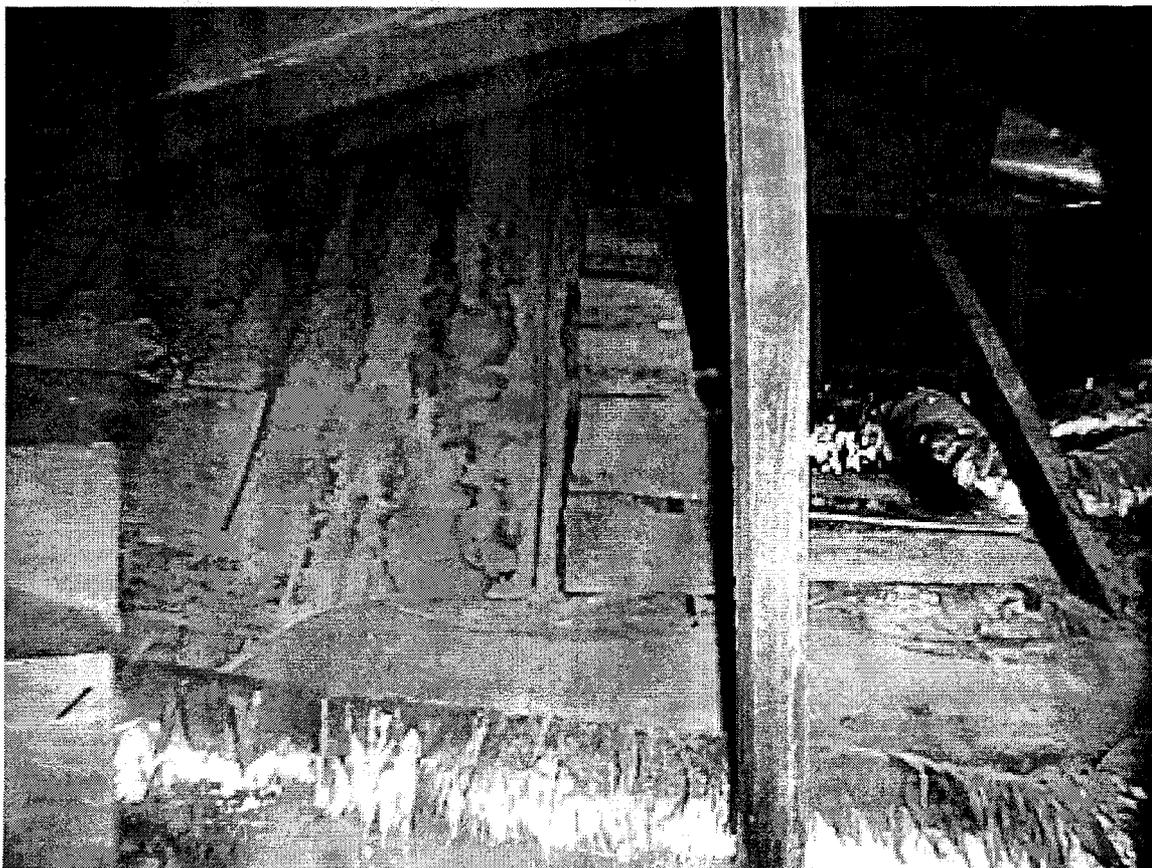
Figure 8. Looking from Period Three roof south as it cuts into Period One roof gable.

The roof framing system has provided significant insight into the various phases of Craigs Store and suggests possible construction dates. The attic is accessed through a pull-down ladder in the northeast bedroom on the second floor. The roofing system above the north one-third of the house consists of a north-south gable and is part of the Period Three construction. The Period Three roof encloses much of the Period One roof on the exterior, however the interior of the roof framing system reveals the original roof (fig. 8). The Period One roof is a gable roof running east-west and can be seen as the smaller, perpendicular gable on the exterior. The framing system of this roof has common rafters meeting at a center ridge board (fig. 9). The boarding on the roof consists of partially sawn wood boards still containing bark; a tin roof then covers the boards. The Period Two roof is inaccessible, but from the exterior is seen to be a low shed roof connecting to the Period One gable.
