CHOPAWAMSIC RECREATIONAL DEMONSTRATION AREA -  
CABIN CAMP 1, DINING HALL  
(Prince William Forest Park Cabin Camp 1 - Goodwill, Building 60)  
Prince William Forest Park  
Prince William Forest Park  
Triangle  
Prince William County  
Virginia

HABS VA-1494-A  
*HABS VA-1494-A*

### CHOPAWASMIC RECREATIONAL DEMONSTRATION AREA – CABIN CAMP 1, DINING HALL (Prince William Forest Park Cabin Camp 1 – Goodwill, Building 60)

HABS No. VA-1494-A

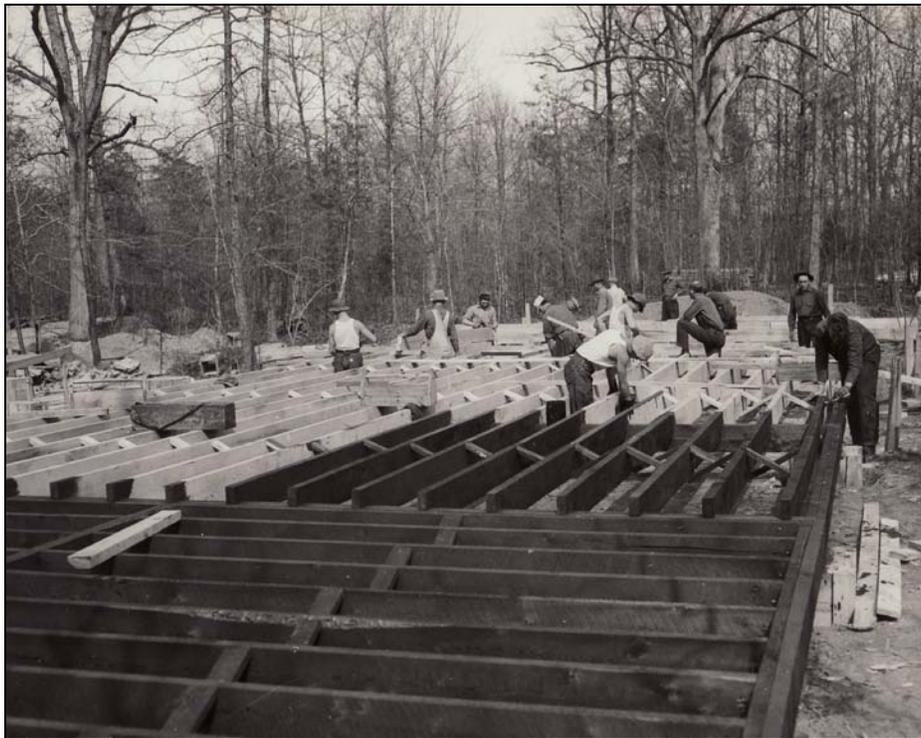
Figure 1: Camp 1 Dining Hall Under Construction, 30 March 1936.  
Source: Record Group 79, National Archives & Records Administration II.

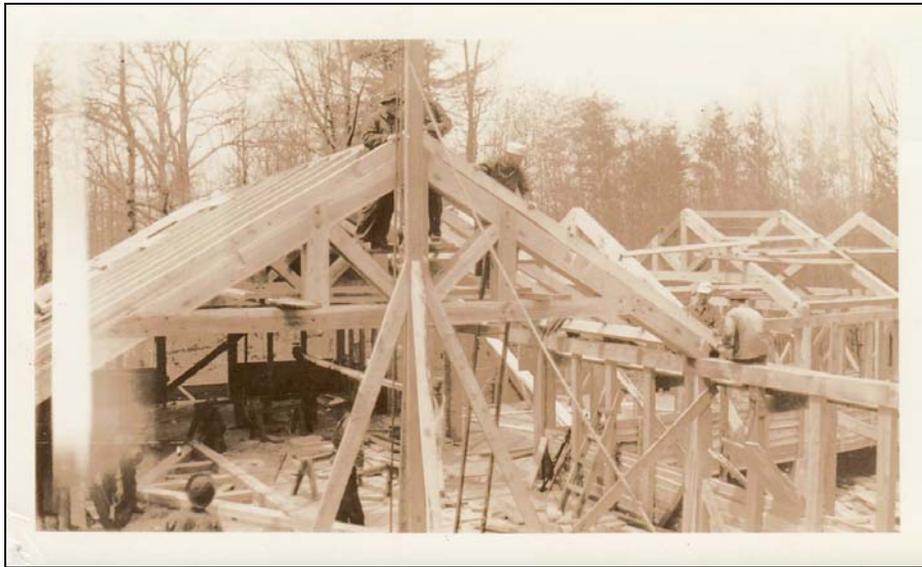
Figure 2: Construction of Camp 1 Dining Hall Trusses, c. April 1936.  
Source: File 3764, PRWI Archives.

4. Structural system, framing: The Dining Hall is a load-bearing, heavy timber structure on concrete piers. The roof is supported by large trusses formed from sistered two by eight planks held together with metal bolts. The ends of the trusses rest on a heavy timber tilted false plate. The vertical truss members are tenoned into the horizontal ones. There is a large timber ridge beam, and rafters rest above each truss (Figure 8).

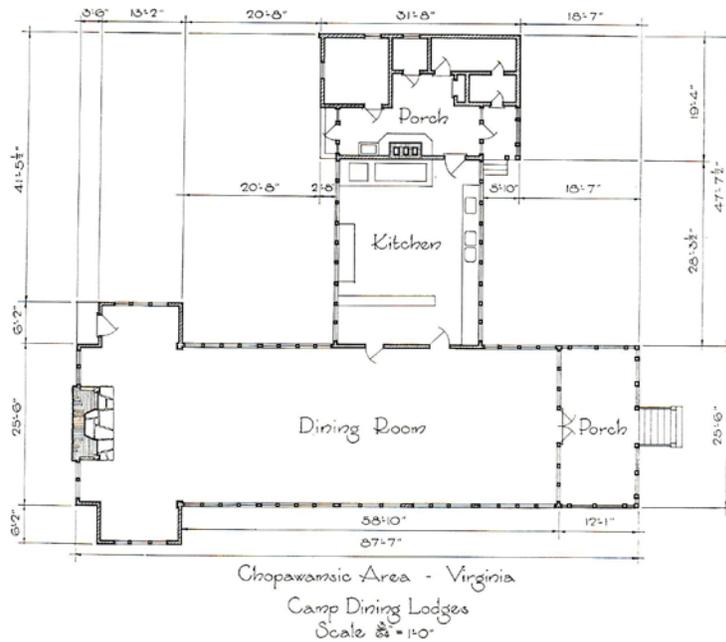
Figure 3: Chopawamsic RDA Dining Hall Floor Plan (Camp 2).  
Source: adapted from Good, *Park and Recreation Structures*.

four Chopawamsic camp dining halls, but not identical. It most closely resembles the Camp 2 Dining Hall, which has a mirror-image plan.

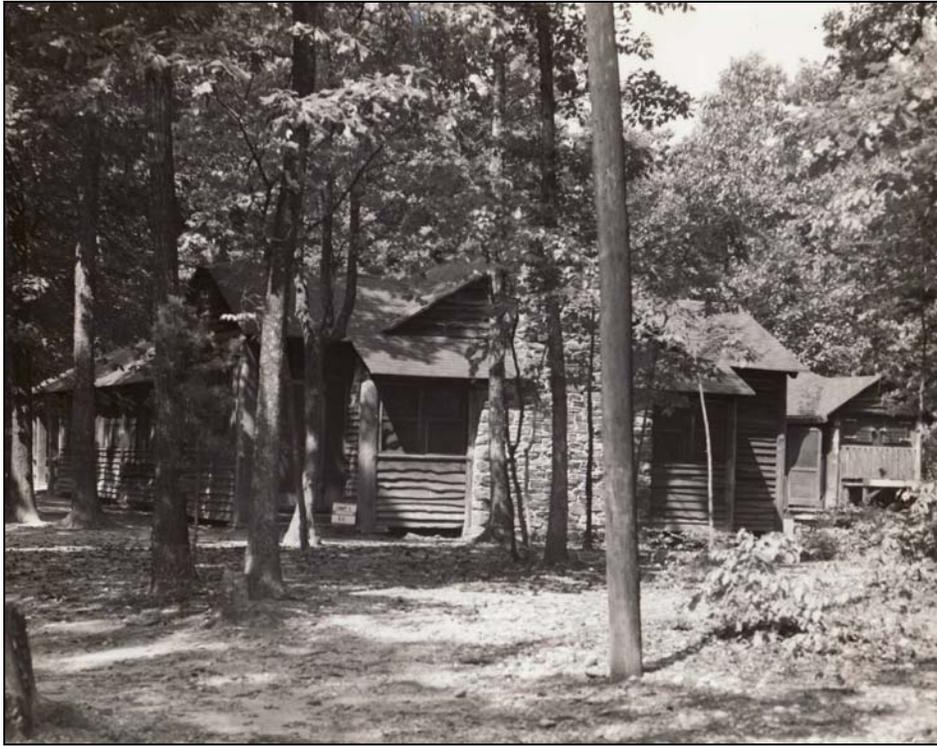
Figure 4: View of Camp 1 Dining Hall, 1951. Note exterior ice box doors at right.  
Source: File 2684, PRWI Archives.

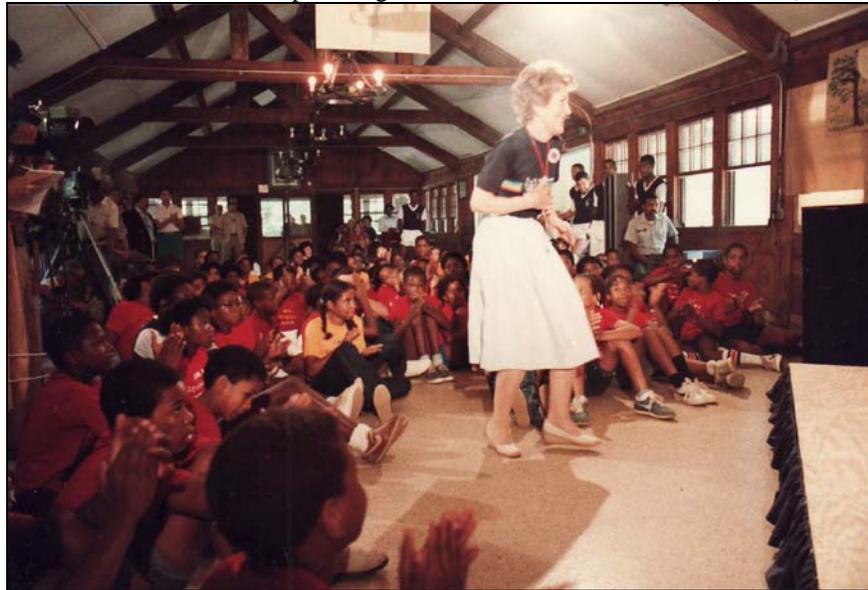
Figure 7: First Lady Nancy Reagan Inside the Camp 1 Dining Hall During a Visit.  
Source: File 1754, PRWI Archives.

The dining room ceiling is unfinished wood beam trusses while the kitchen has a white painted plywood tray ceiling. Photographs from the early 1980s (see Figure 7) show a plywood or fiberboard ceiling which has been removed. There is a hatch in the kitchen ceiling near the range. The pantry area also has white plywood ceilings.

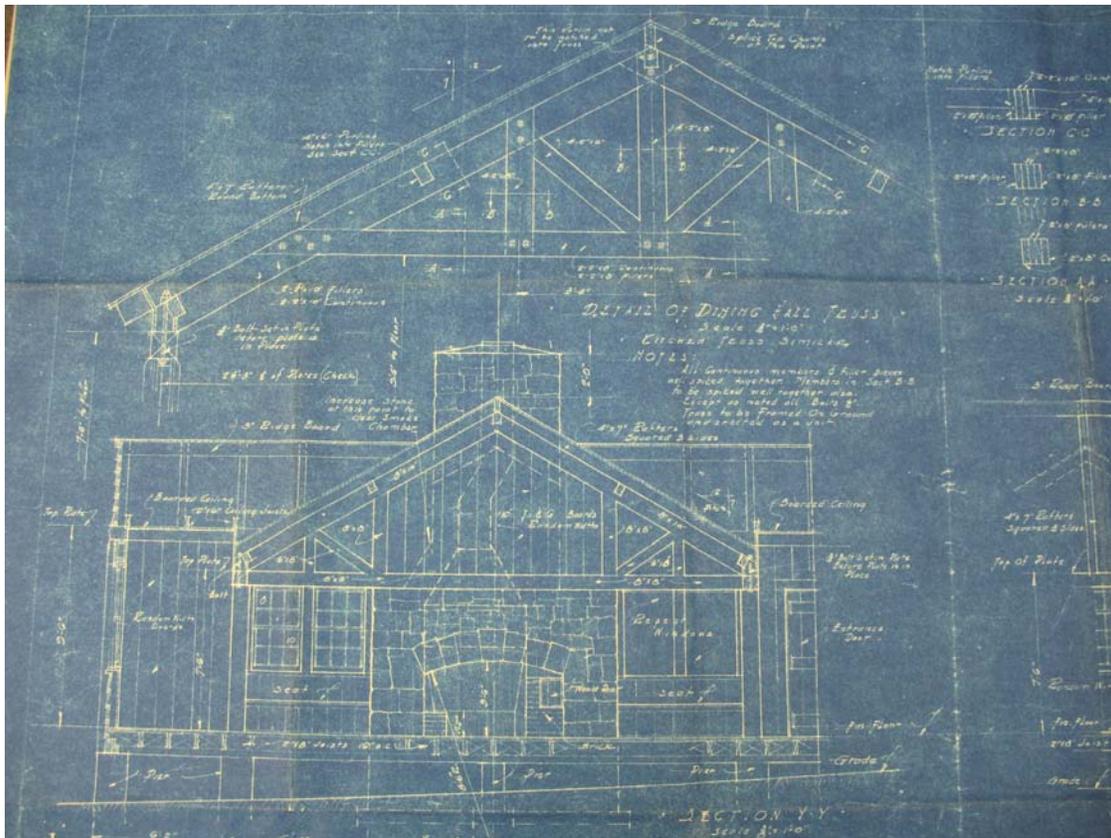
Figure 8: Blueprint Detail of Camp 1 Dining Hall Truss and Fireplace, 17 March 1936.  
Source: File 3662, PRWI Archives.
