CHOPAWAMSIC RECREATIONAL DEMONSTRATION AREA -
CABIN CAMP 1, UNIT LODGE A
(Prince William Forest Park Cabin Camp 1 - Goodwill, Building A12)
Prince William Forest Park
Prince William Forest Park
Triangle
Prince William County
Virginia

HABS VA-1494-J
HABS VA-1494-J

CHOPAWASMIC RECREATIONAL DEMONSTRATION AREA – CABIN CAMP 1,
UNIT LODGE A

HABS No. VA-1494-J

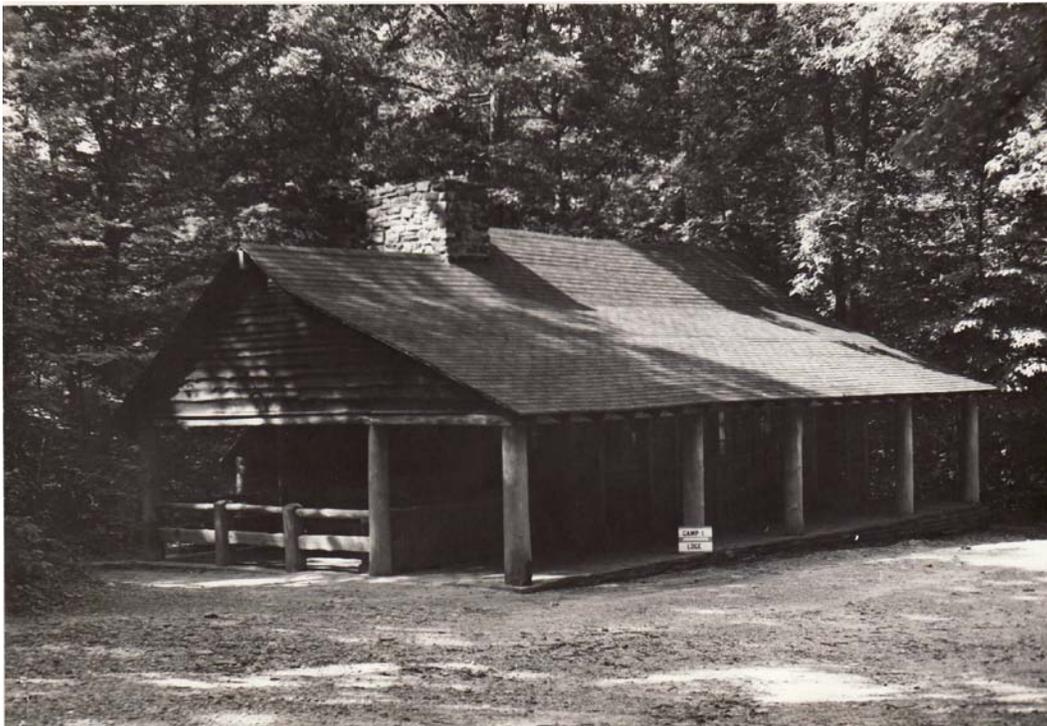
Figure 1: View of Camp 1 Unit Lodge A, c. 1952.
Source: File 2672, PRWI Archives.

B. Early Views: An exterior photograph of Unit Lodge A from a 1952 inventory is located in the PRWI Archives (File 2672) (Figure 1).
